Figure 38. Distribution of selected water-quality constituents relative to time for  
Patterson Hollow at Highway 50 near Vroman, Co., station 380456103473701.

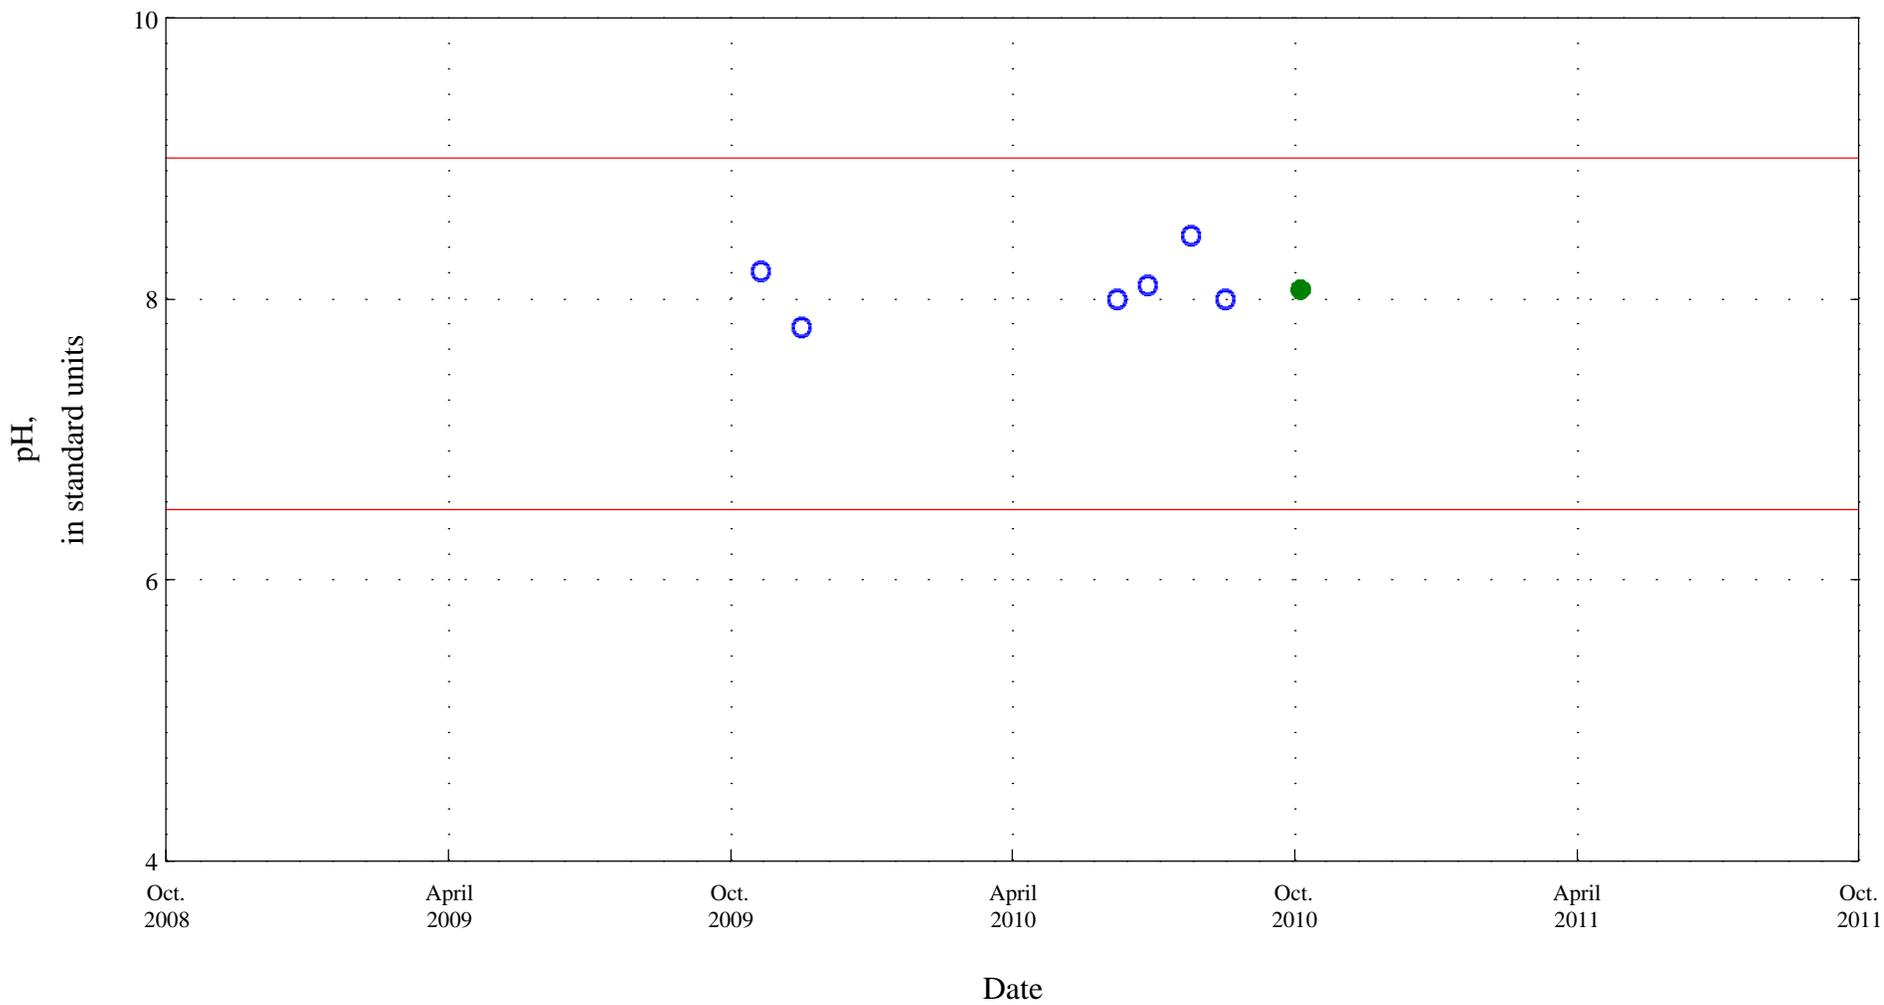
Figure 38. Distribution of selected water-quality constituents relative to time for  
Patterson Hollow at Highway 50 near Vroman, Co., station 380456103473701.

Aquatic Life Standard 6.5 to 9.0

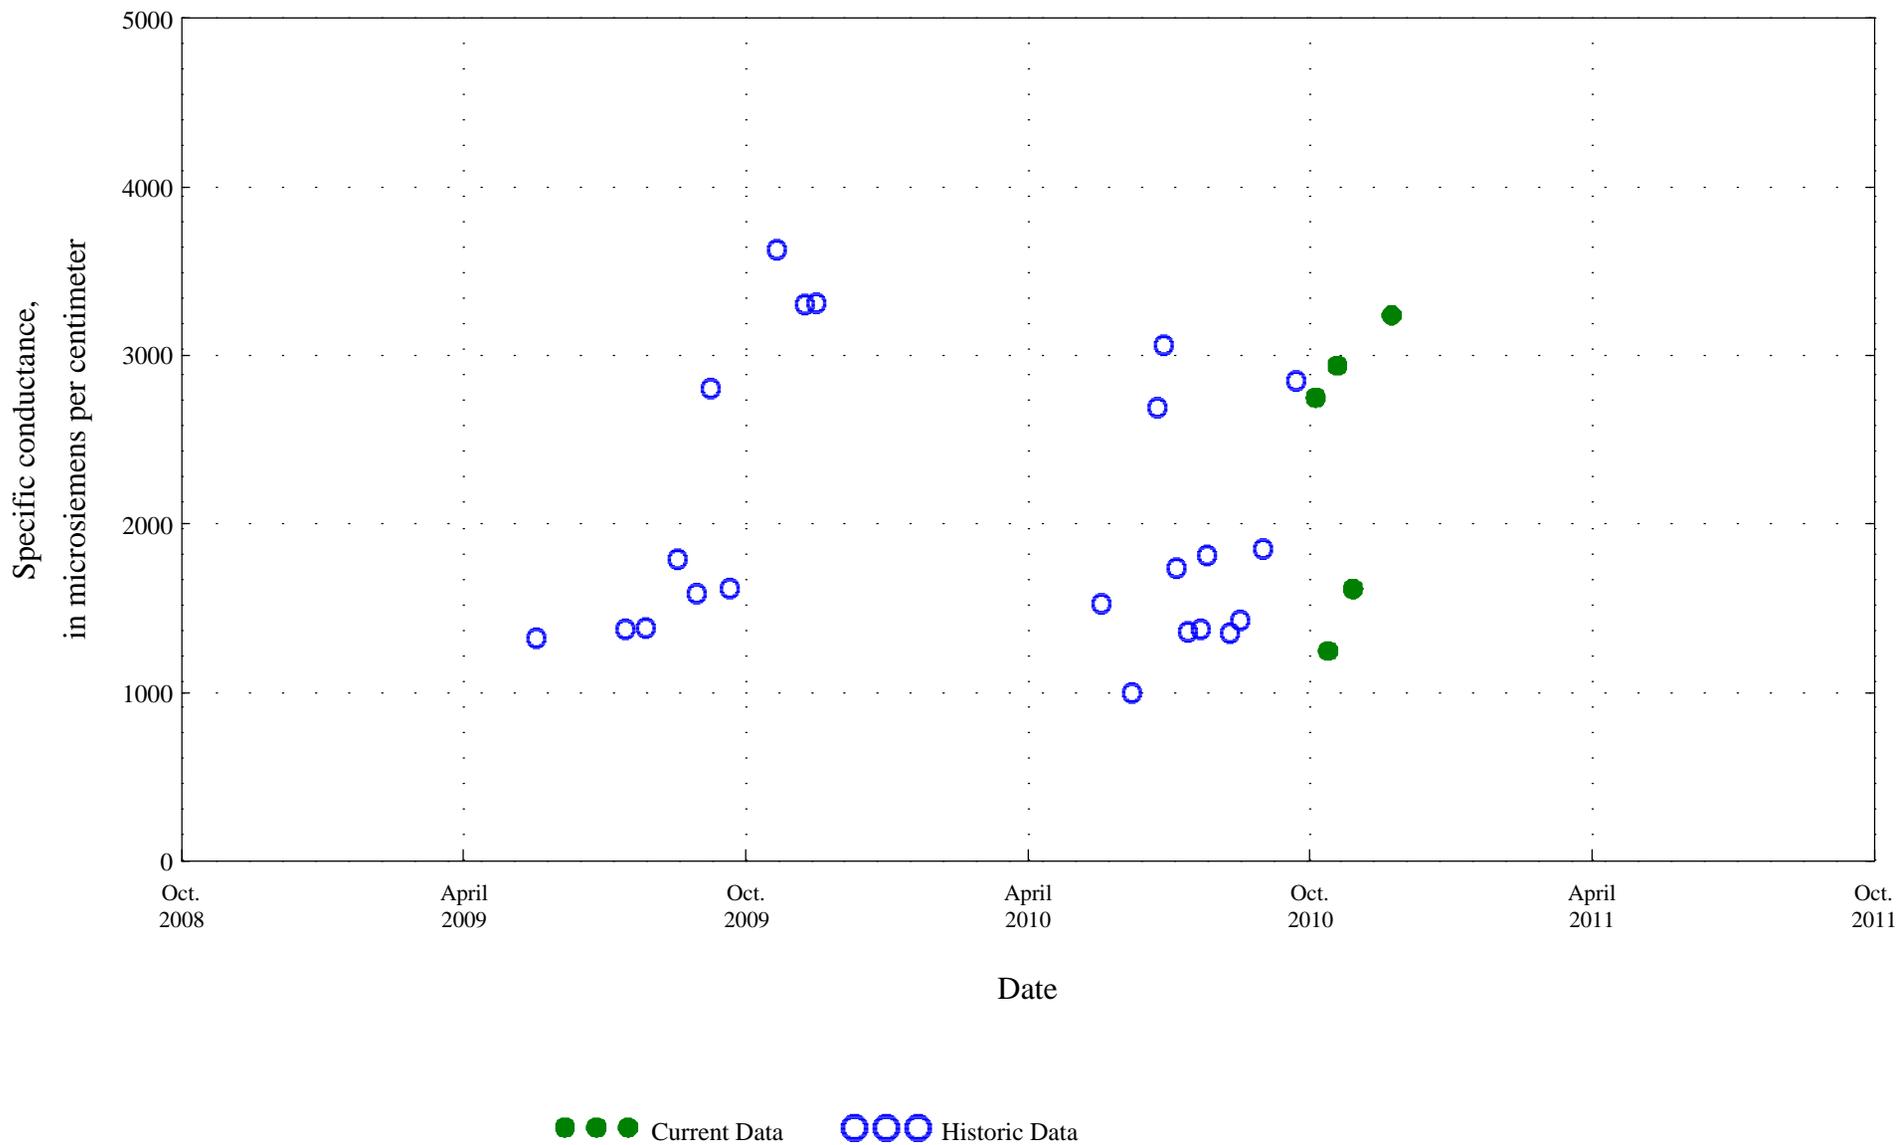
Figure 38. Distribution of selected water-quality constituents relative to time for  
Patterson Hollow at Highway 50 near Vroman, Co., station 380456103473701.

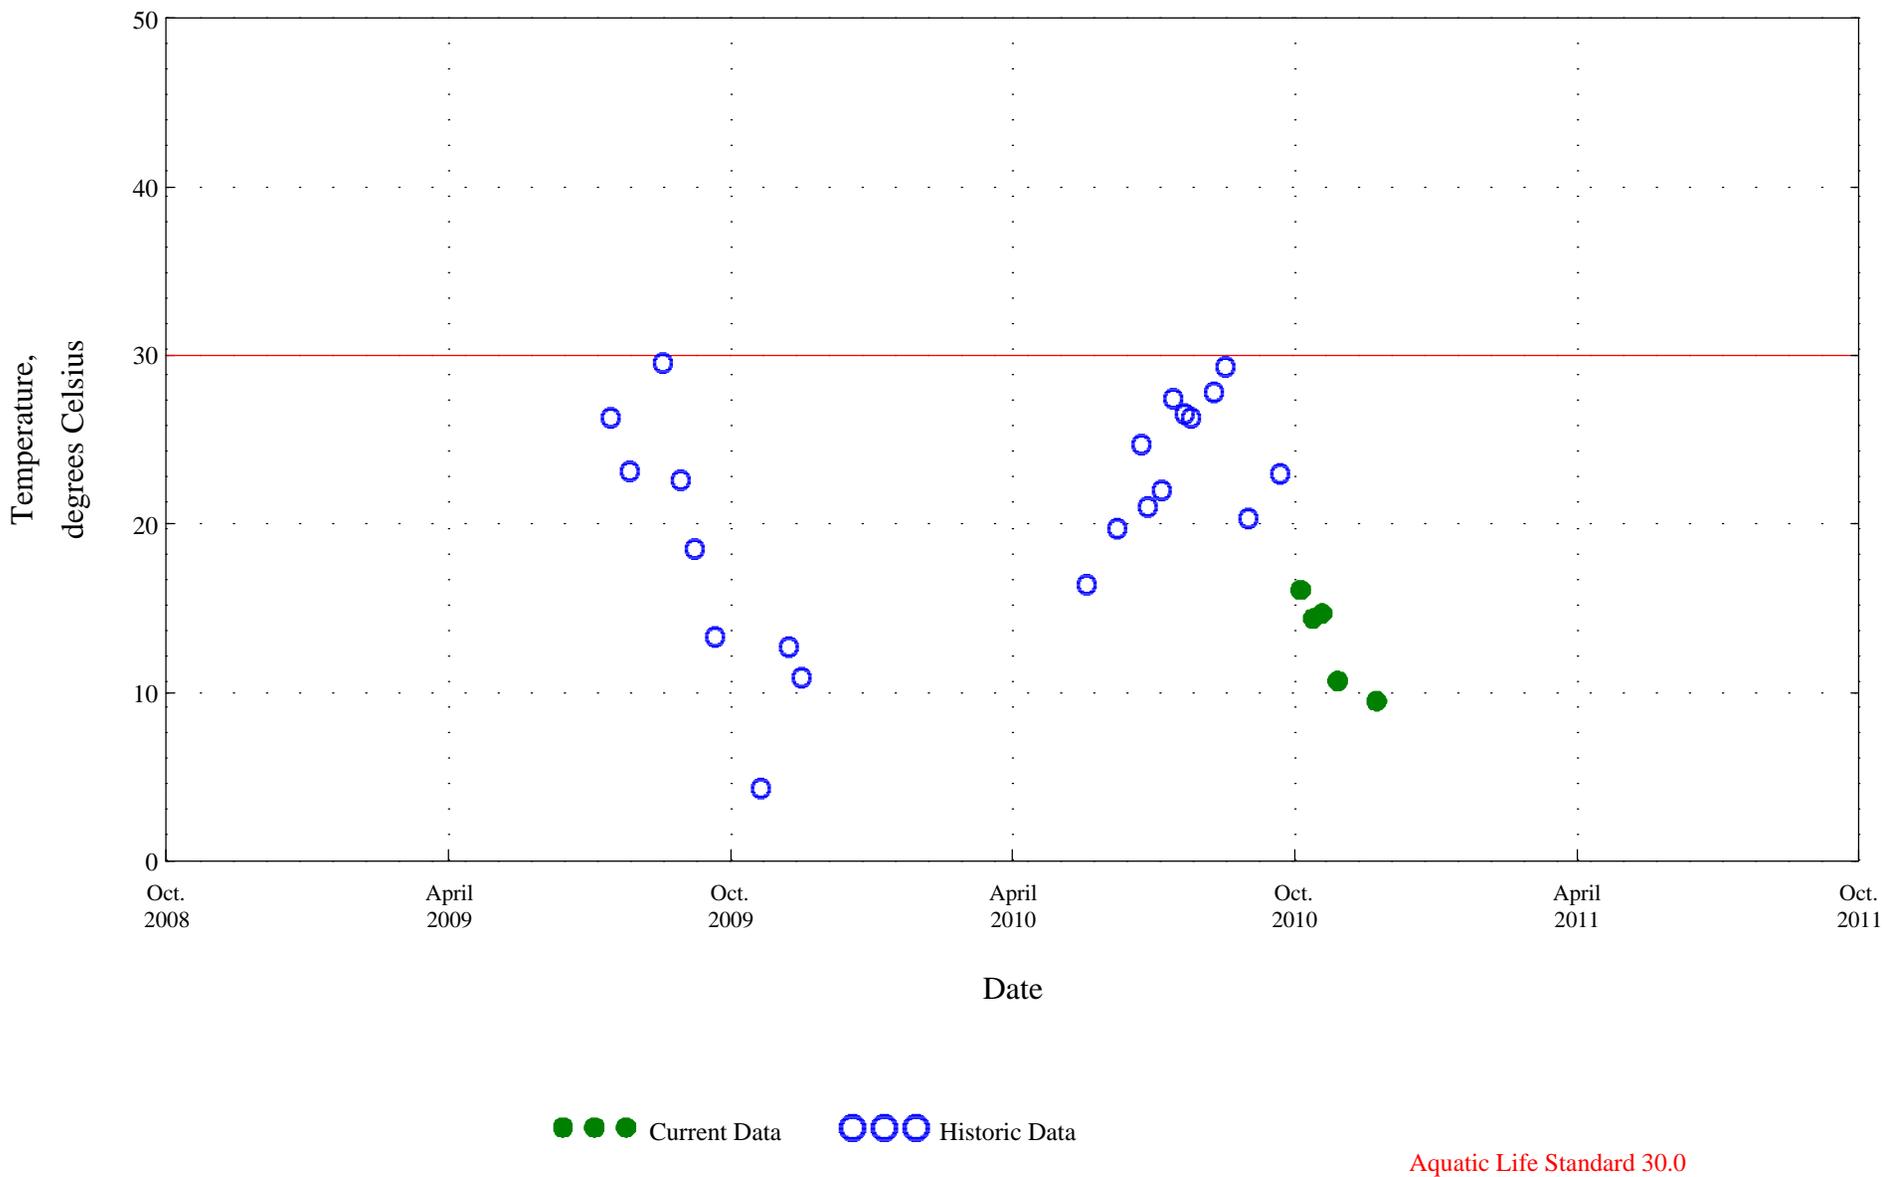
Figure 38. Distribution of selected water-quality constituents relative to time for  
Patterson Hollow at Highway 50 near Vroman, Co., station 380456103473701.

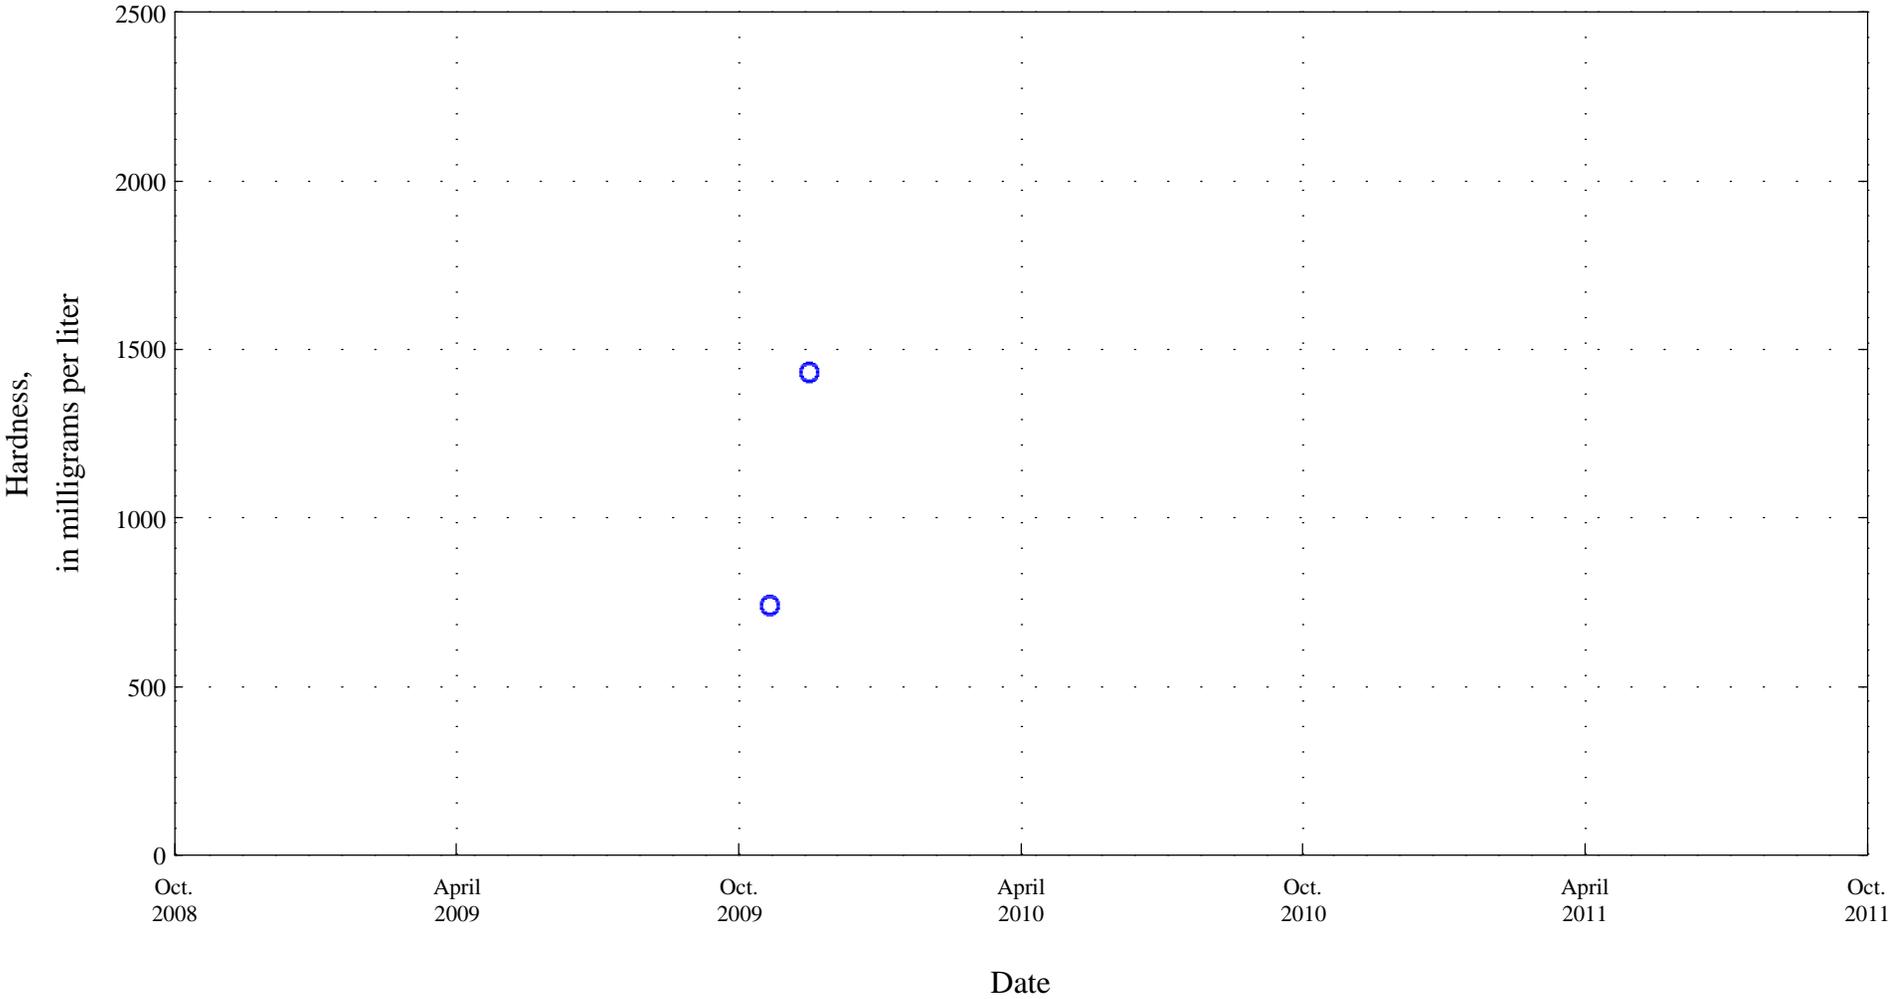
Figure 38. Distribution of selected water-quality constituents relative to time for  
Patterson Hollow at Highway 50 near Vroman, Co., station 380456103473701.

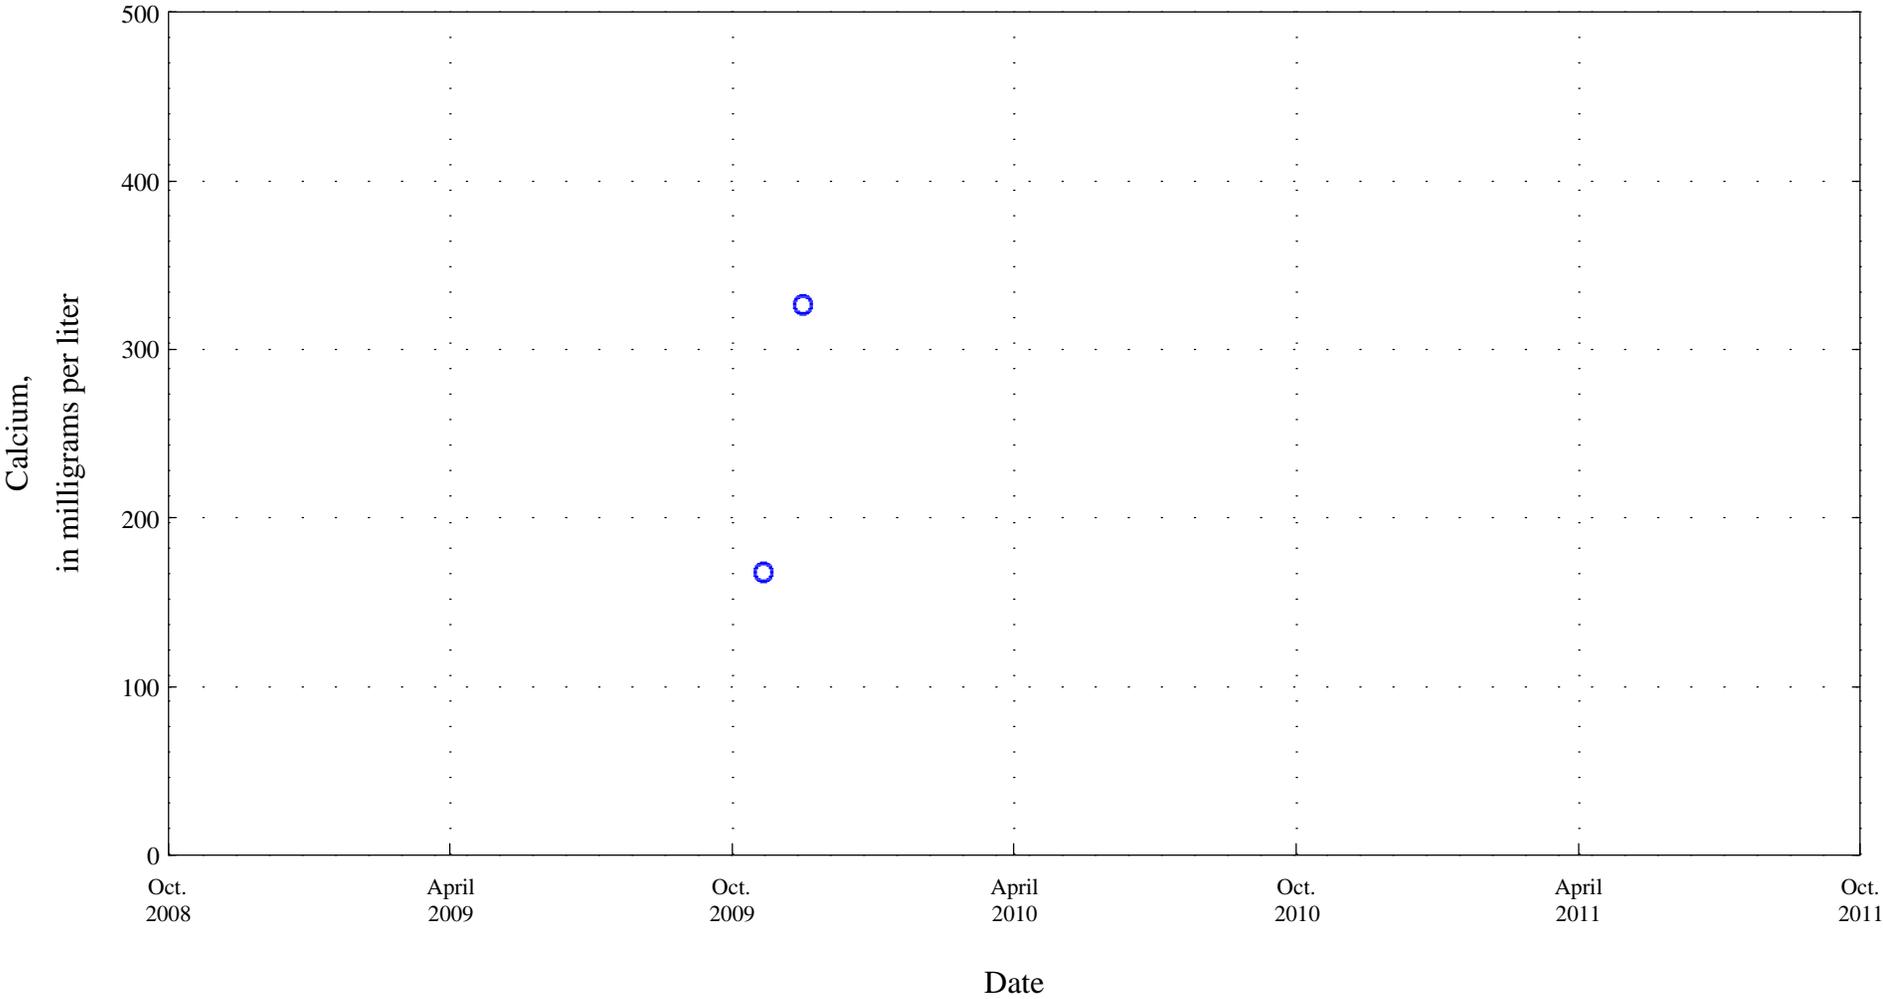
Figure 38. Distribution of selected water-quality constituents relative to time for  
Patterson Hollow at Highway 50 near Vroman, Co., station 380456103473701.

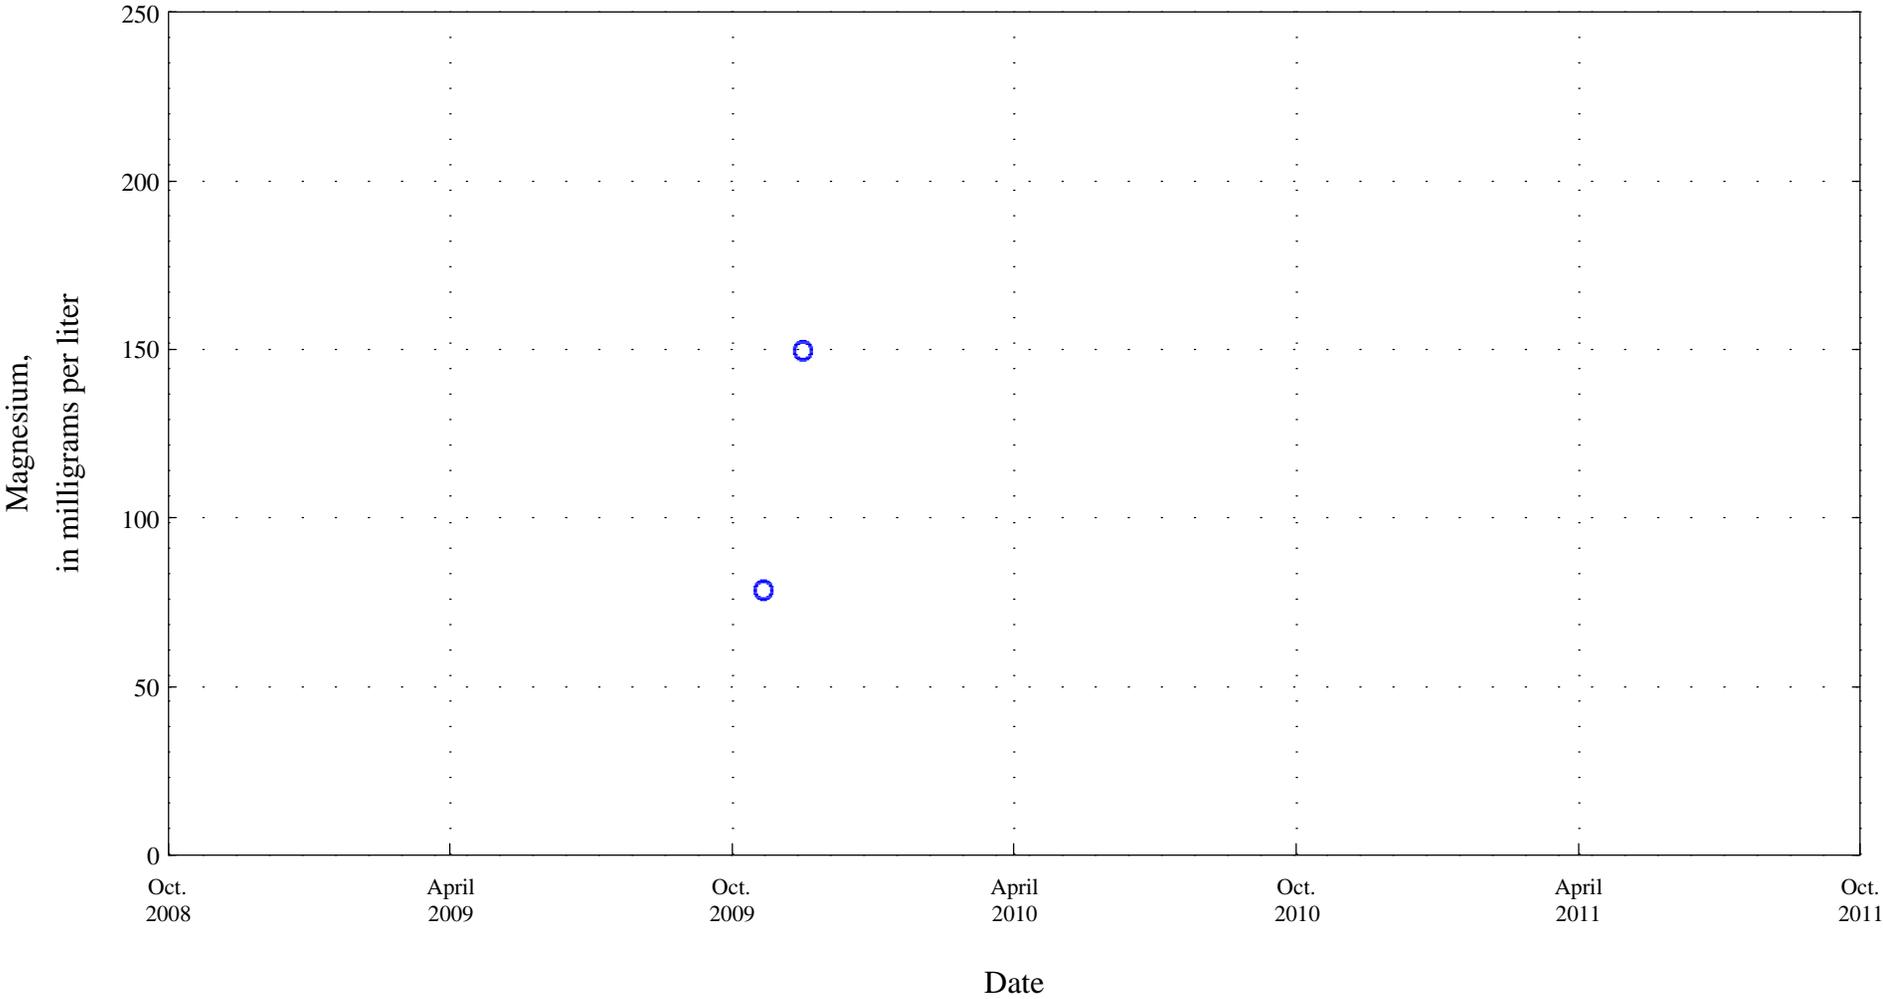
Figure 38. Distribution of selected water-quality constituents relative to time for  
Patterson Hollow at Highway 50 near Vroman, Co., station 380456103473701.

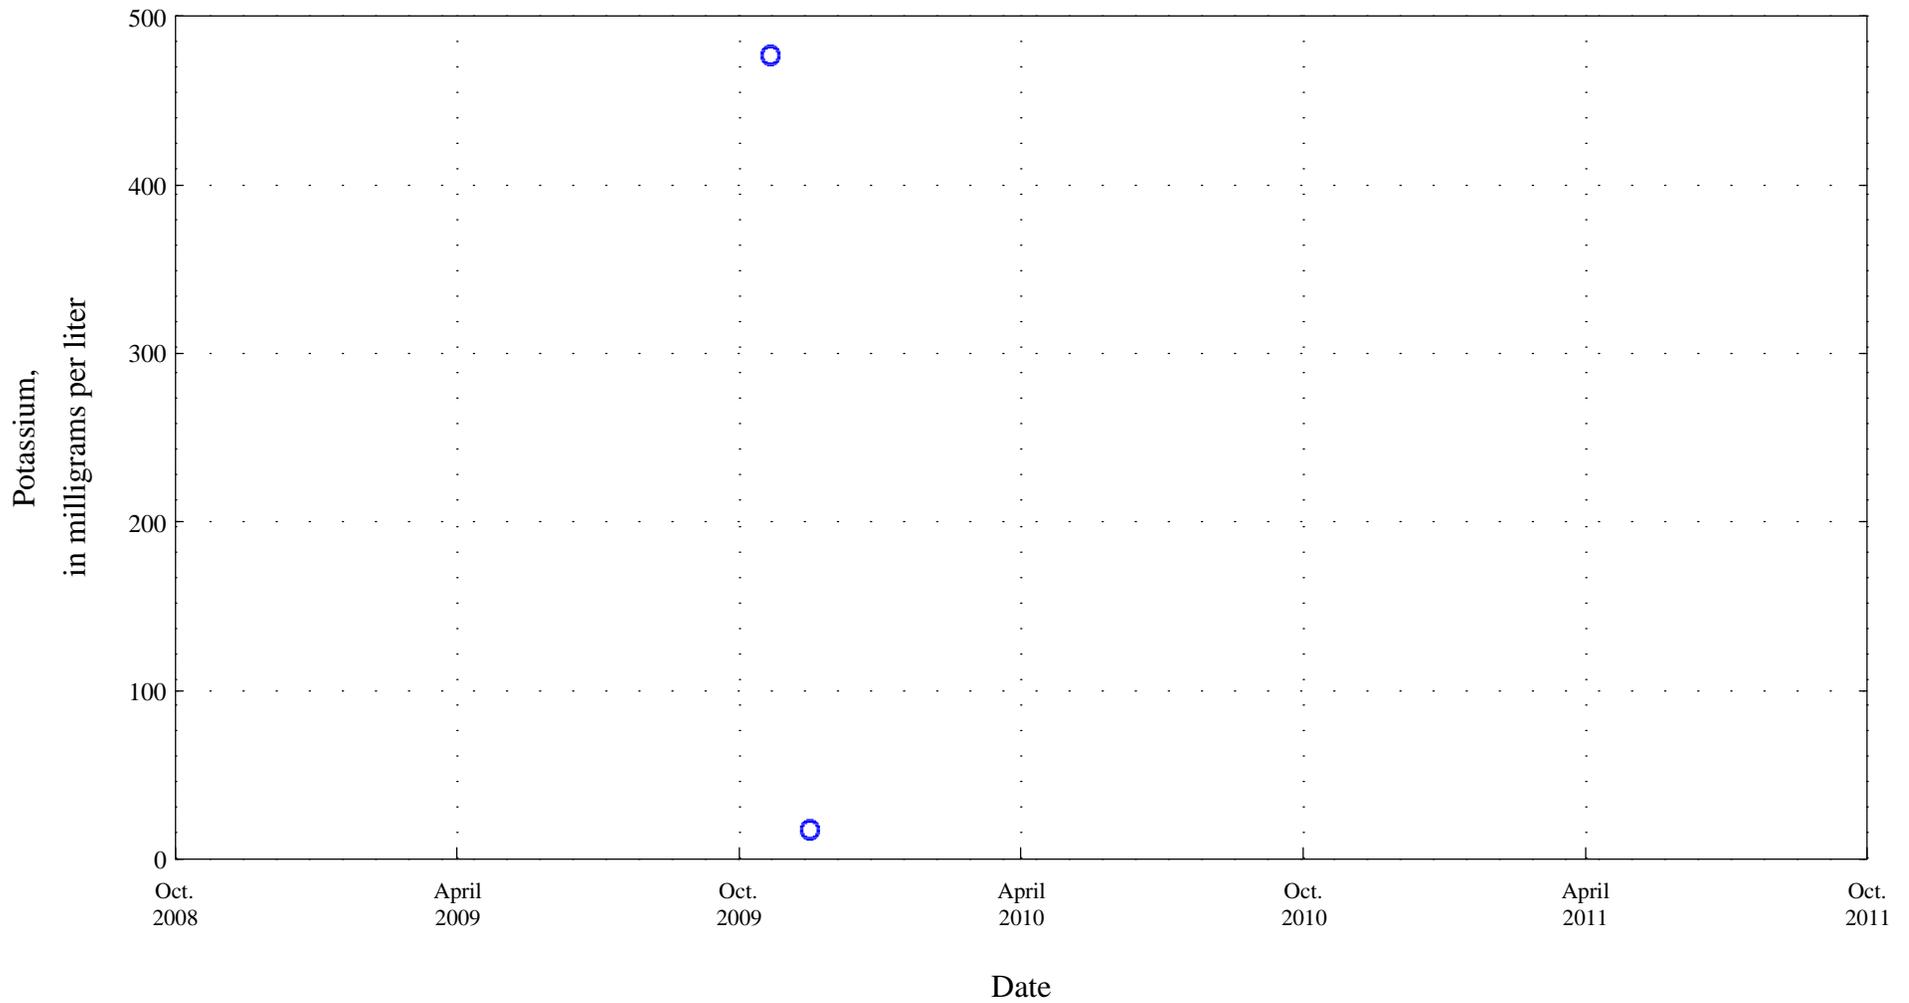
Figure 38. Distribution of selected water-quality constituents relative to time for Patterson Hollow at Highway 50 near Vroman, Co., station 380456103473701.

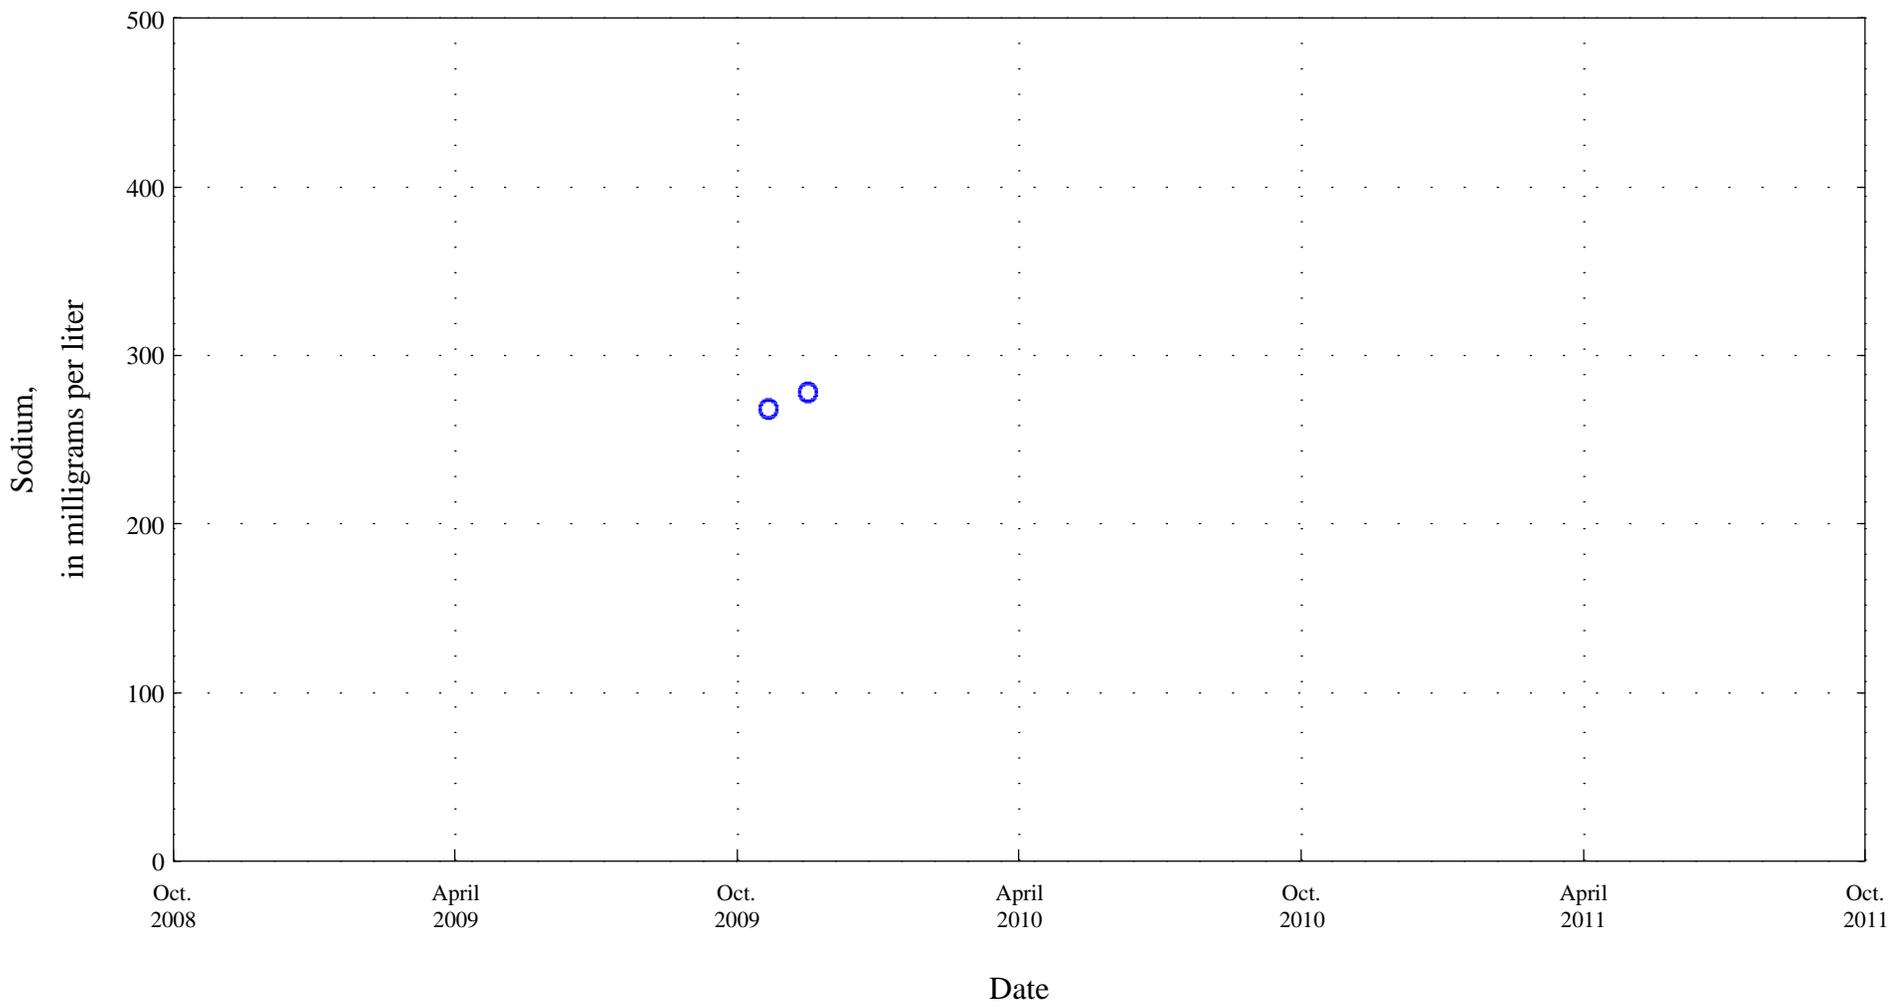
Figure 38. Distribution of selected water-quality constituents relative to time for  
Patterson Hollow at Highway 50 near Vroman, Co., station 380456103473701.

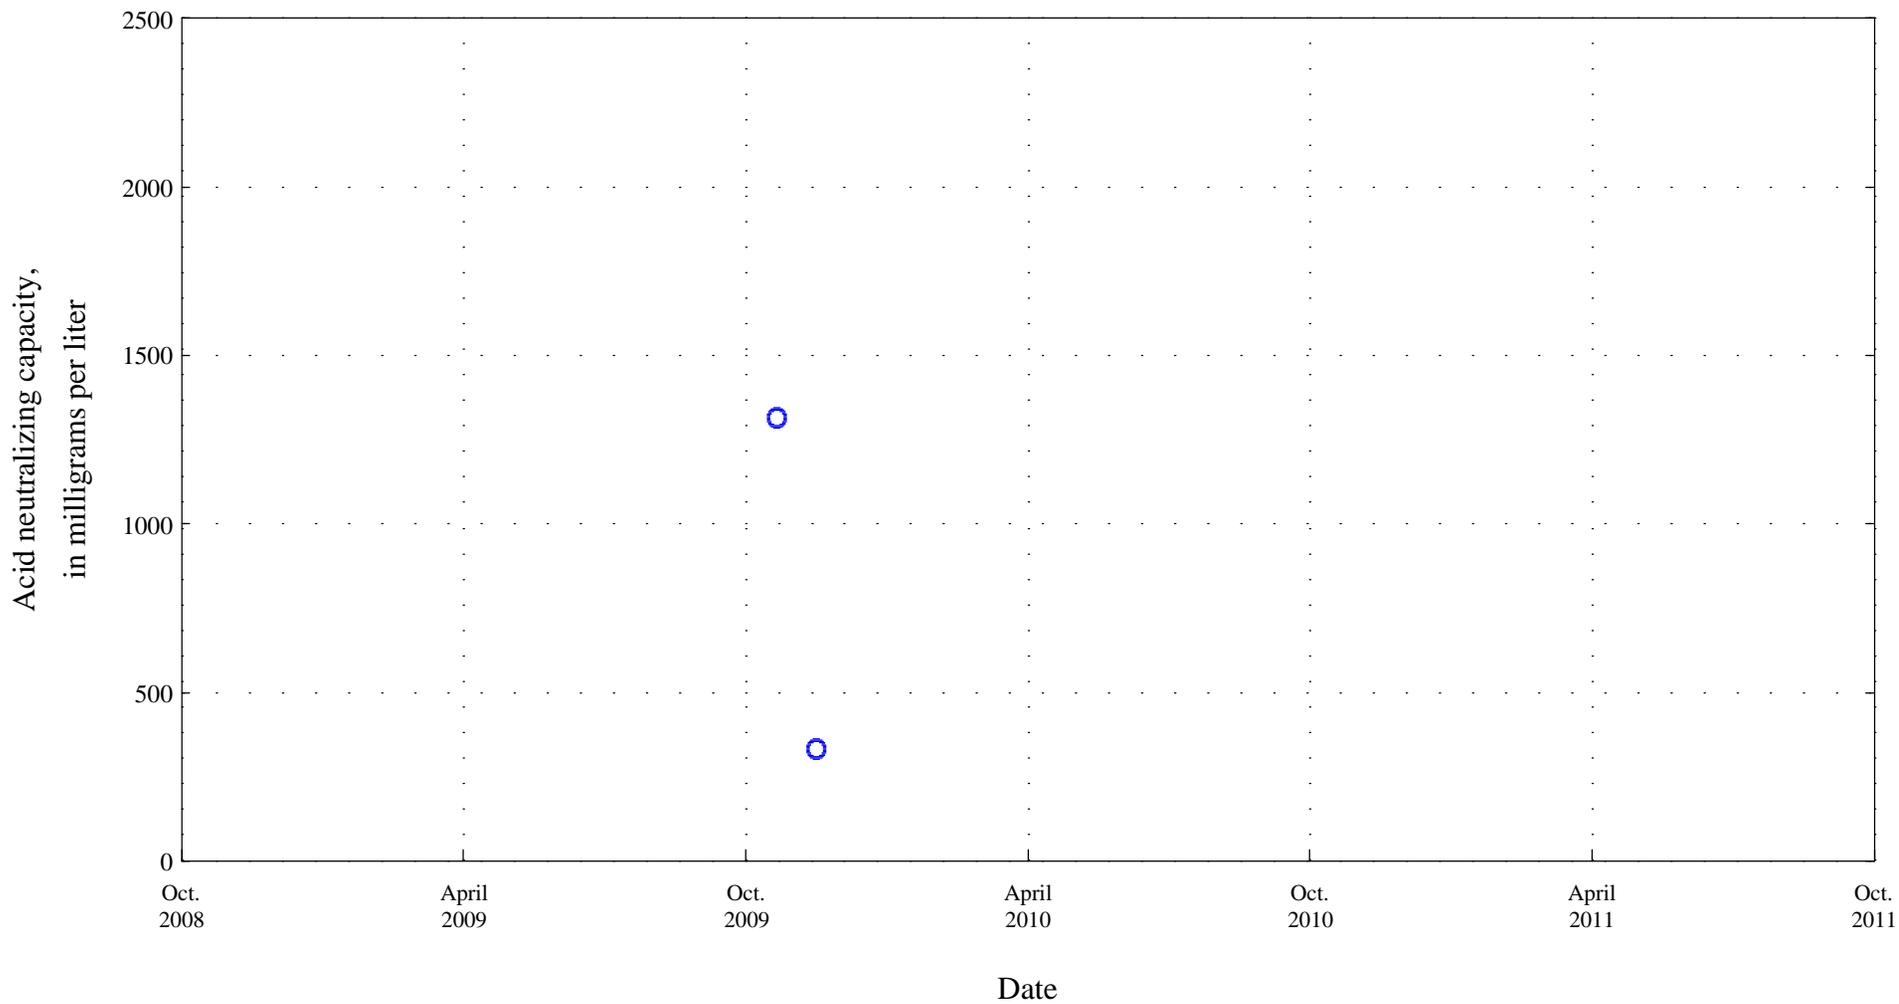
Figure 38. Distribution of selected water-quality constituents relative to time for  
Patterson Hollow at Highway 50 near Vroman, Co., station 380456103473701.

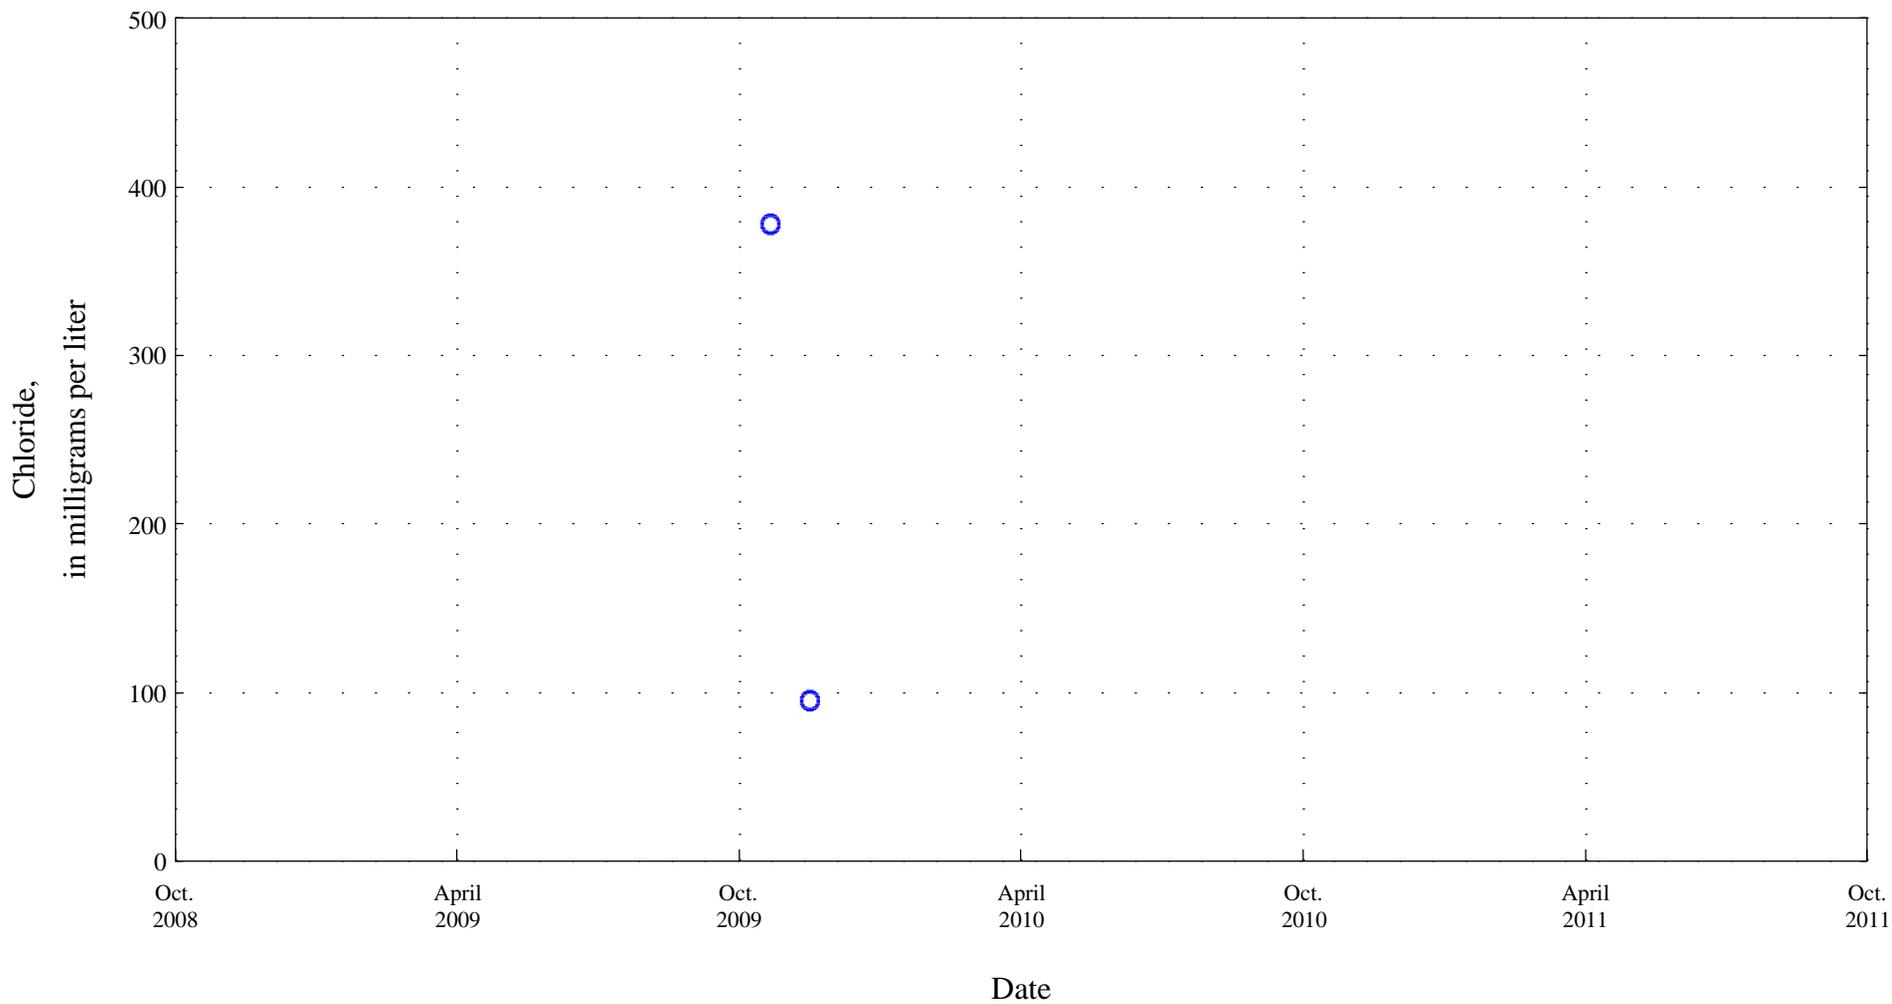
Figure 38. Distribution of selected water-quality constituents relative to time for Patterson Hollow at Highway 50 near Vroman, Co., station 380456103473701.

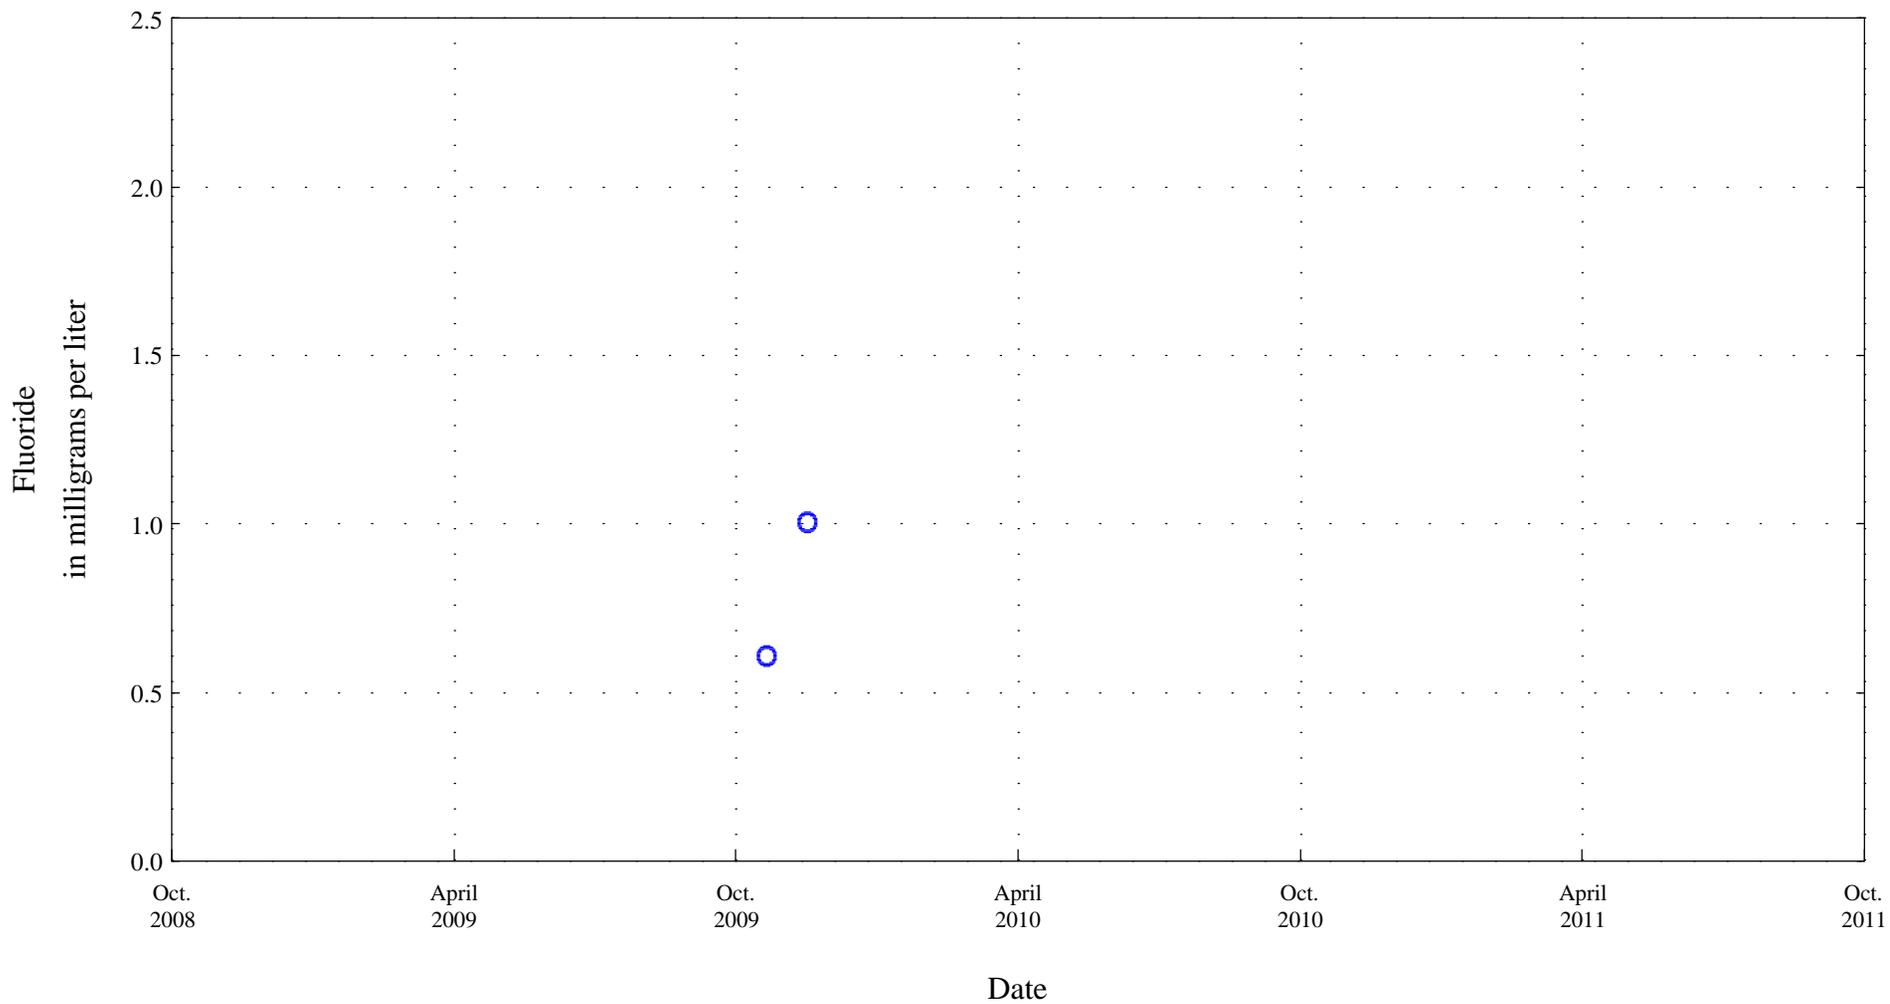
Figure 38. Distribution of selected water-quality constituents relative to time for  
Patterson Hollow at Highway 50 near Vroman, Co., station 380456103473701.
