Figure 38. Distribution of selected water-quality constituents relative to time for  
Patterson Hollow at Highway 50 near Vroman, Co., station 380456103473701.

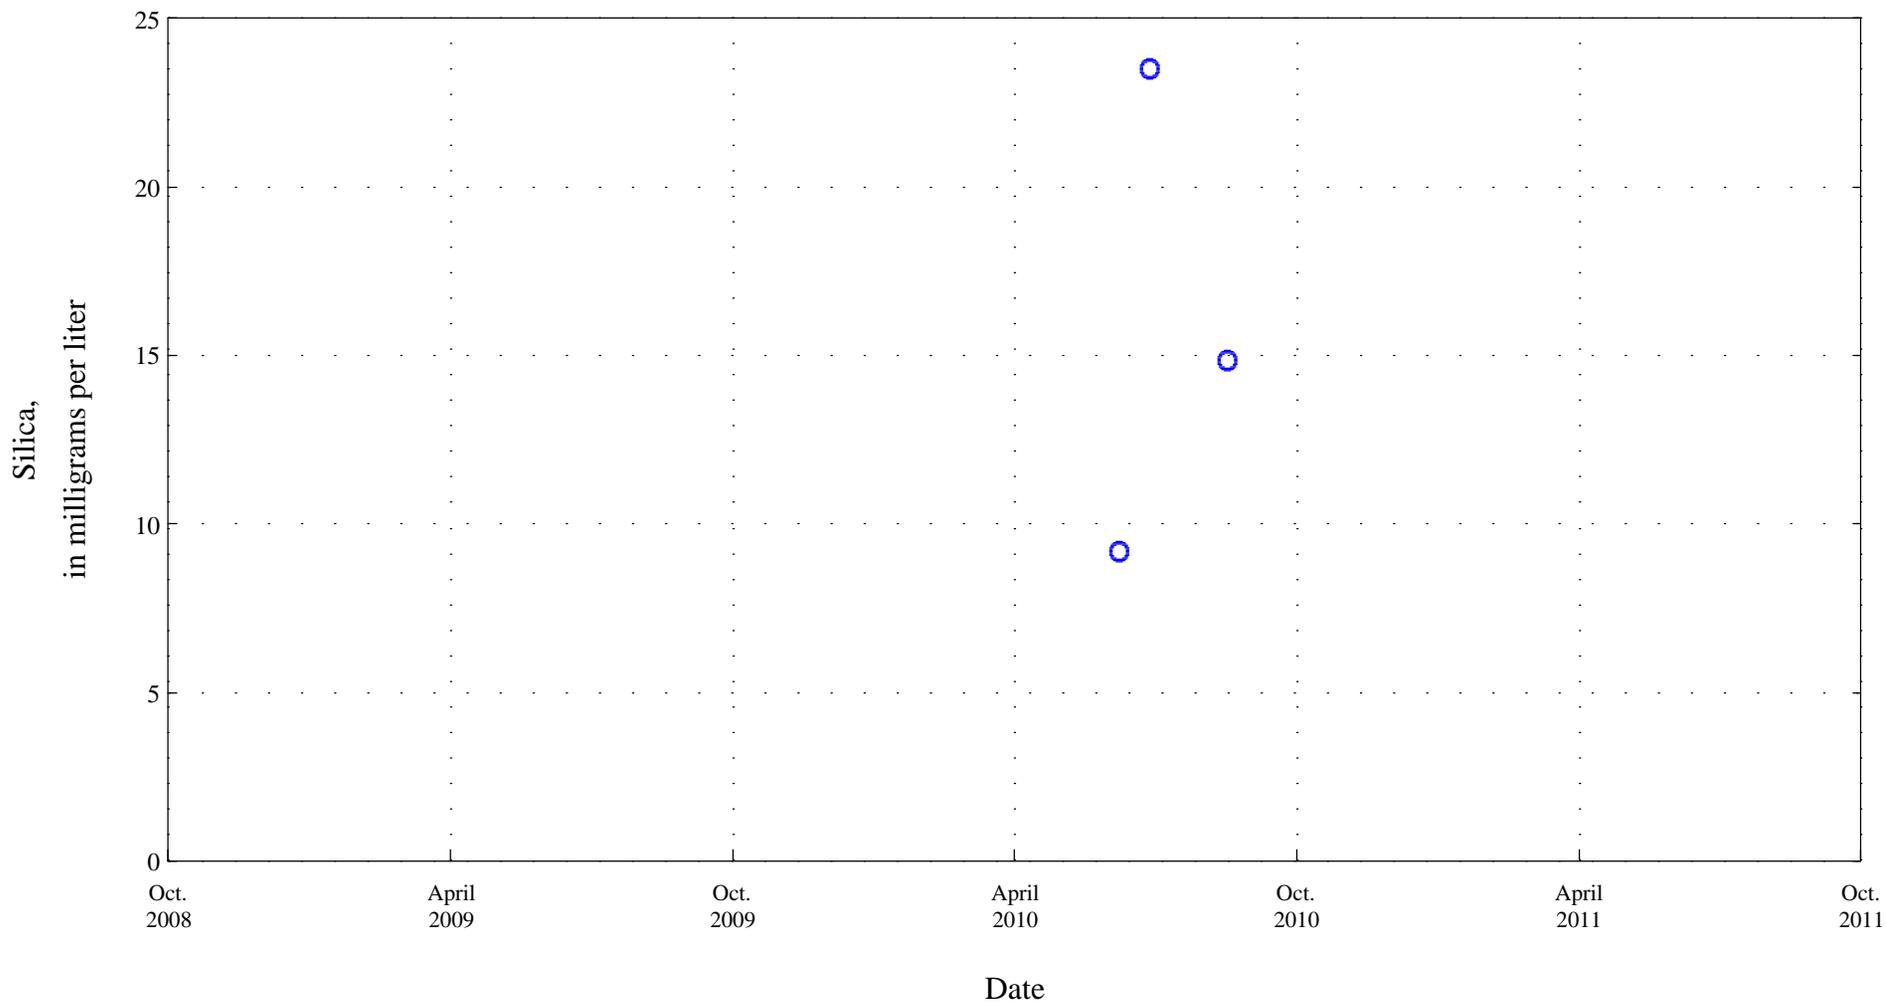
Figure 38. Distribution of selected water-quality constituents relative to time for  
Patterson Hollow at Highway 50 near Vroman, Co., station 380456103473701.

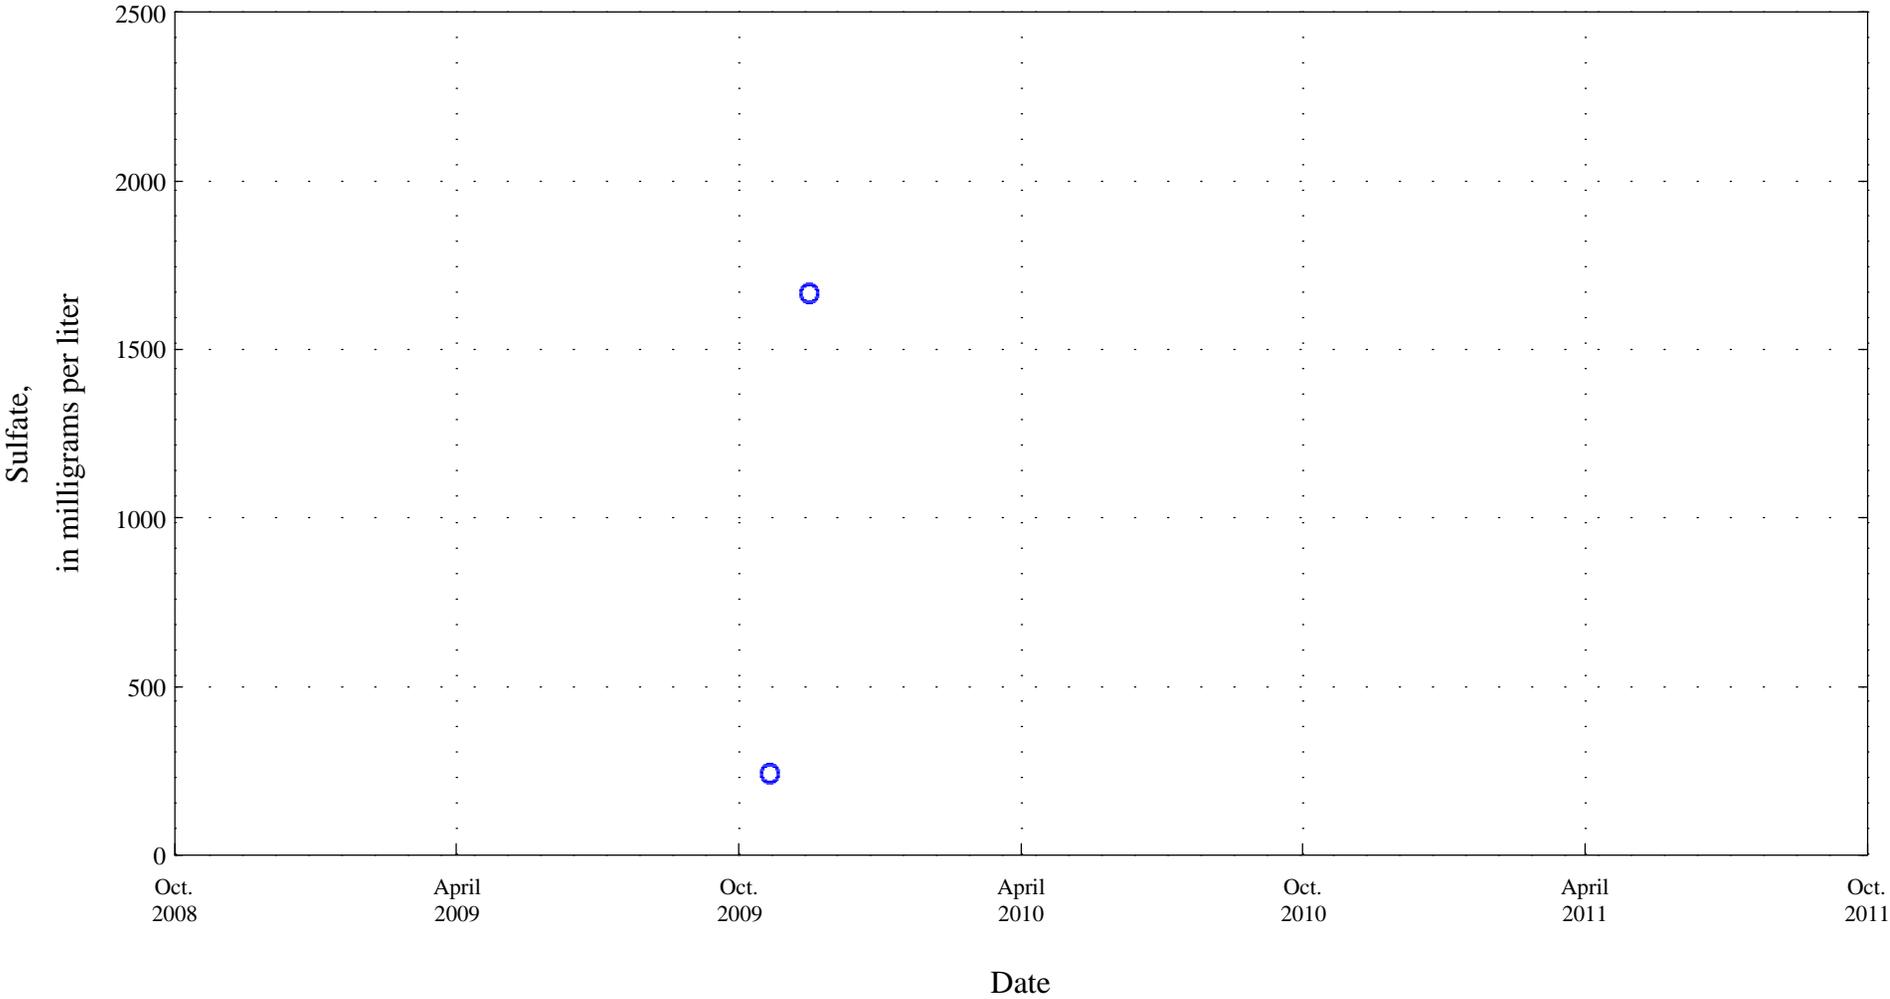
Figure 38. Distribution of selected water-quality constituents relative to time for  
Patterson Hollow at Highway 50 near Vroman, Co., station 380456103473701.

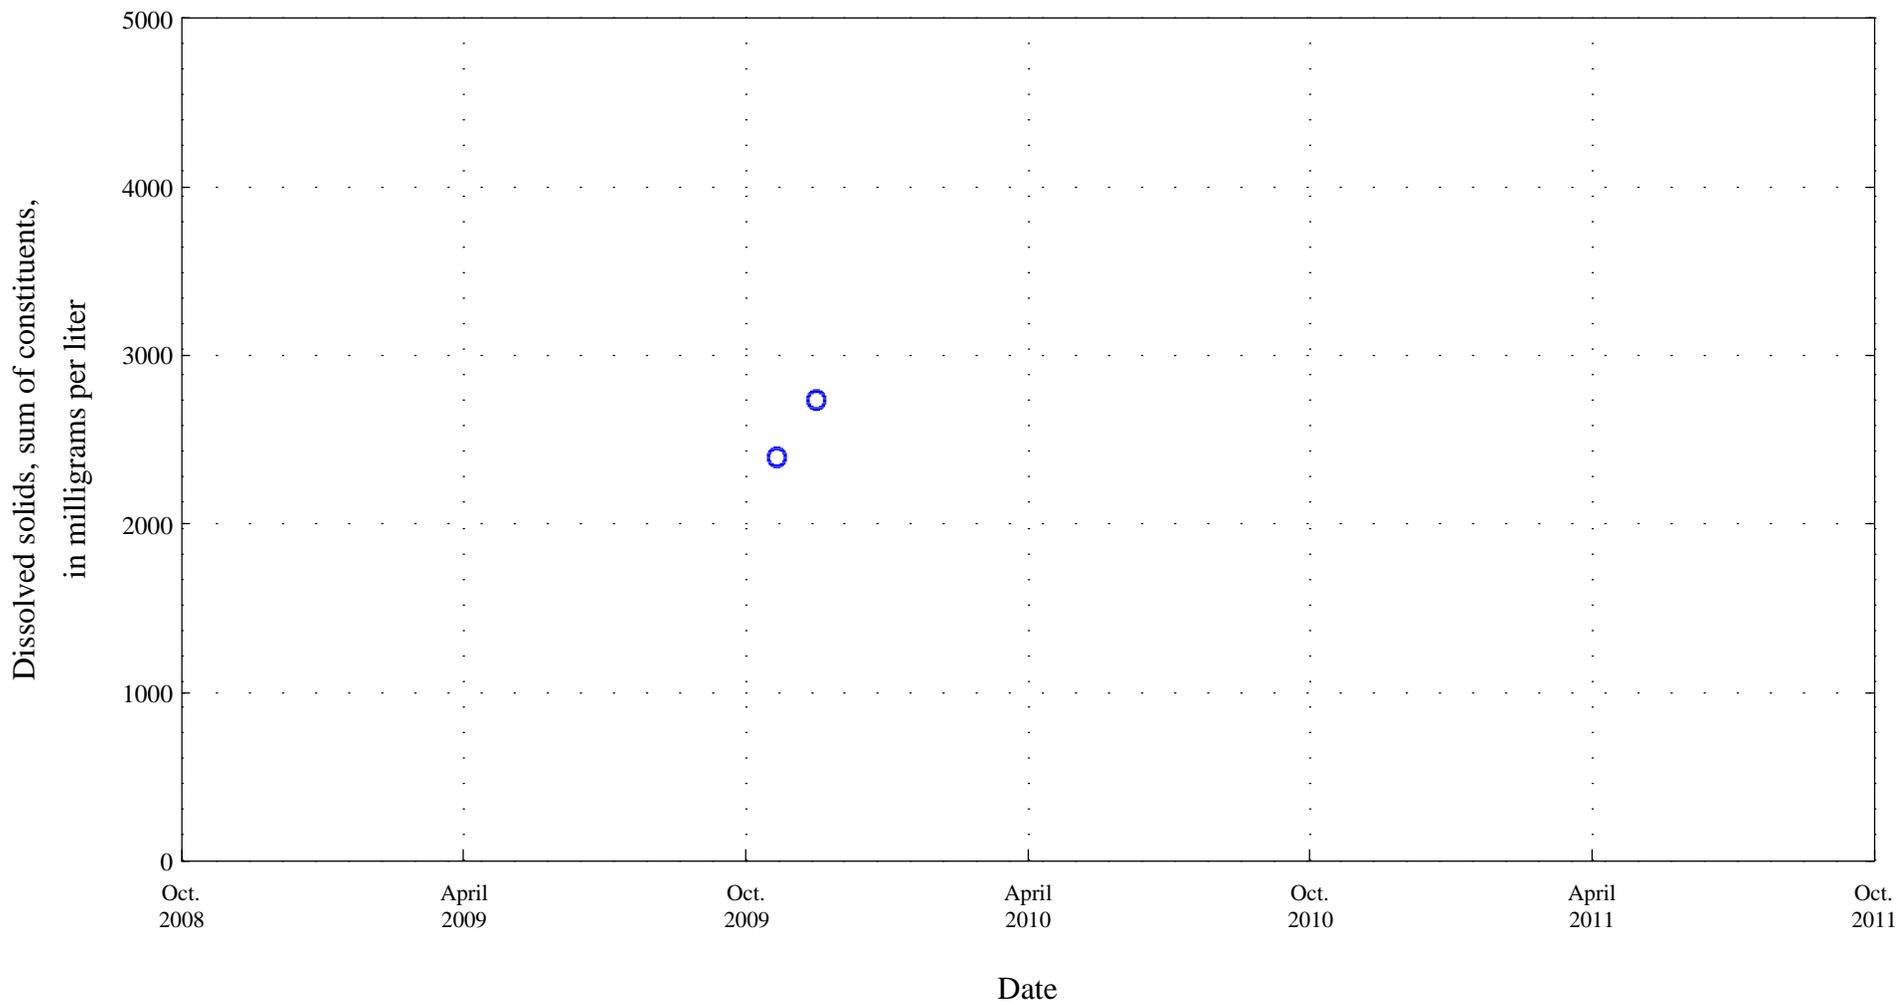
Figure 38. Distribution of selected water-quality constituents relative to time for Patterson Hollow at Highway 50 near Vroman, Co., station 380456103473701.

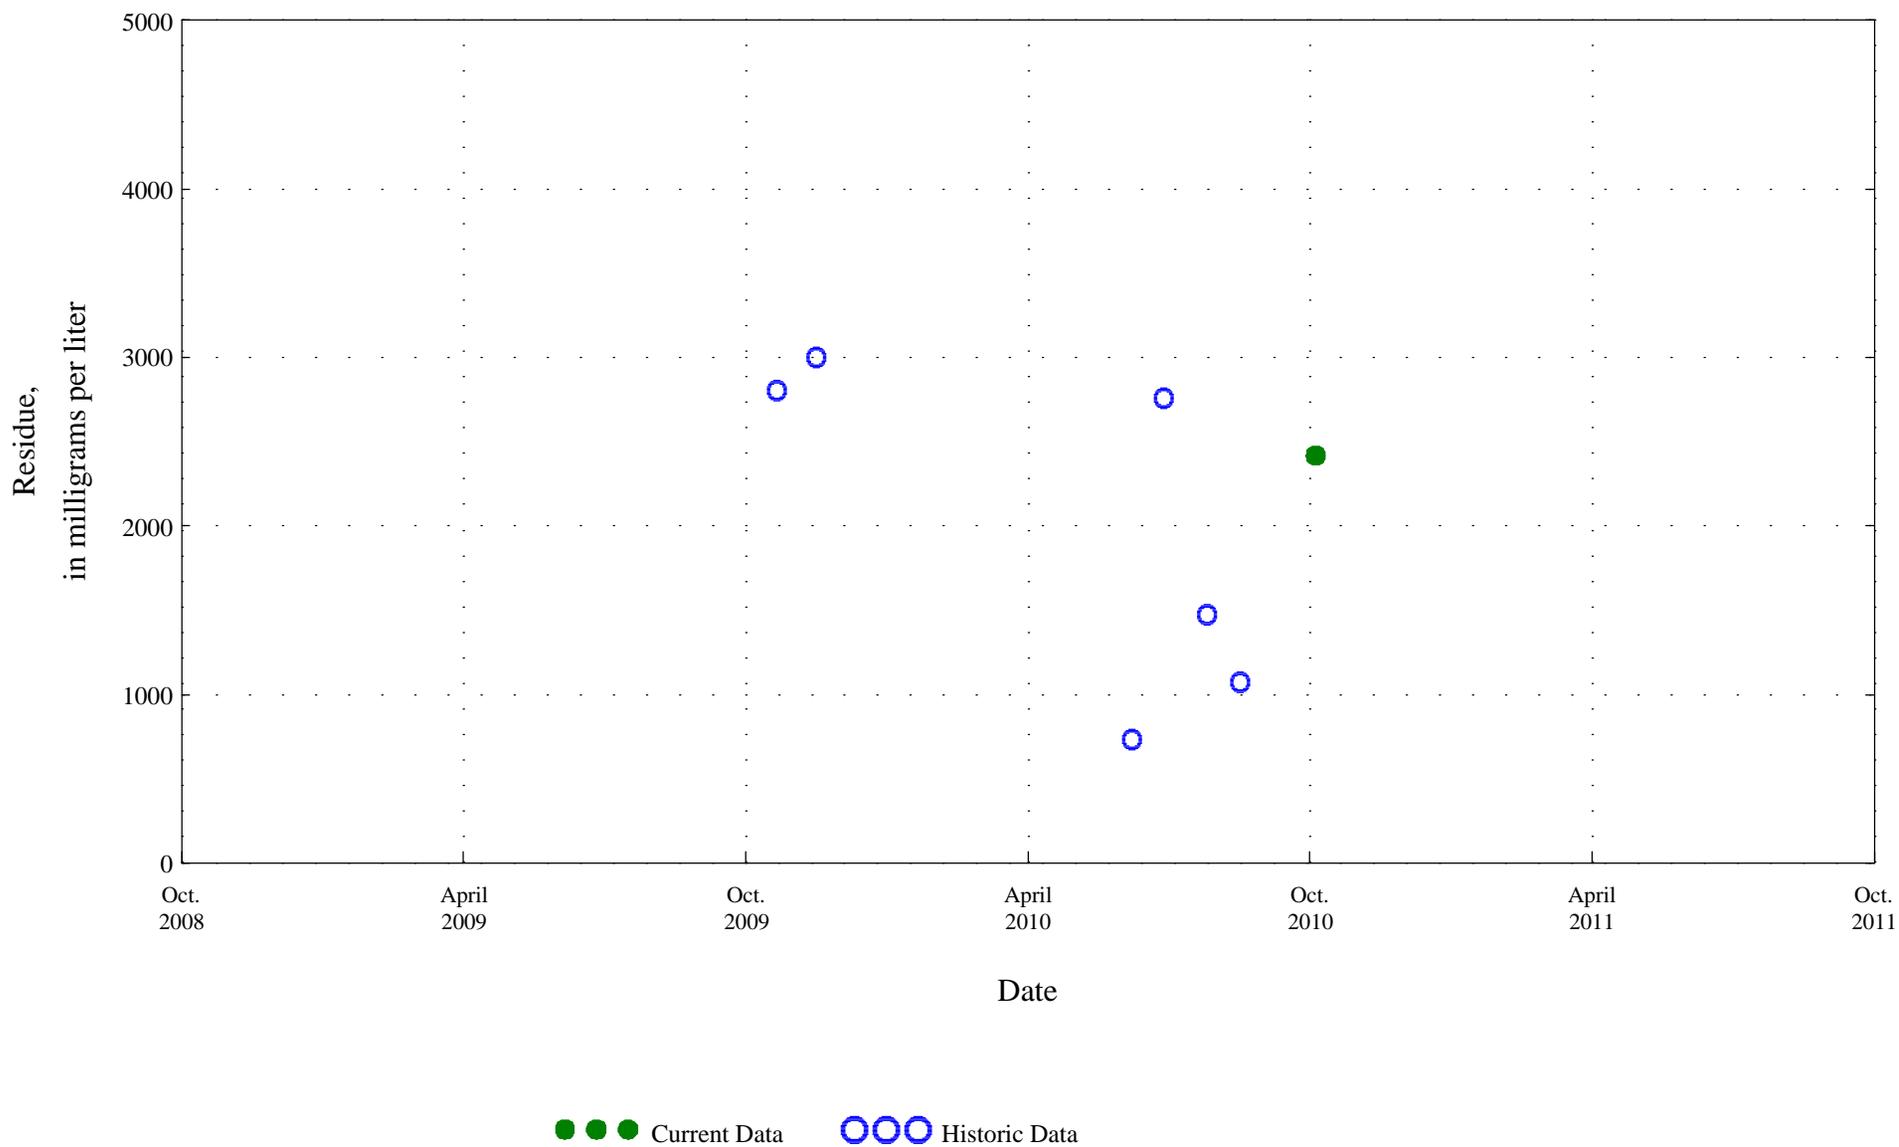
Figure 38. Distribution of selected water-quality constituents relative to time for  
Patterson Hollow at Highway 50 near Vroman, Co., station 380456103473701.

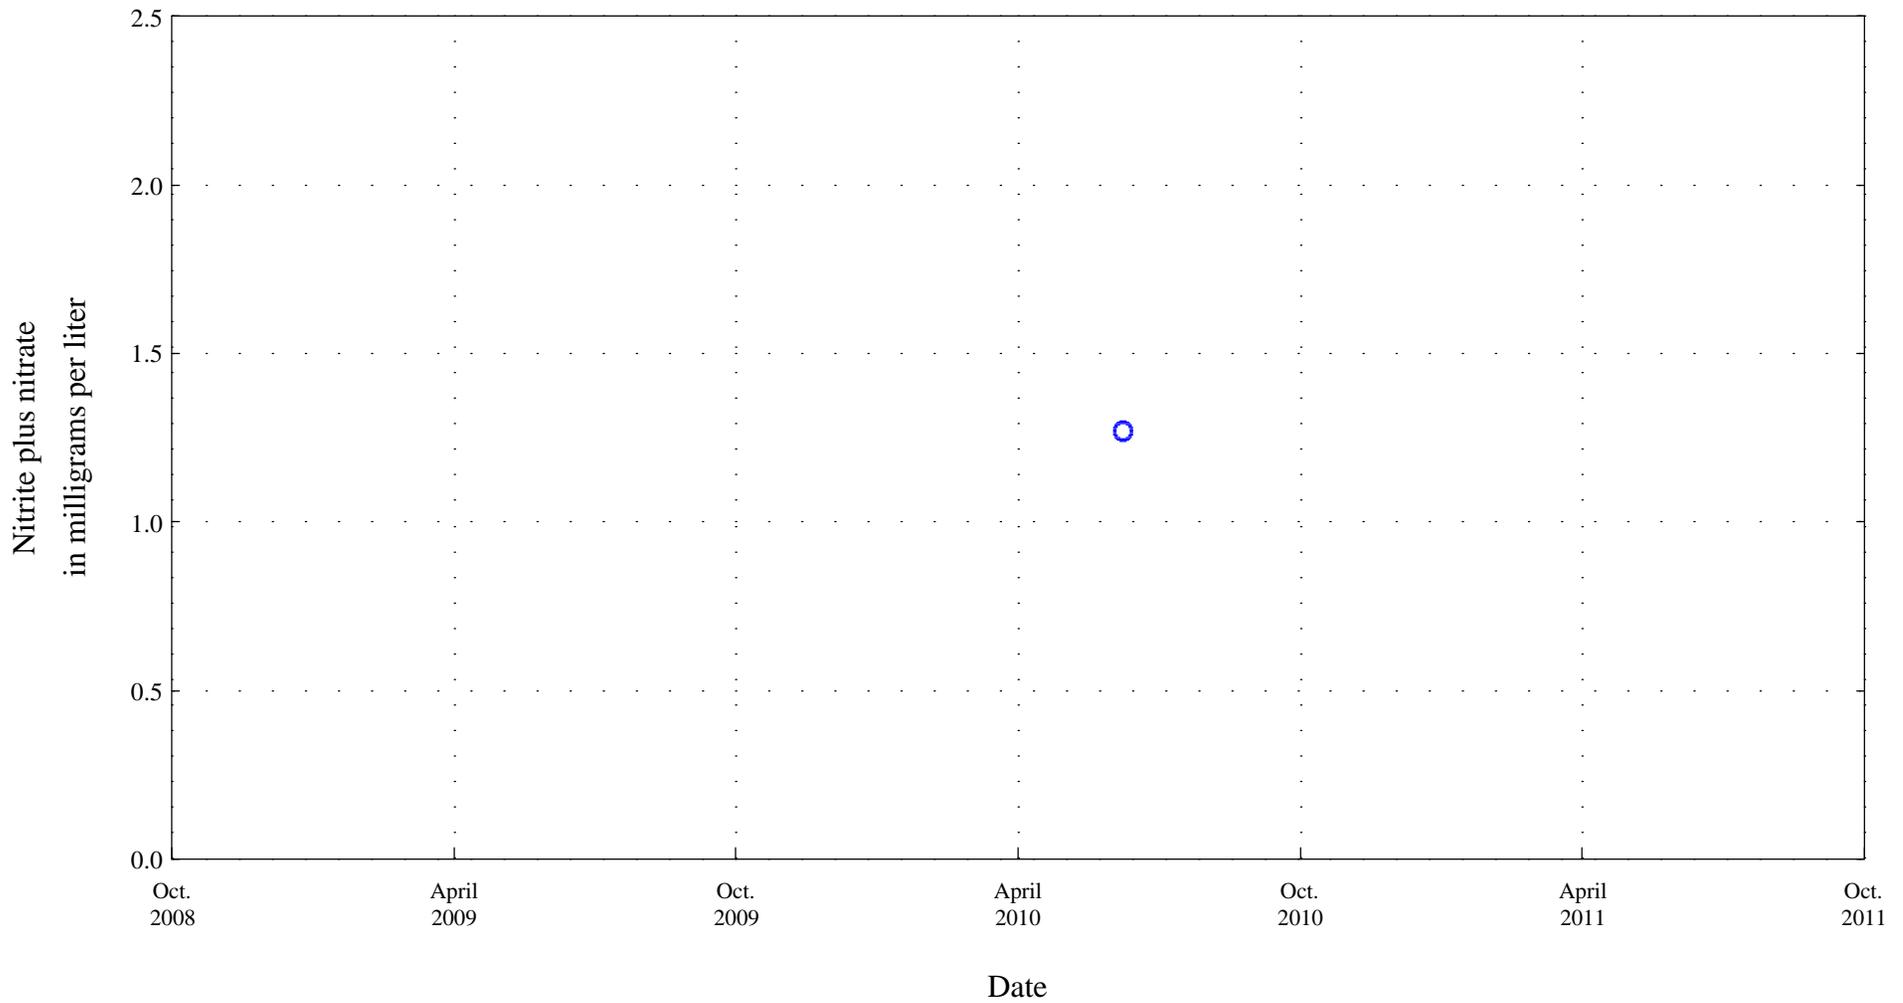
Figure 38. Distribution of selected water-quality constituents relative to time for  
Patterson Hollow at Highway 50 near Vroman, Co., station 380456103473701.

Agriculture Chronic Standard 100

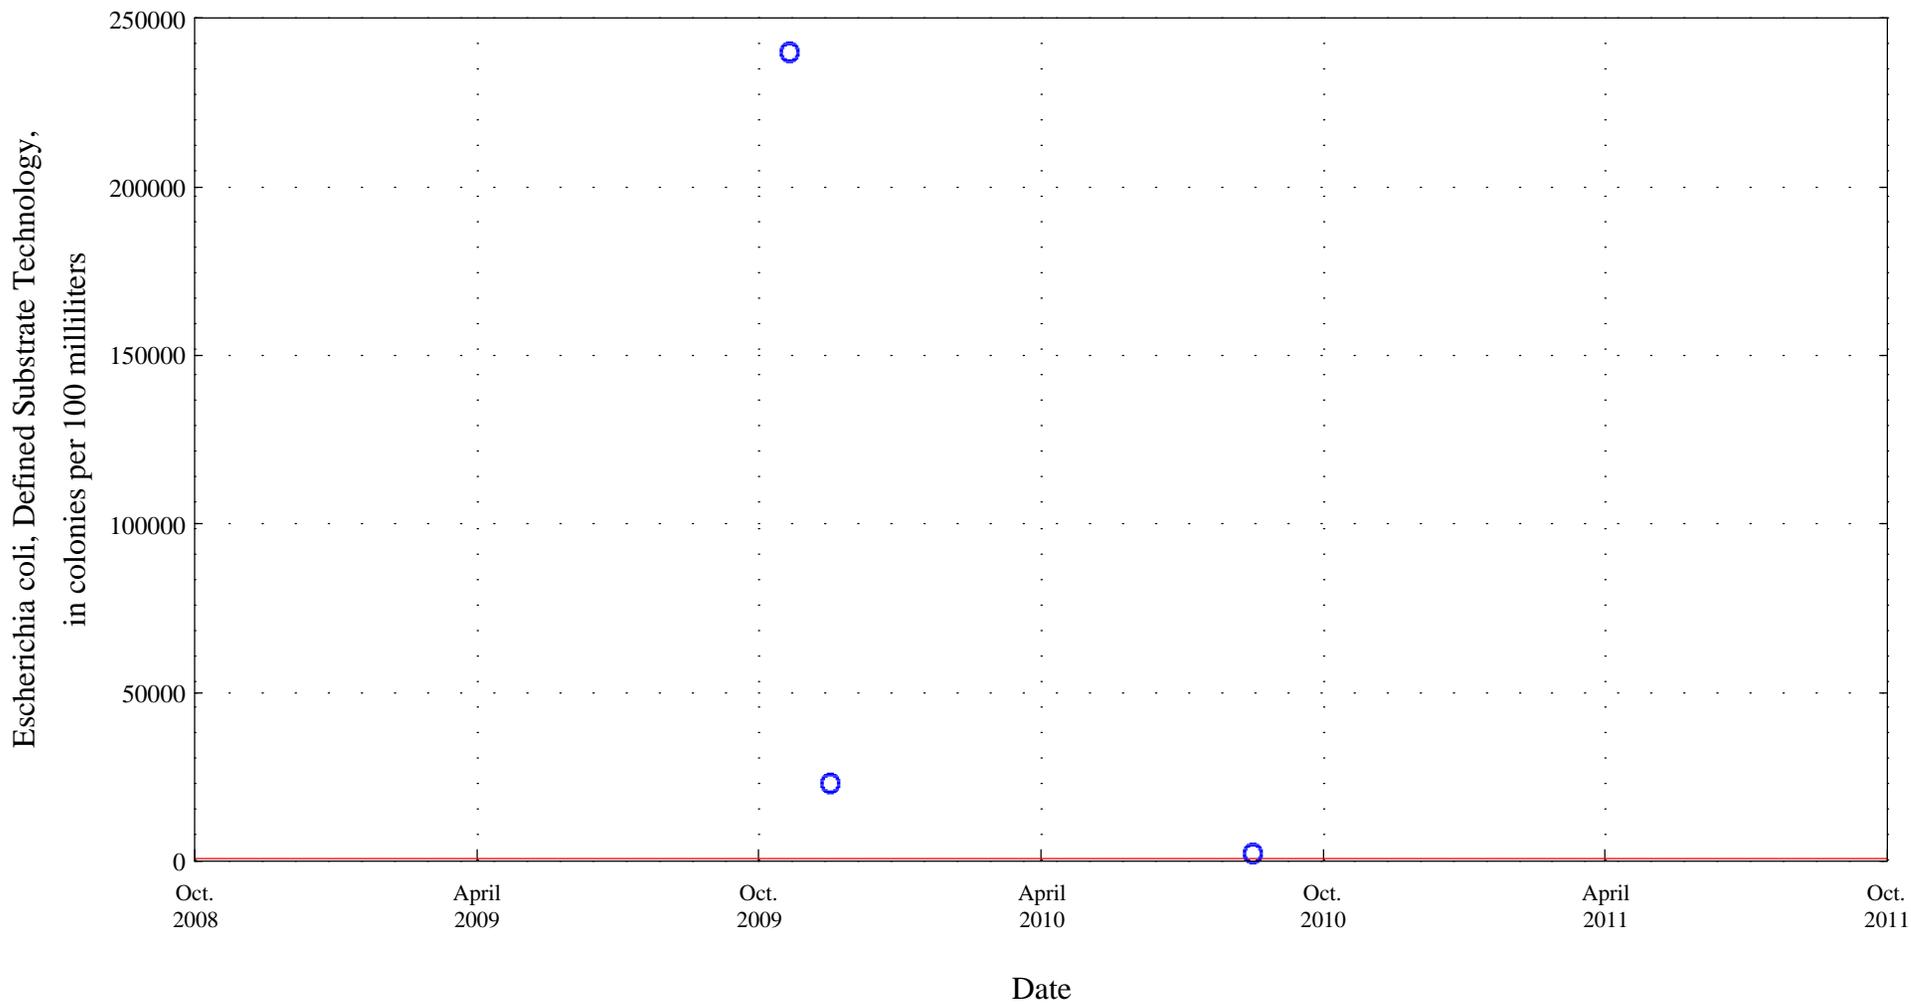
Figure 38. Distribution of selected water-quality constituents relative to time for  
Patterson Hollow at Highway 50 near Vroman, Co., station 380456103473701.

Recreational Standard 630

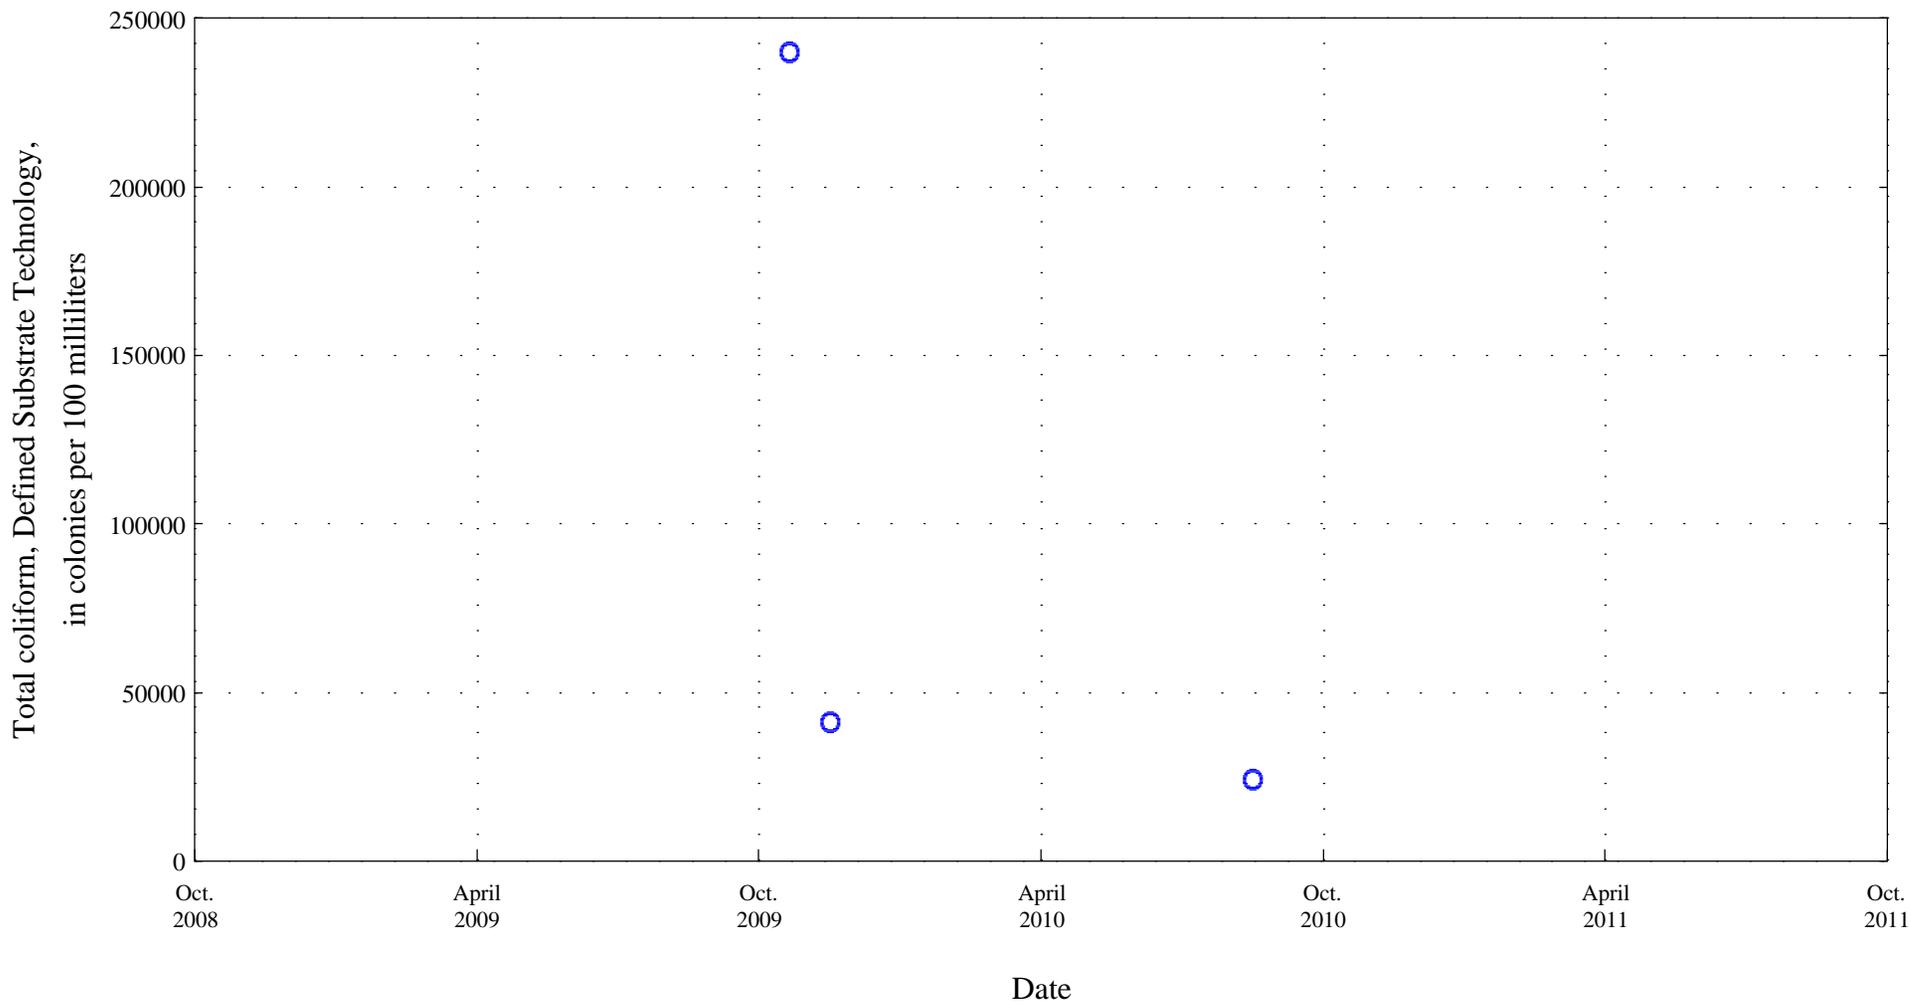
Figure 38. Distribution of selected water-quality constituents relative to time for  
Patterson Hollow at Highway 50 near Vroman, Co., station 380456103473701.

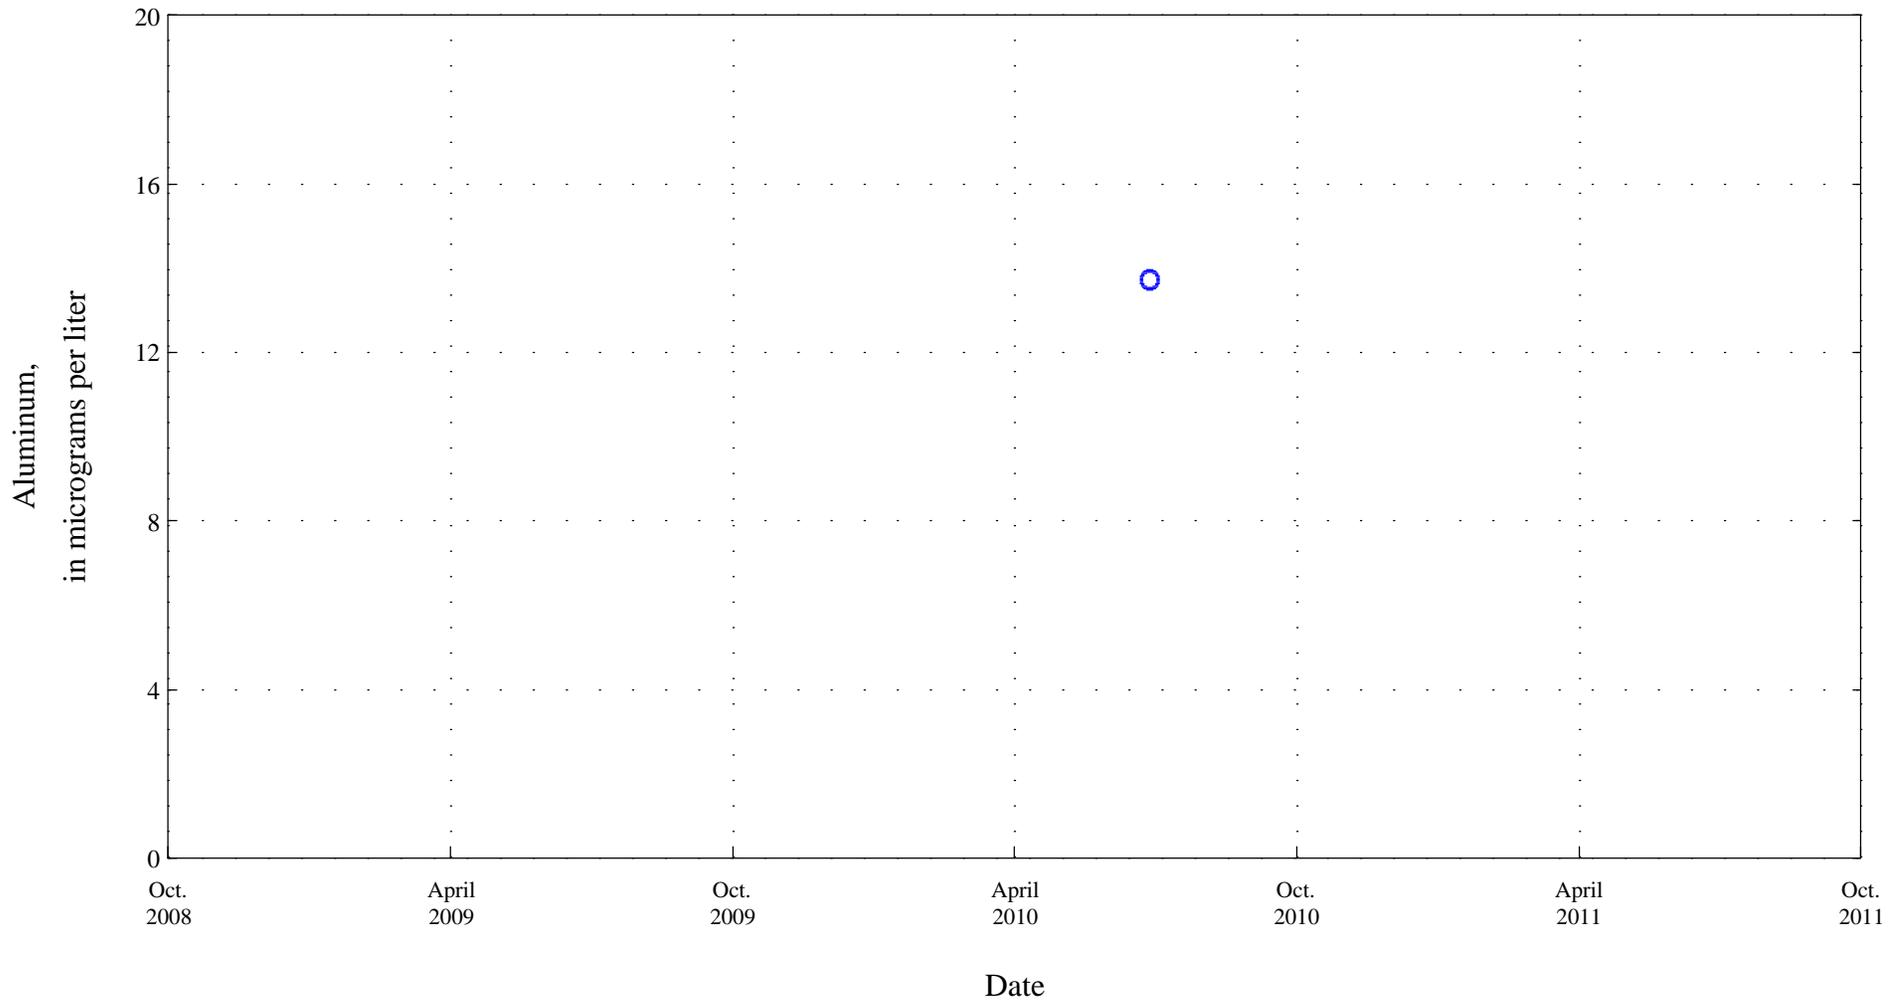
Figure 38. Distribution of selected water-quality constituents relative to time for  
Patterson Hollow at Highway 50 near Vroman, Co., station 380456103473701.

Aquatic Life Acute Standard 10,071  
Aquatic Life Chronic Standard 1,438

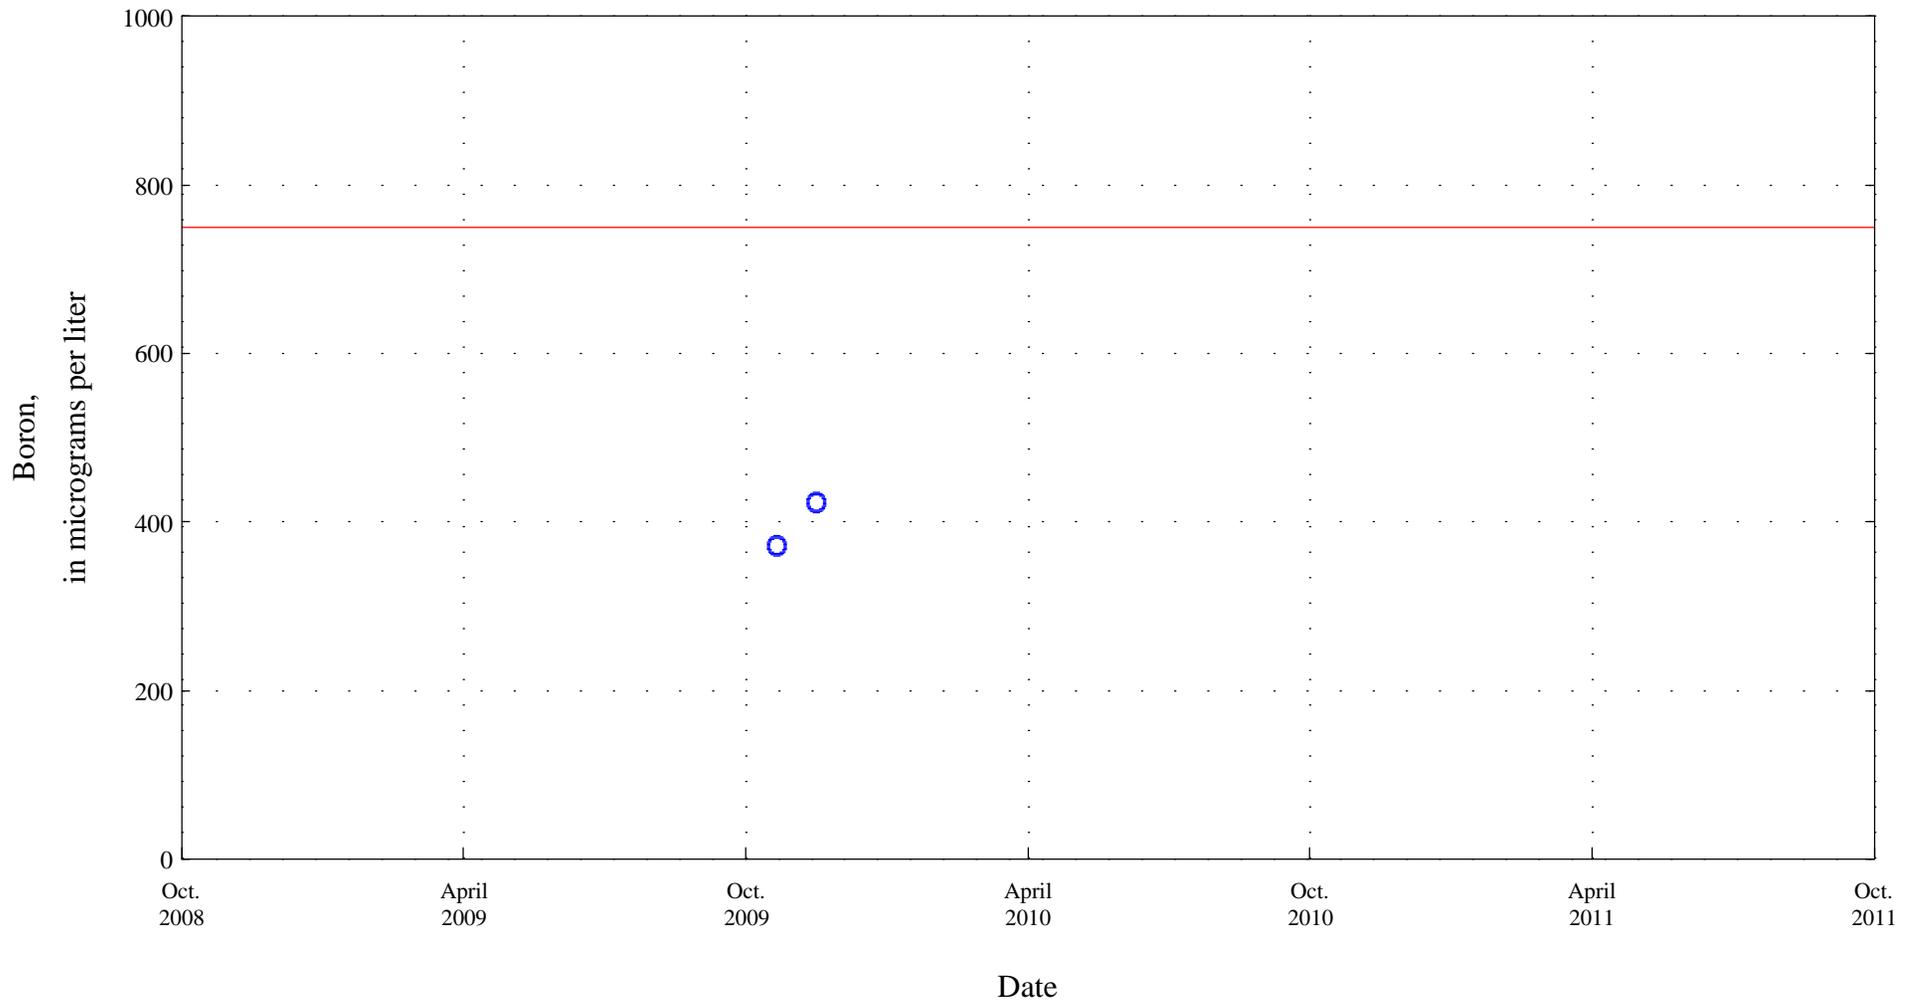
Figure 38. Distribution of selected water-quality constituents relative to time for  
Patterson Hollow at Highway 50 near Vroman, Co., station 380456103473701.

Agriculture Chronic Standard 750

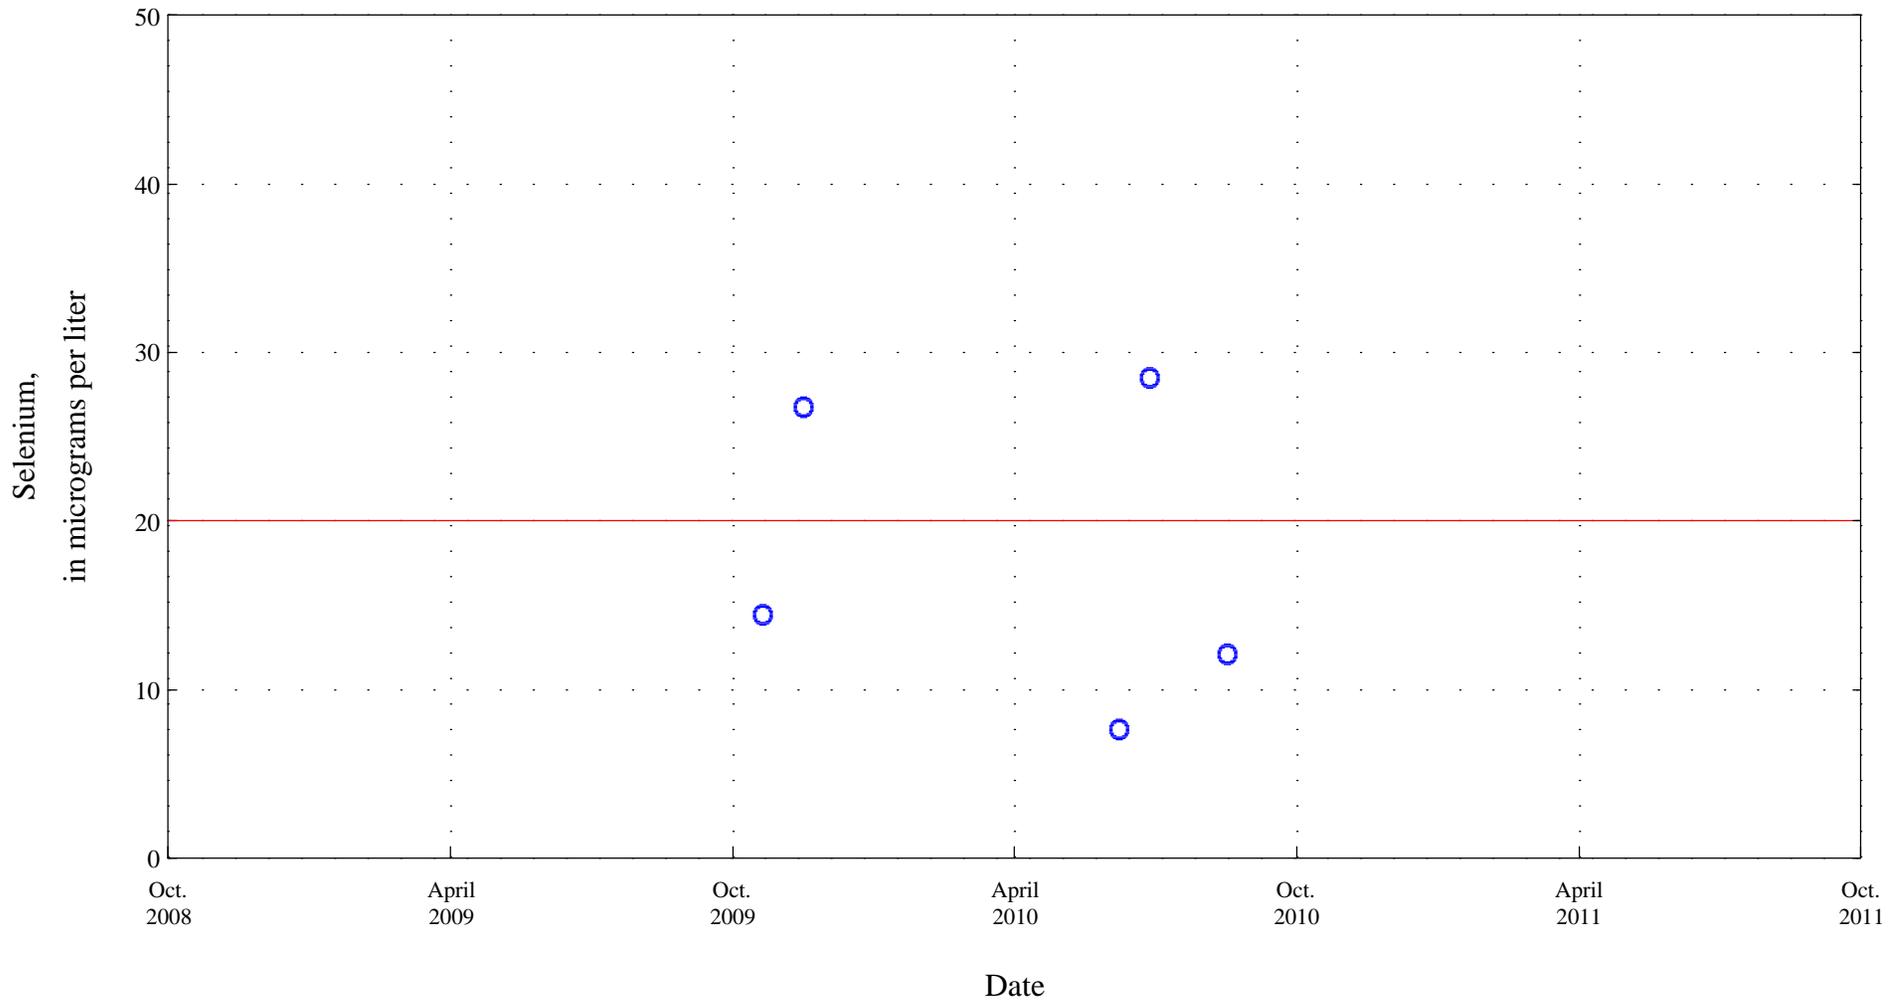
Figure 38. Distribution of selected water-quality constituents relative to time for  
Patterson Hollow at Highway 50 near Vroman, Co., station 380456103473701.

Agriculture Chronic Standard 20.0

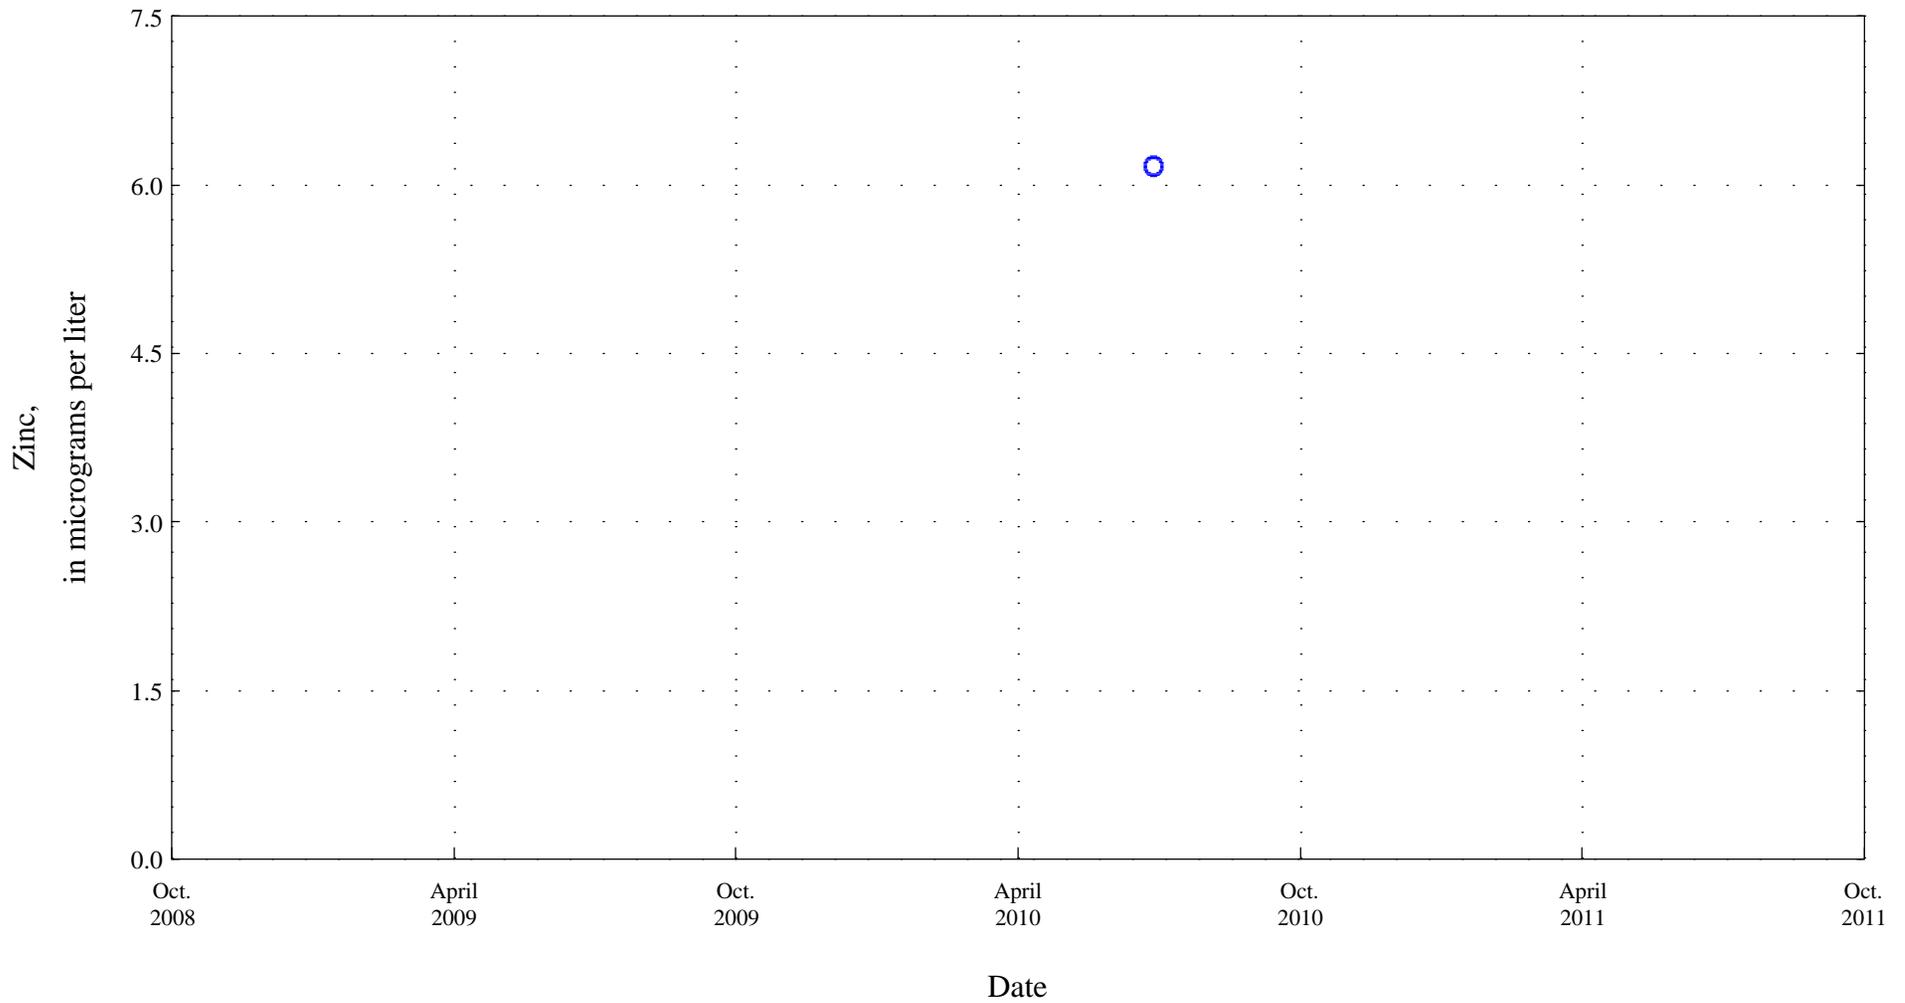
Figure 38. Distribution of selected water-quality constituents relative to time for  
Patterson Hollow at Highway 50 near Vroman, Co., station 380456103473701.

Agriculture Chronic Standard 2,000
