Figure 38. Distribution of selected water-quality constituents relative to time for  
Patterson Hollow at Highway 50 near Vroman, Co., station 380456103473701.

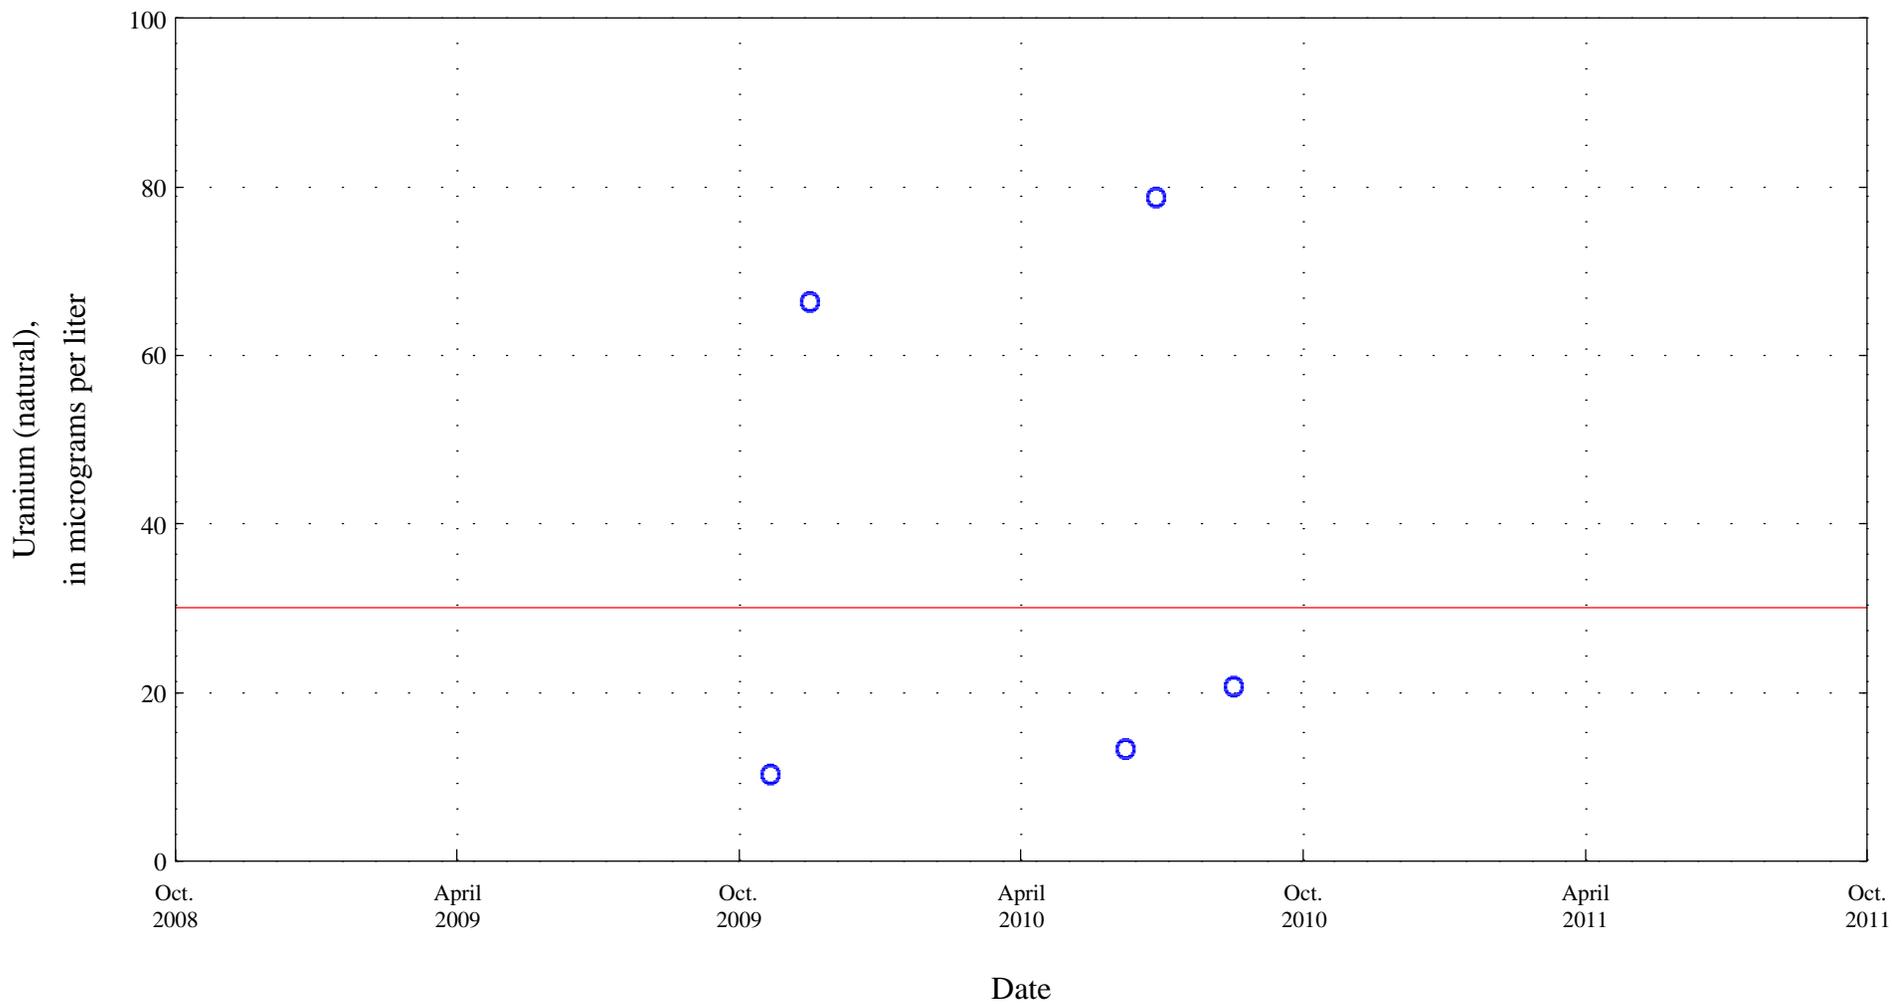
Figure 38. Distribution of selected water-quality constituents relative to time for Patterson Hollow at Highway 50 near Vroman, Co., station 380456103473701.

Basic Standard Chronic Standard 30.0
