Figure 26. Distribution of selected water-quality constituents relative to time for

Purgatoire River at Rock Crossing near Timpas, Co., station 07126485.

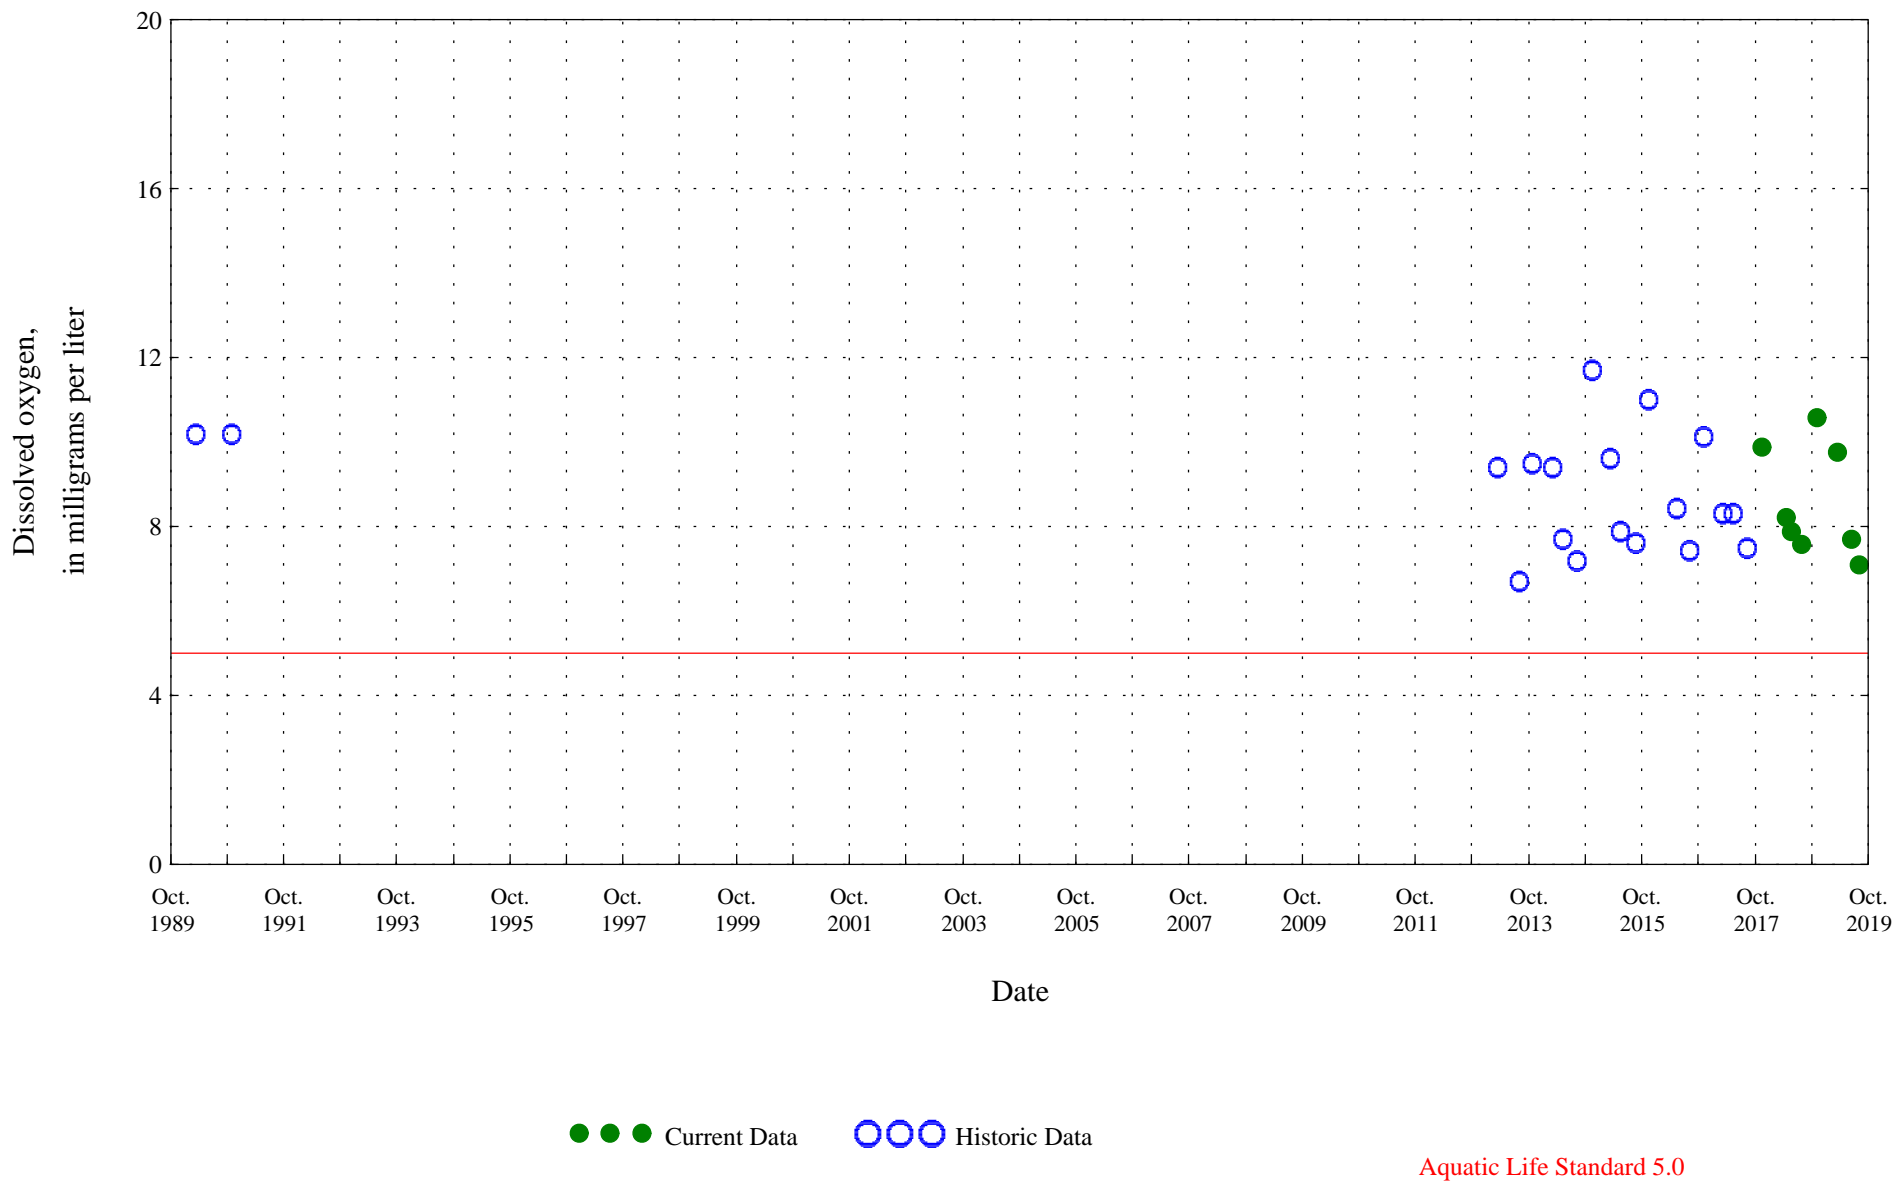
Figure 26. Distribution of selected water-quality constituents relative to time for

Purgatoire River at Rock Crossing near Timpas, Co., station 07126485.

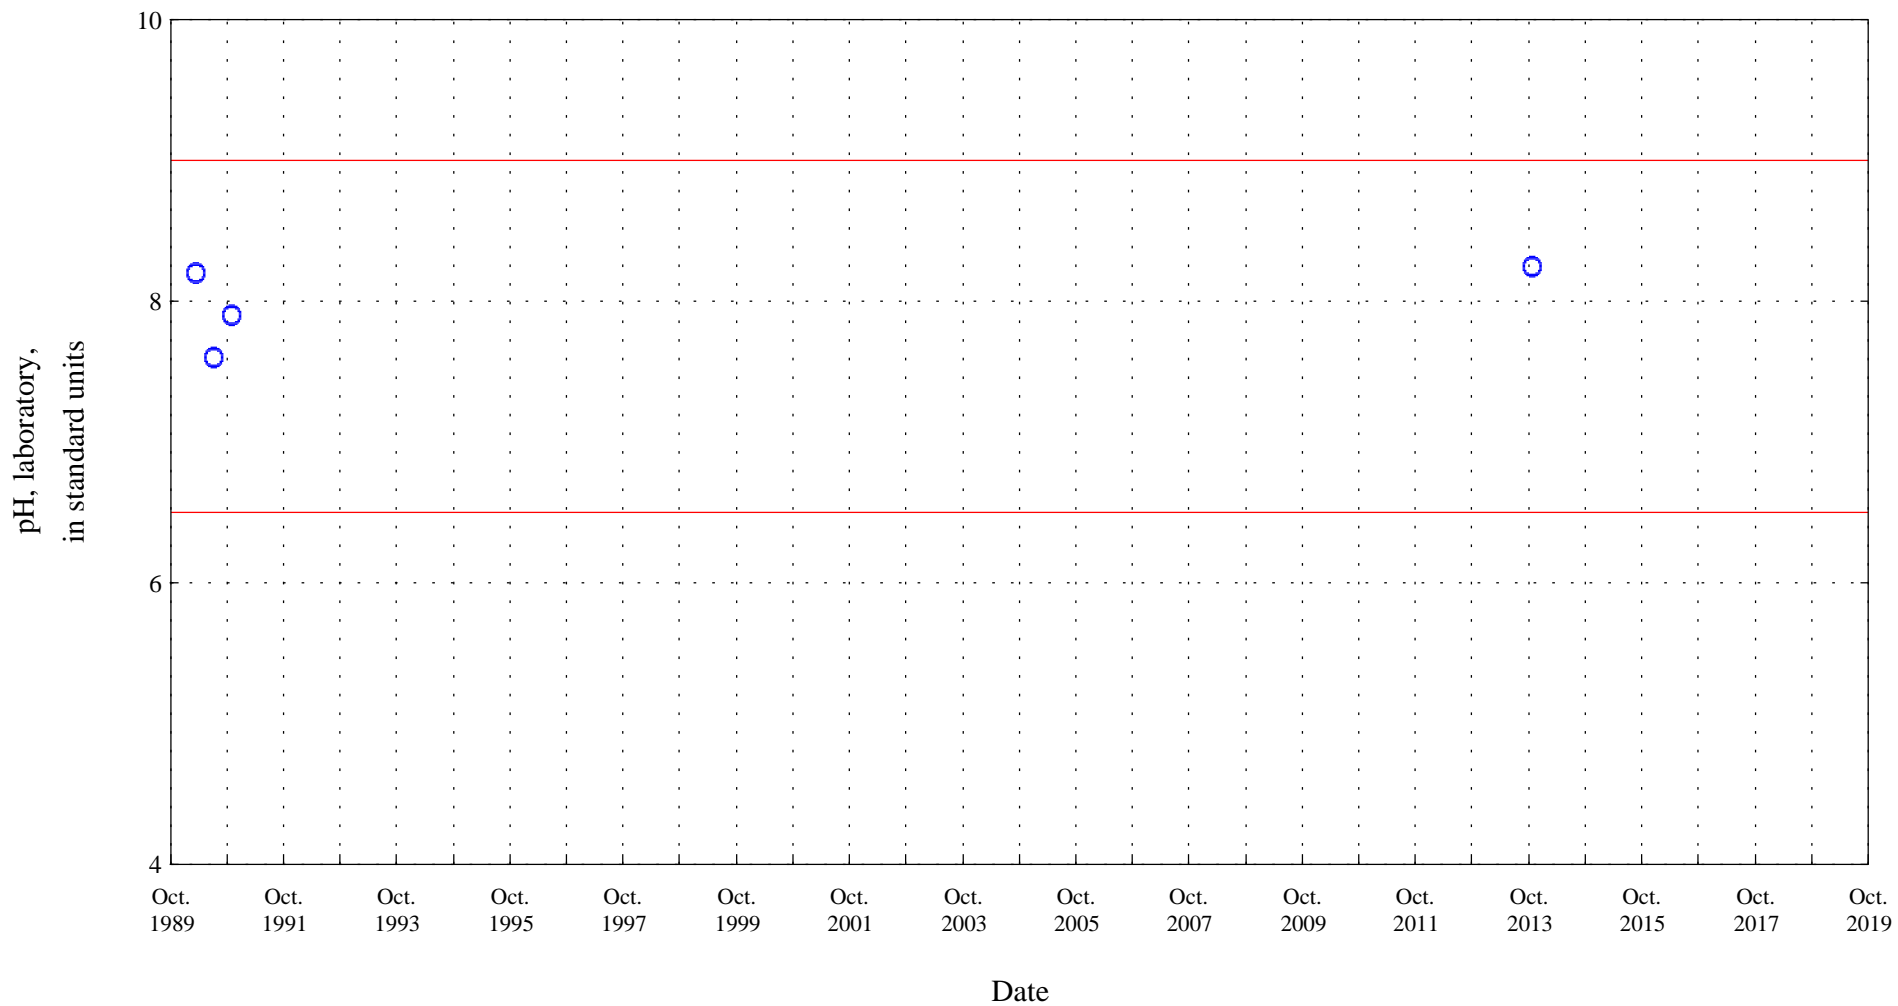
Aquatic Life Standard 5.0

Figure 26. Distribution of selected water-quality constituents relative to time for

Purgatoire River at Rock Crossing near Timpas, Co., station 07126485.

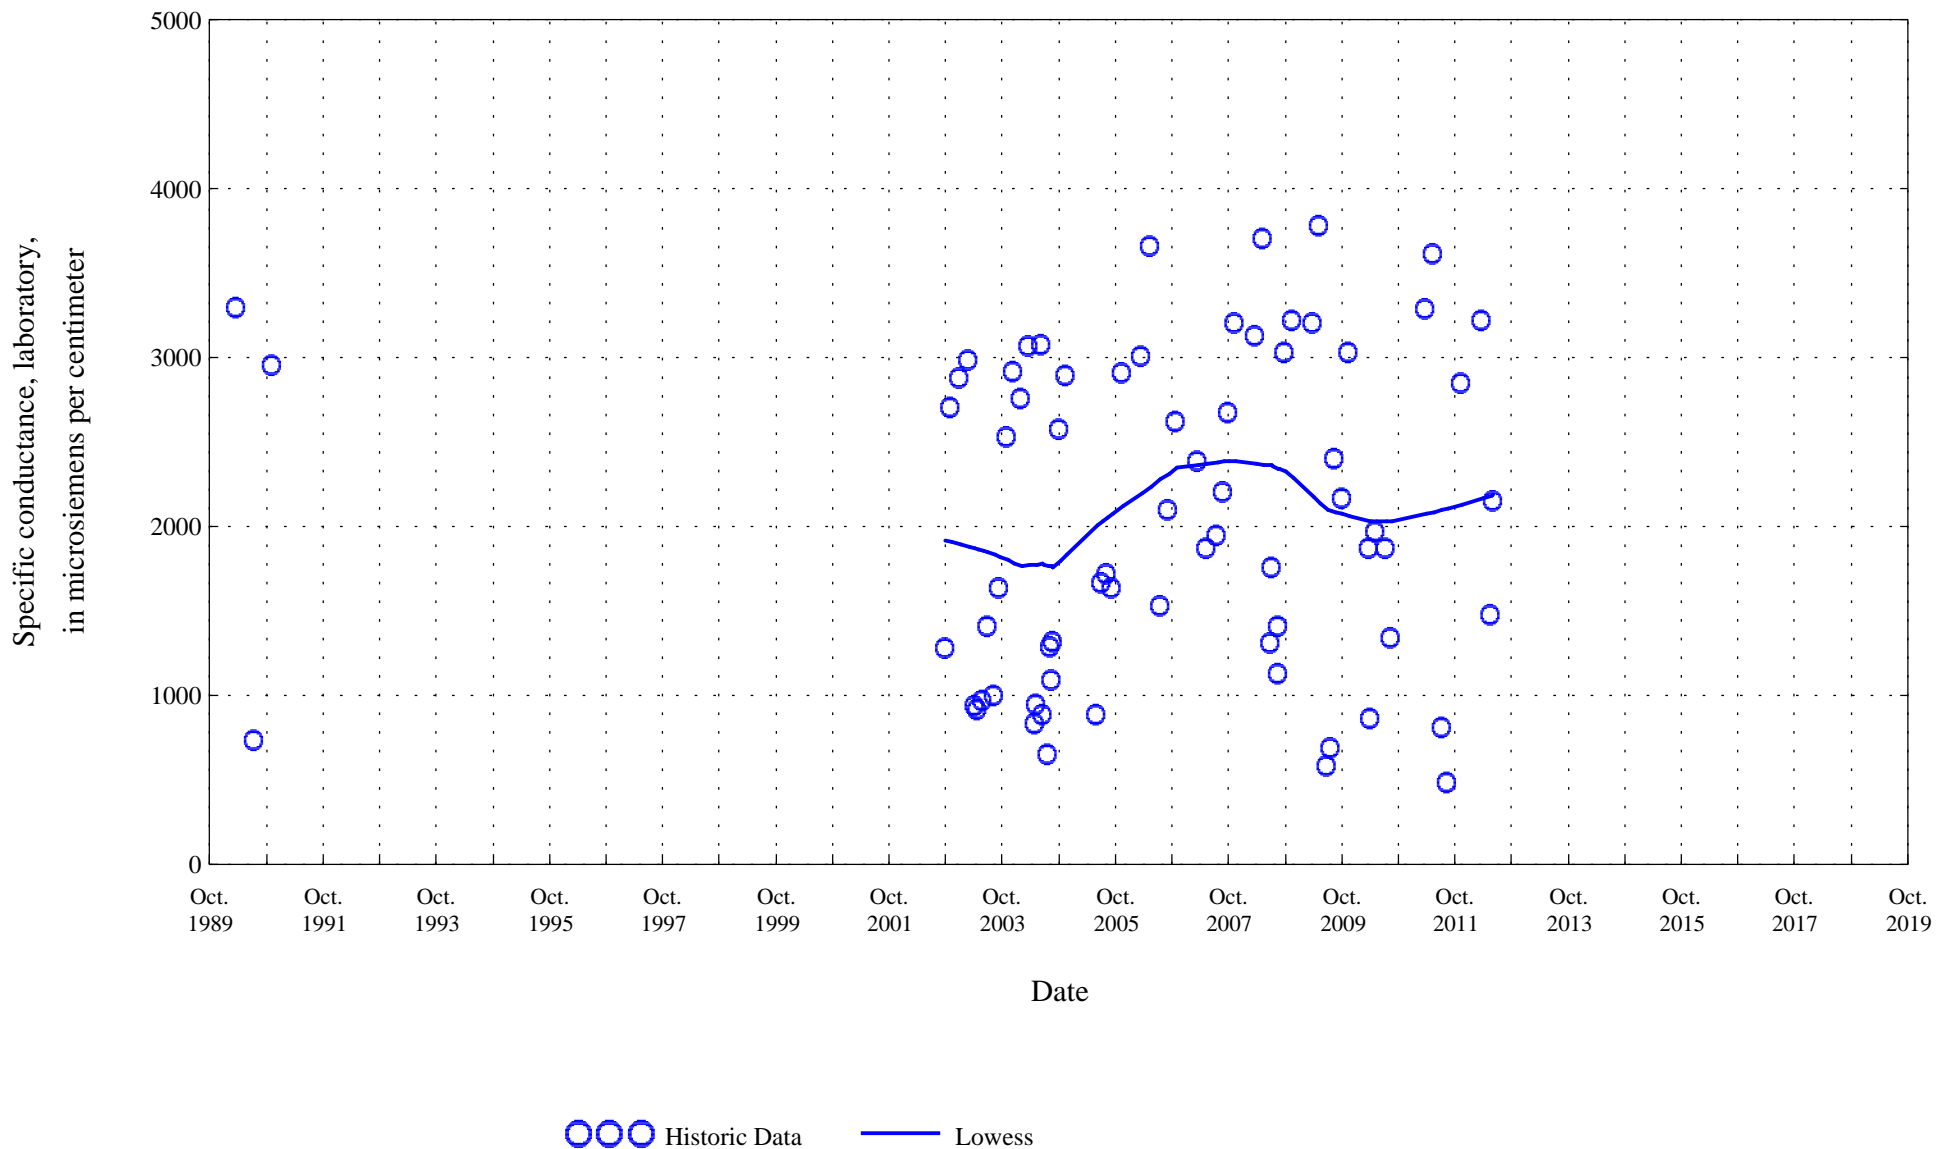
Aquatic Life Standard 6.5 to 9.0

Figure 26. Distribution of selected water-quality constituents relative to time for

Purgatoire River at Rock Crossing near Timpas, Co., station 07126485.

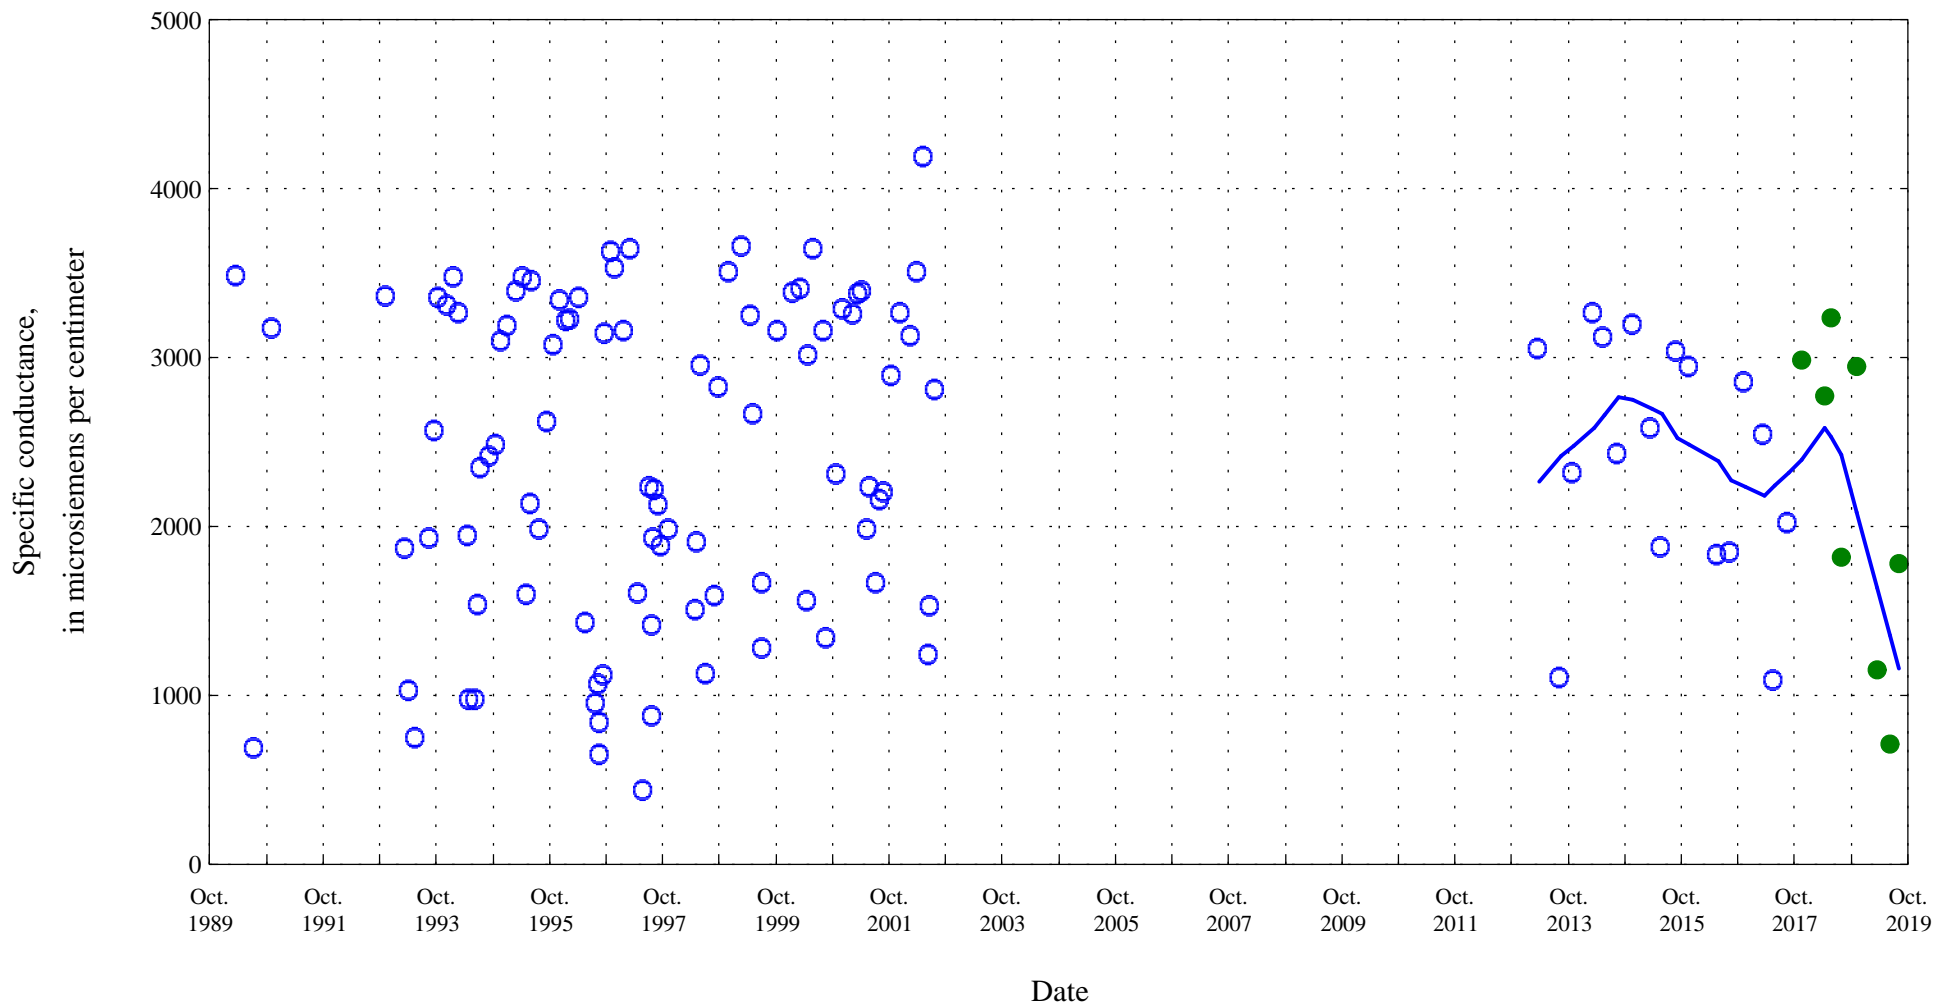
Figure 26. Distribution of selected water-quality constituents relative to time for

Purgatoire River at Rock Crossing near Timpas, Co., station 07126485.

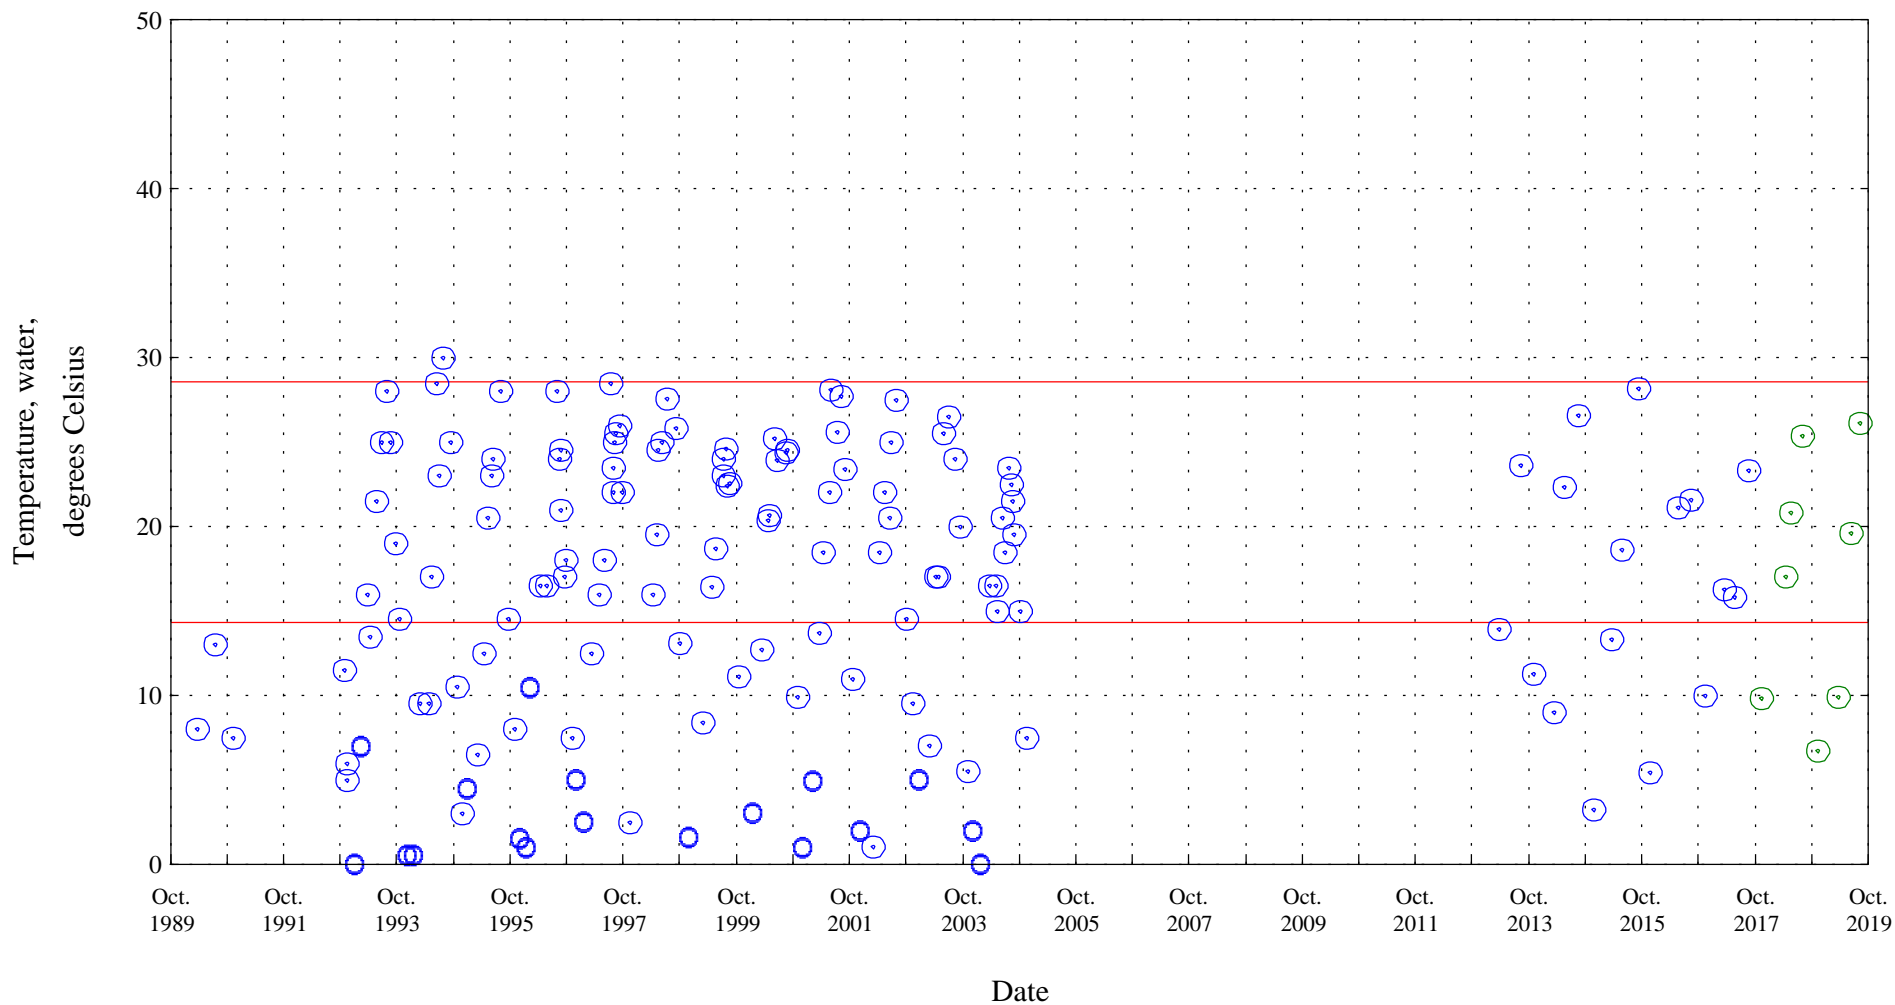
Figure 26. Distribution of selected water-quality constituents relative to time for

Purgatoire River at Rock Crossing near Timpas, Co., station 07126485.

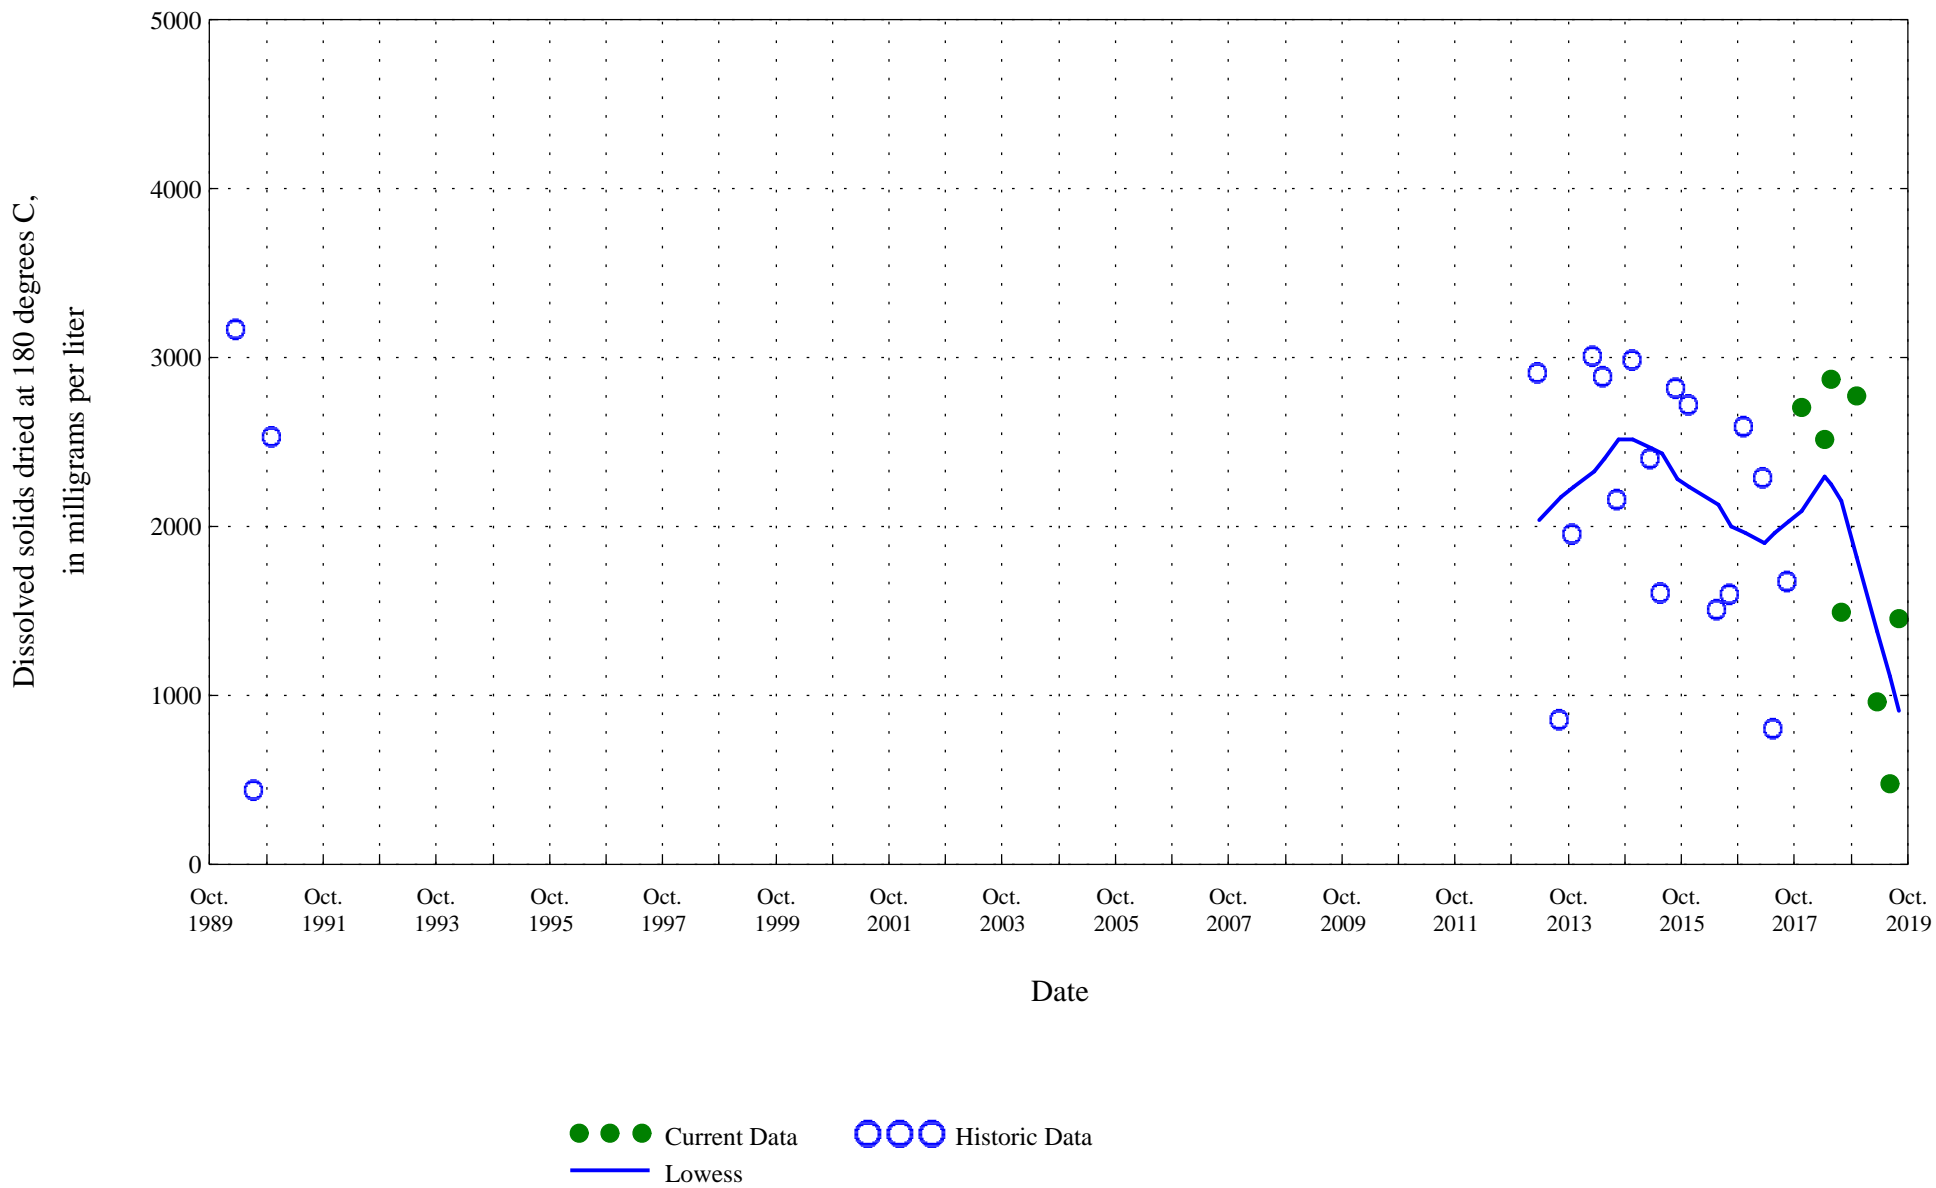
Aquatic Life Dec - Feb, Cool Season Std 14.3
Aquatic Life Mar - Nov, Warm Season Std 28.6

Figure 26. Distribution of selected water-quality constituents relative to time for

Purgatoire River at Rock Crossing near Timpas, Co., station 07126485.

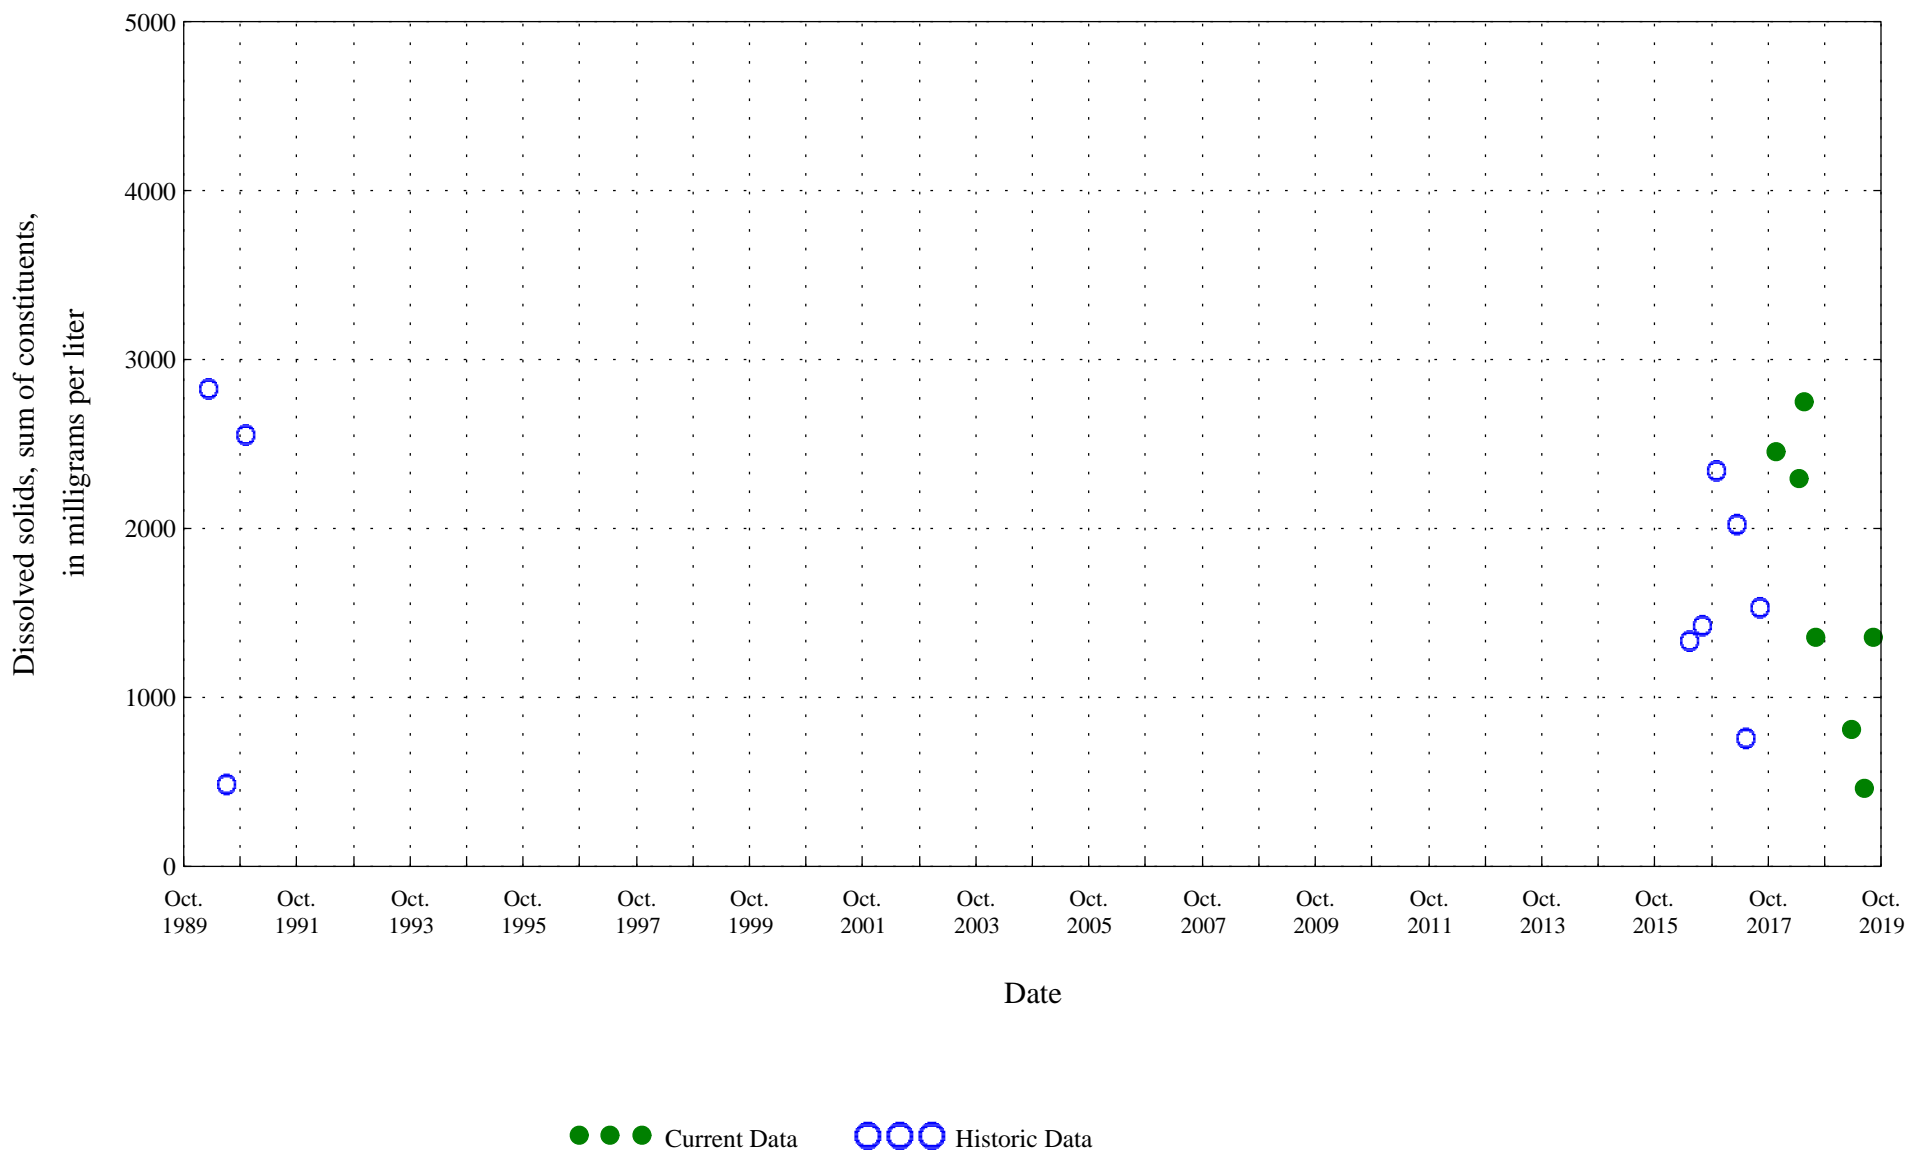
Figure 26. Distribution of selected water-quality constituents relative to time for

Purgatoire River at Rock Crossing near Timpas, Co., station 07126485.

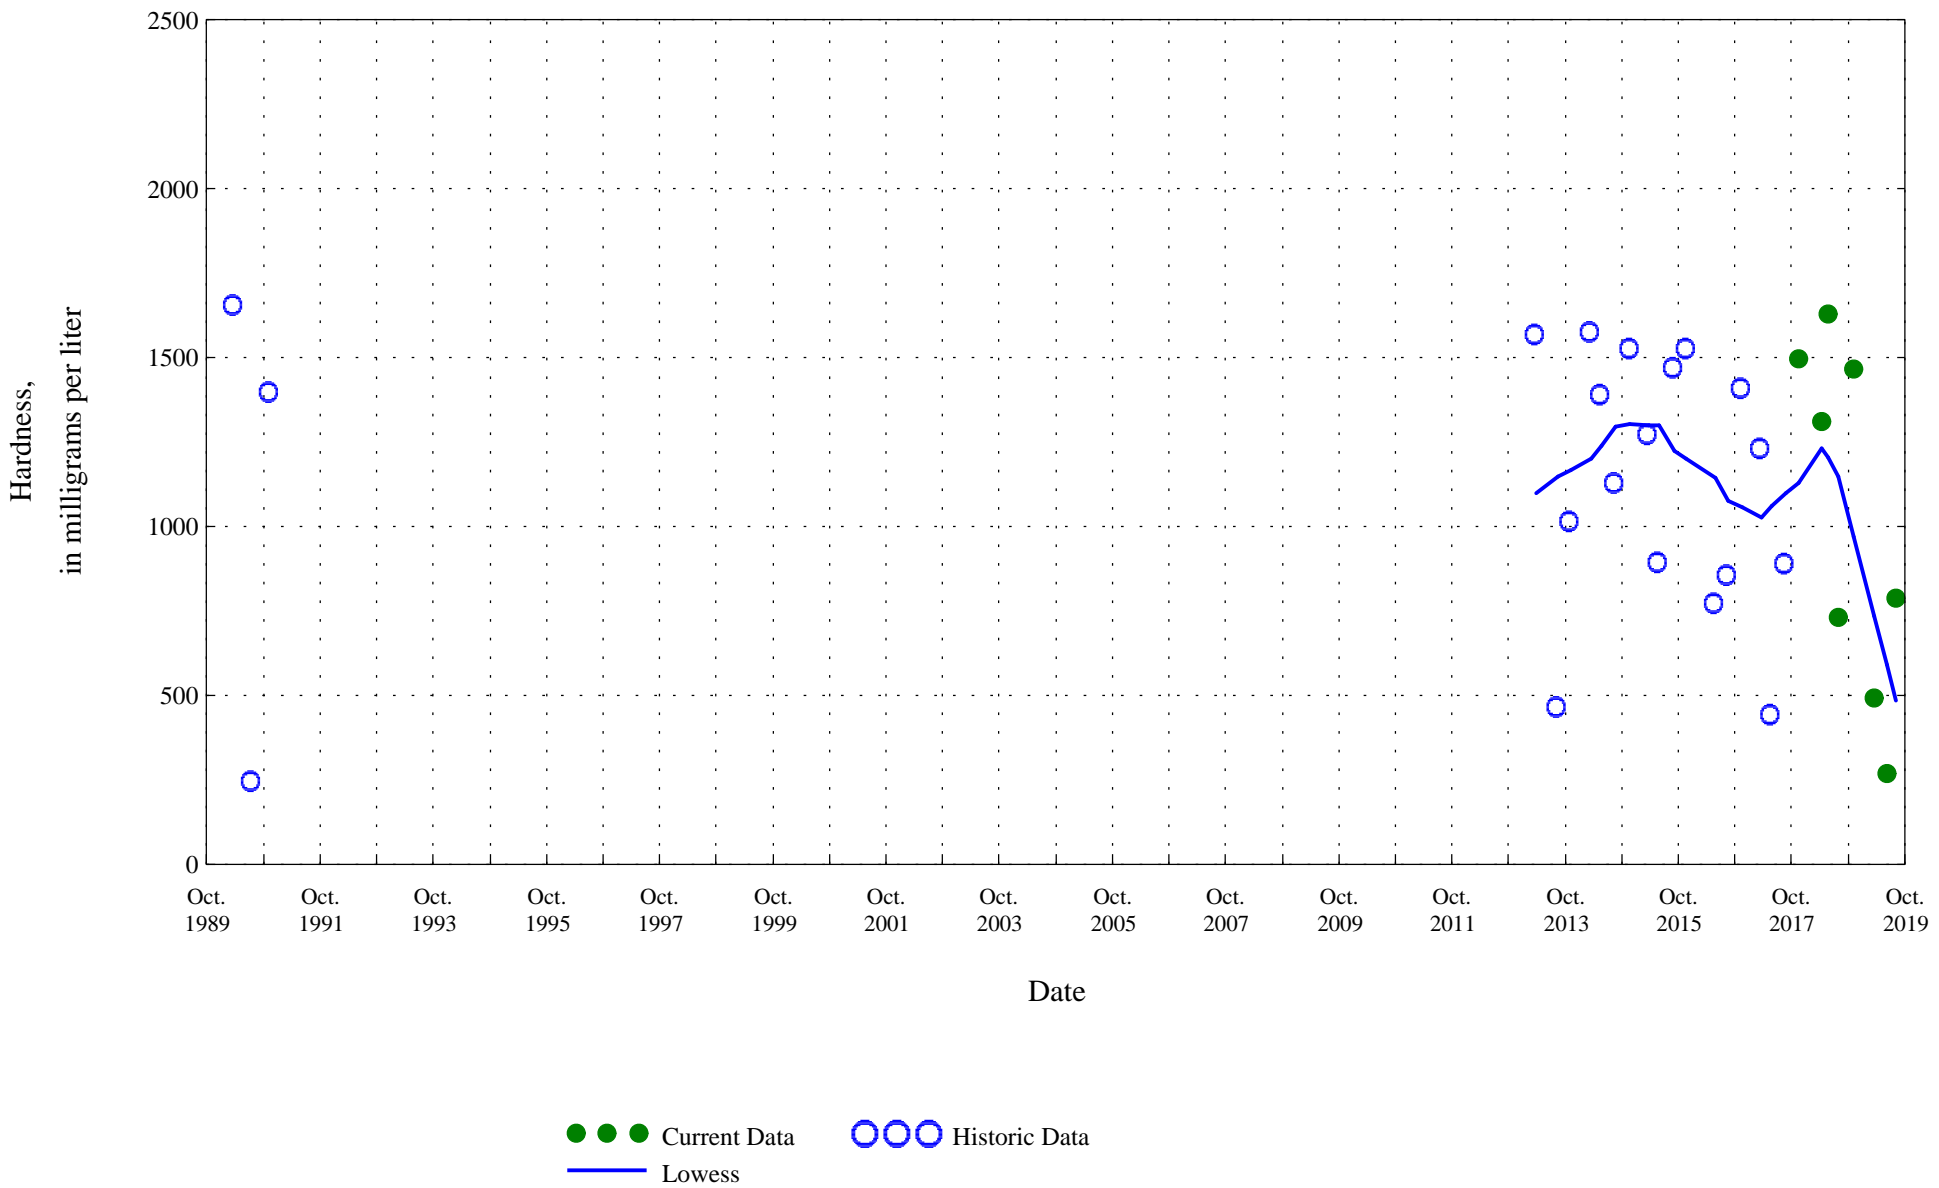
Figure 26. Distribution of selected water-quality constituents relative to time for

Purgatoire River at Rock Crossing near Timpas, Co., station 07126485.

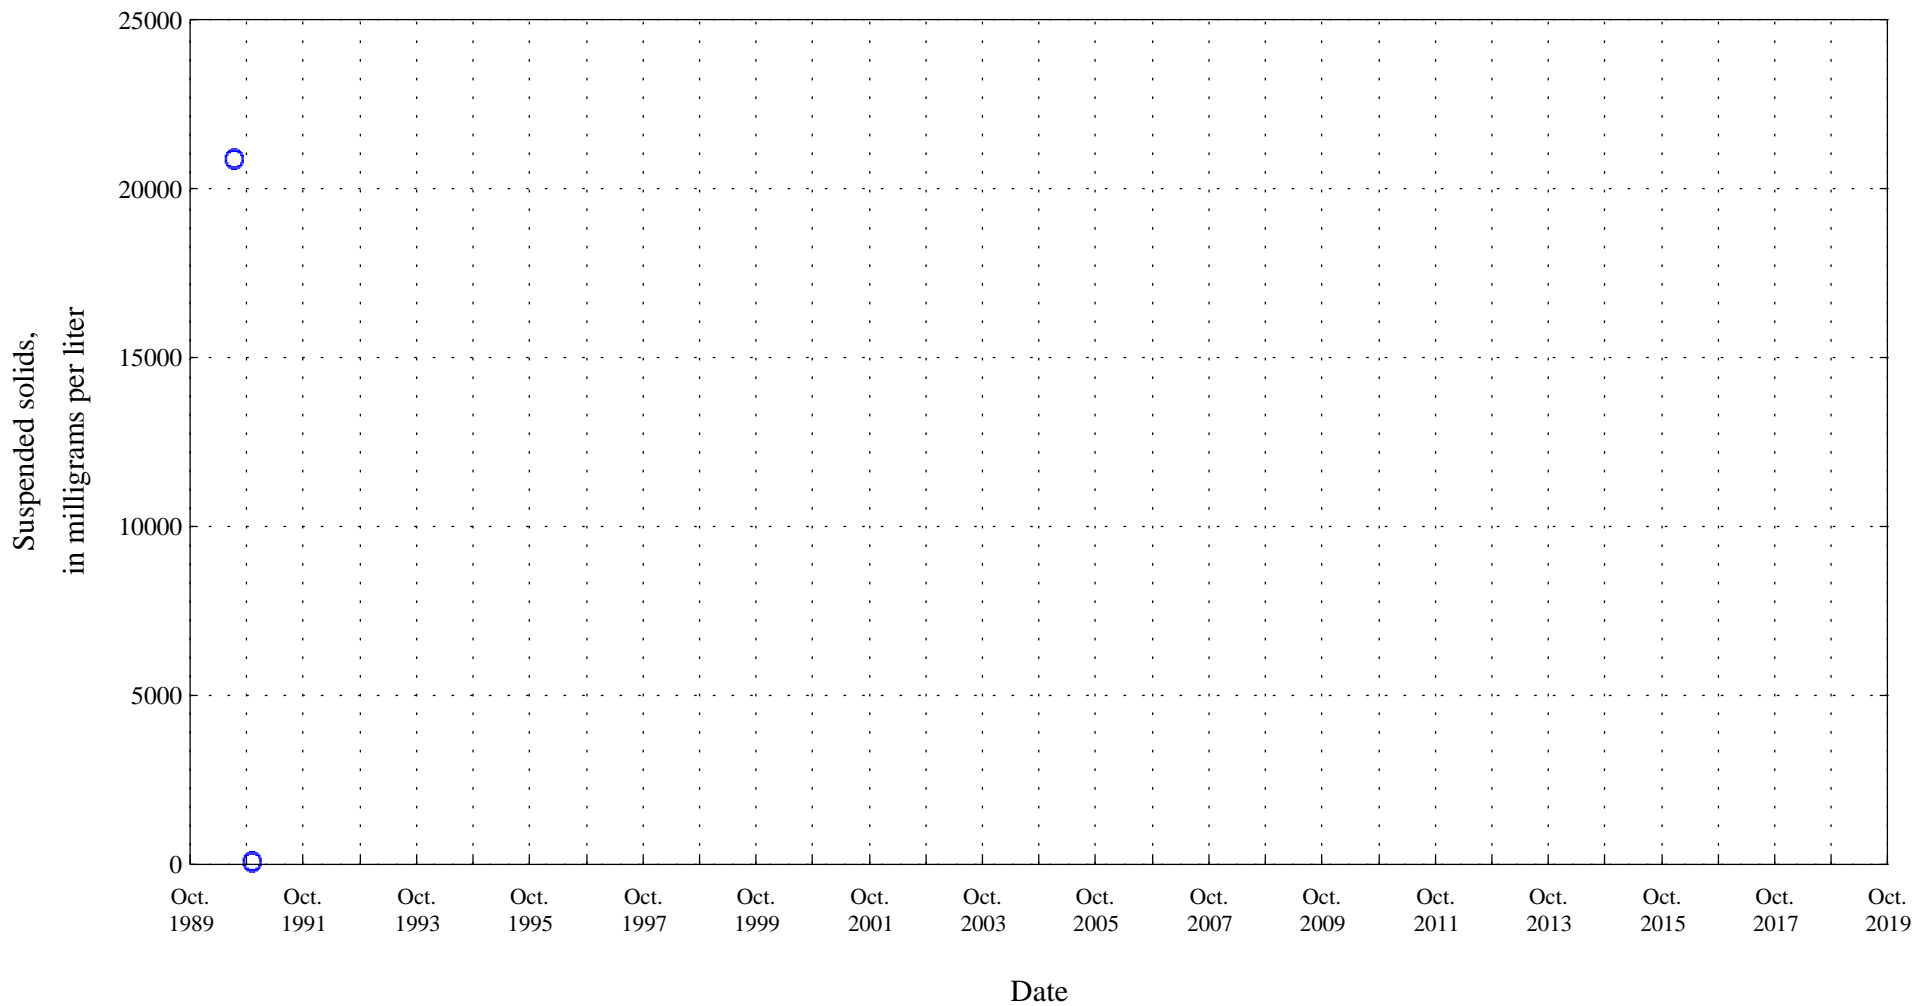
Figure 26. Distribution of selected water-quality constituents relative to time for

Purgatoire River at Rock Crossing near Timpas, Co., station 07126485.

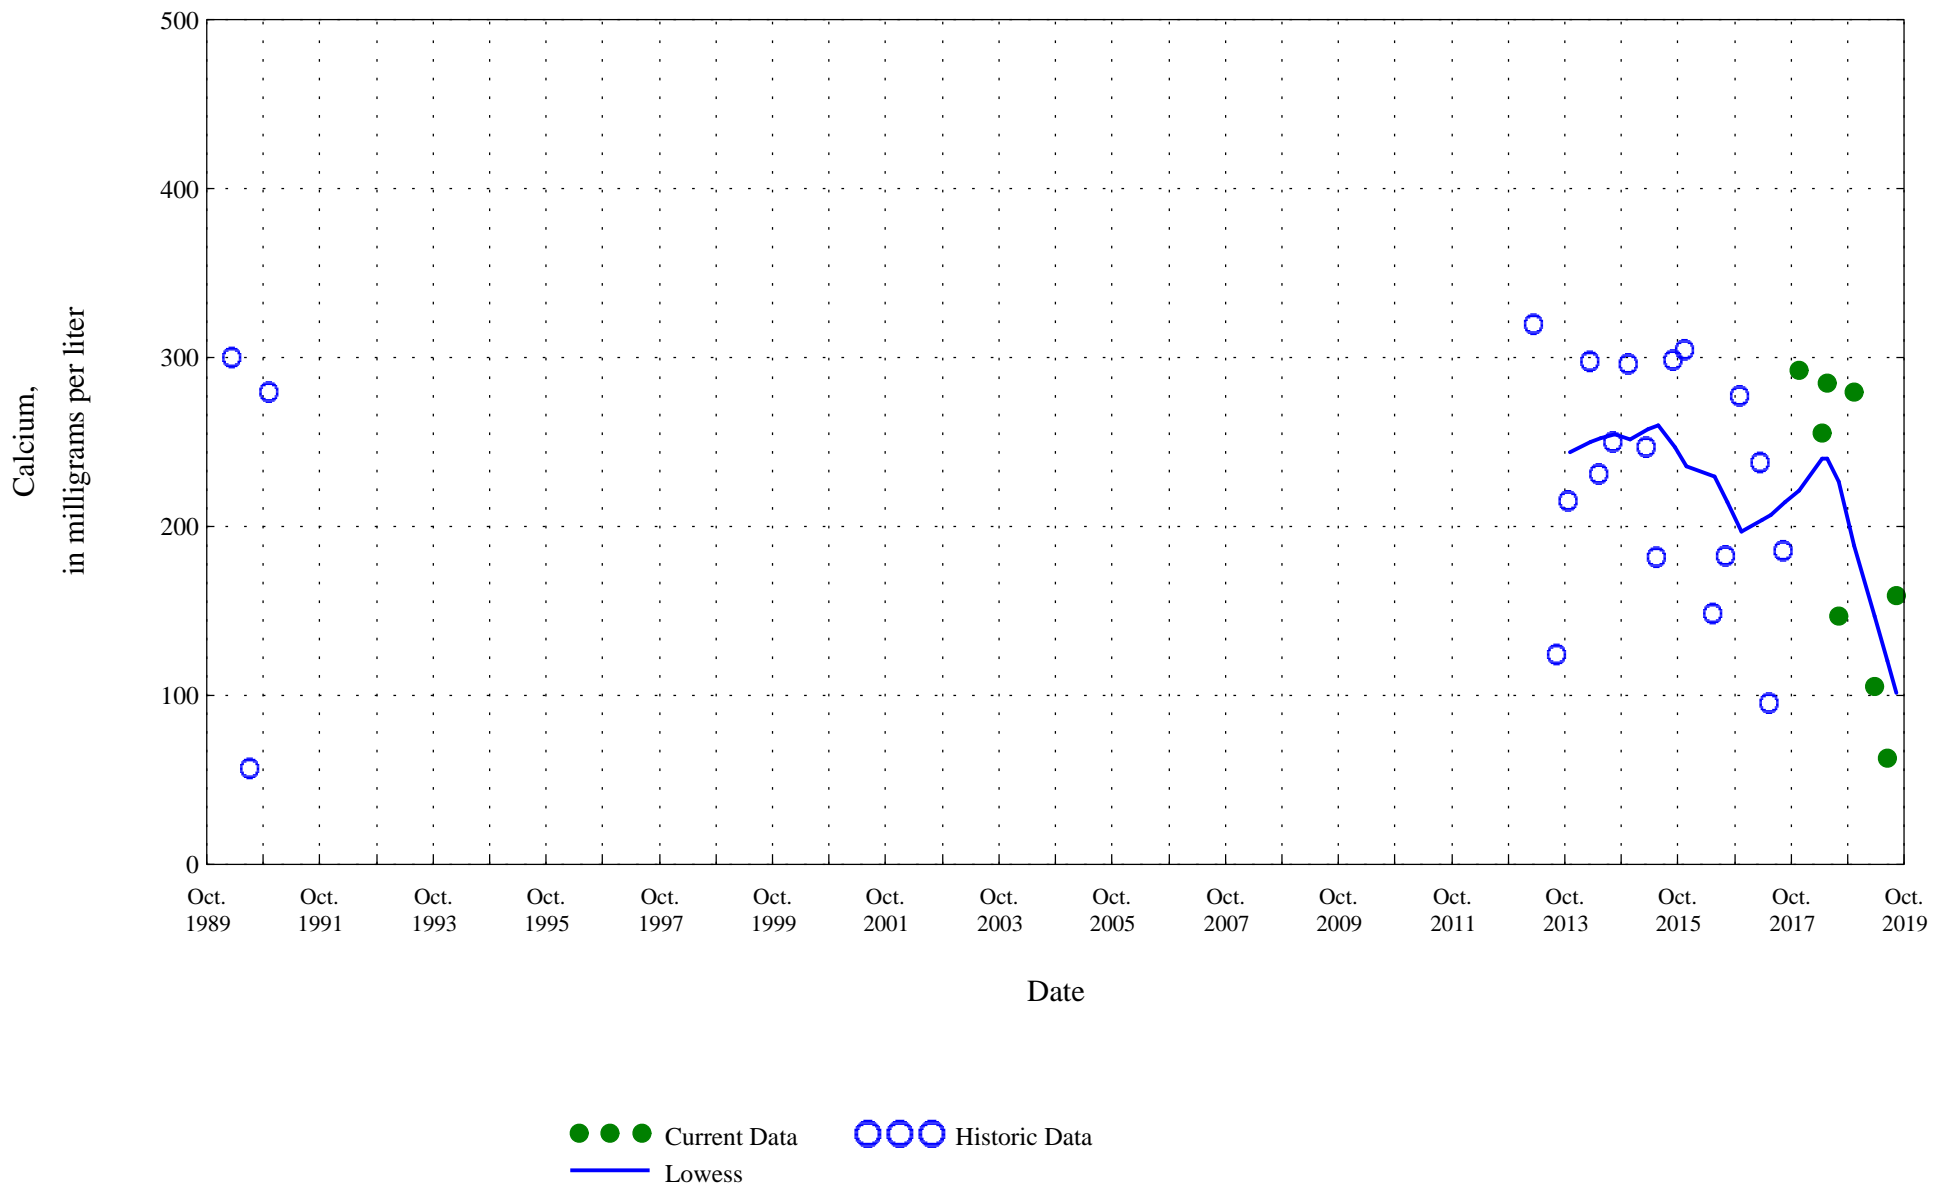
Figure 26. Distribution of selected water-quality constituents relative to time for

Purgatoire River at Rock Crossing near Timpas, Co., station 07126485.
