Figure 26. Distribution of selected water-quality constituents relative to time for

Purgatoire River at Rock Crossing near Timpas, Co., station 07126485.

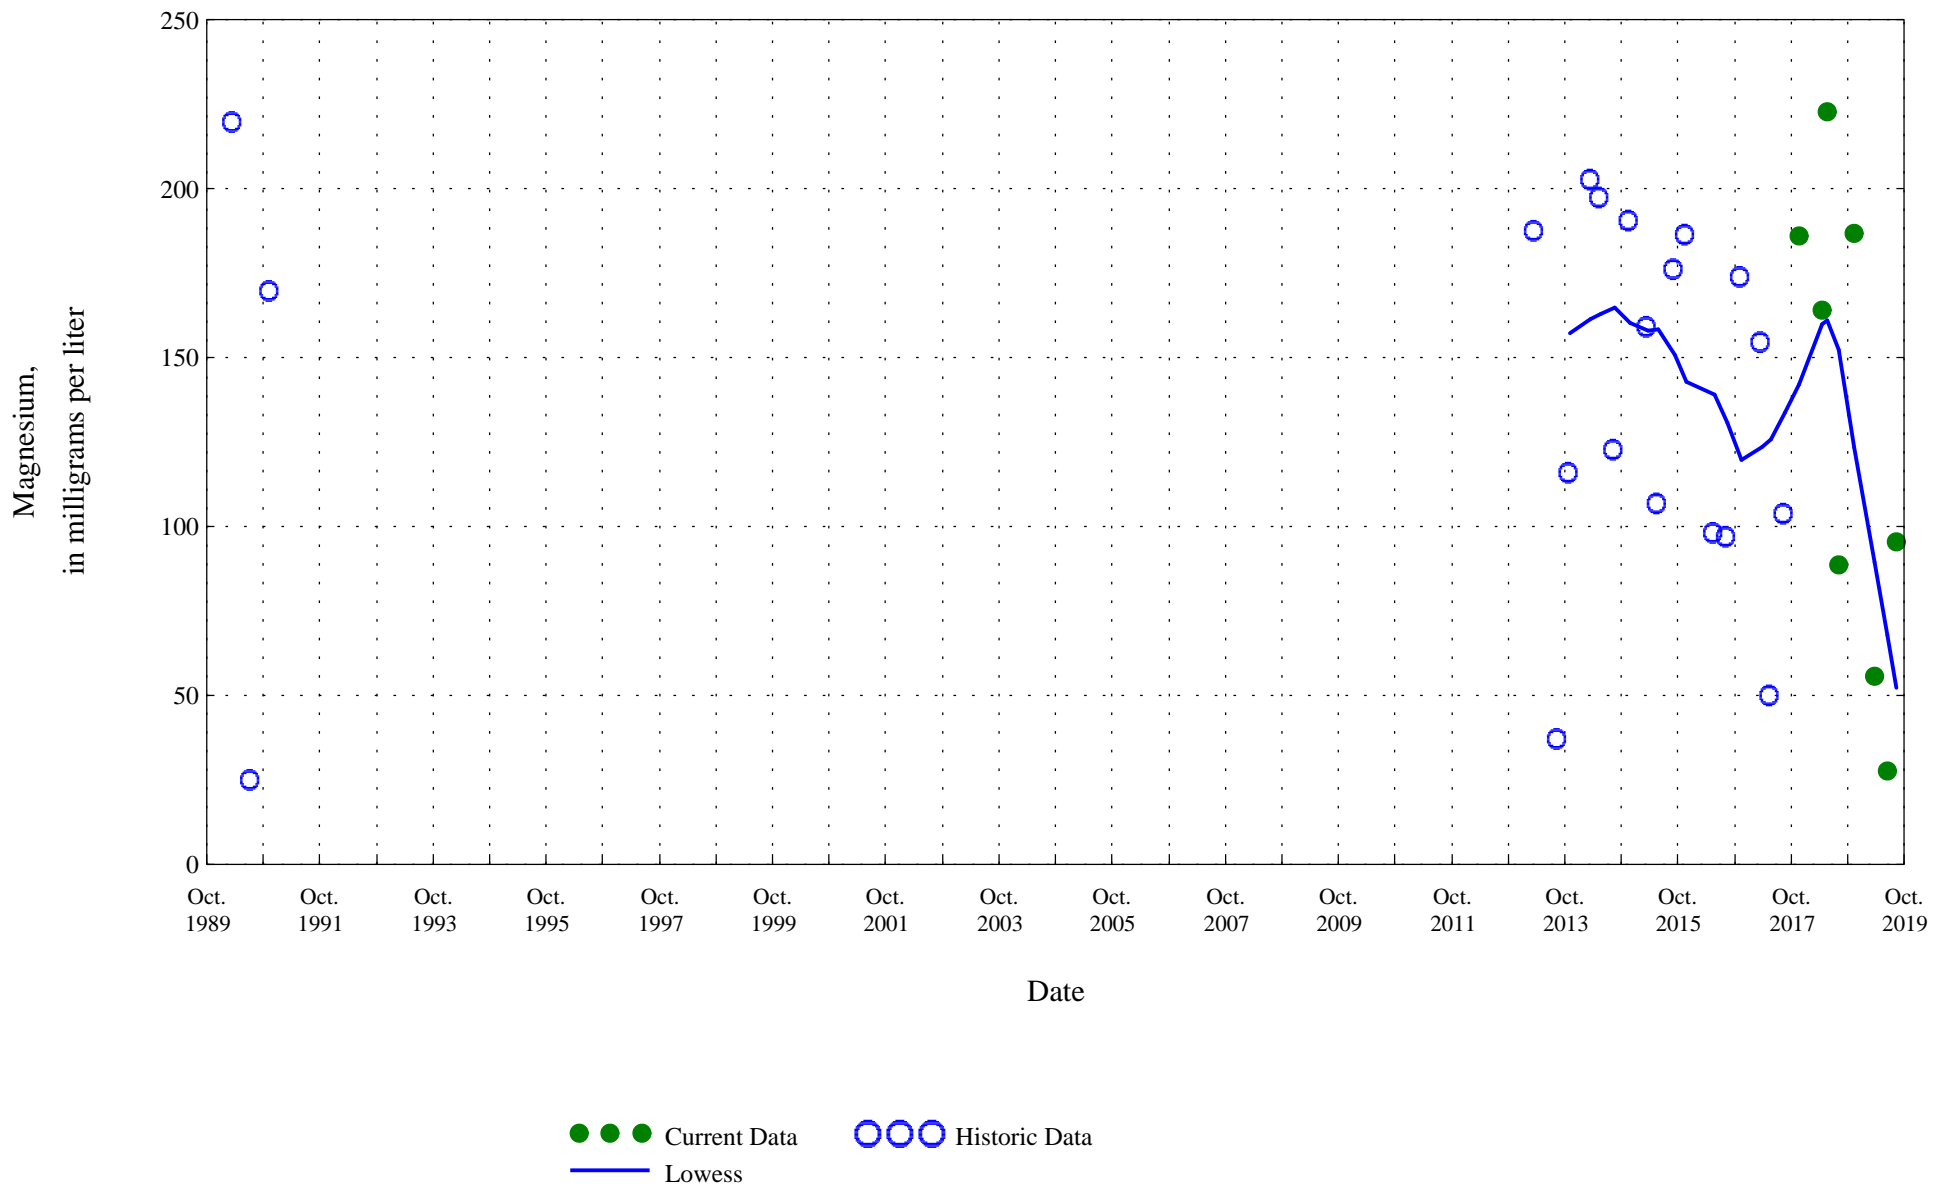
Figure 26. Distribution of selected water-quality constituents relative to time for

Purgatoire River at Rock Crossing near Timpas, Co., station 07126485.

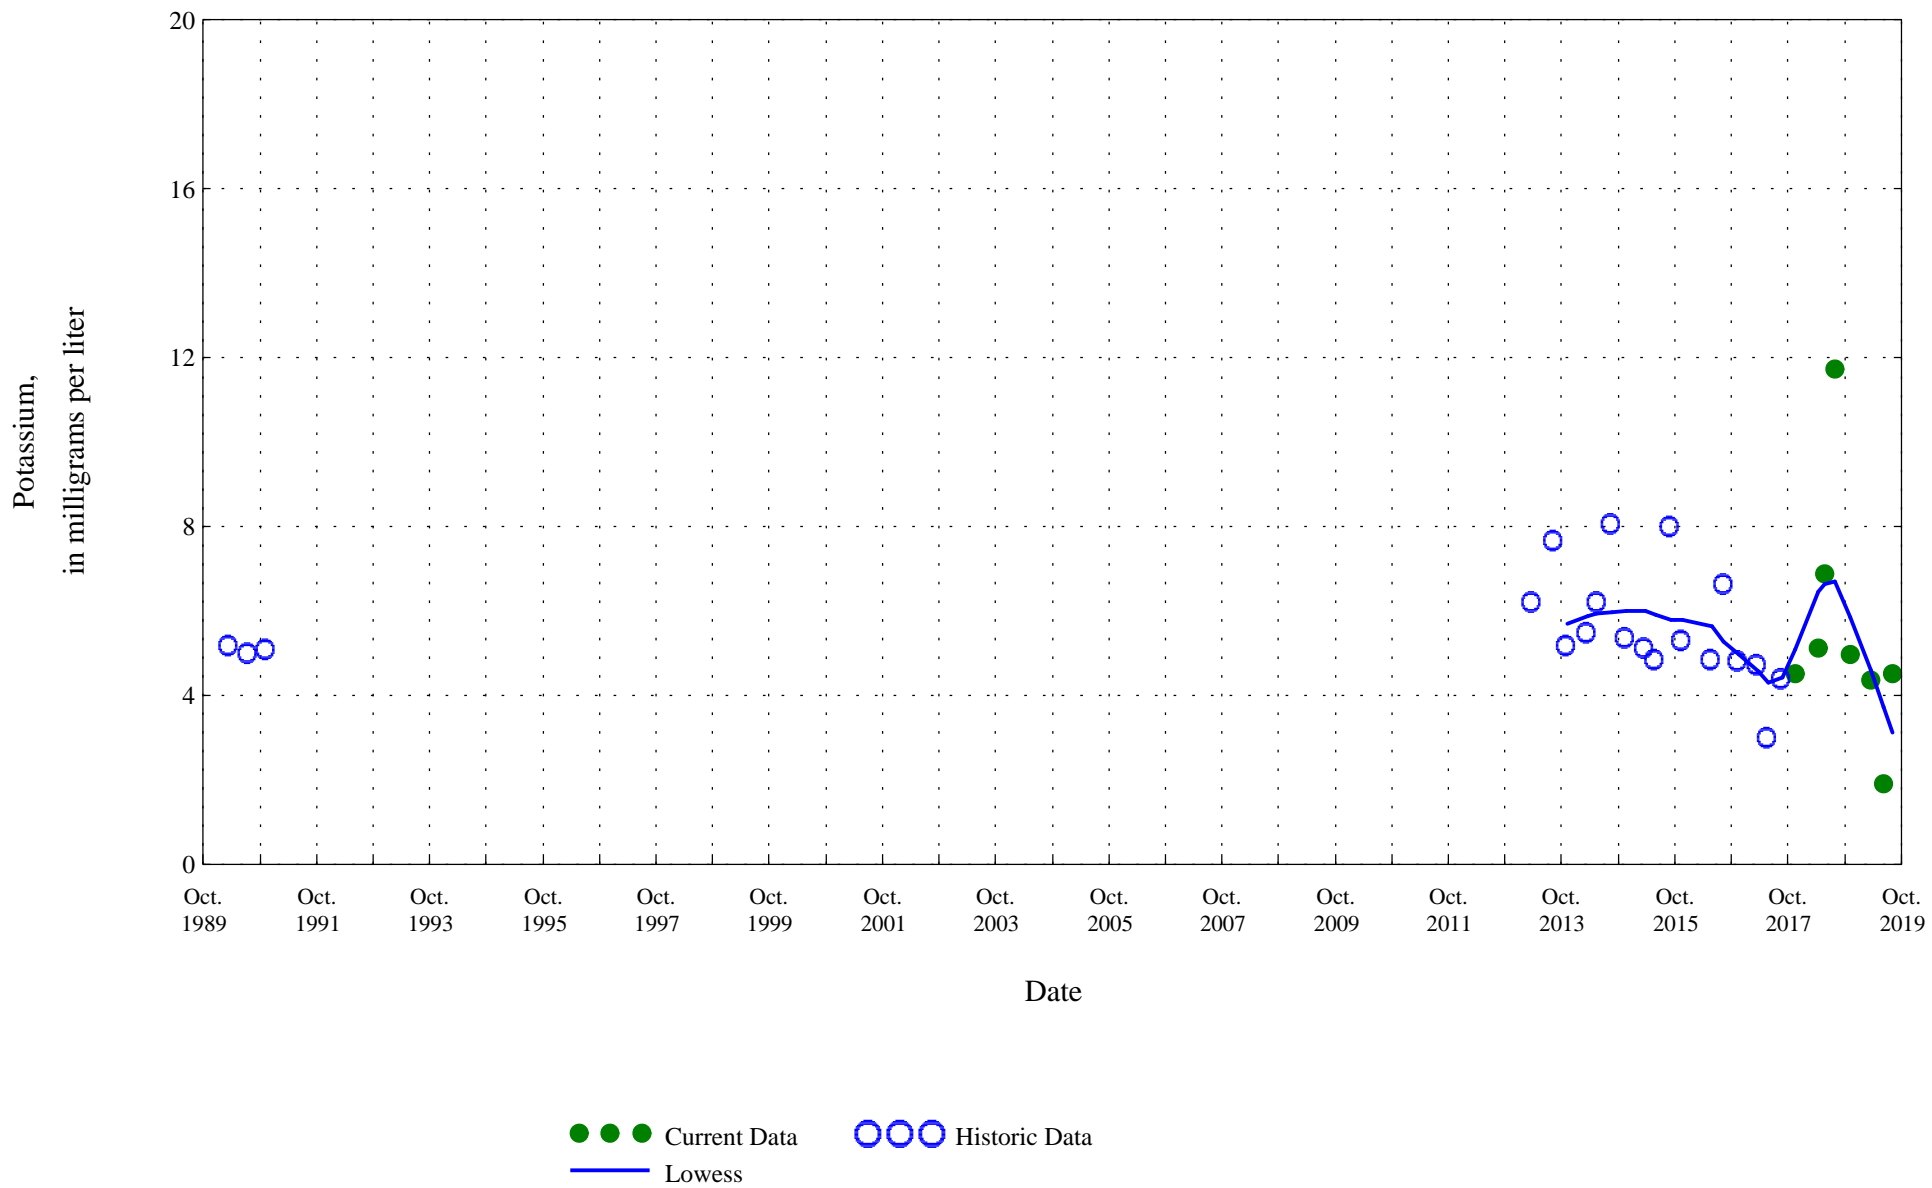
Figure 26. Distribution of selected water-quality constituents relative to time for

Purgatoire River at Rock Crossing near Timpas, Co., station 07126485.

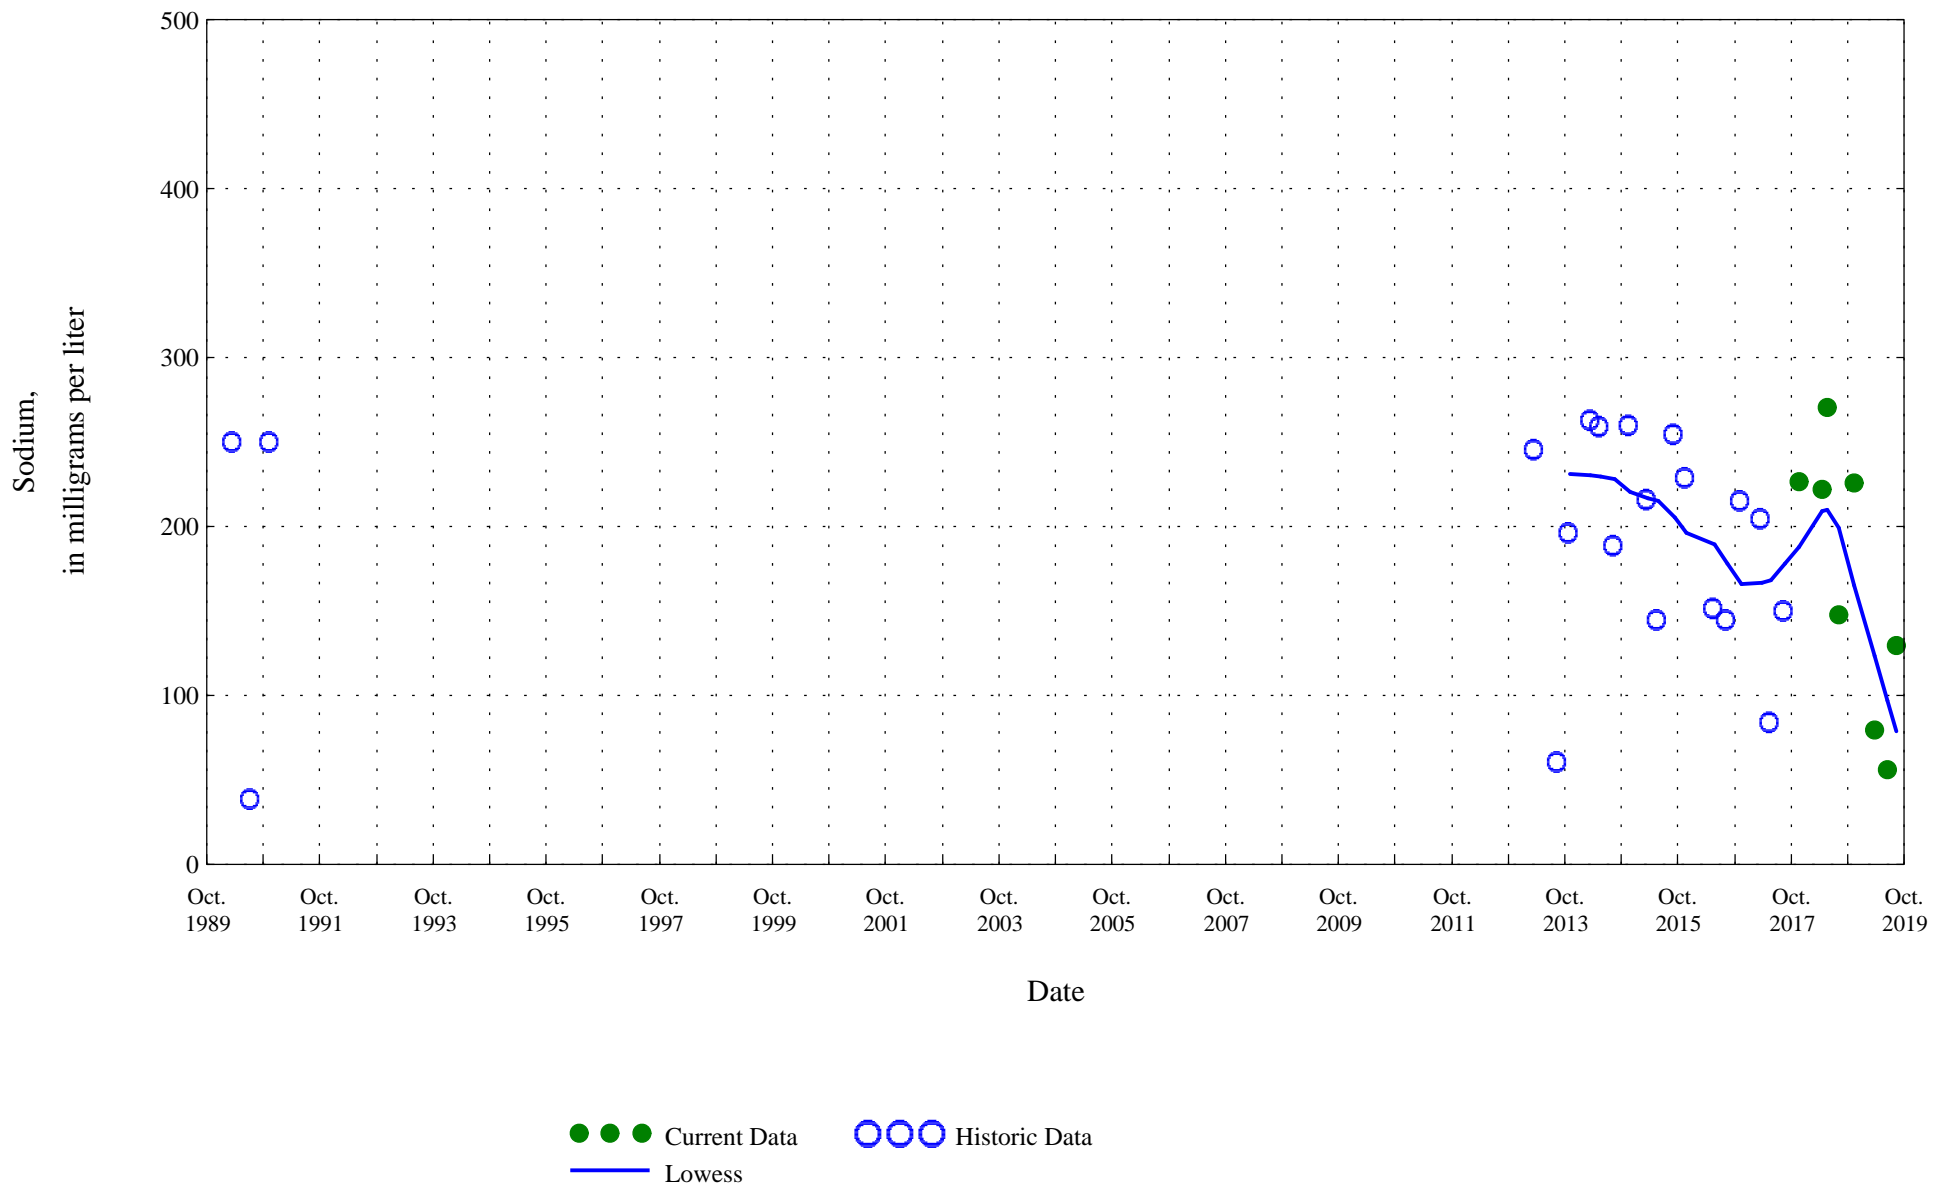
Figure 26. Distribution of selected water-quality constituents relative to time for

Purgatoire River at Rock Crossing near Timpas, Co., station 07126485.

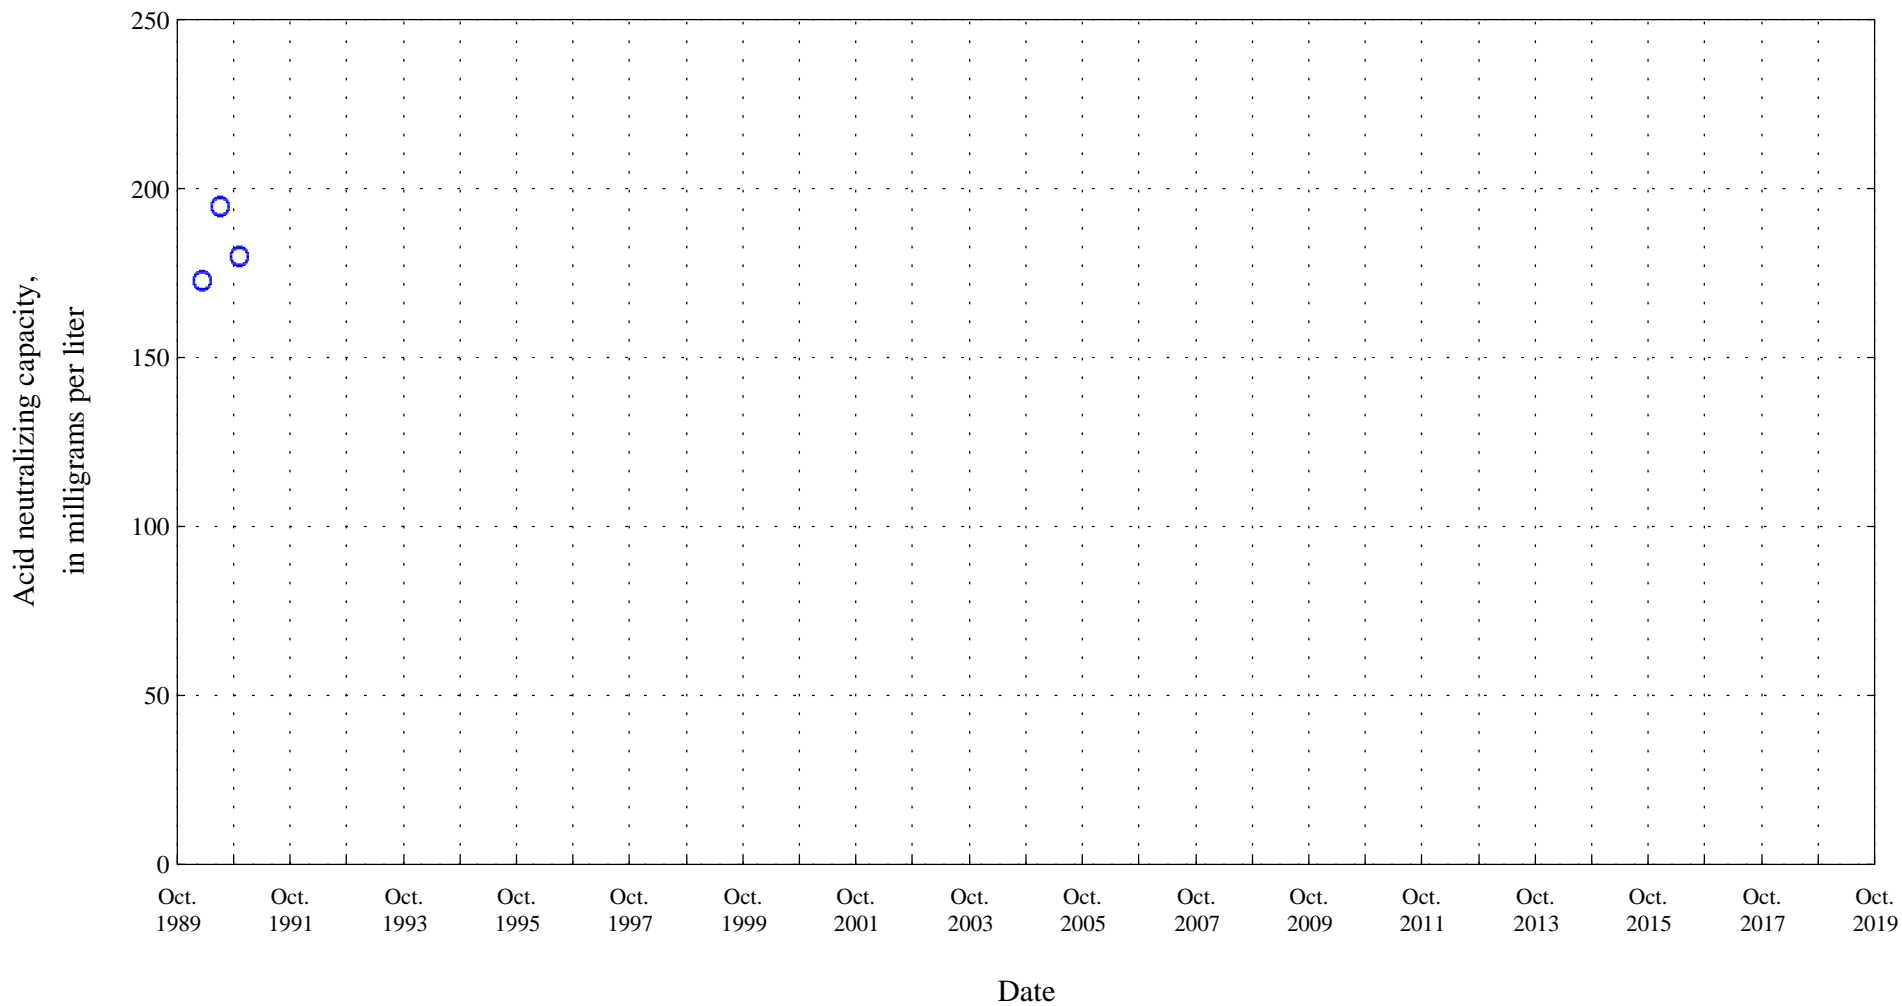
Figure 26. Distribution of selected water-quality constituents relative to time for

Purgatoire River at Rock Crossing near Timpas, Co., station 07126485.

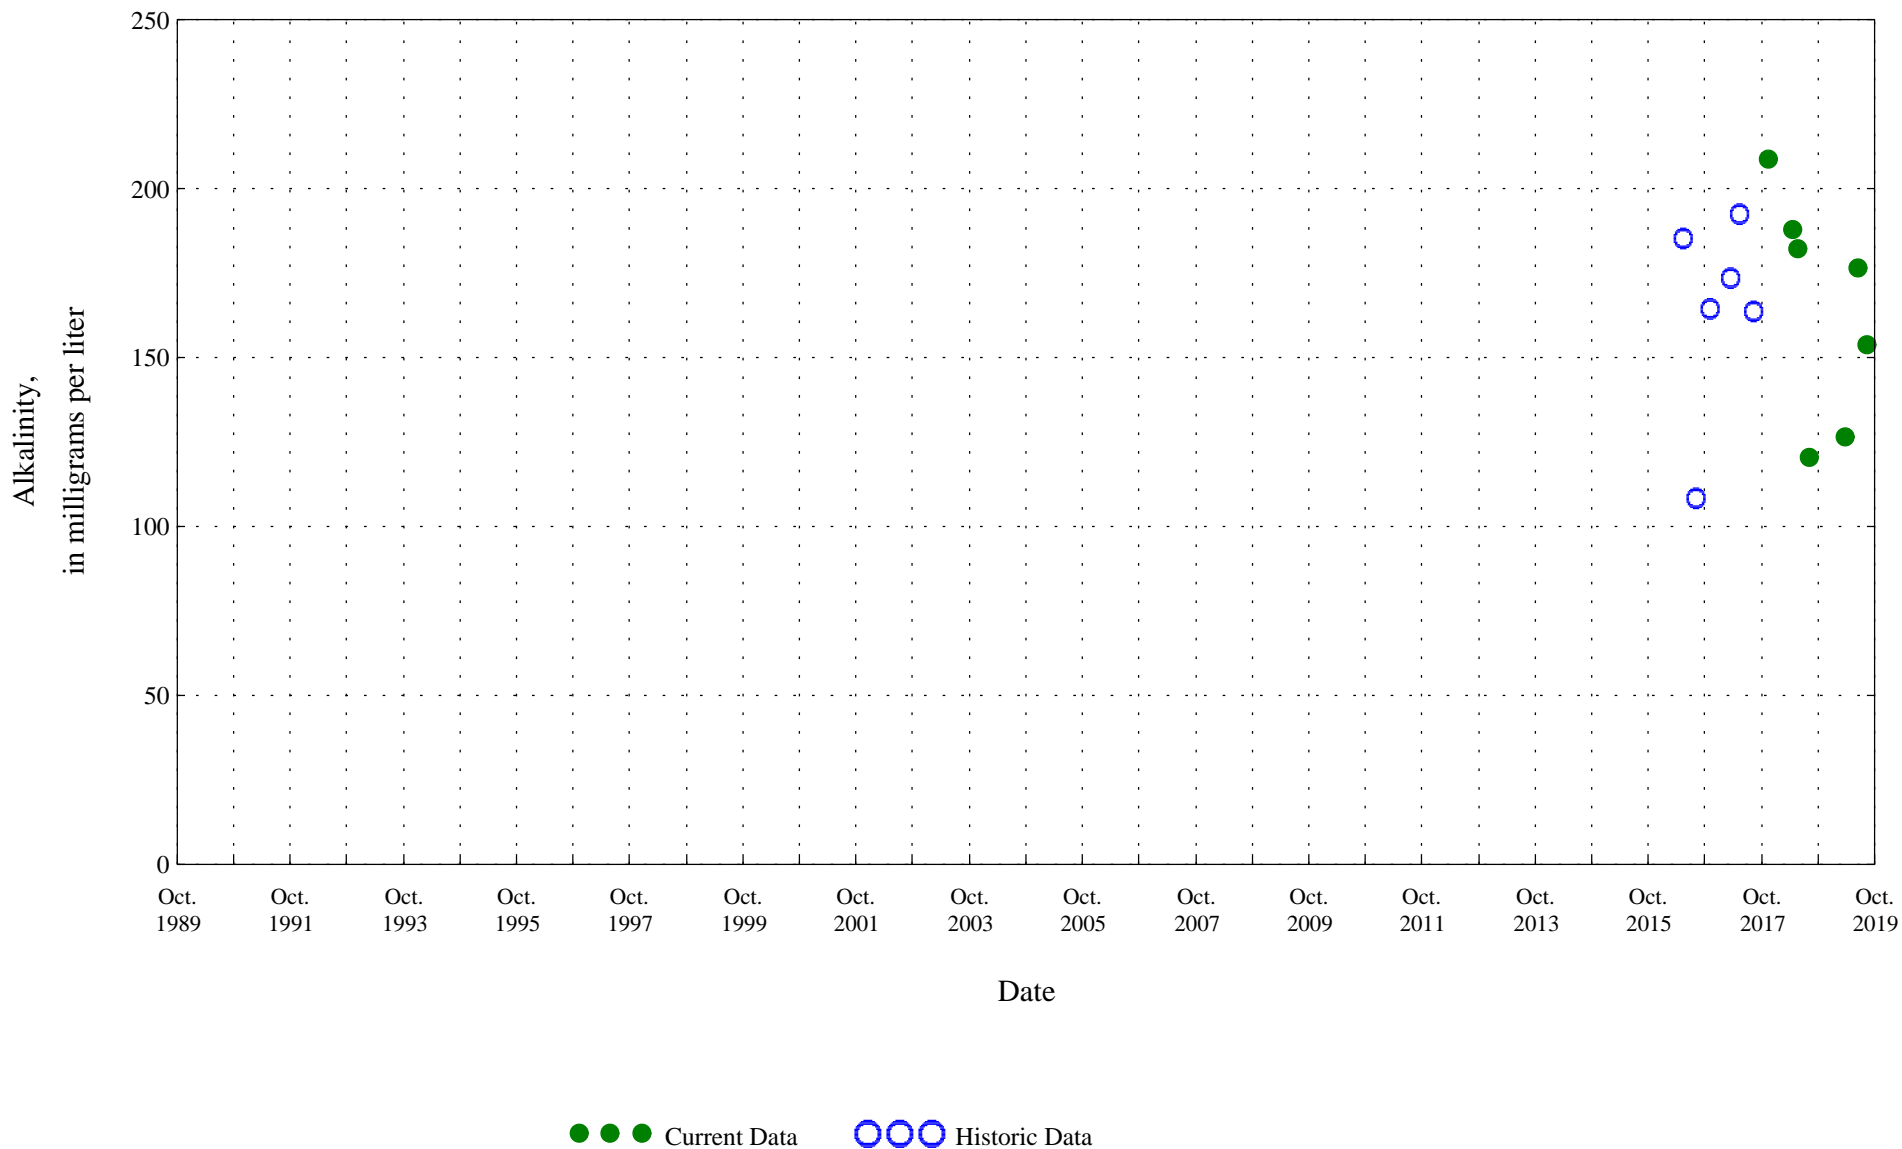
Figure 26. Distribution of selected water-quality constituents relative to time for

Purgatoire River at Rock Crossing near Timpas, Co., station 07126485.

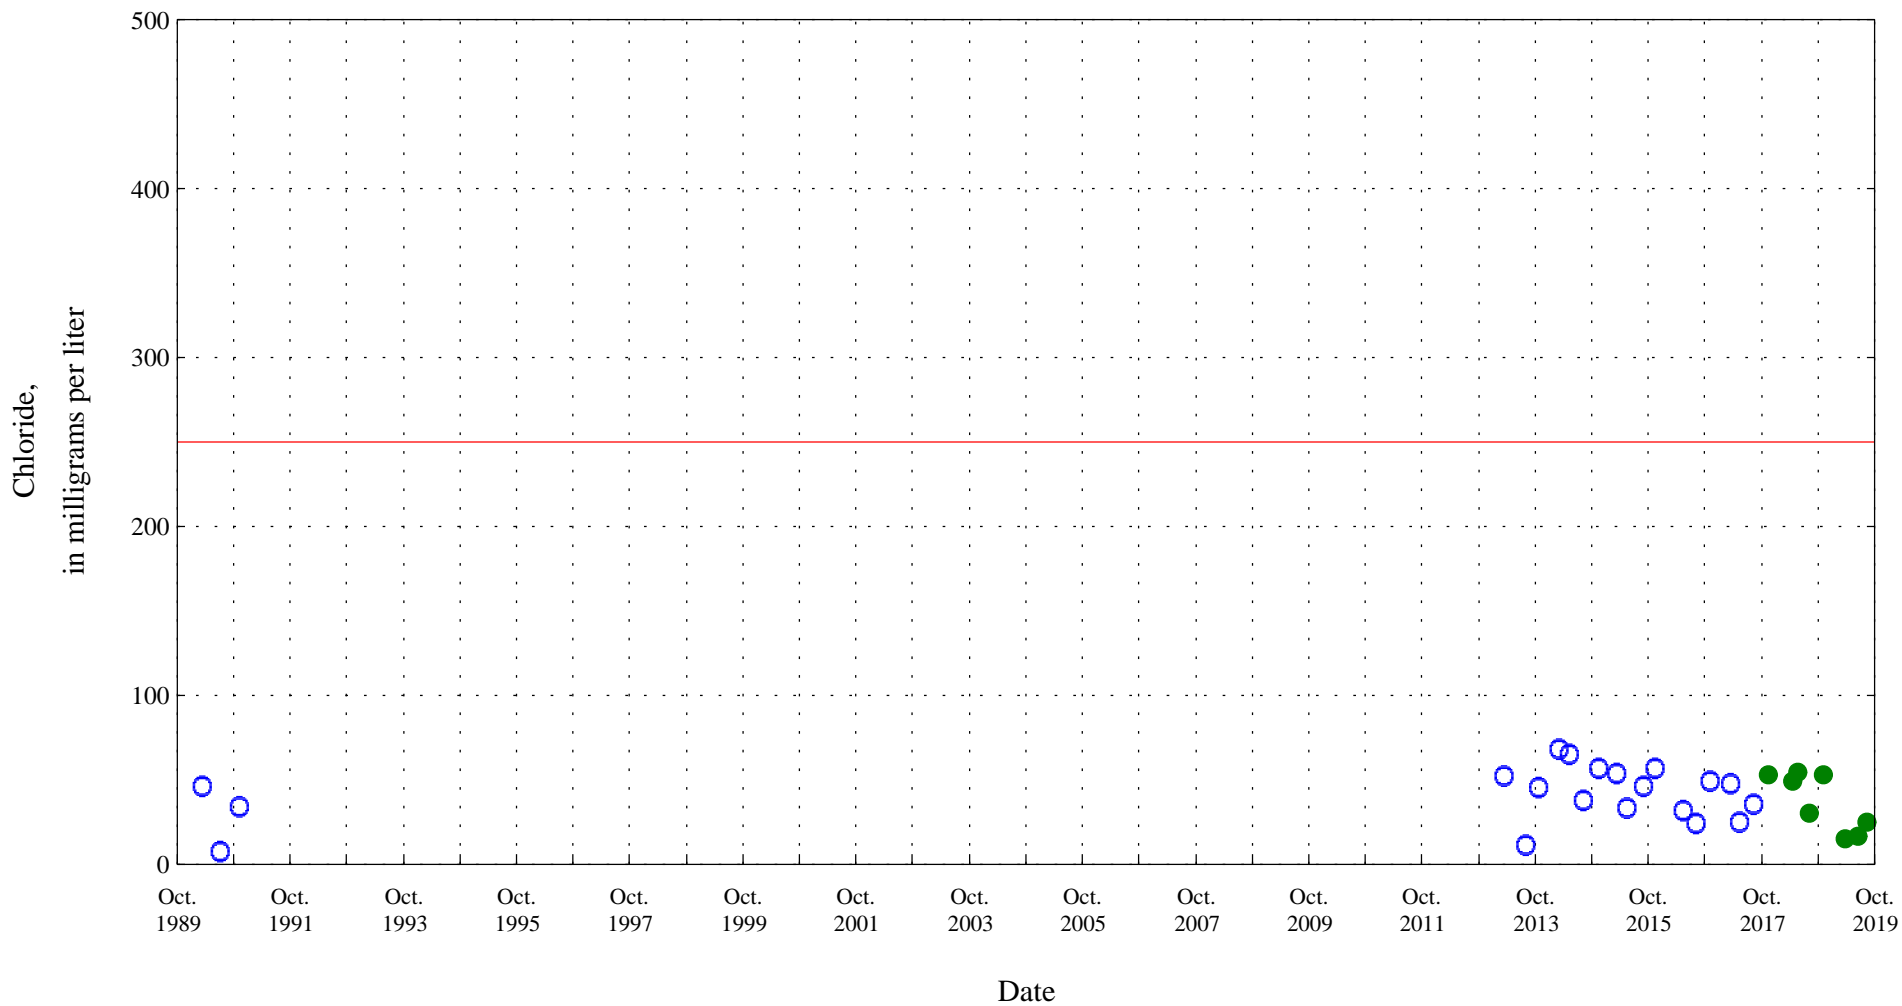
Figure 26. Distribution of selected water-quality constituents relative to time for

Purgatoire River at Rock Crossing near Timpas, Co., station 07126485.

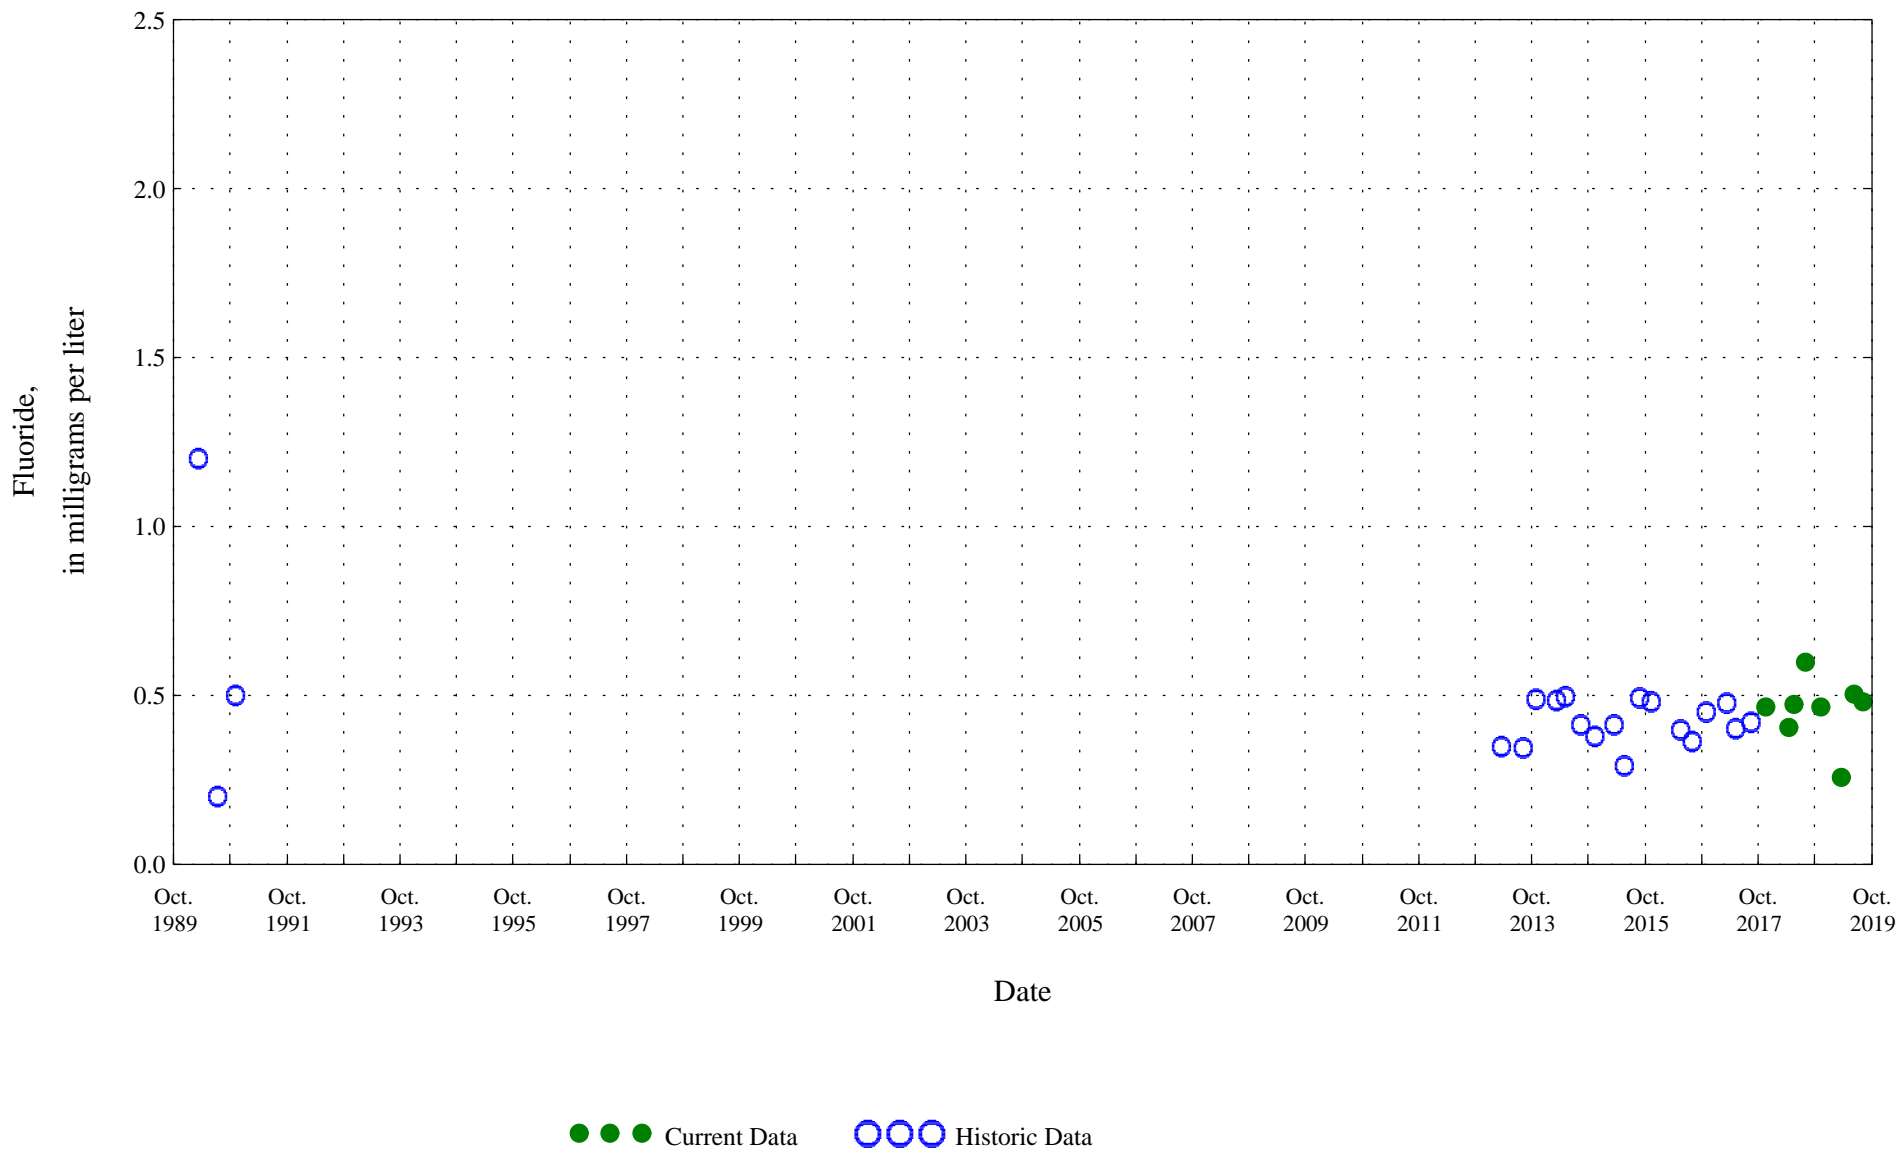
Human Health Based Water Supply Chronic Standard 250

Figure 26. Distribution of selected water-quality constituents relative to time for

Purgatoire River at Rock Crossing near Timpas, Co., station 07126485.

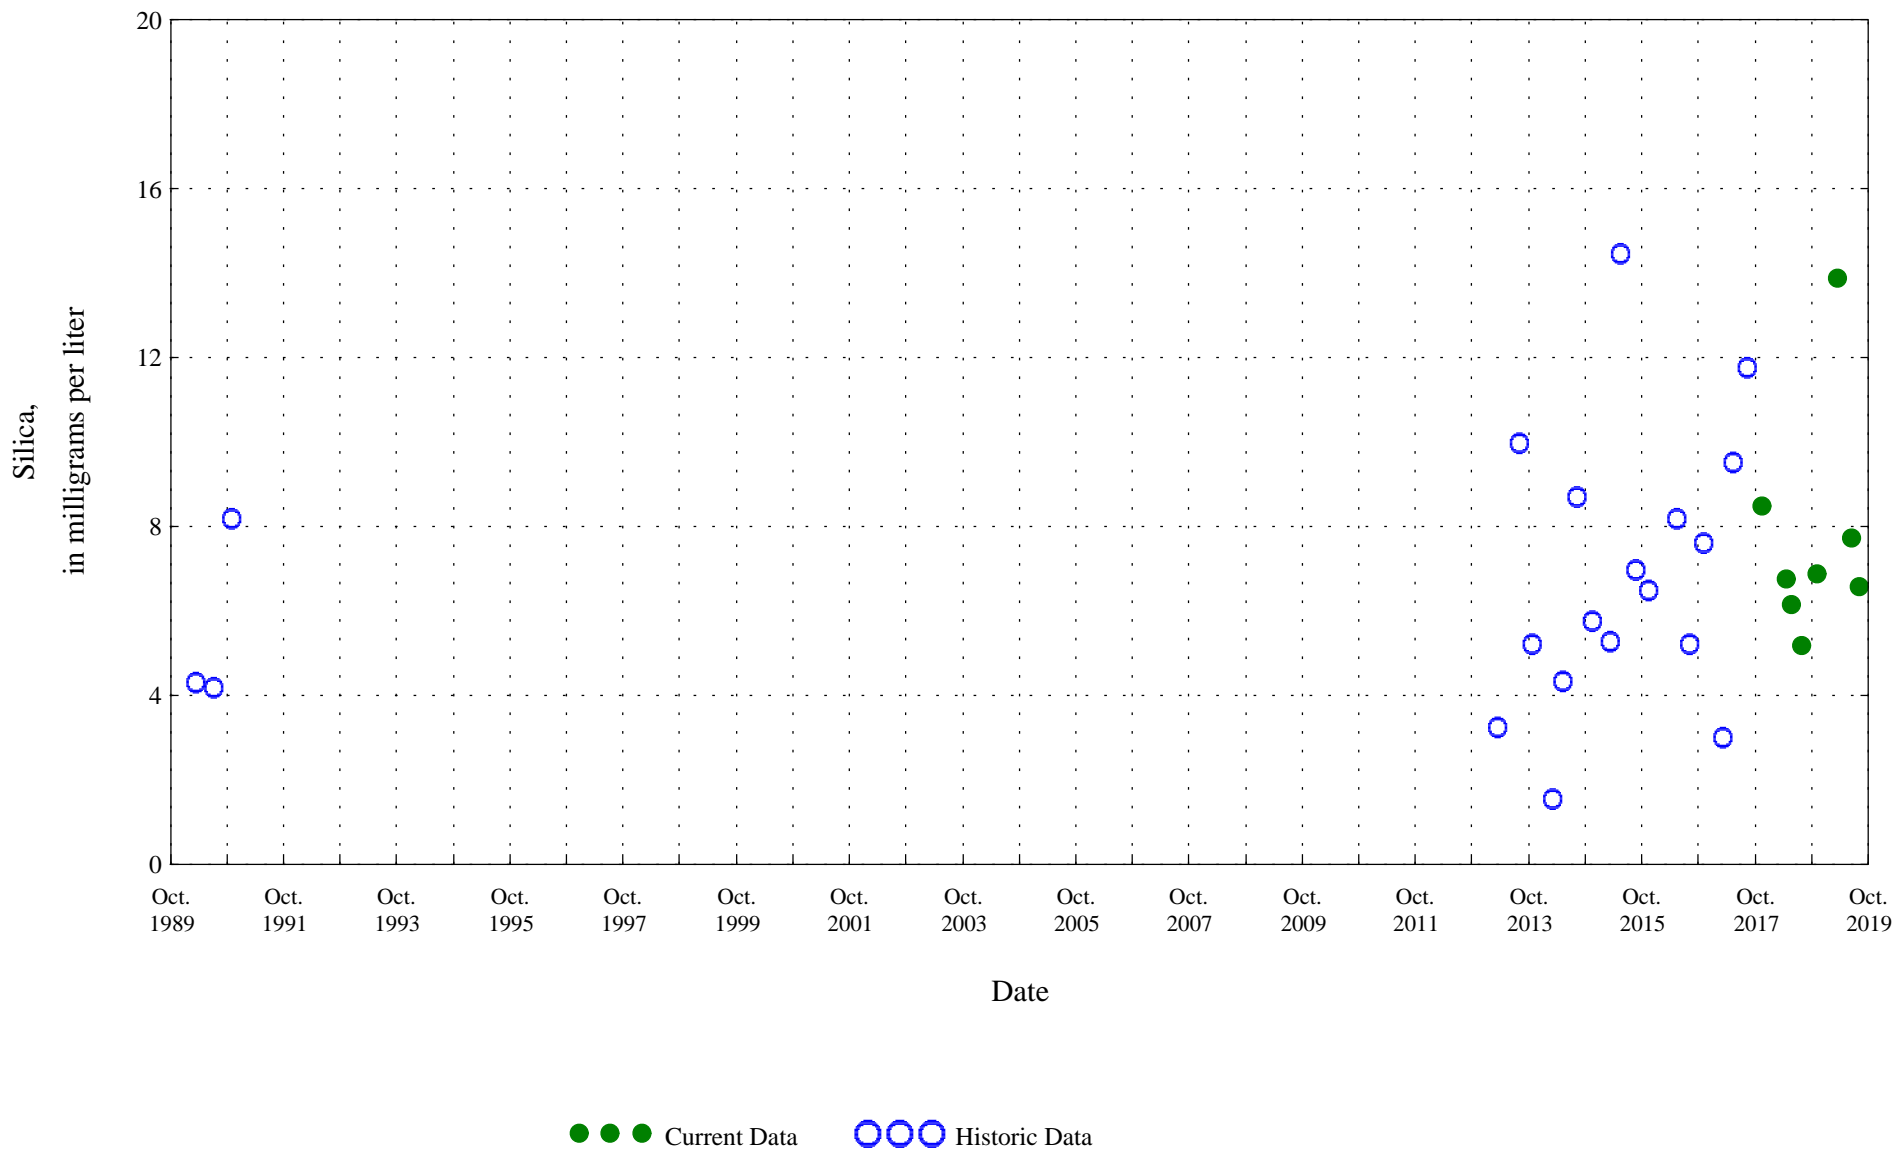
Figure 26. Distribution of selected water-quality constituents relative to time for

Purgatoire River at Rock Crossing near Timpas, Co., station 07126485.

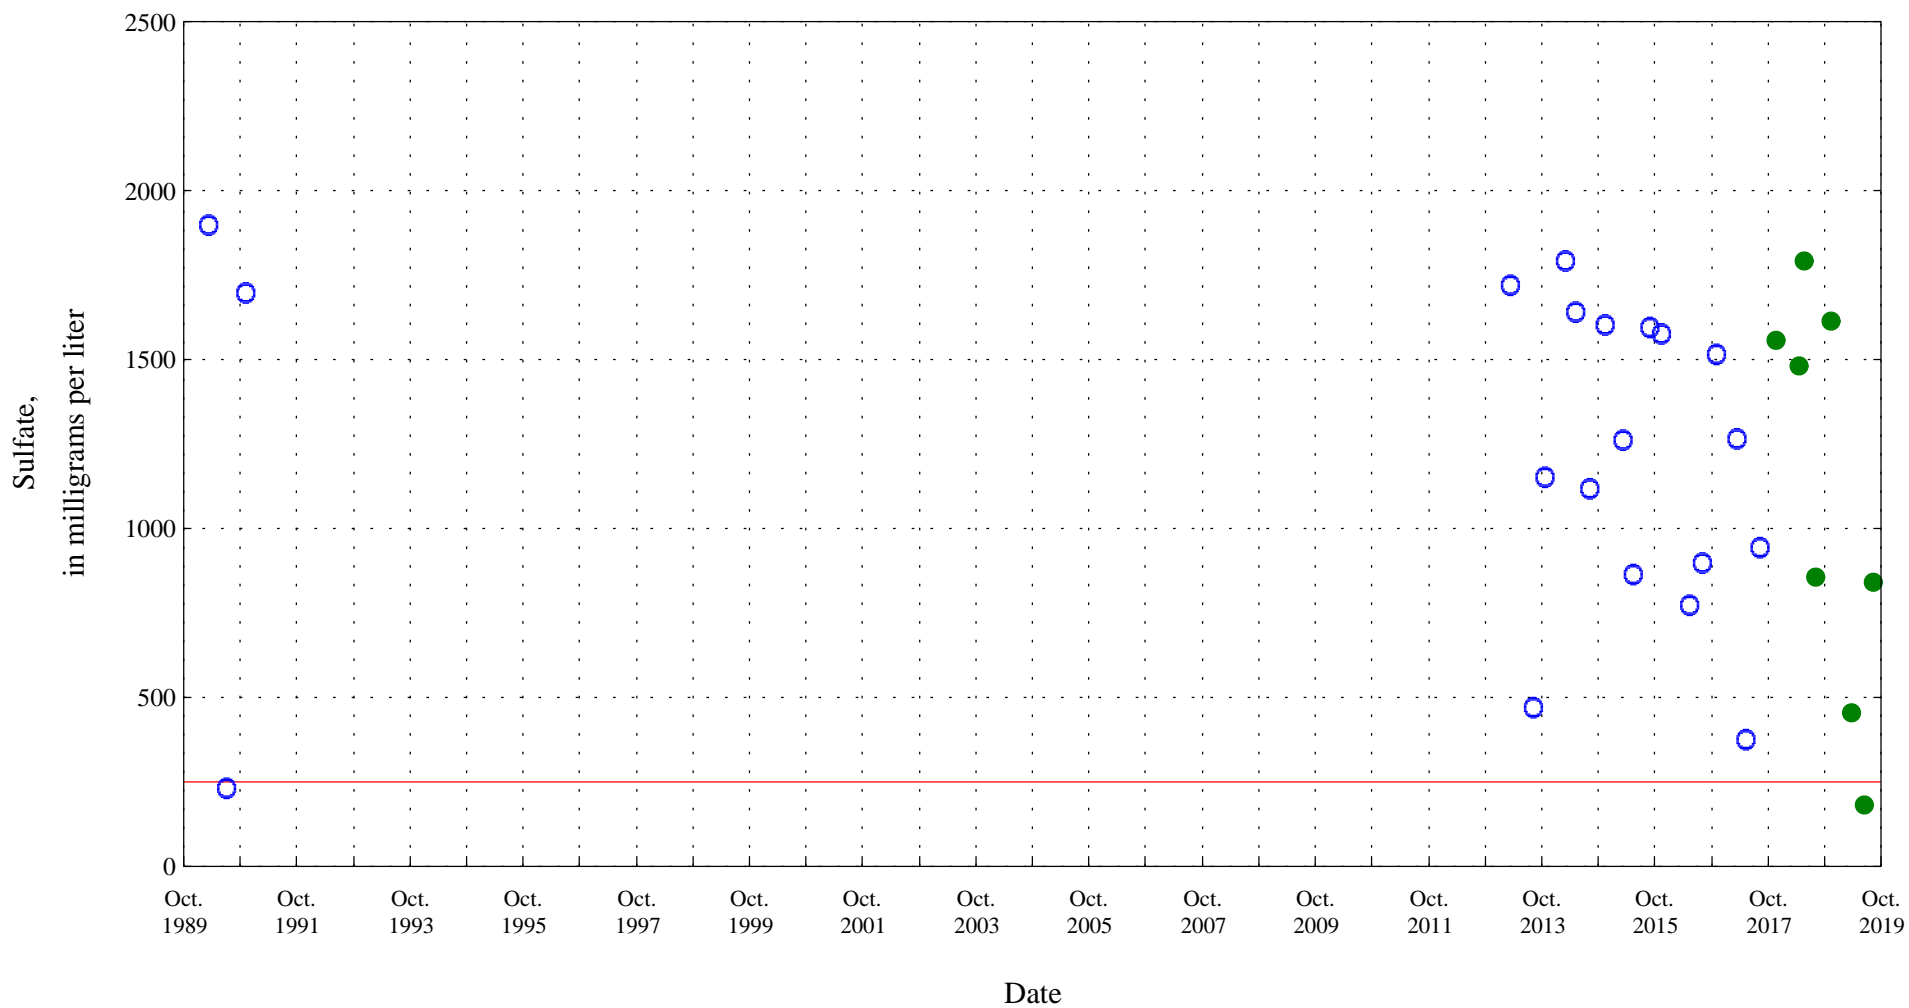
Figure 26. Distribution of selected water-quality constituents relative to time for

Purgatoire River at Rock Crossing near Timpas, Co., station 07126485.

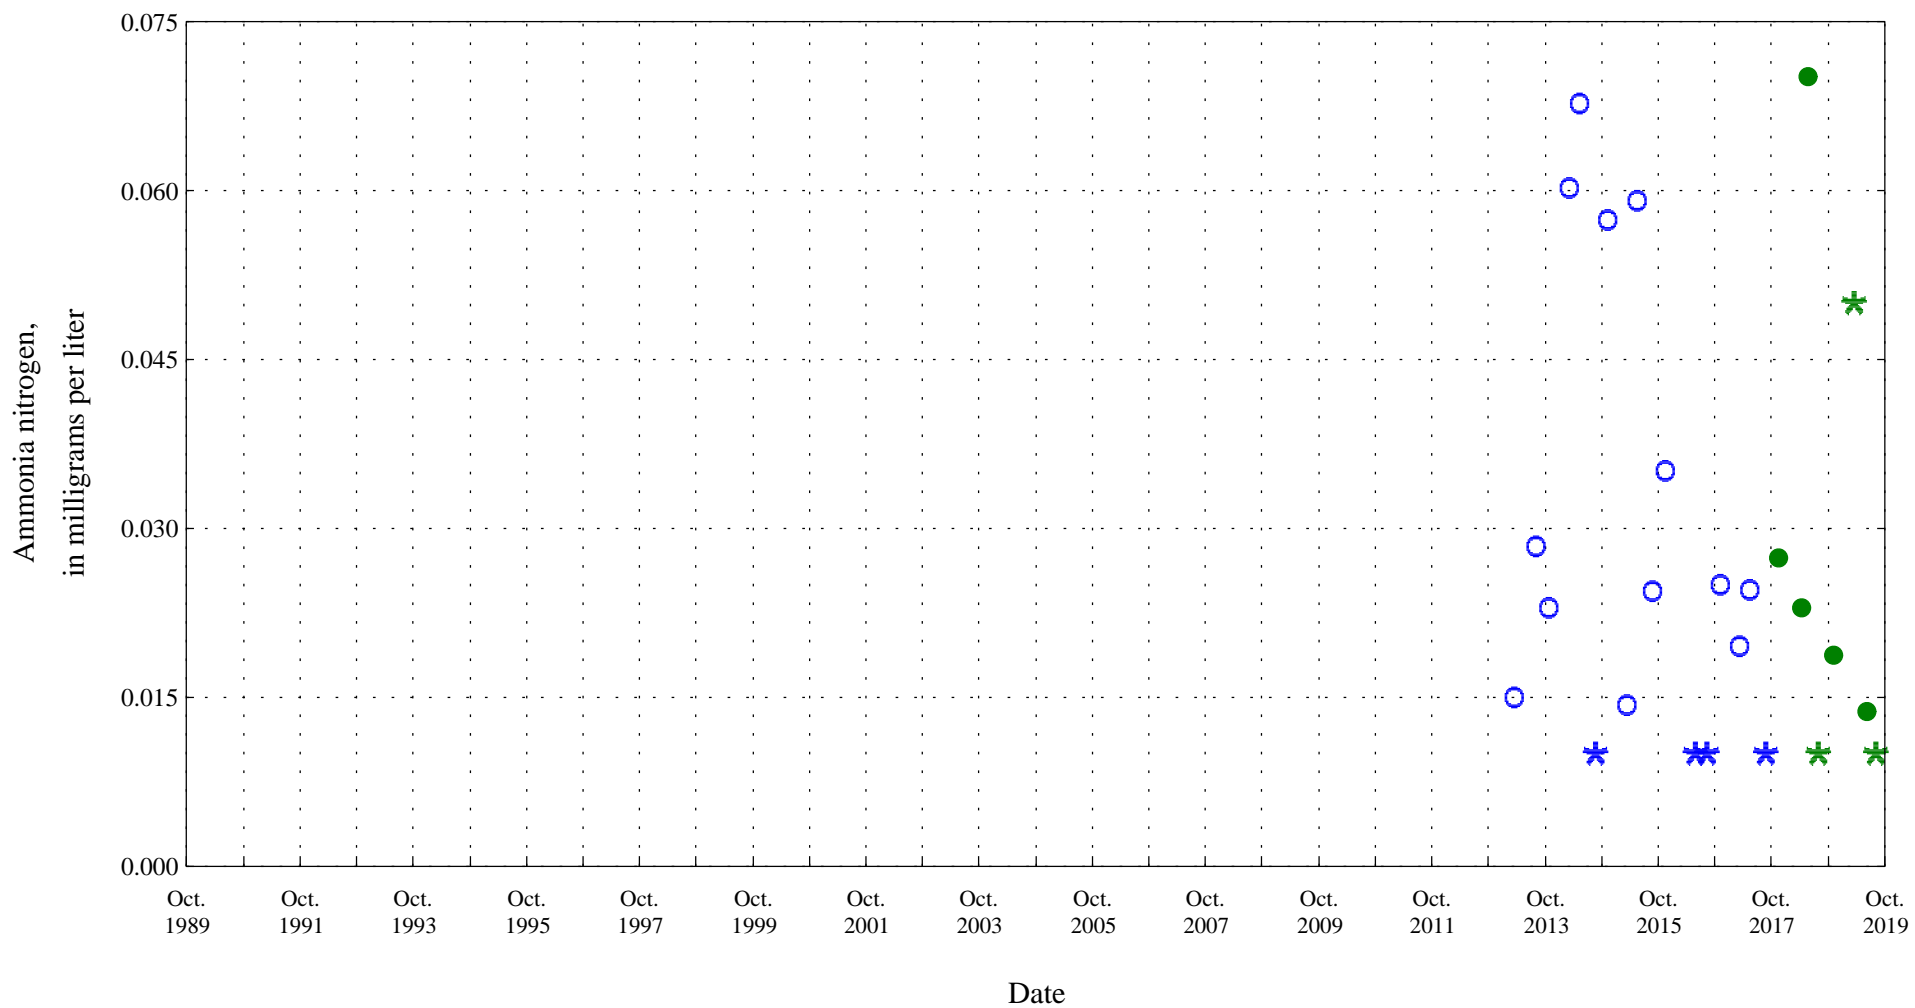
Human Health Based Water Supply Chronic Standard 250

Figure 26. Distribution of selected water-quality constituents relative to time for

Purgatoire River at Rock Crossing near Timpas, Co., station 07126485.
