Figure 26. Distribution of selected water-quality constituents relative to time for

Purgatoire River at Rock Crossing near Timpas, Co., station 07126485.

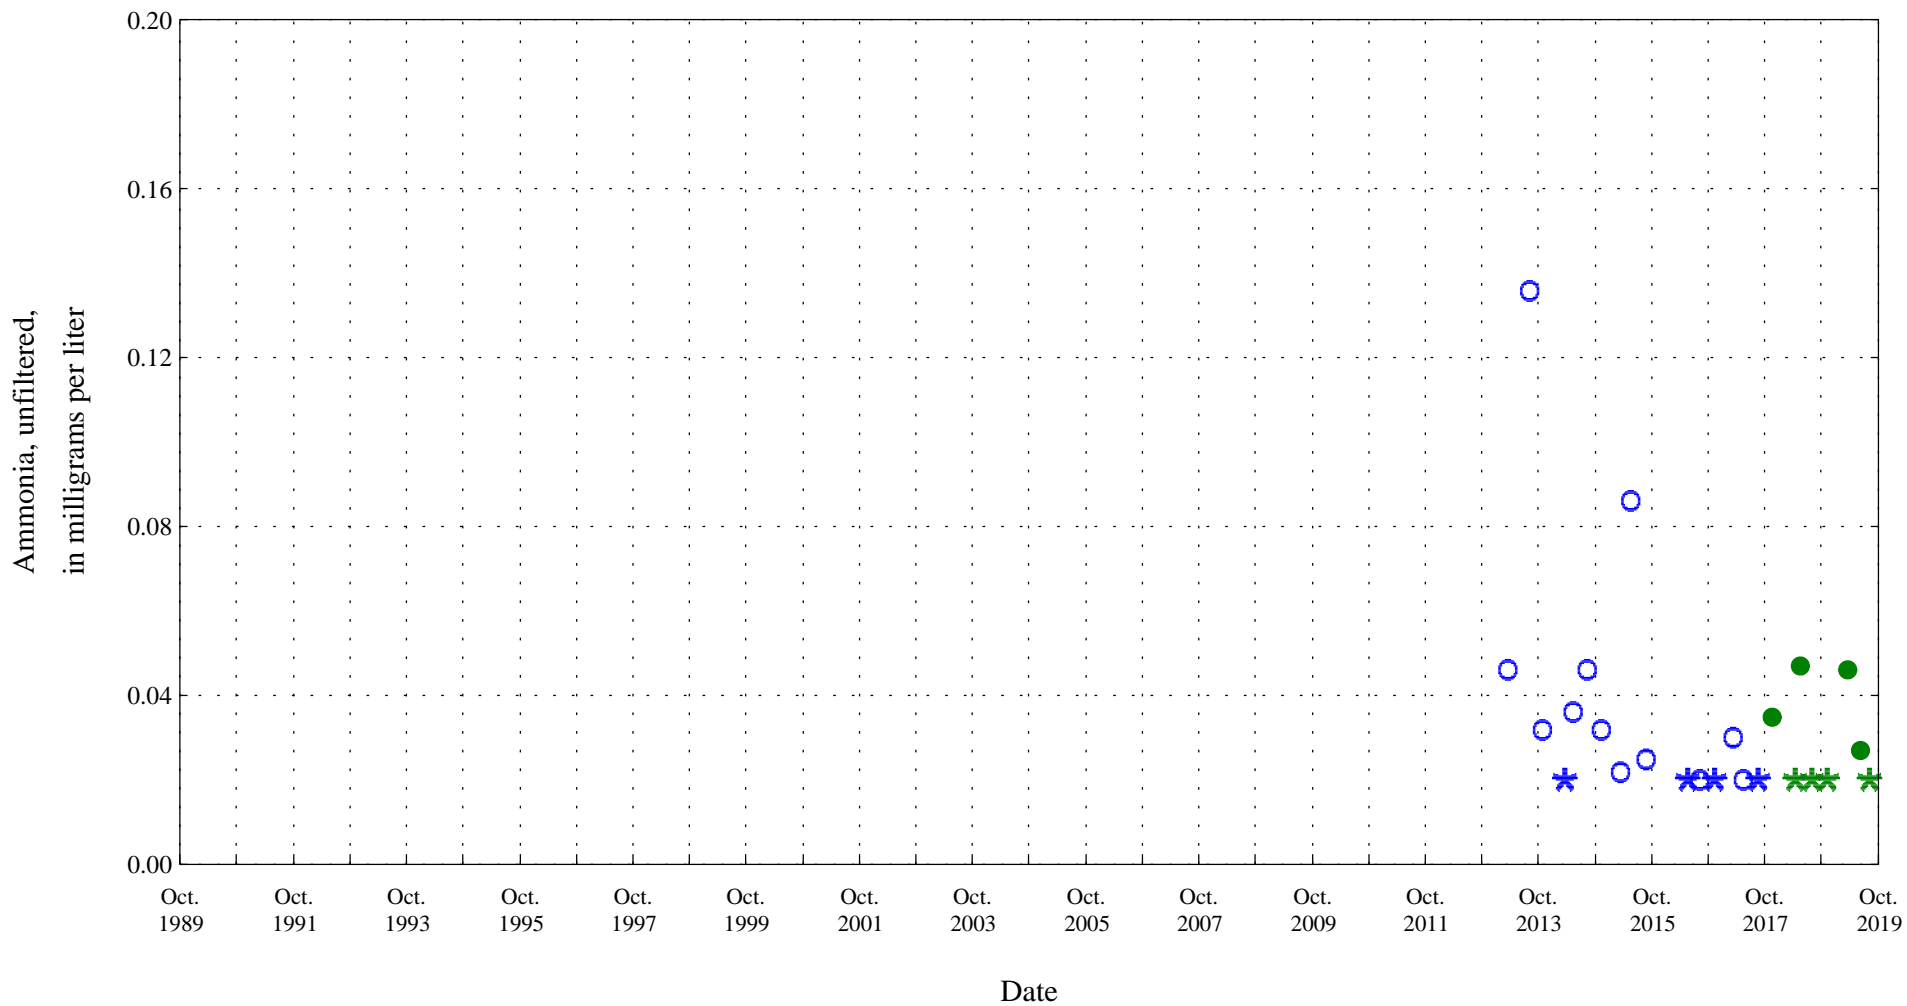
Aquatic Life Acute Standard 3.4
Aquatic Life Chronic Standard 1.2

Figure 26. Distribution of selected water-quality constituents relative to time for

Purgatoire River at Rock Crossing near Timpas, Co., station 07126485.

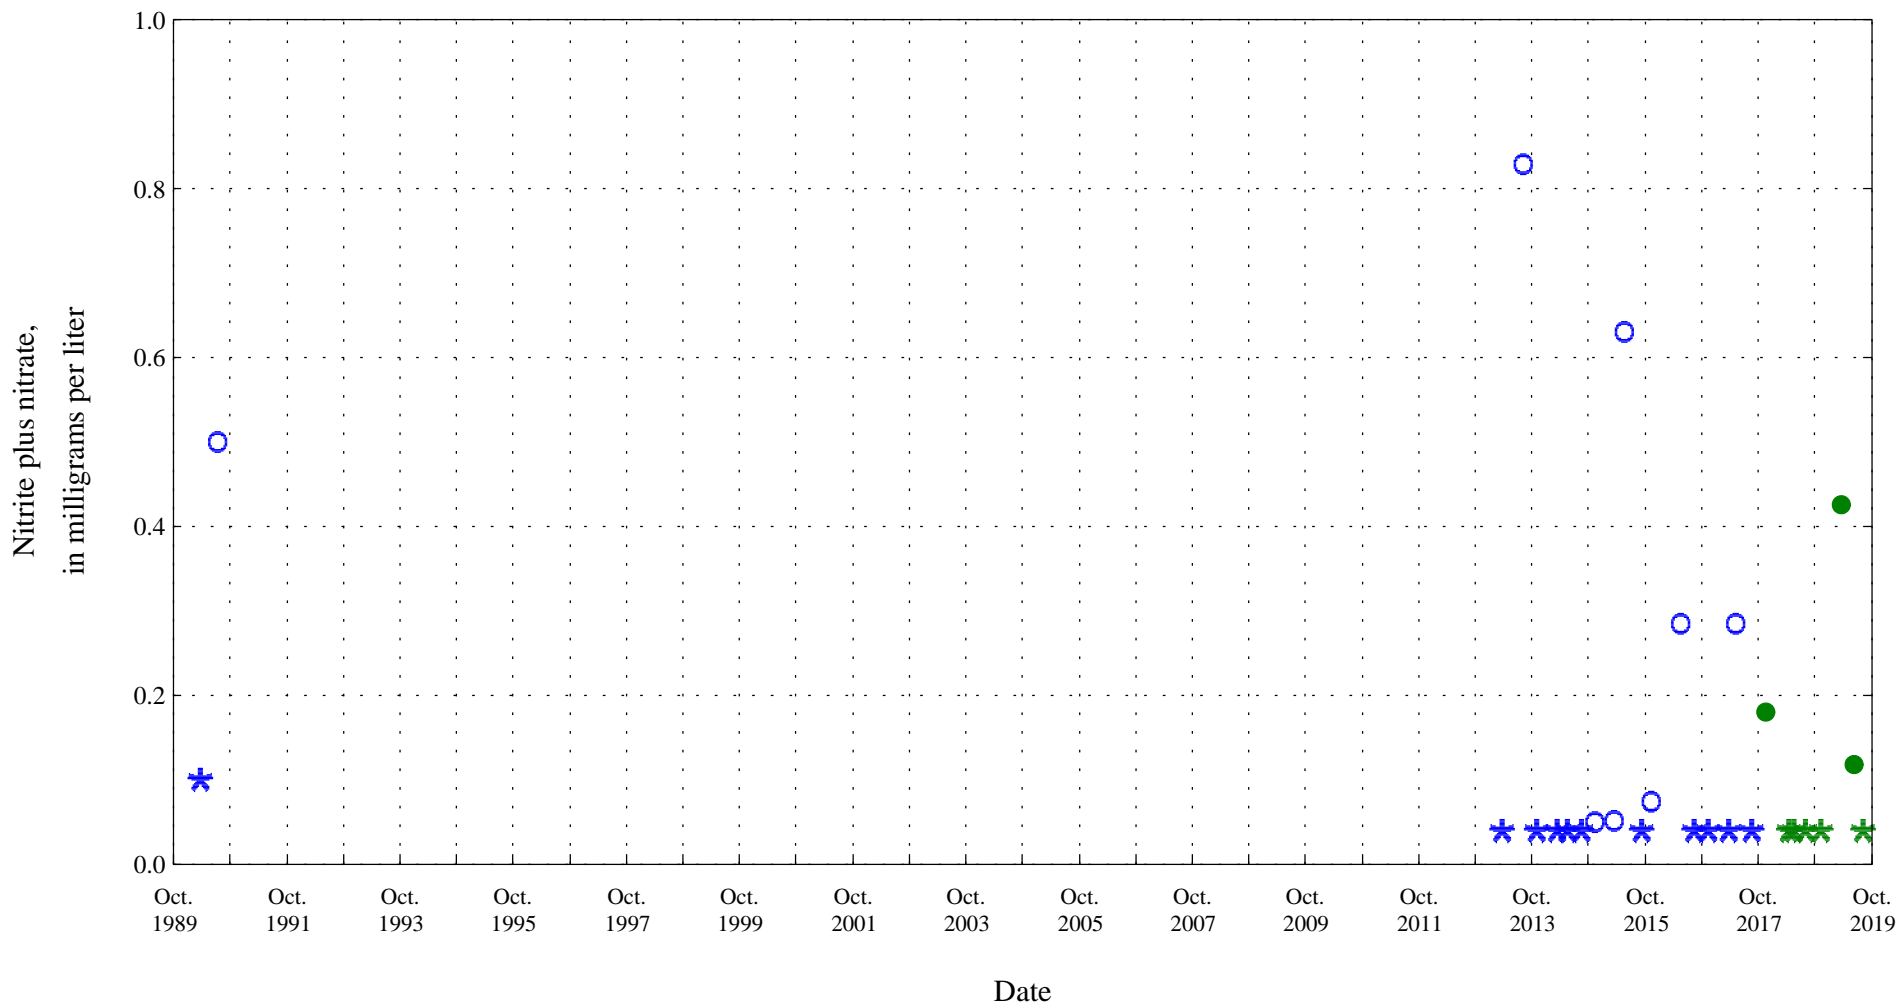
Figure 26. Distribution of selected water-quality constituents relative to time for

Purgatoire River at Rock Crossing near Timpas, Co., station 07126485.

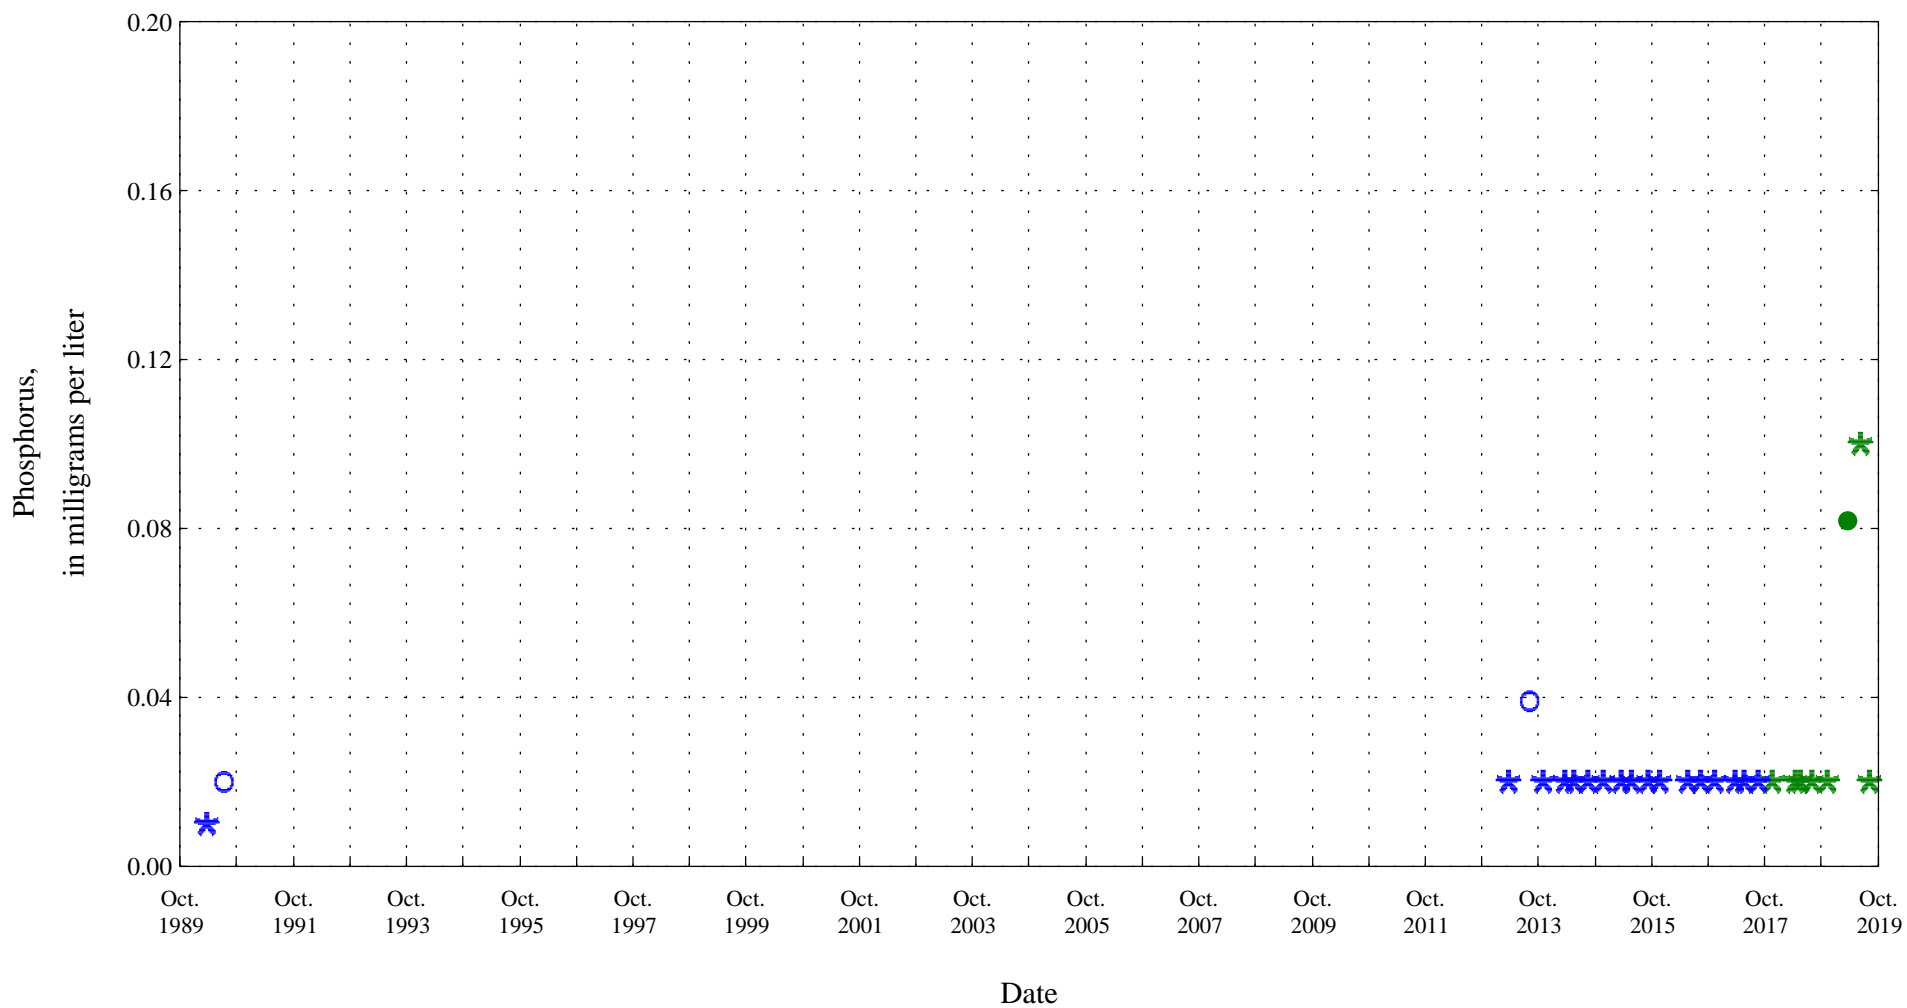
Human Health Based Water Supply Acute Standard 10.0

Figure 26. Distribution of selected water-quality constituents relative to time for

Purgatoire River at Rock Crossing near Timpas, Co., station 07126485.

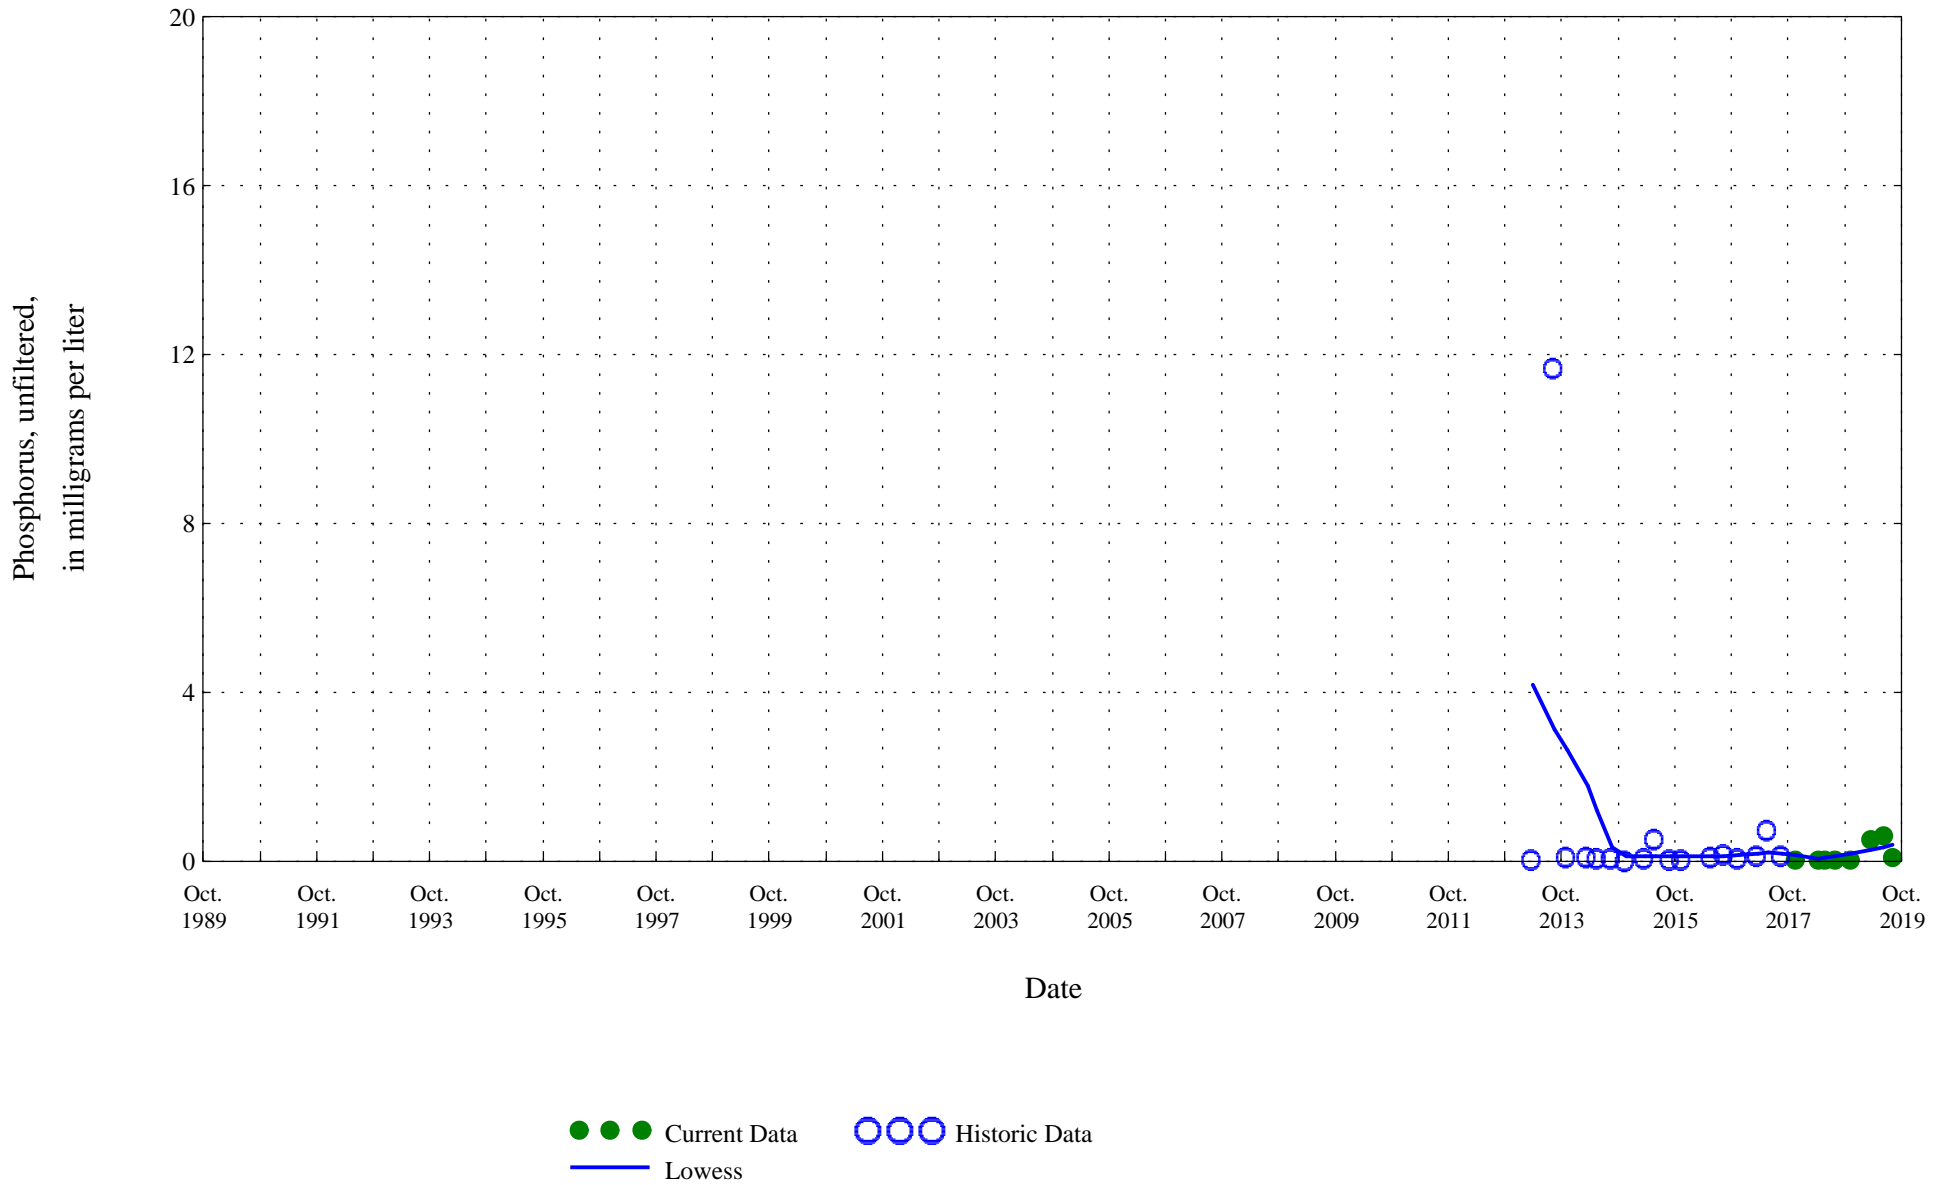
Figure 26. Distribution of selected water-quality constituents relative to time for

Purgatoire River at Rock Crossing near Timpas, Co., station 07126485.

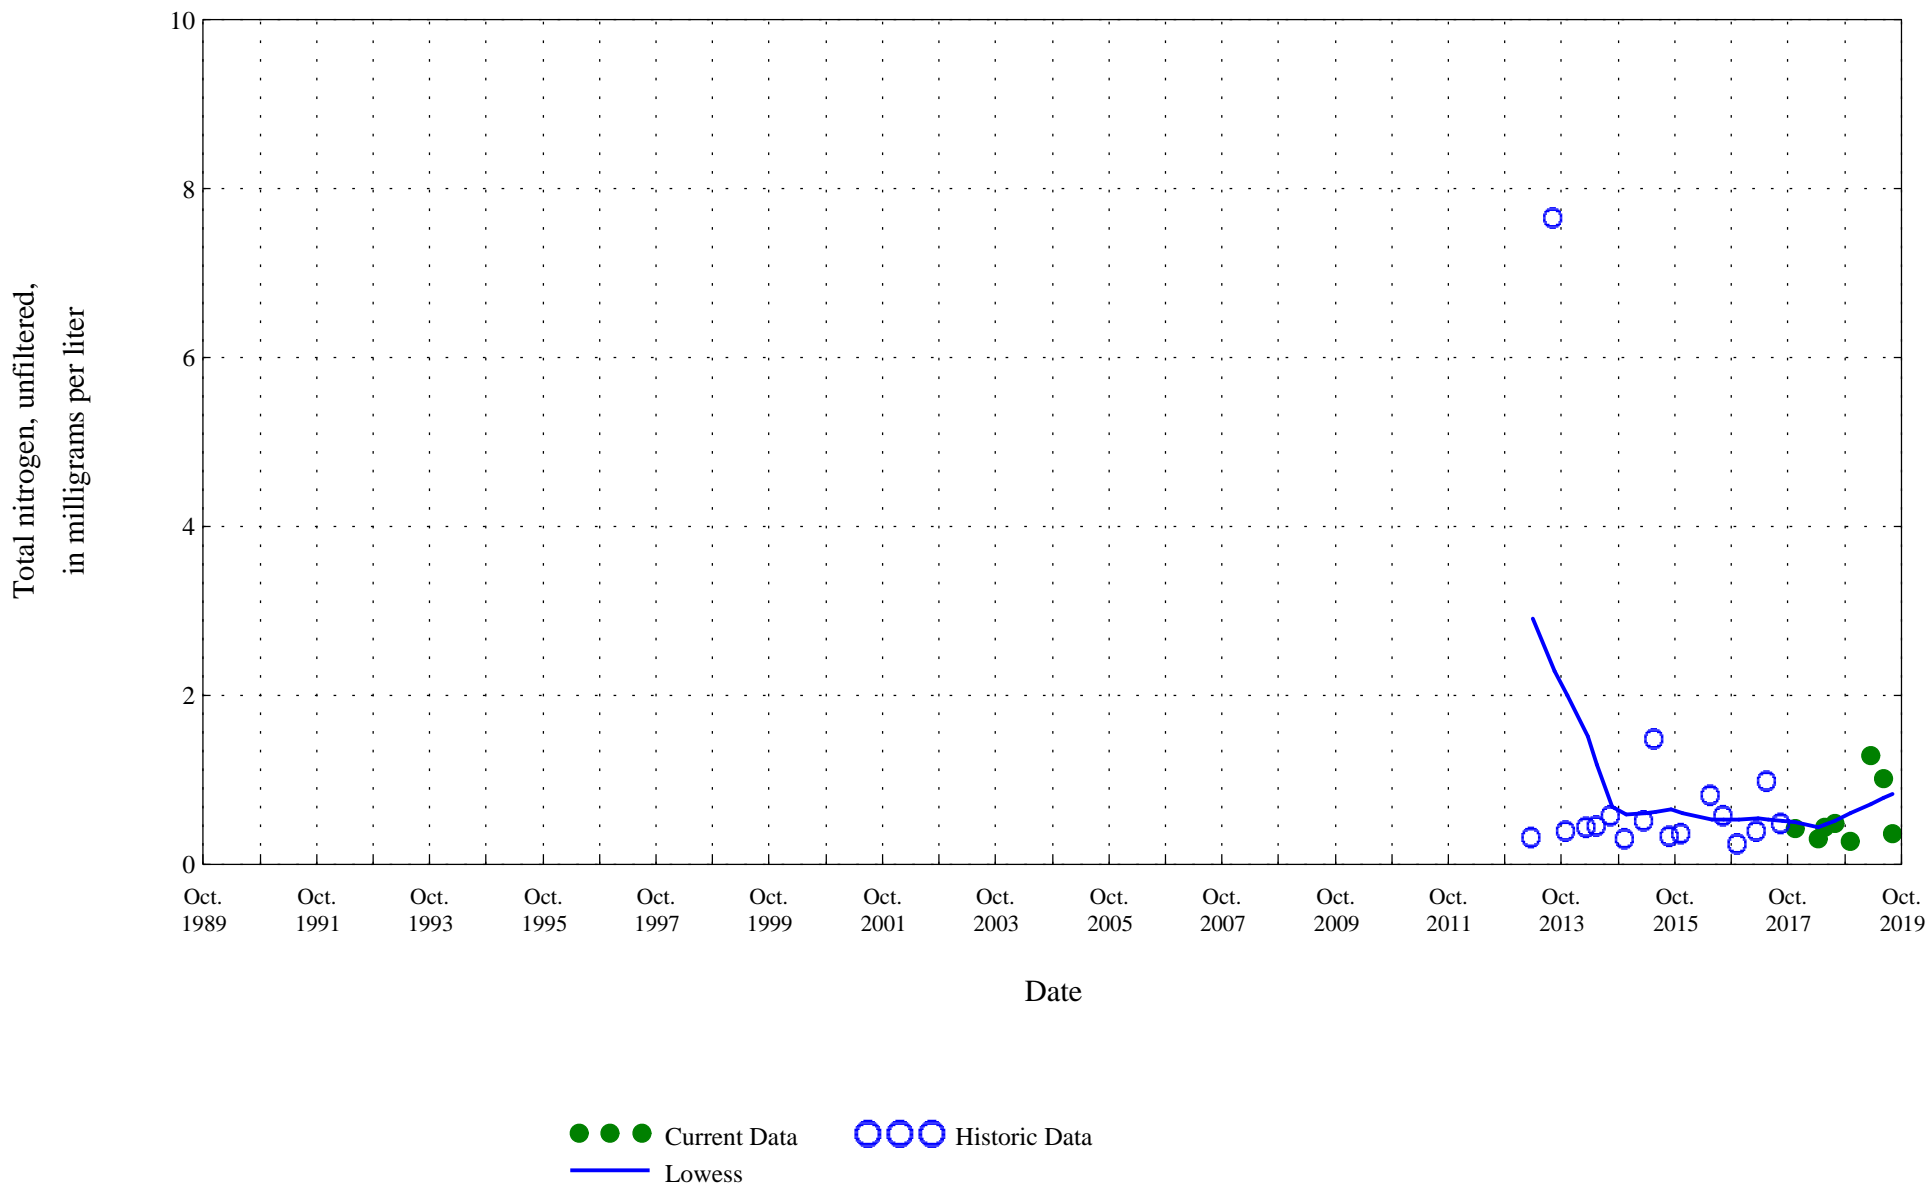
Figure 26. Distribution of selected water-quality constituents relative to time for

Purgatoire River at Rock Crossing near Timpas, Co., station 07126485.

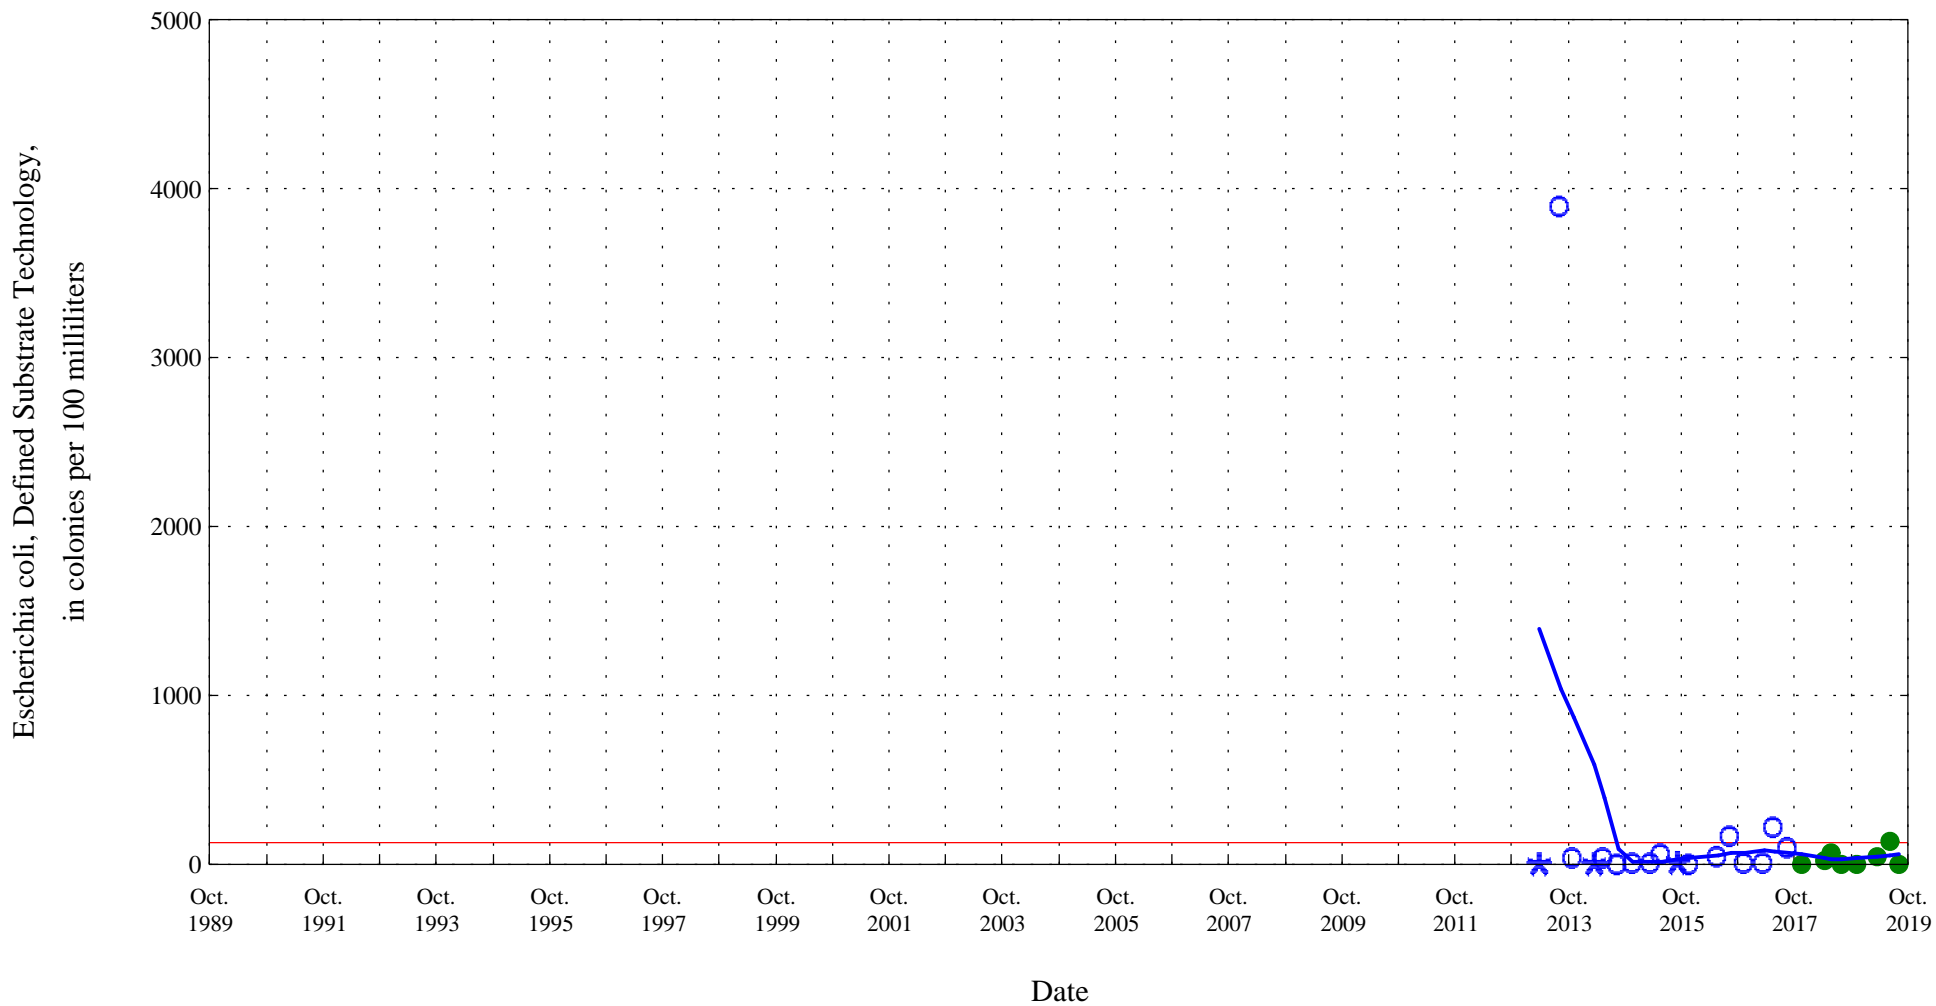
Figure 26. Distribution of selected water-quality constituents relative to time for

Purgatoire River at Rock Crossing near Timpas, Co., station 07126485.

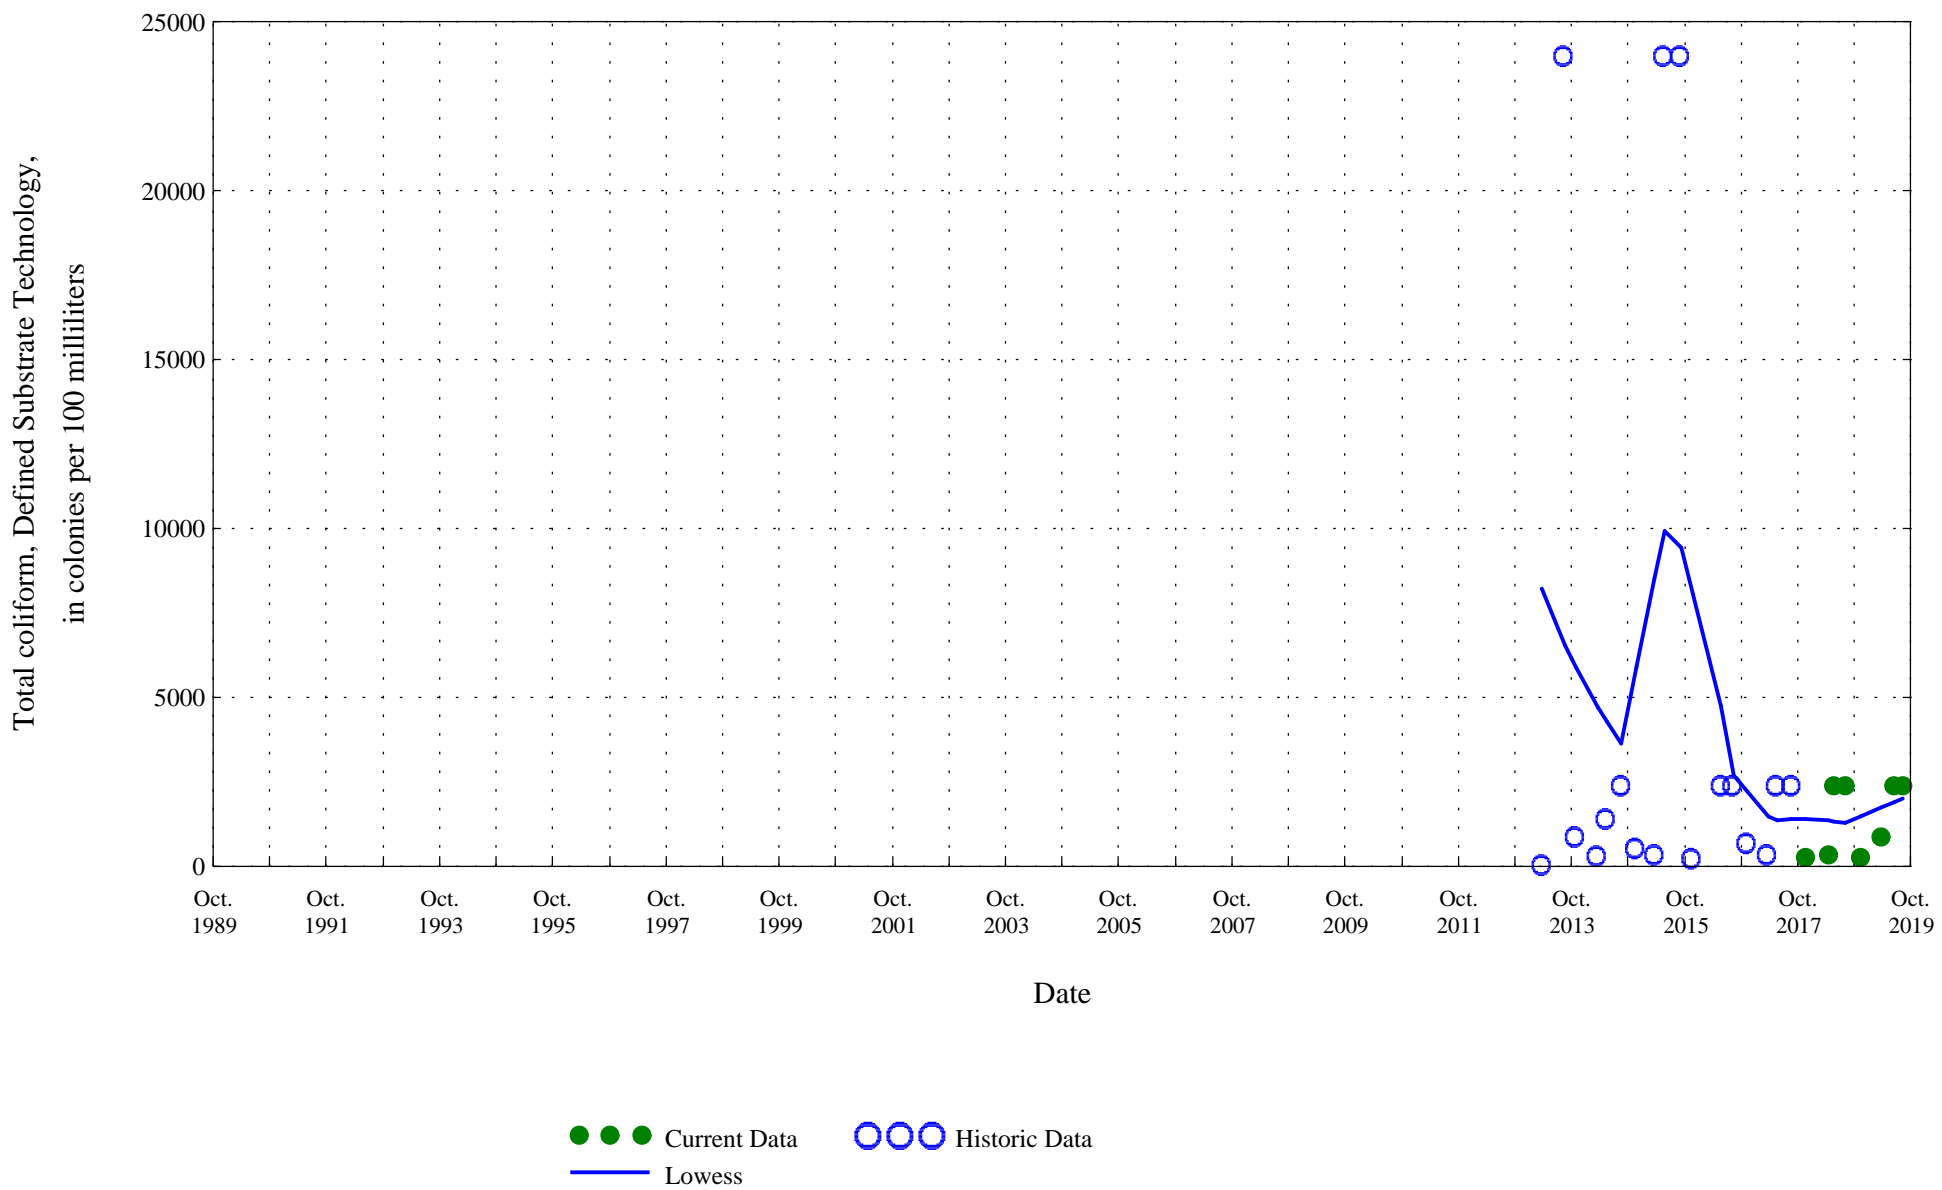
Recreational Standard 126

Figure 26. Distribution of selected water-quality constituents relative to time for

Purgatoire River at Rock Crossing near Timpas, Co., station 07126485.

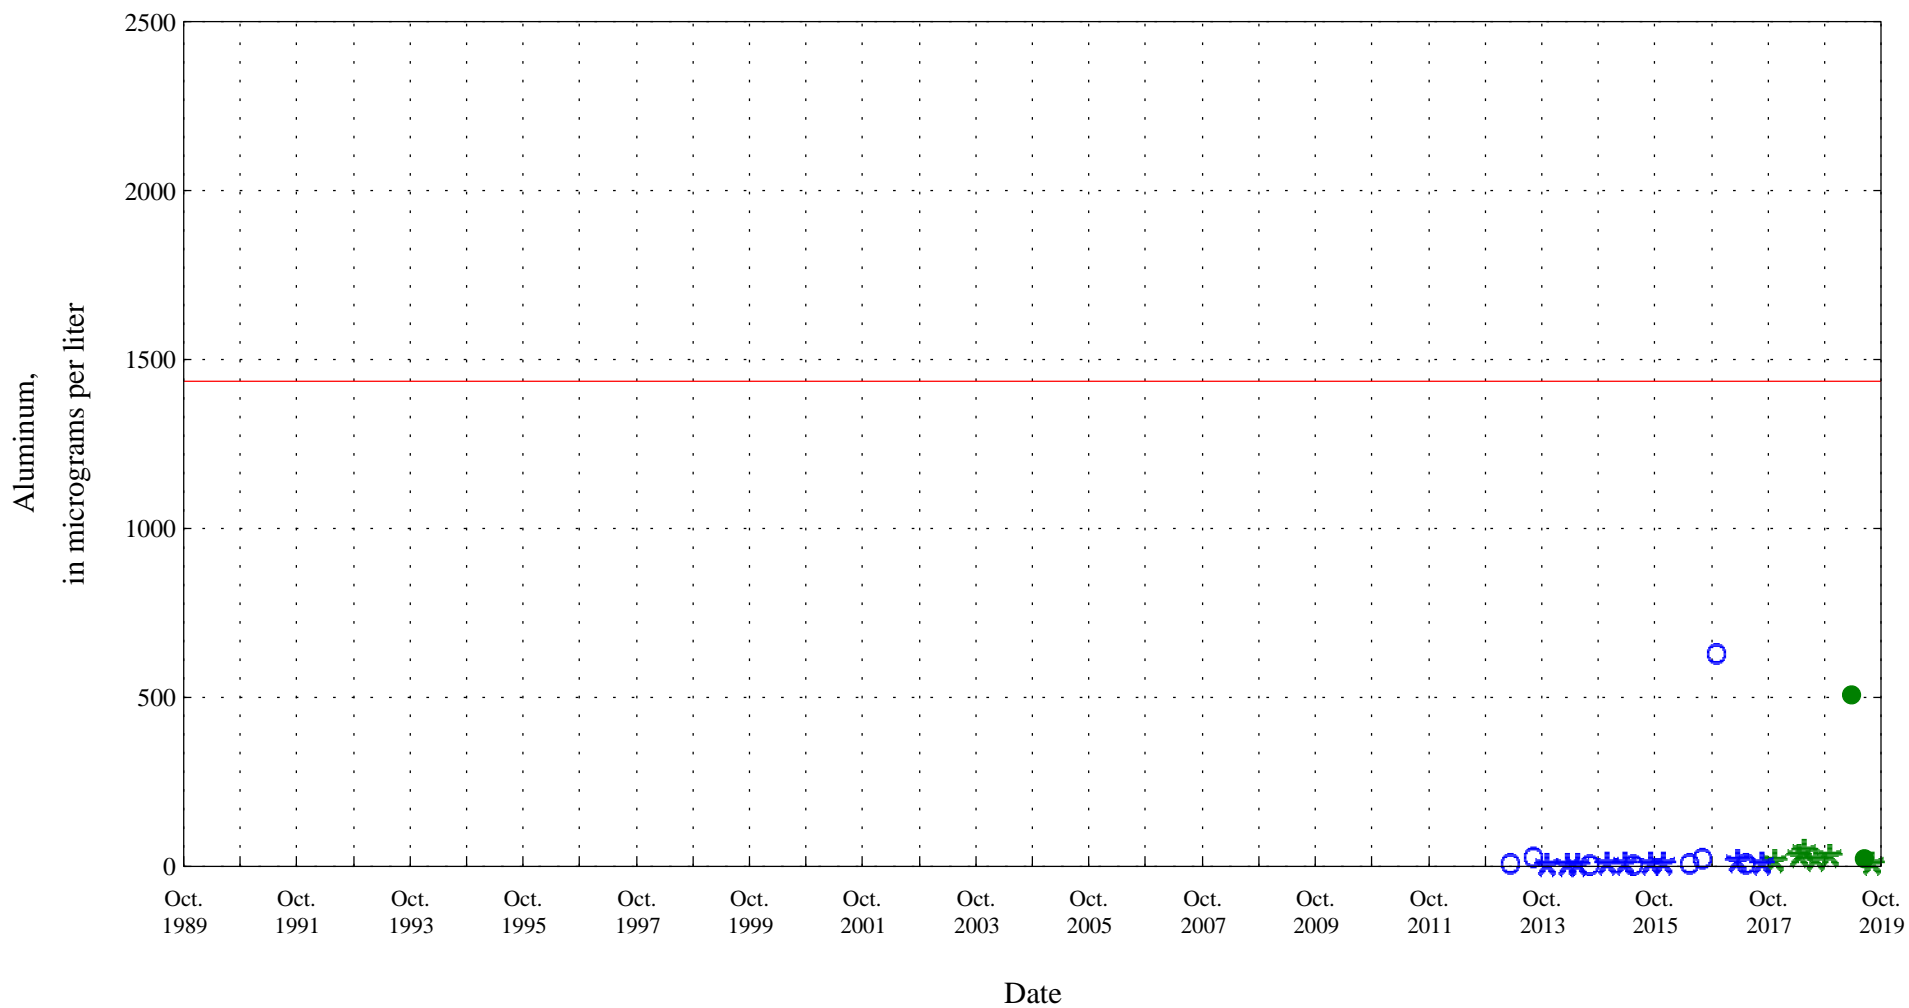
Figure 26. Distribution of selected water-quality constituents relative to time for

Purgatoire River at Rock Crossing near Timpas, Co., station 07126485.

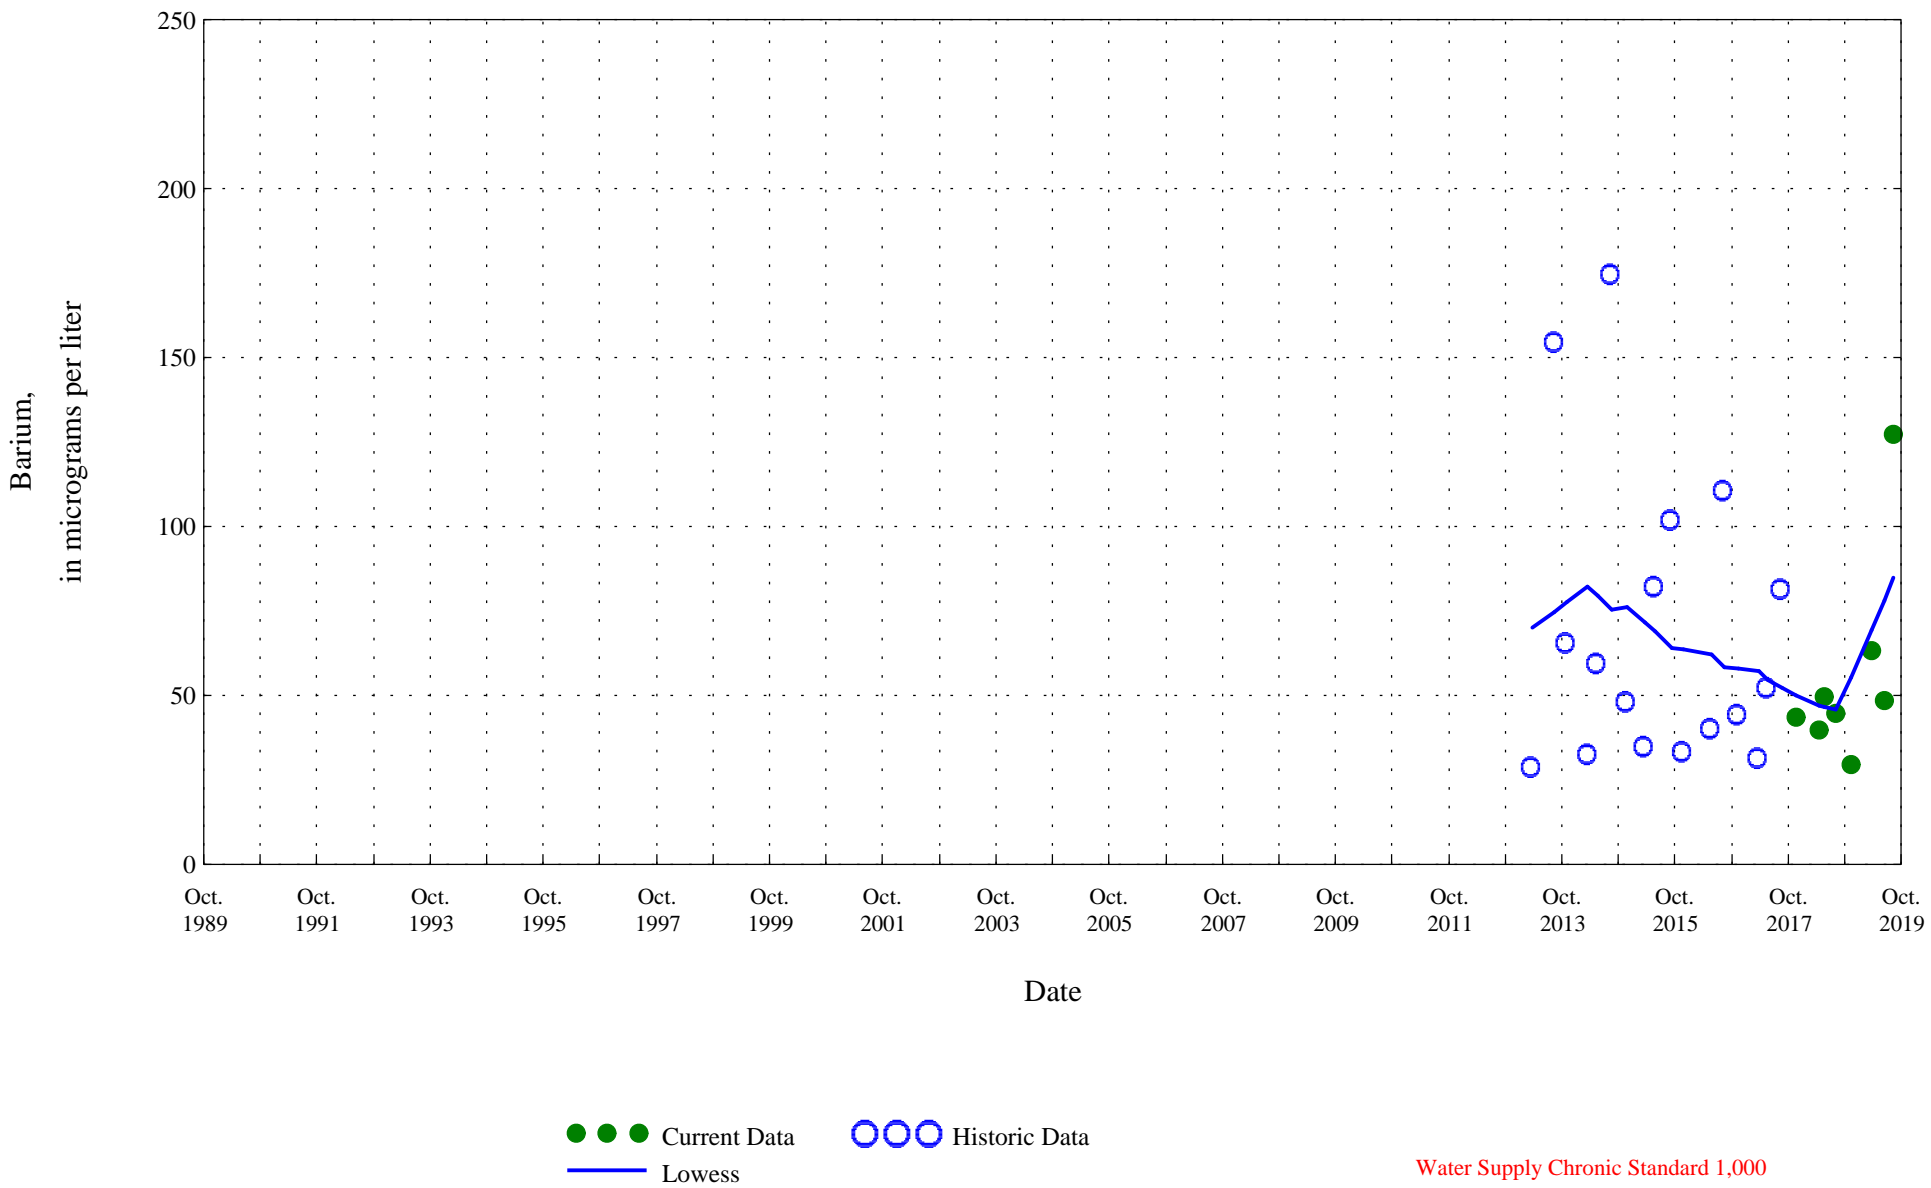
Figure 26. Distribution of selected water-quality constituents relative to time for

Purgatoire River at Rock Crossing near Timpas, Co., station 07126485.

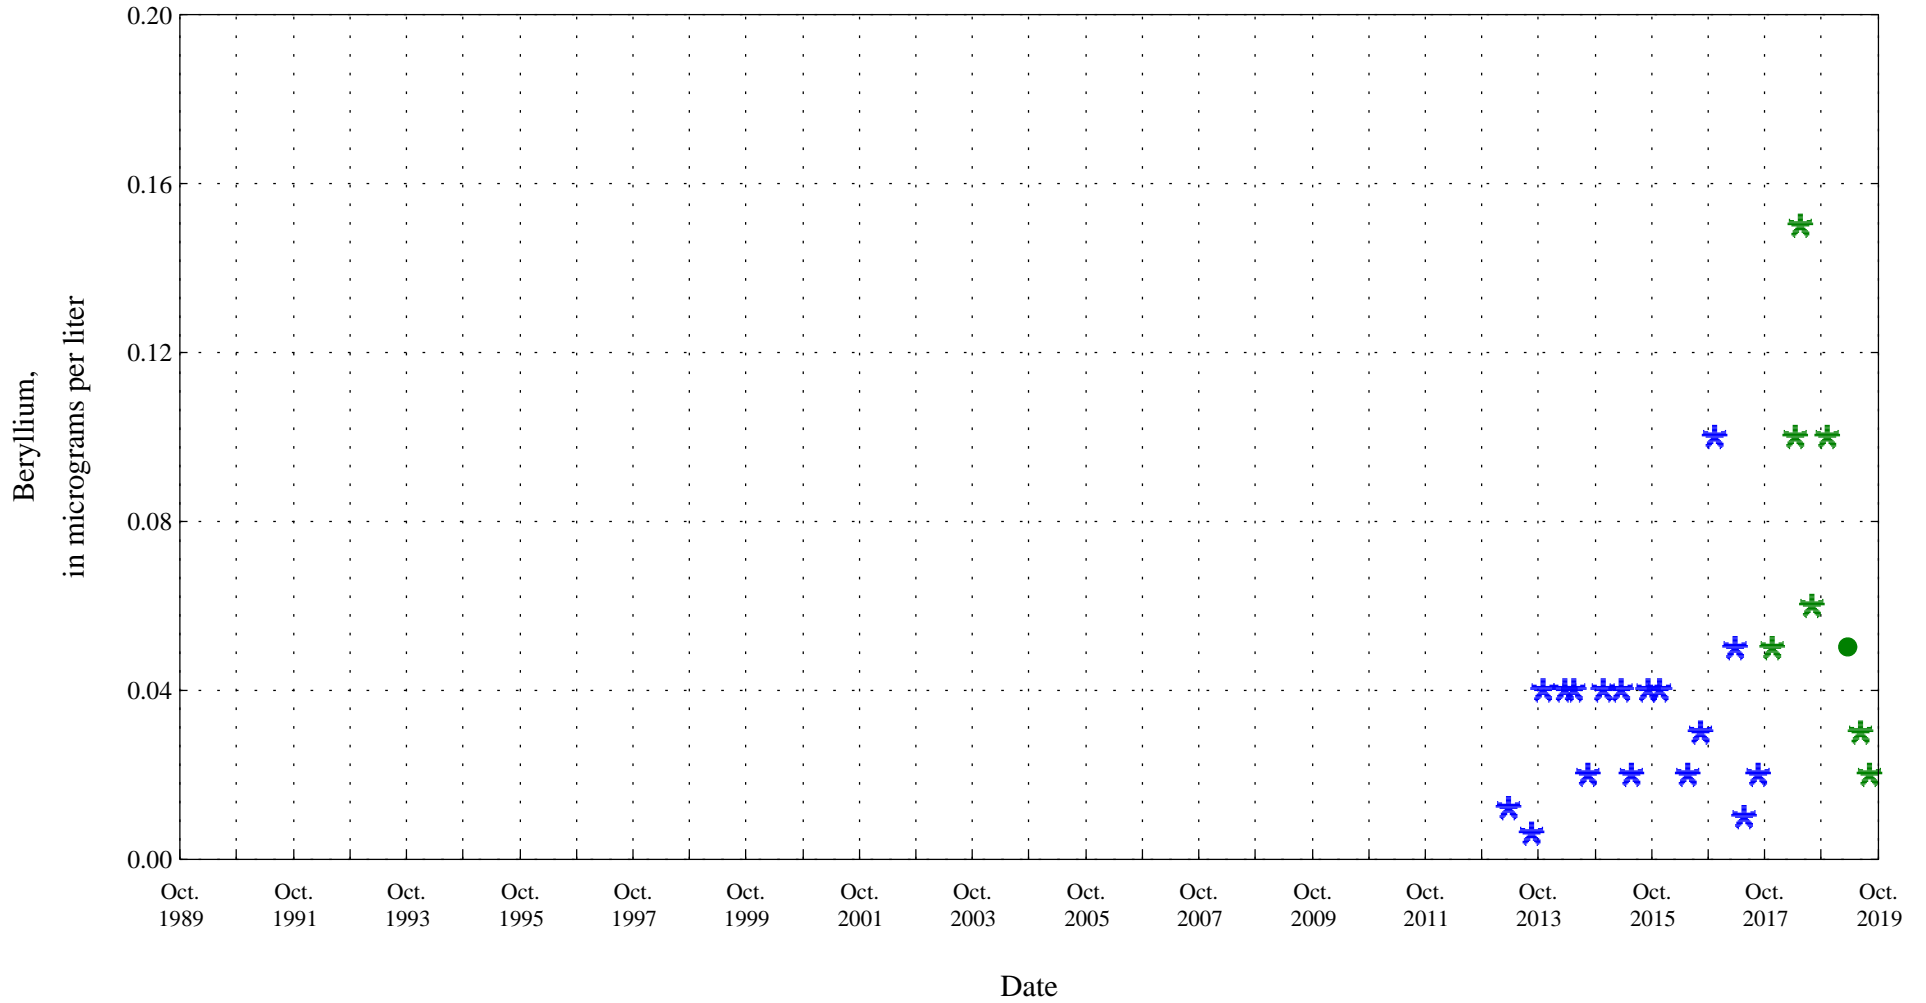
Figure 26. Distribution of selected water-quality constituents relative to time for

Purgatoire River at Rock Crossing near Timpas, Co., station 07126485.

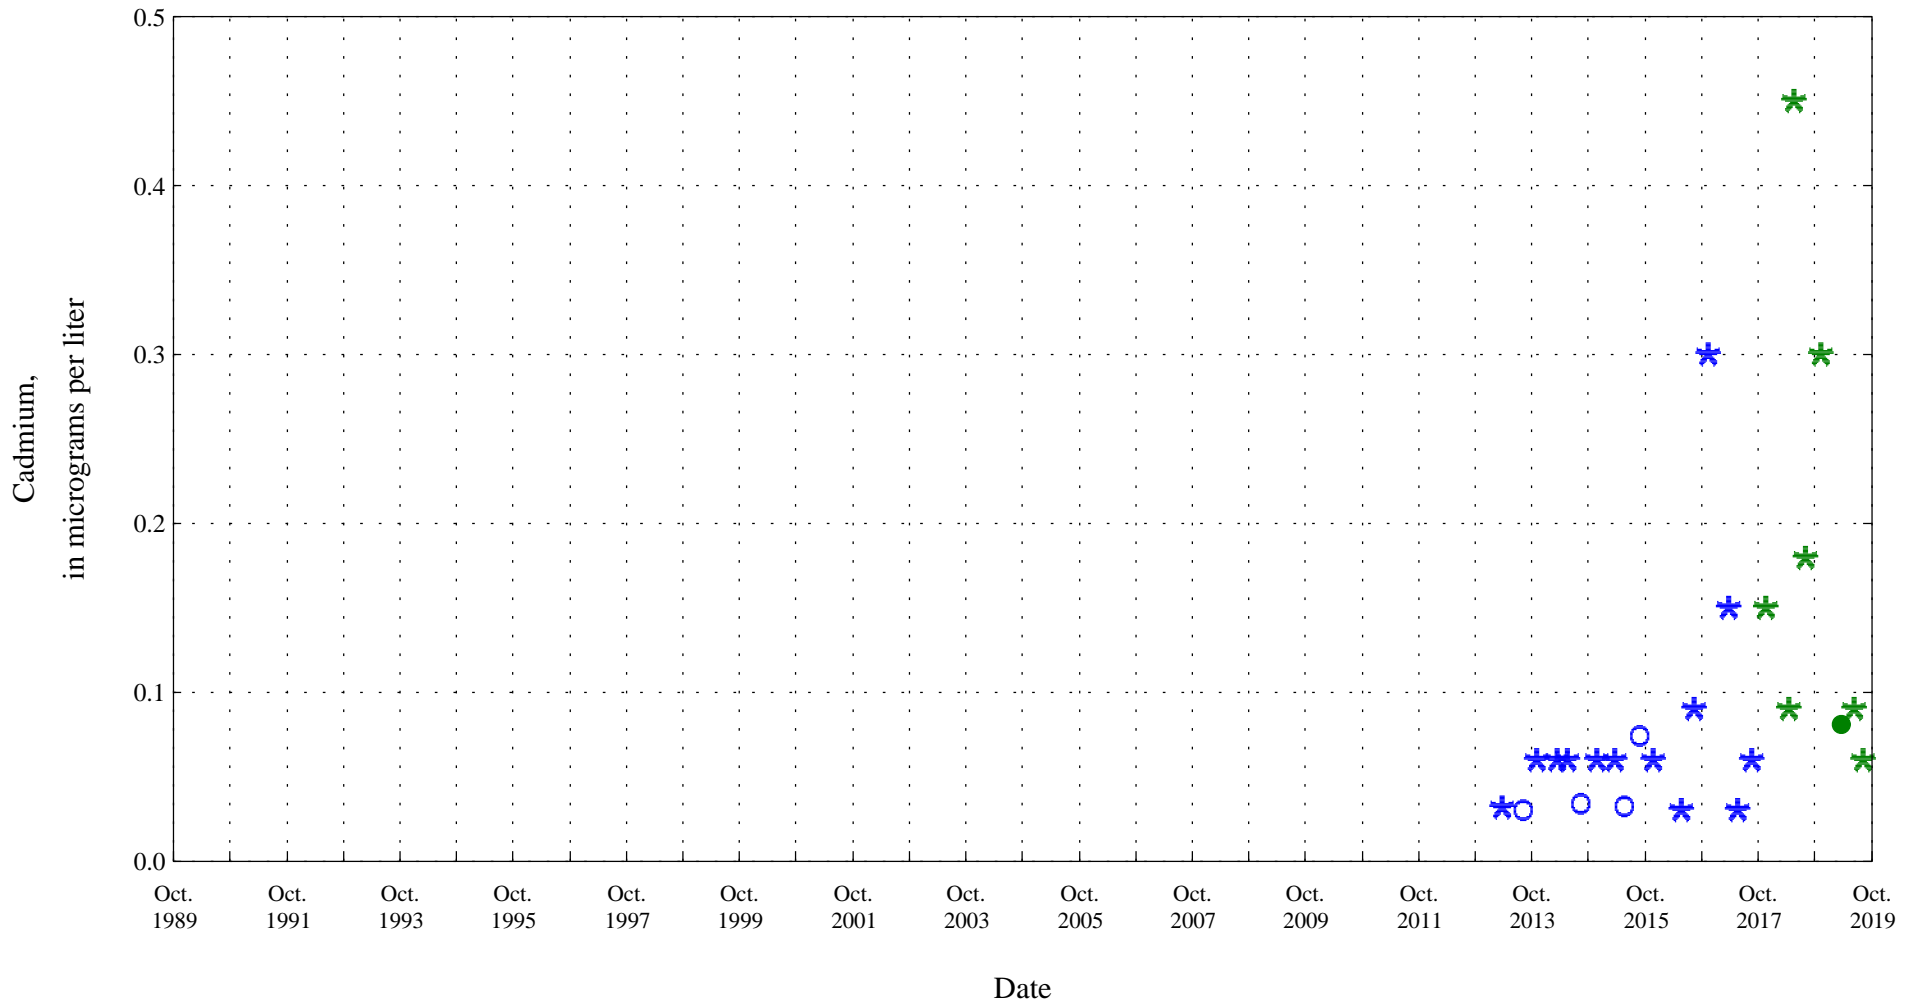
Water Supply Chronic Standard 4.0

Figure 26. Distribution of selected water-quality constituents relative to time for

Purgatoire River at Rock Crossing near Timpas, Co., station 07126485.
