Figure 26. Distribution of selected water-quality constituents relative to time for

Purgatoire River at Rock Crossing near Timpas, Co., station 07126485.

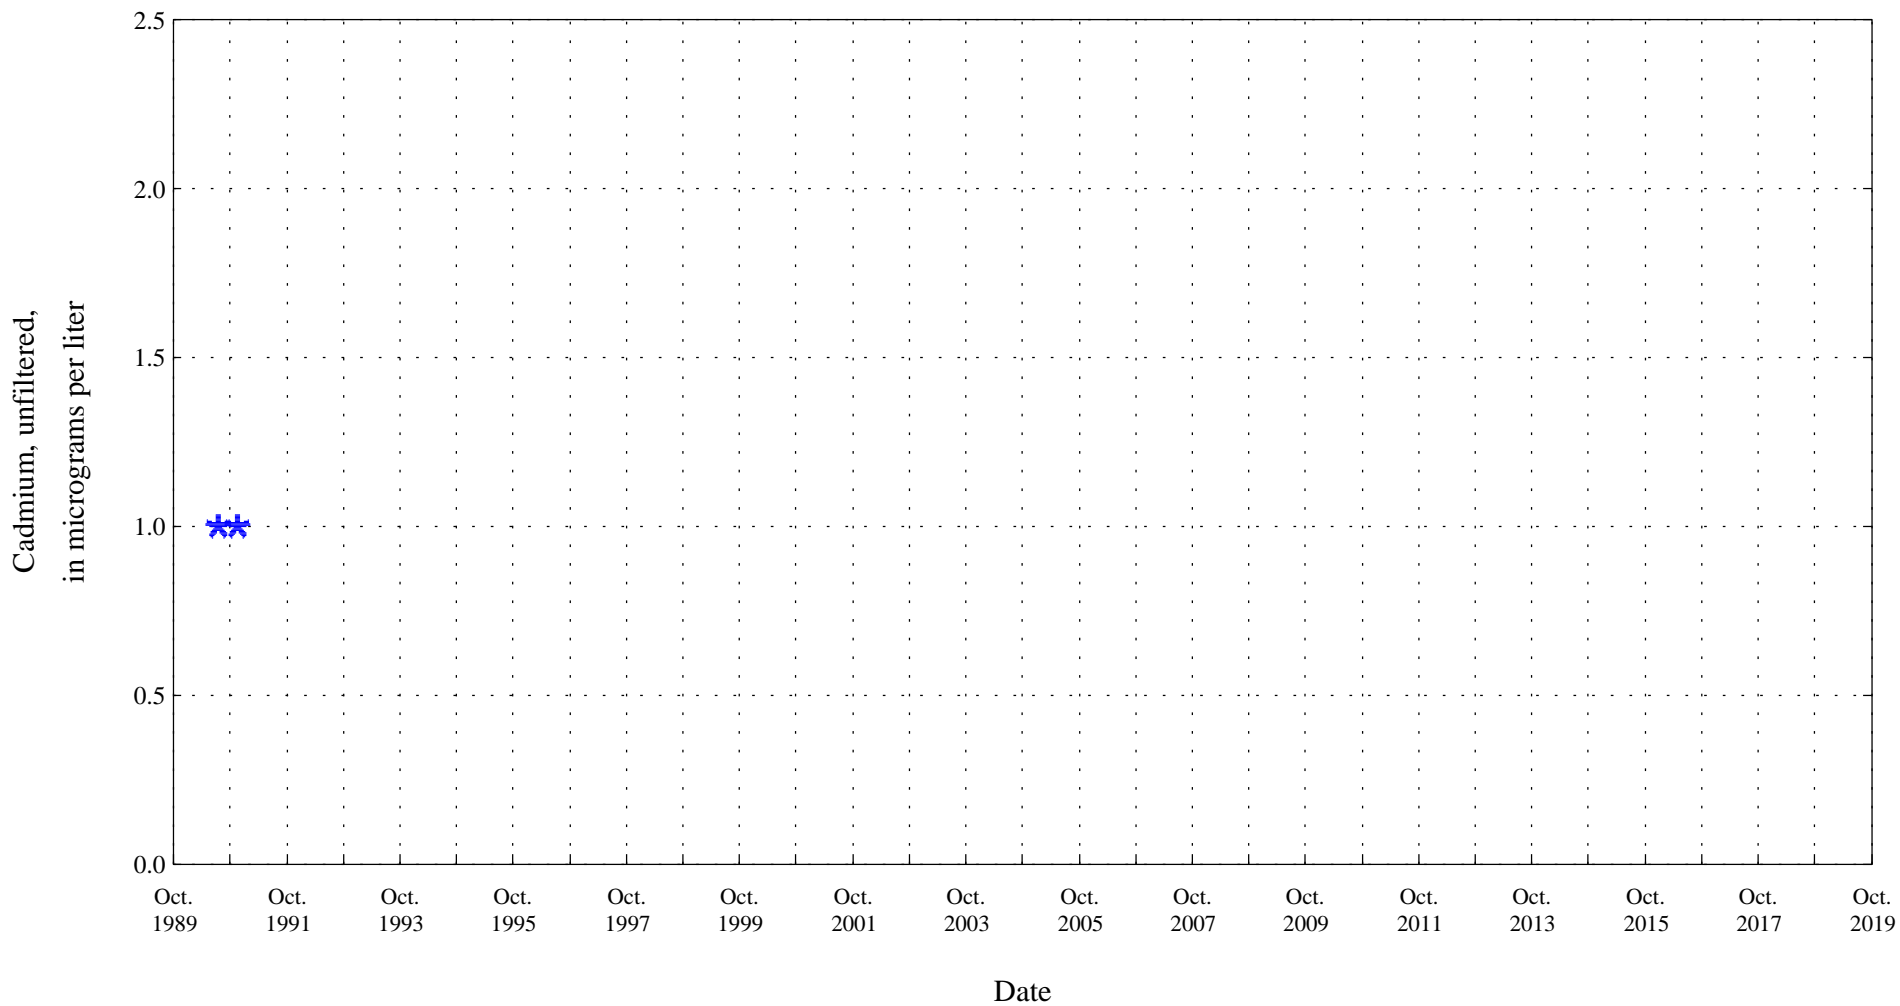
Aquatic Life Acute Standard 10.0
Aquatic Life Chronic Standard 2.0

Figure 26. Distribution of selected water-quality constituents relative to time for

Purgatoire River at Rock Crossing near Timpas, Co., station 07126485.

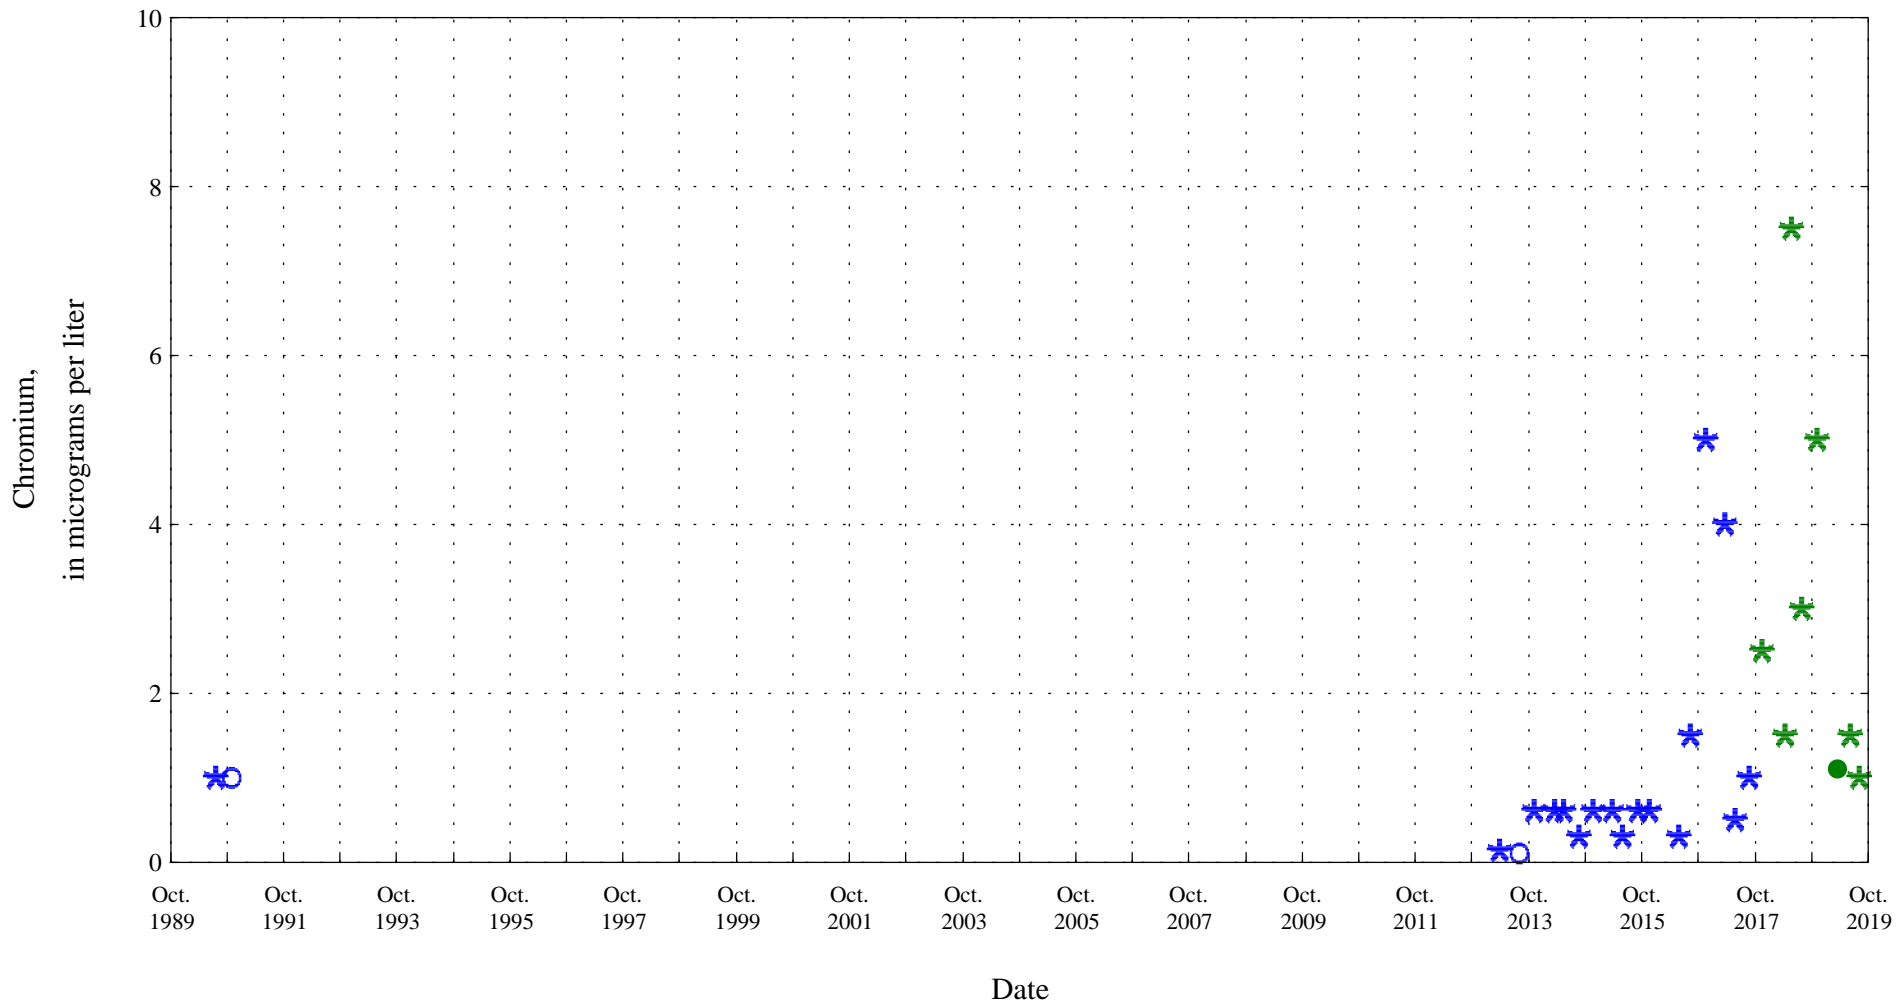
Figure 26. Distribution of selected water-quality constituents relative to time for

Purgatoire River at Rock Crossing near Timpas, Co., station 07126485.

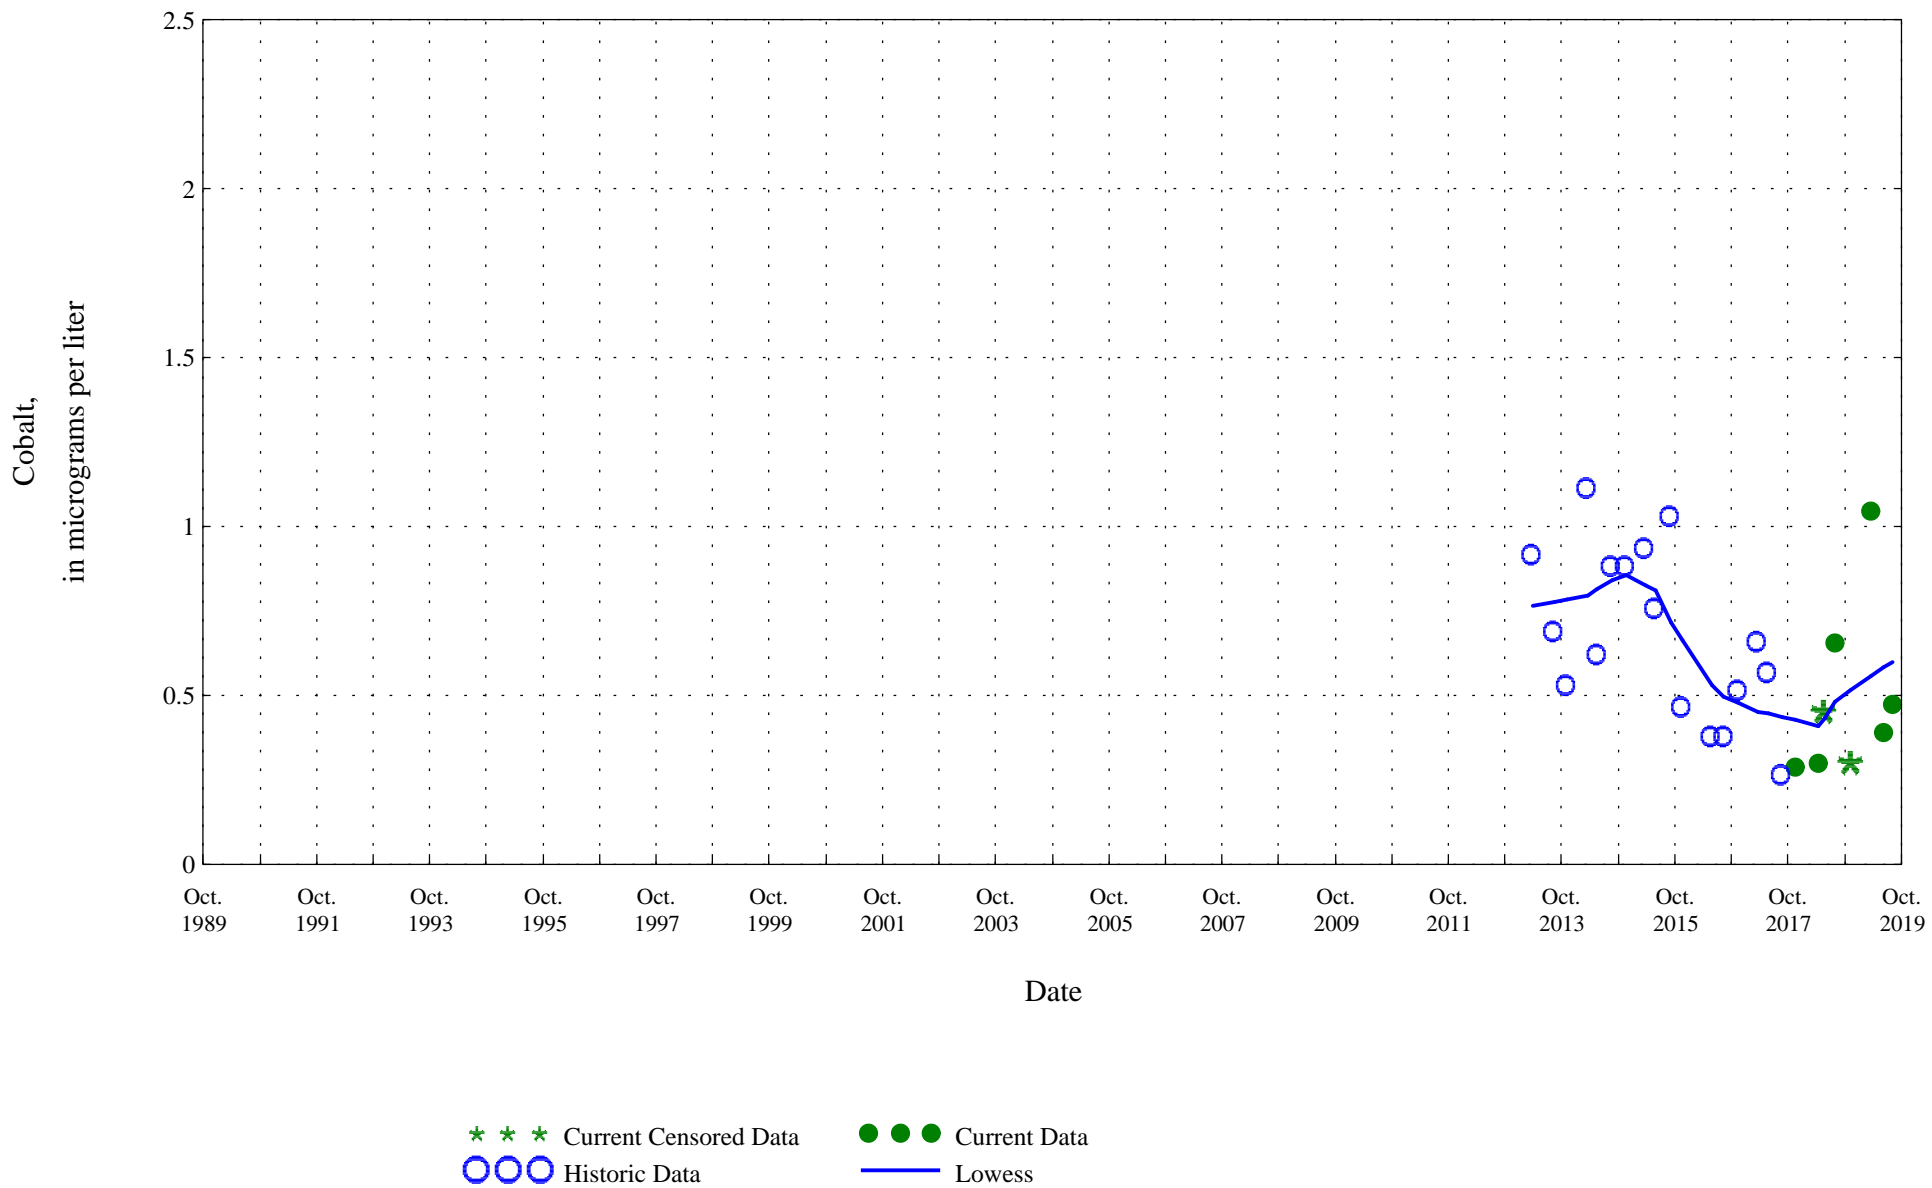
Reach Specific Chronic Standard 231

Figure 26. Distribution of selected water-quality constituents relative to time for

Purgatoire River at Rock Crossing near Timpas, Co., station 07126485.

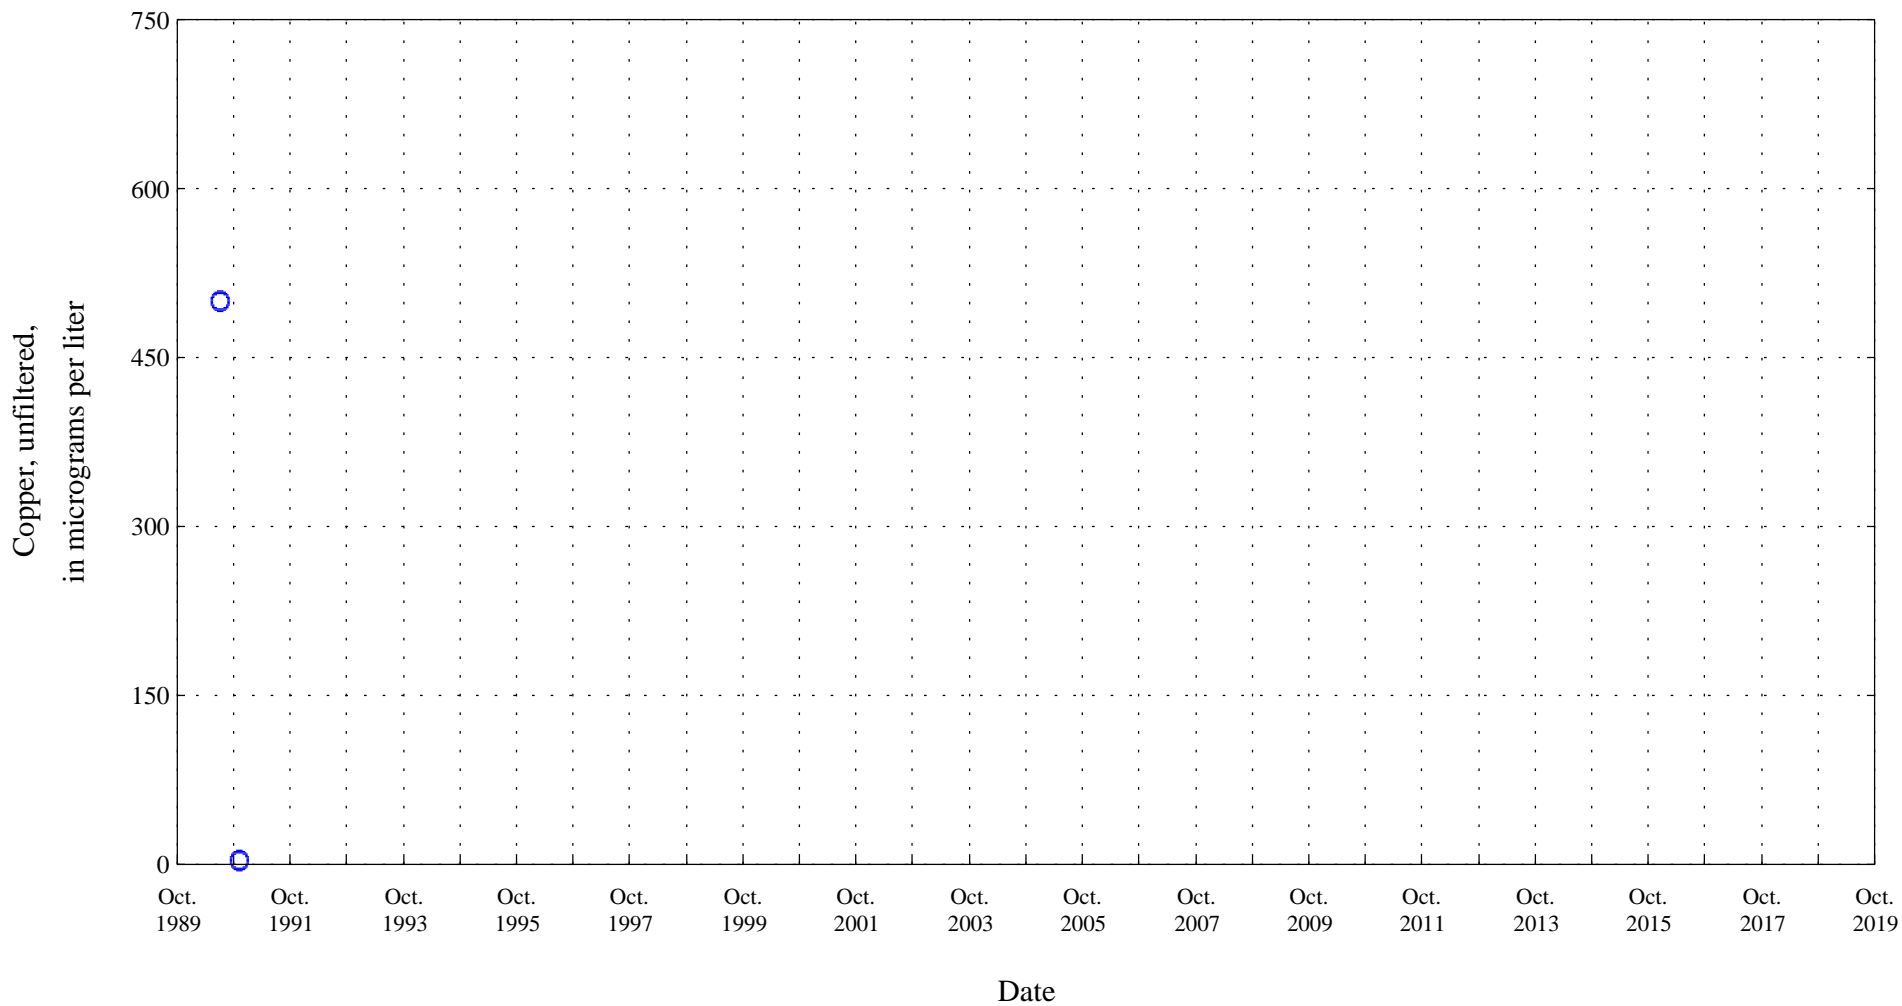
Figure 26. Distribution of selected water-quality constituents relative to time for

Purgatoire River at Rock Crossing near Timpas, Co., station 07126485.

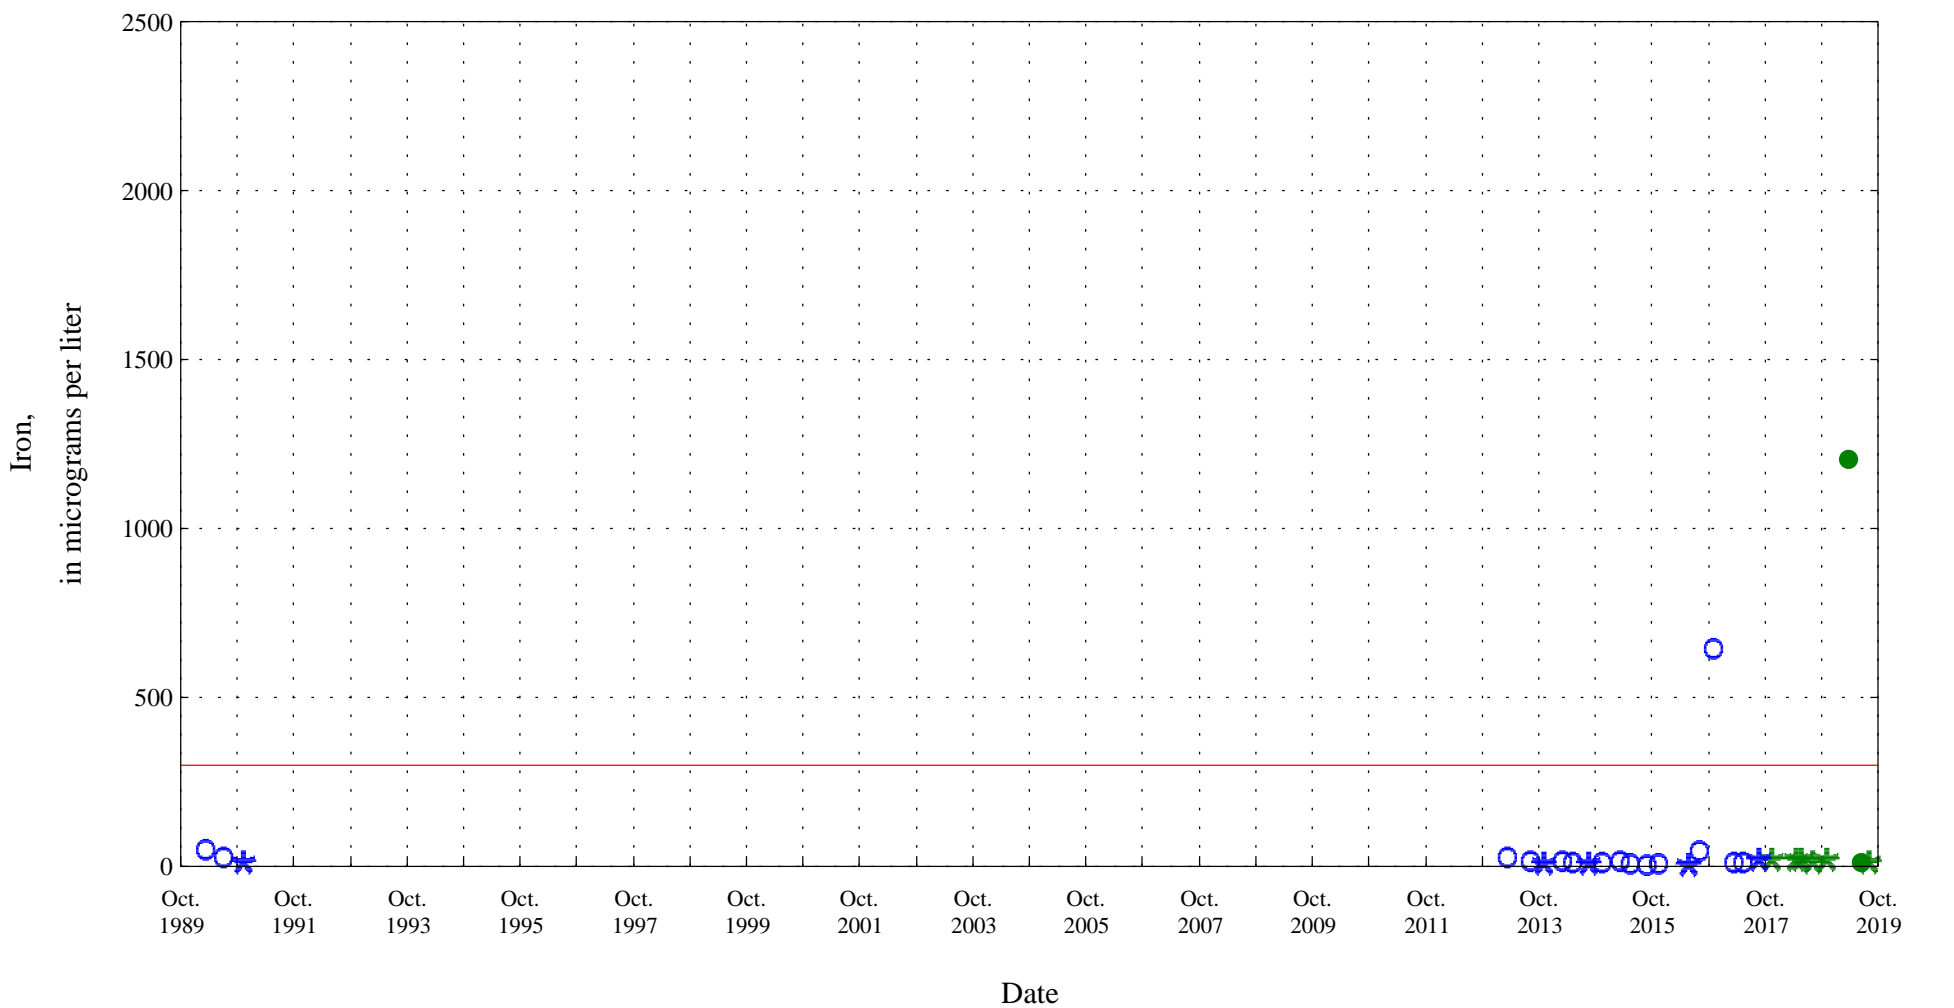
Figure 26. Distribution of selected water-quality constituents relative to time for

Purgatoire River at Rock Crossing near Timpas, Co., station 07126485.

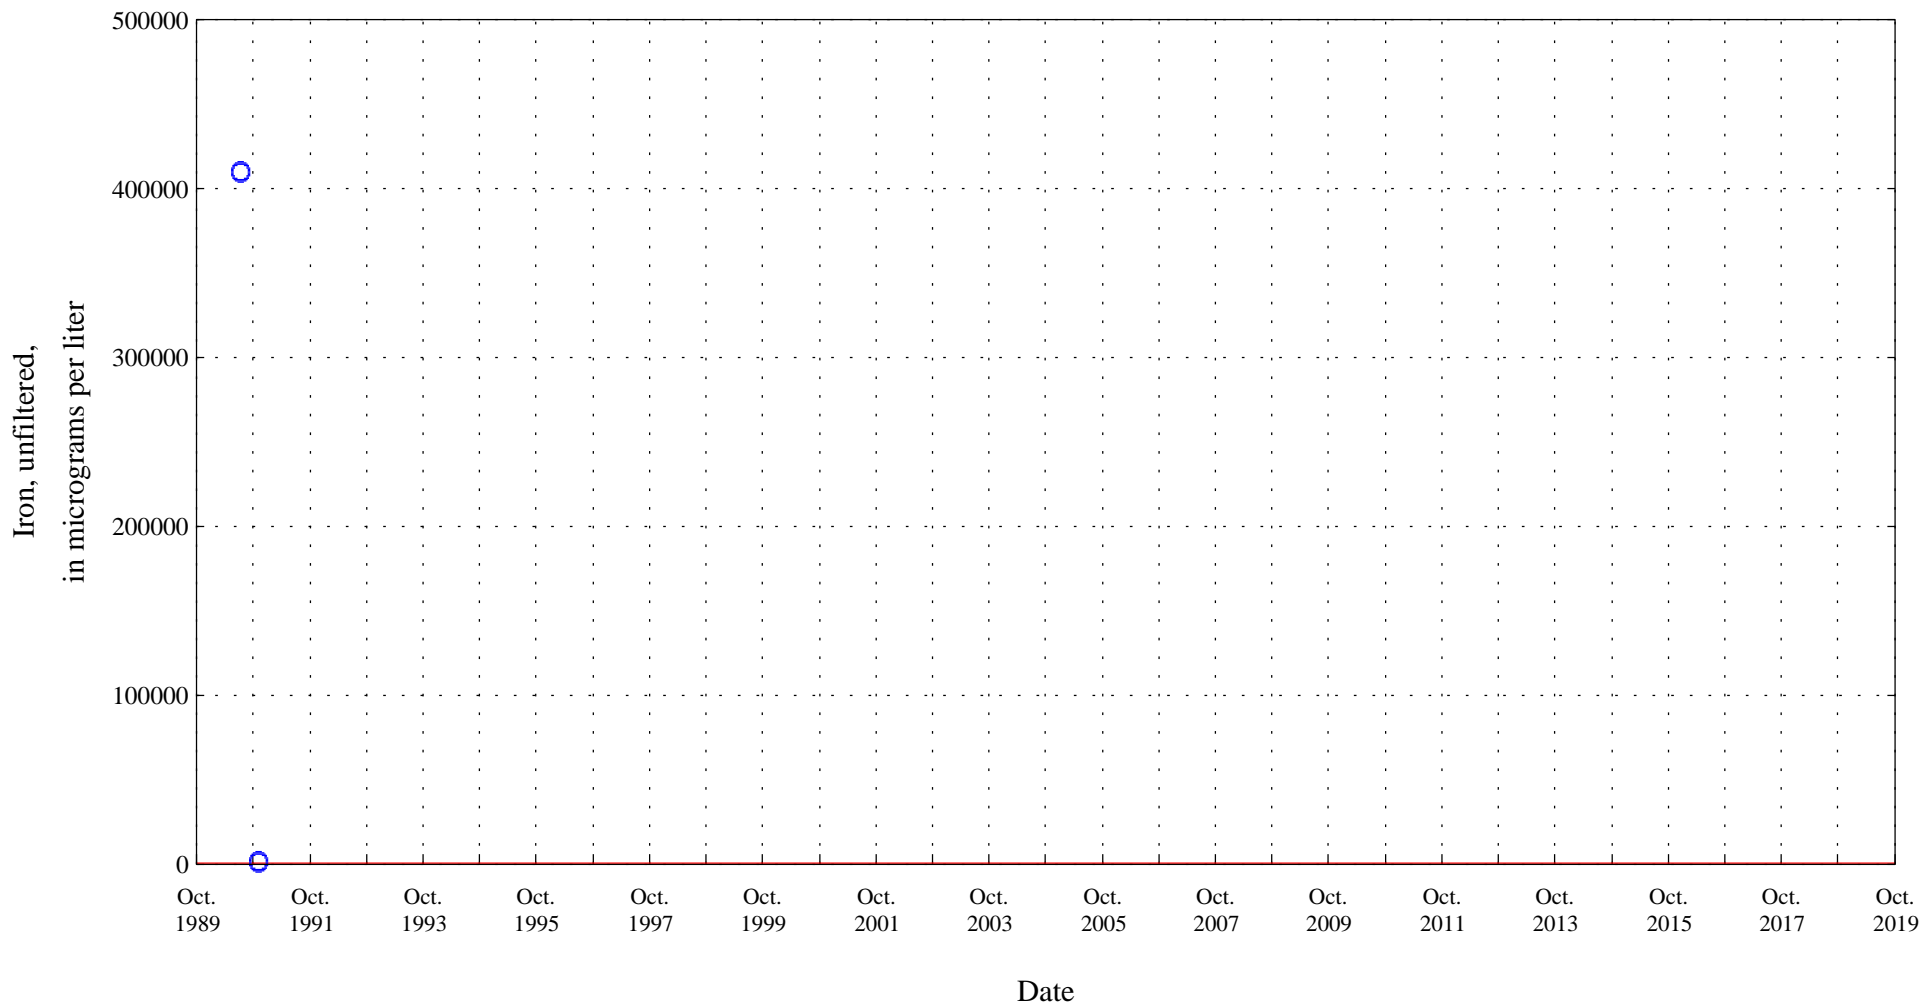
Human Health Based Water Supply Chronic Standard 300

Figure 26. Distribution of selected water-quality constituents relative to time for

Purgatoire River at Rock Crossing near Timpas, Co., station 07126485.

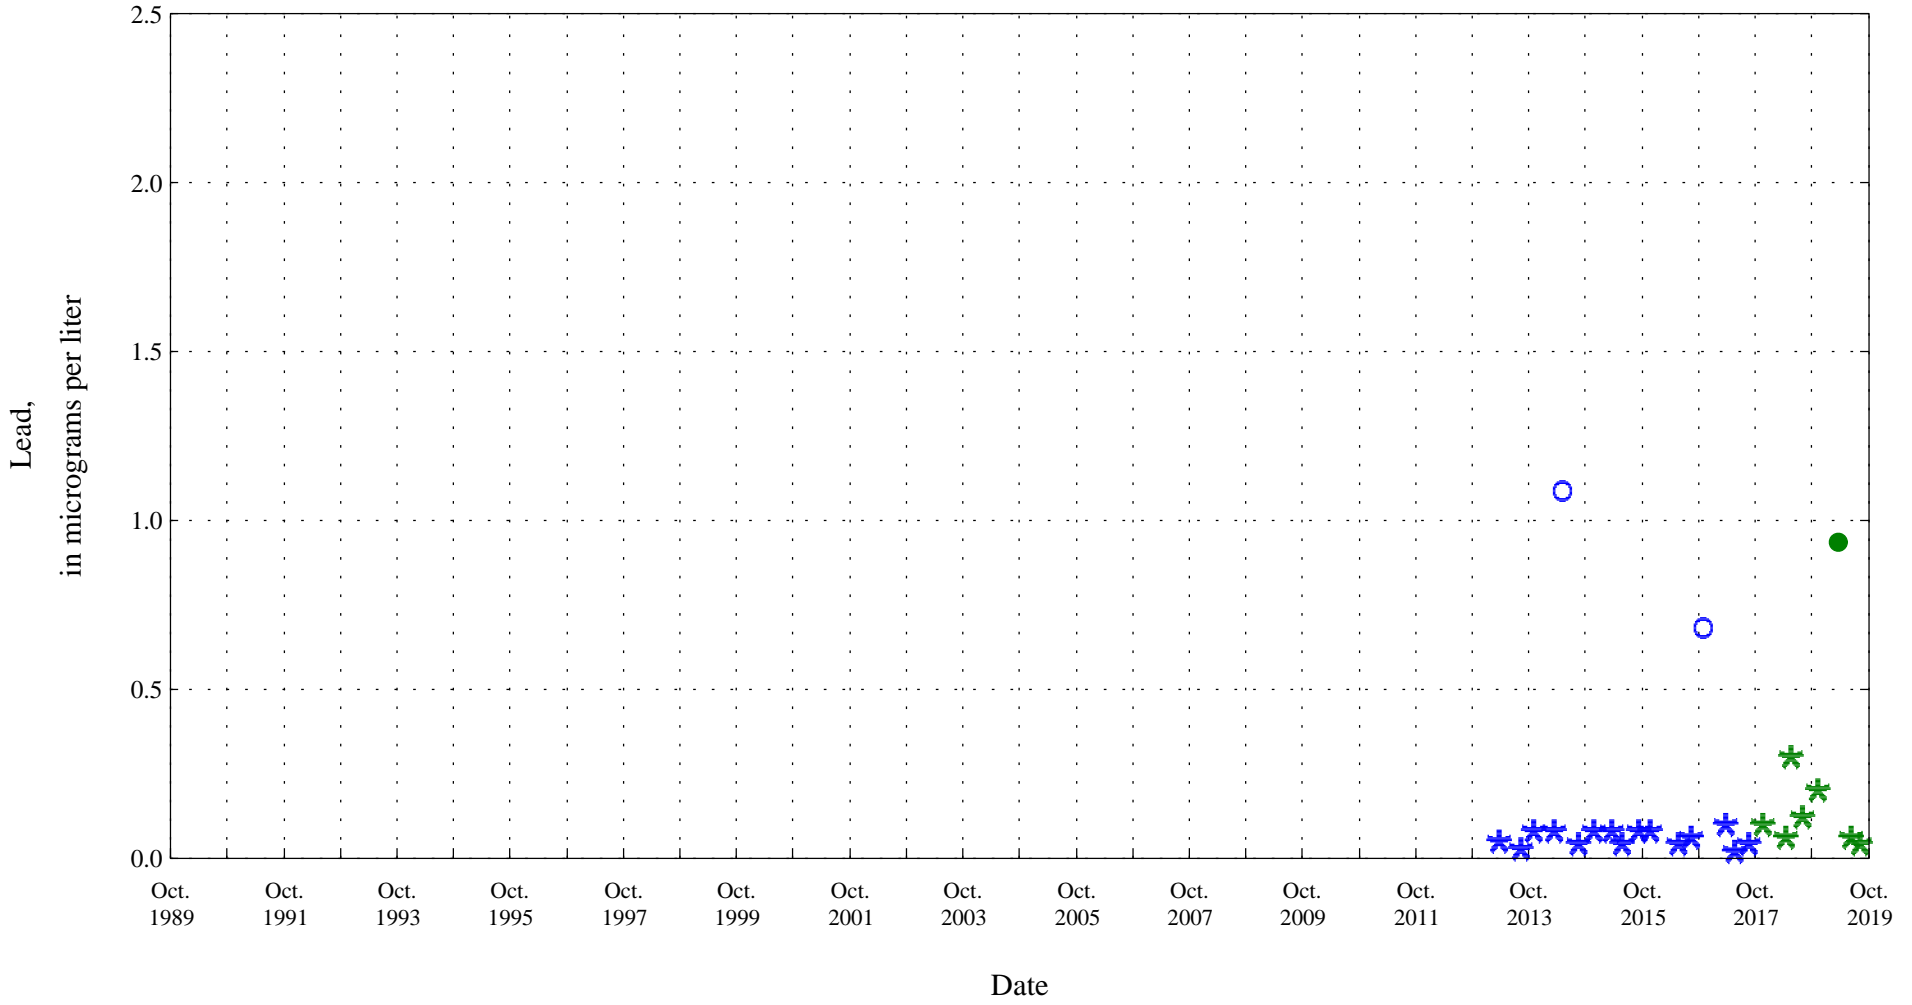
Aquatic Life Chronic Standard 1,000

Figure 26. Distribution of selected water-quality constituents relative to time for

Purgatoire River at Rock Crossing near Timpas, Co., station 07126485.

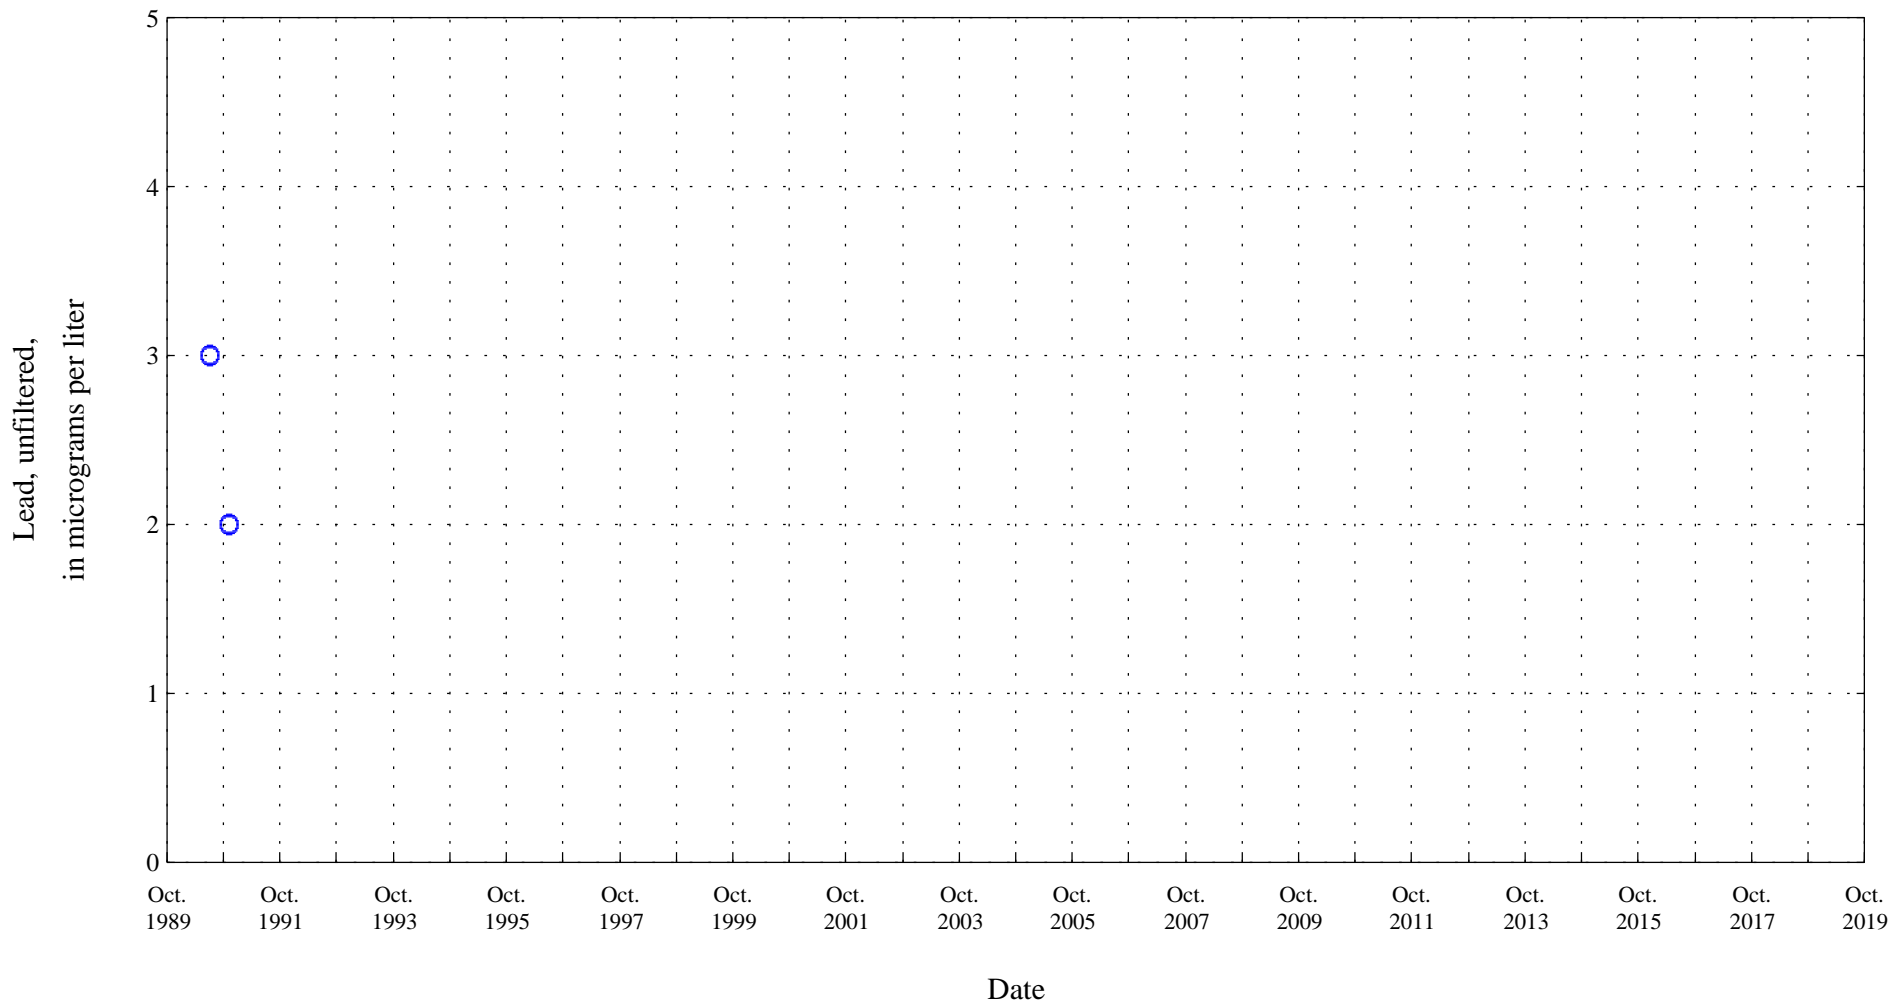
Aquatic Life Acute Standard 281
 Aquatic Life Chronic Standard 10.9

Figure 26. Distribution of selected water-quality constituents relative to time for

Purgatoire River at Rock Crossing near Timpas, Co., station 07126485.

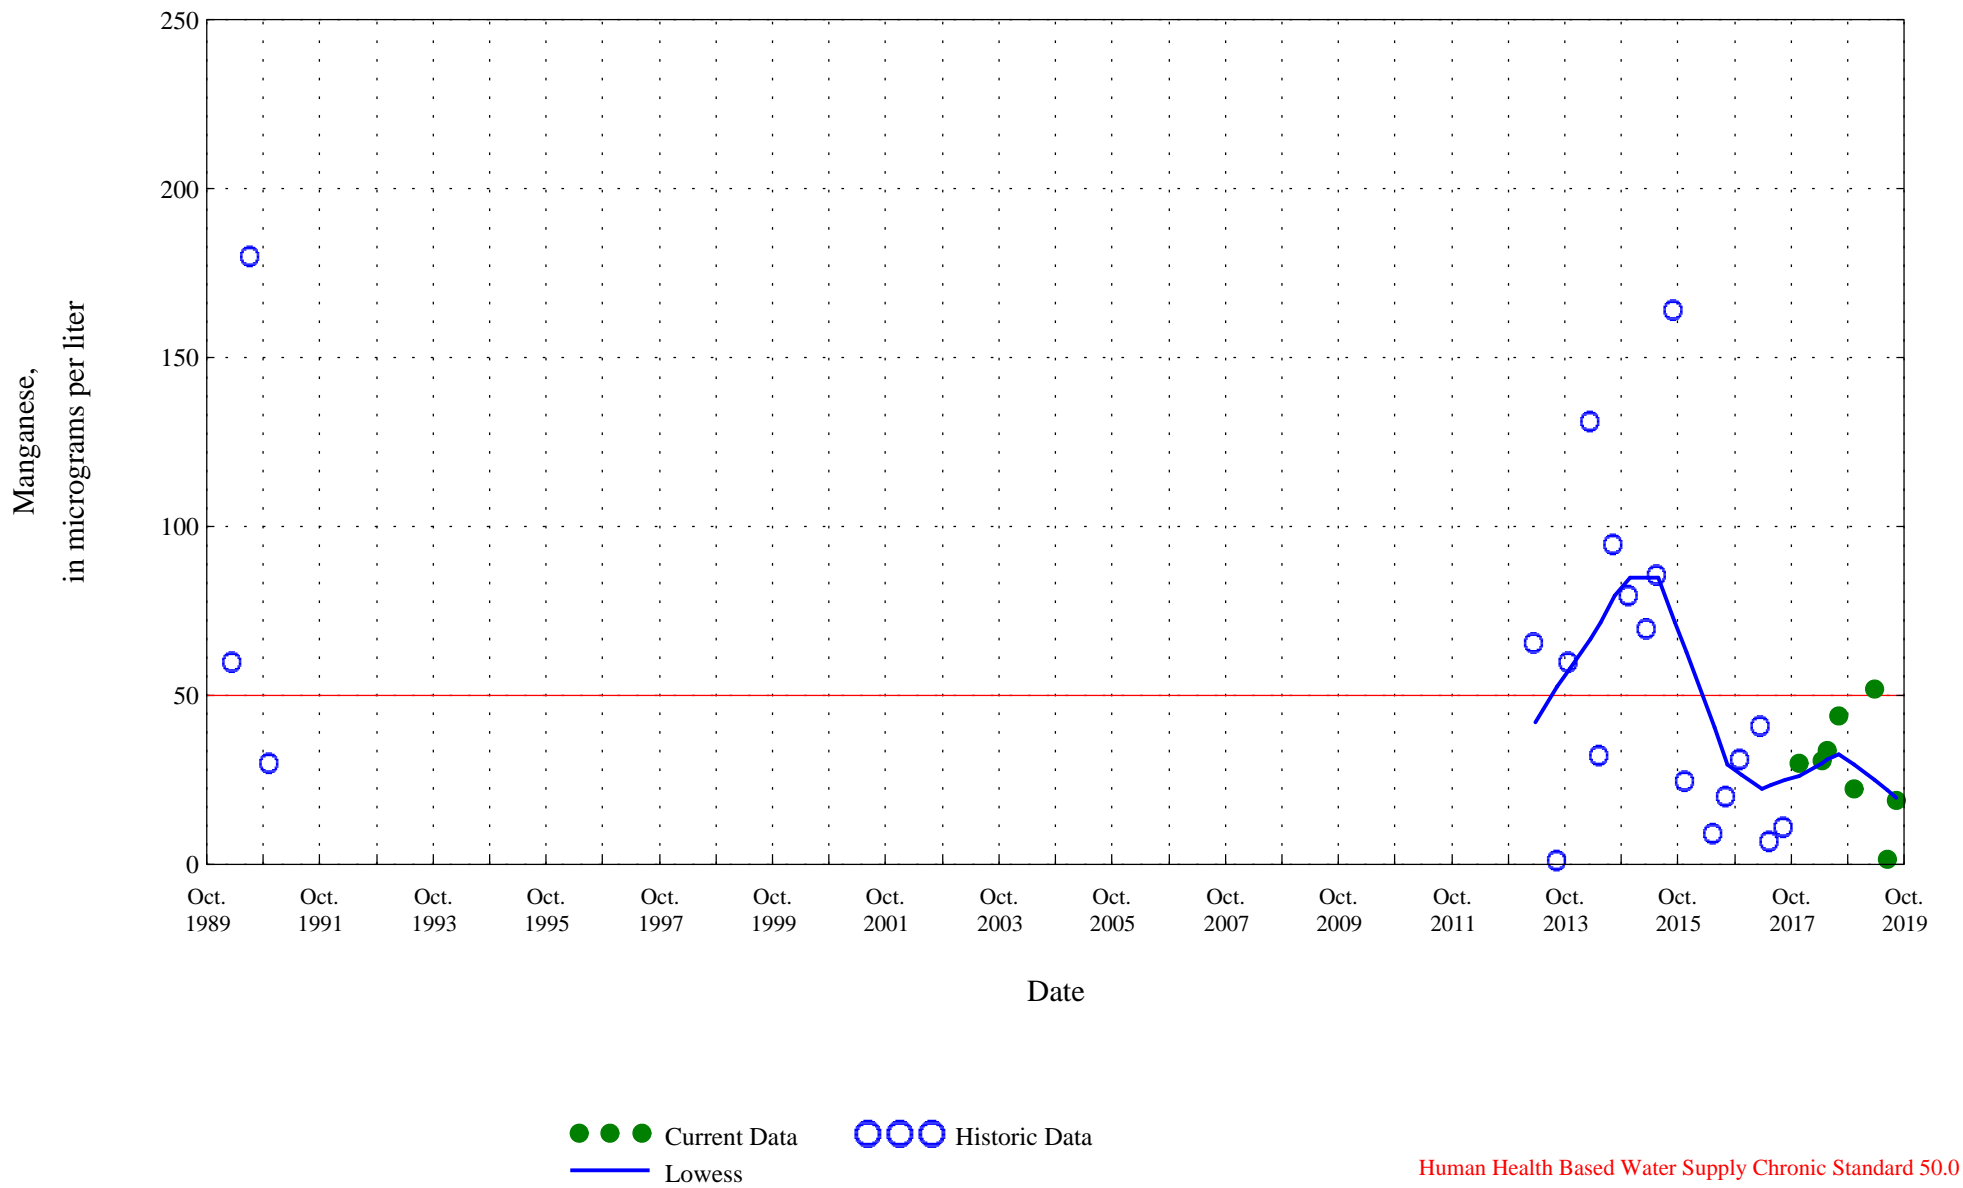
Water Supply Acute Standard 50.0

Figure 26. Distribution of selected water-quality constituents relative to time for

Purgatoire River at Rock Crossing near Timpas, Co., station 07126485.

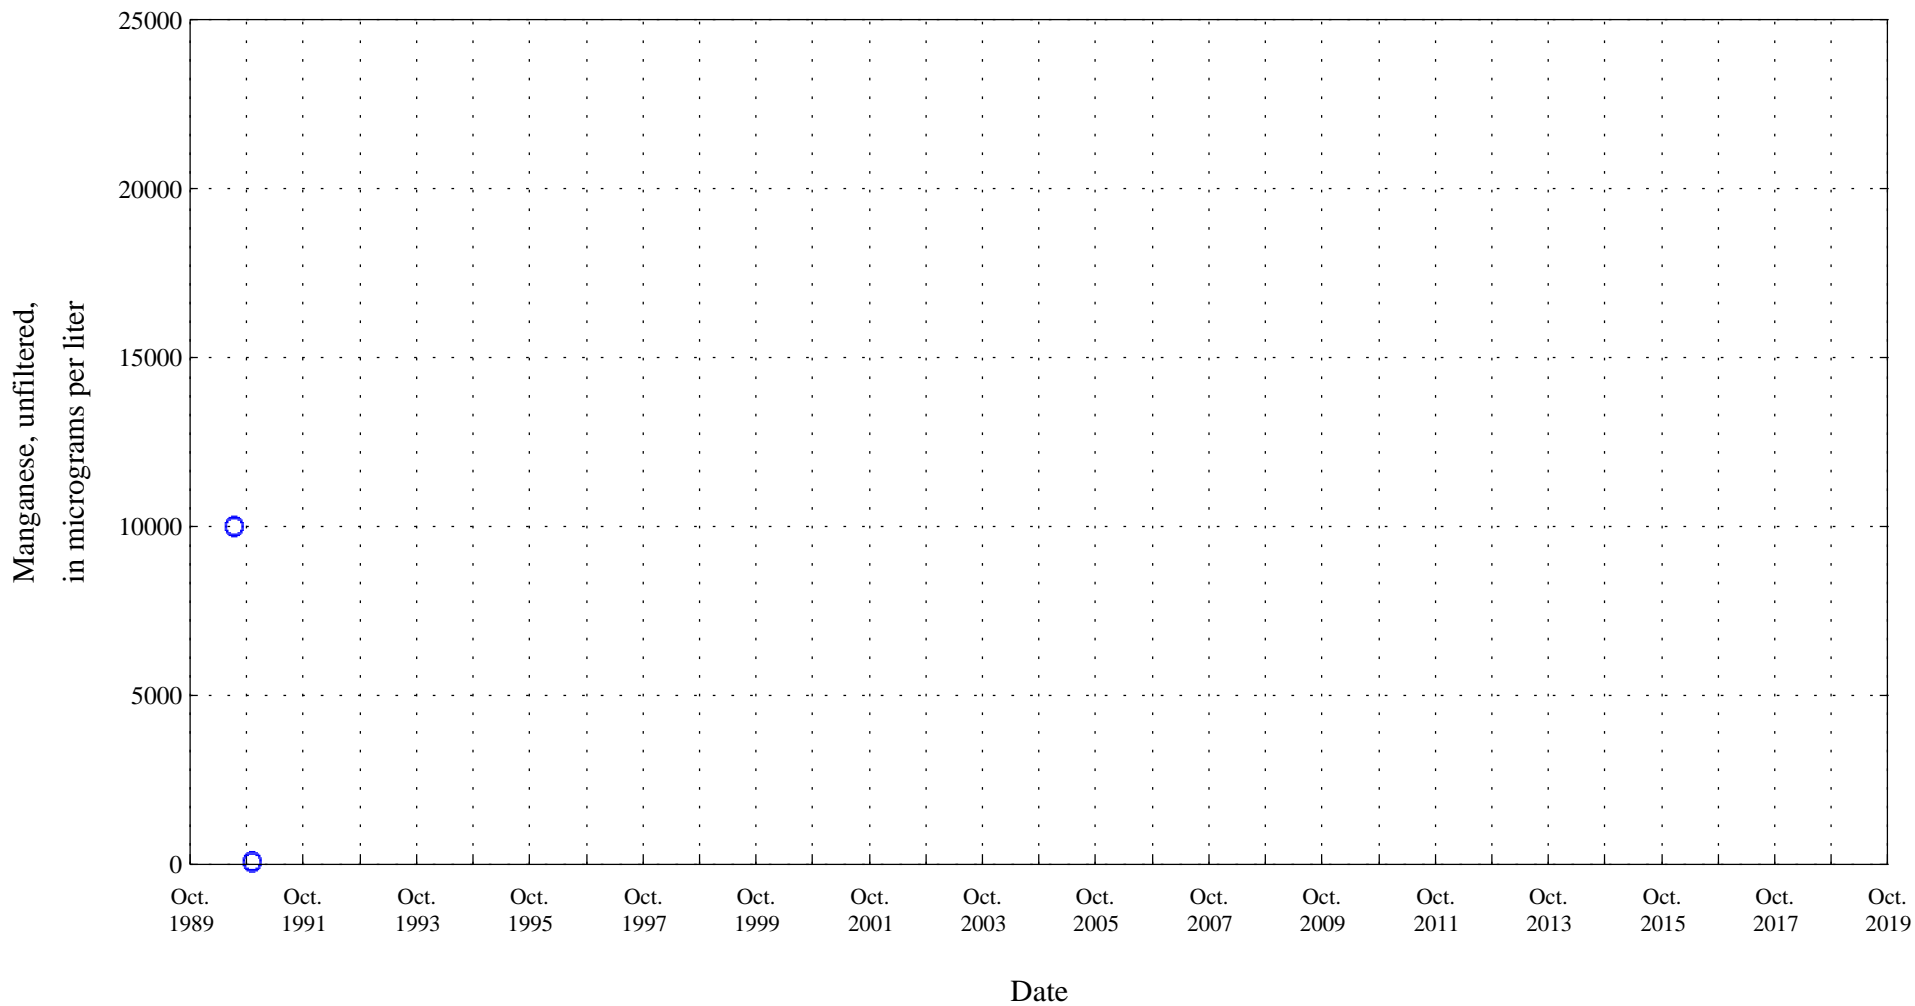
Human Health Based Water Supply Chronic Standard 50.0

Figure 26. Distribution of selected water-quality constituents relative to time for

Purgatoire River at Rock Crossing near Timpas, Co., station 07126485.

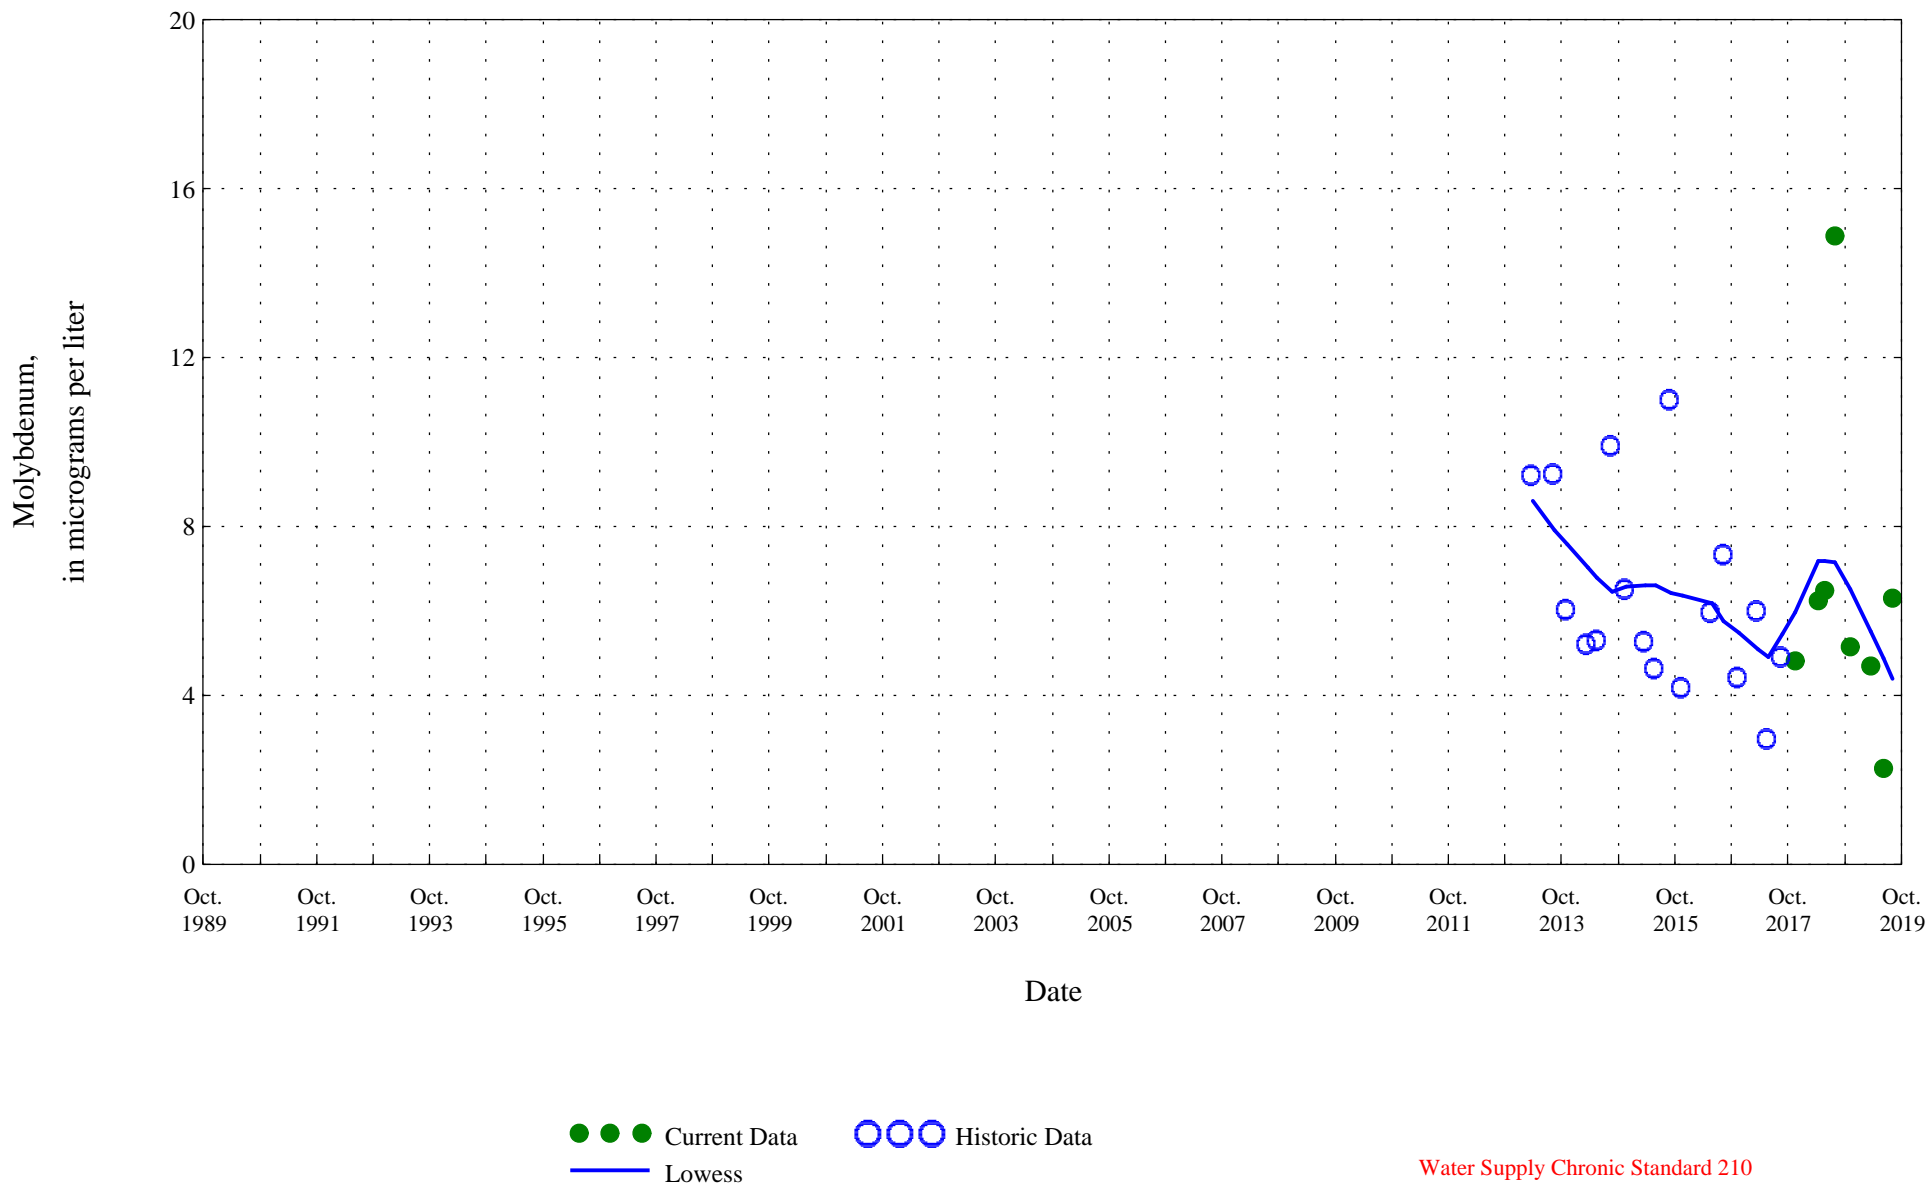
Figure 26. Distribution of selected water-quality constituents relative to time for

Purgatoire River at Rock Crossing near Timpas, Co., station 07126485.
