Figure 26. Distribution of selected water-quality constituents relative to time for

Purgatoire River at Rock Crossing near Timpas, Co., station 07126485.

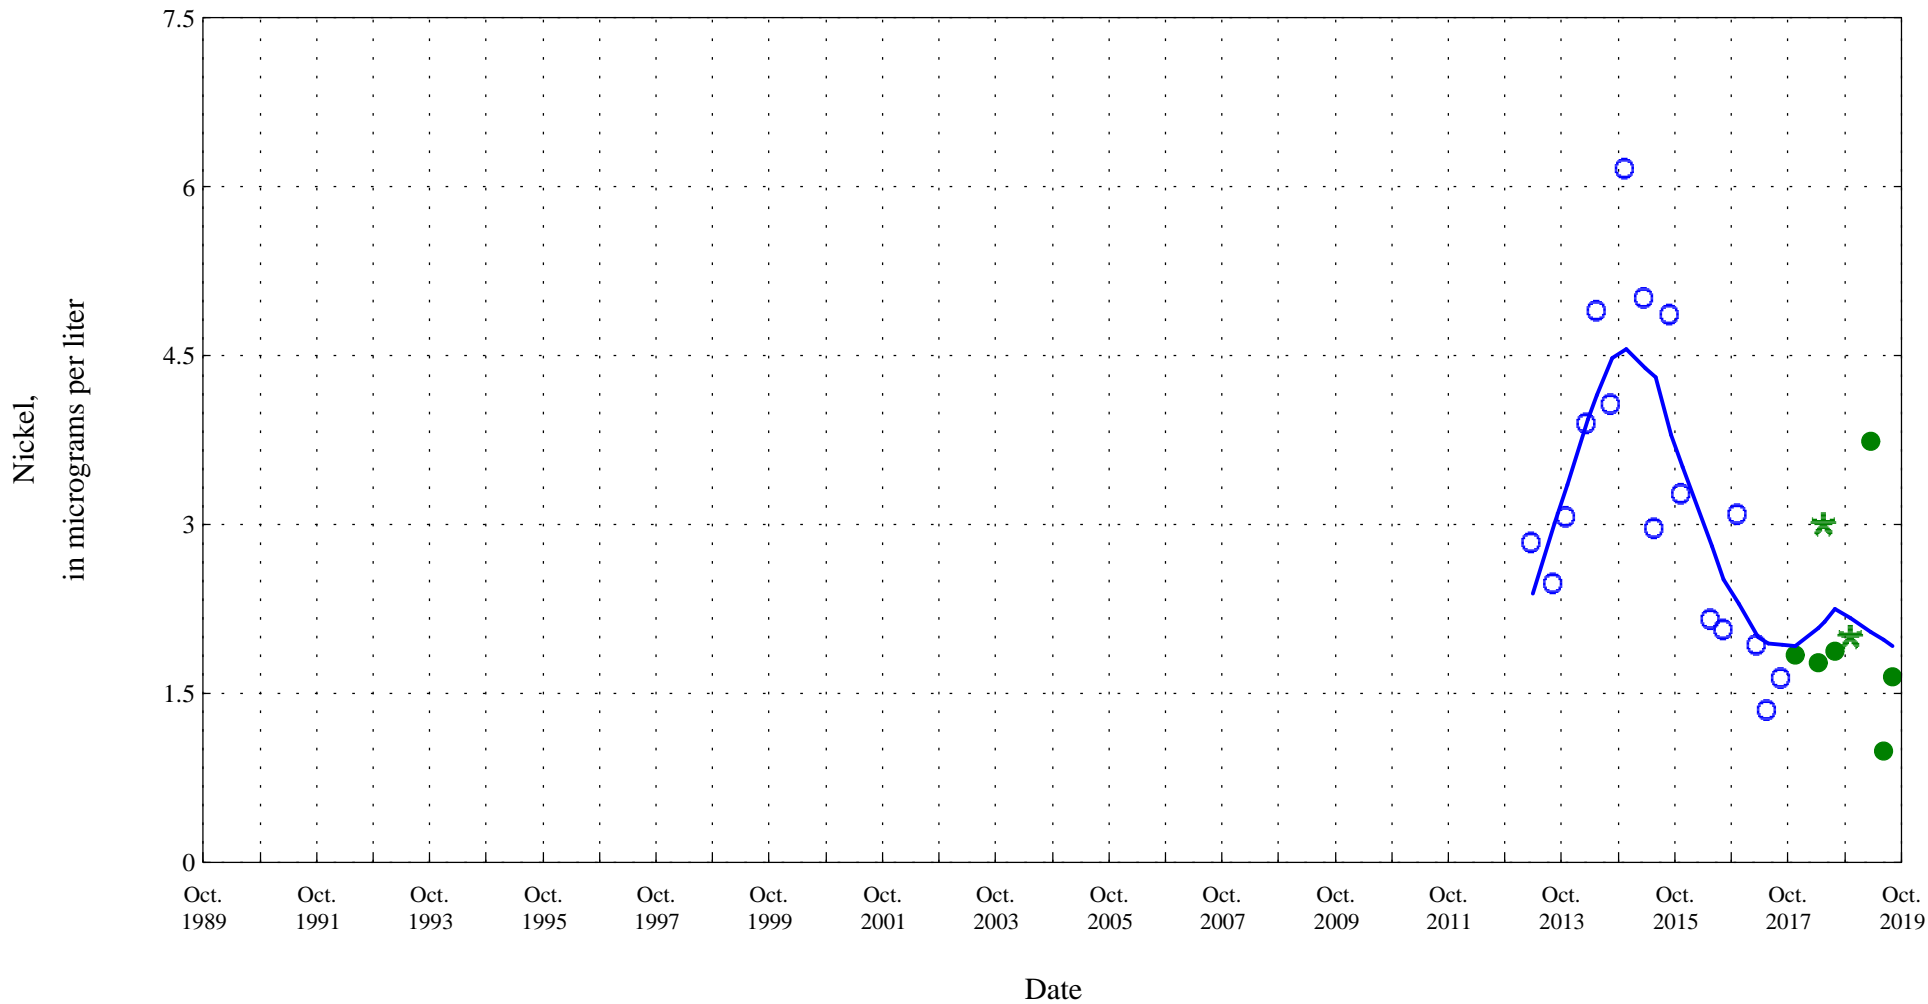
Figure 26. Distribution of selected water-quality constituents relative to time for

Purgatoire River at Rock Crossing near Timpas, Co., station 07126485.

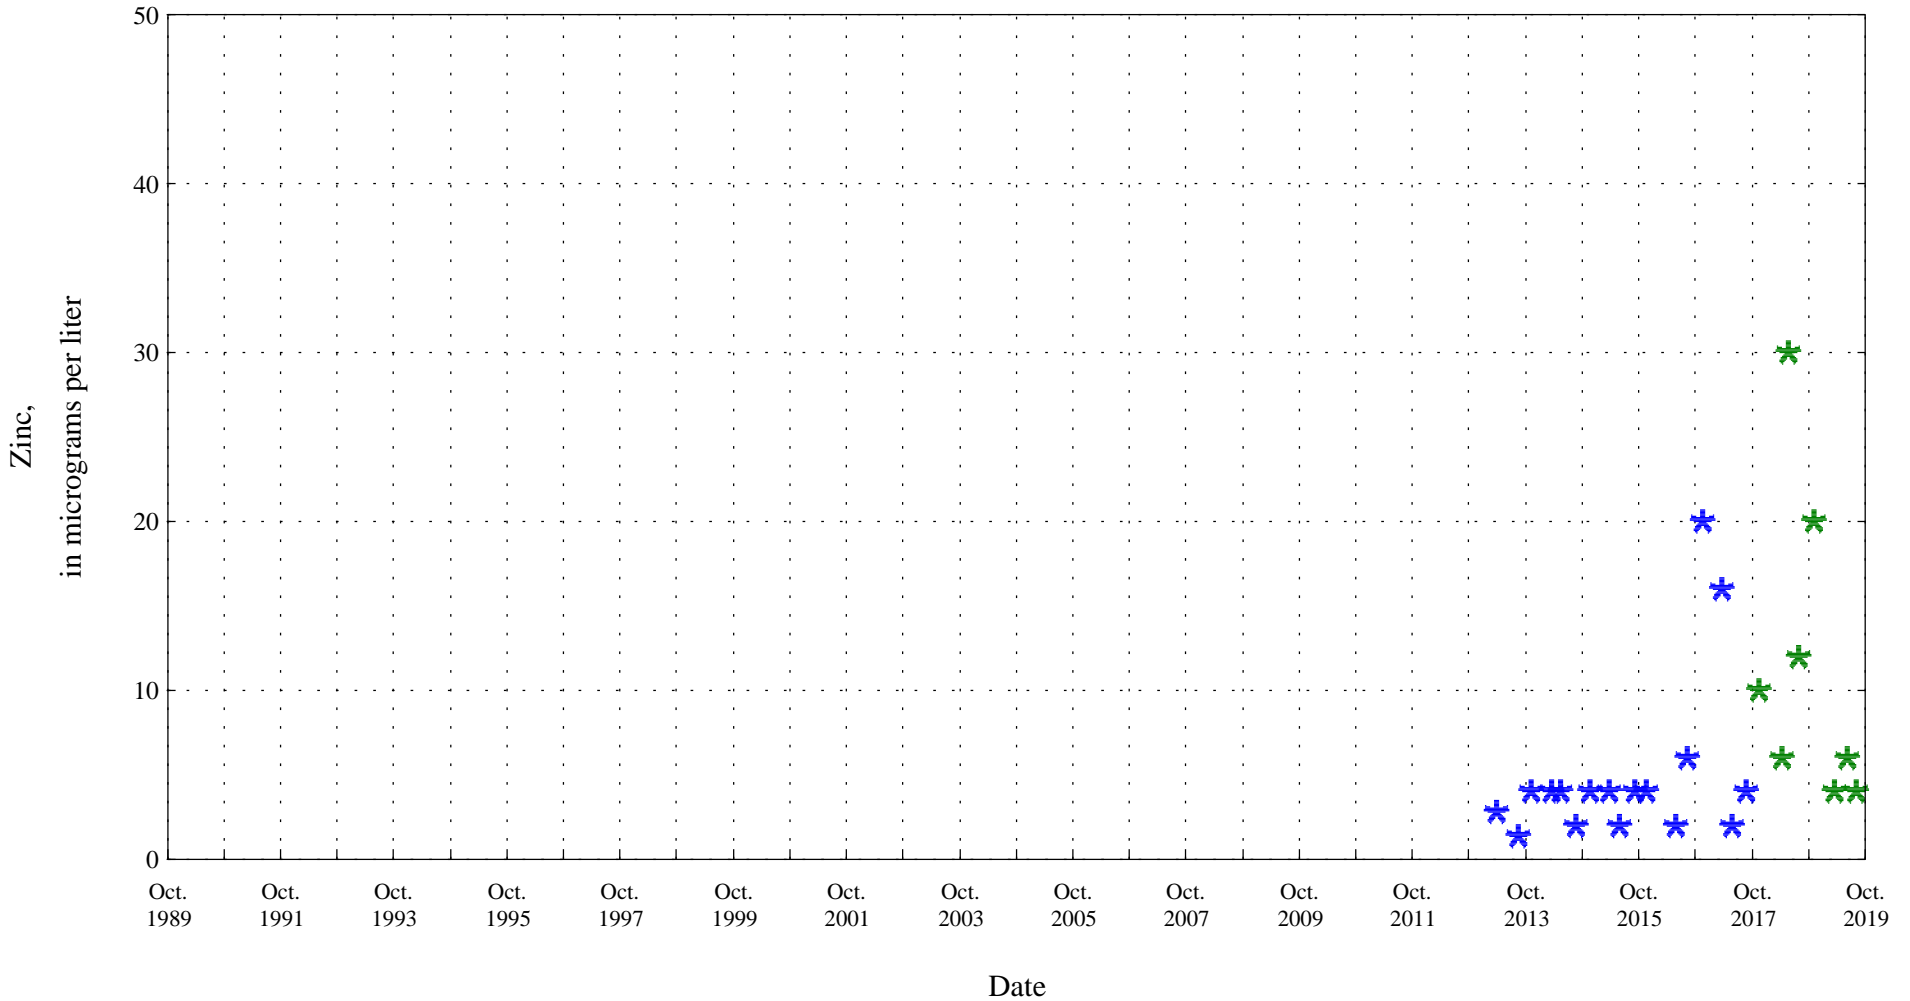
Aquatic Life Acute Standard 1,513
Aquatic Life Chronic Standard 168

Figure 26. Distribution of selected water-quality constituents relative to time for

Purgatoire River at Rock Crossing near Timpas, Co., station 07126485.

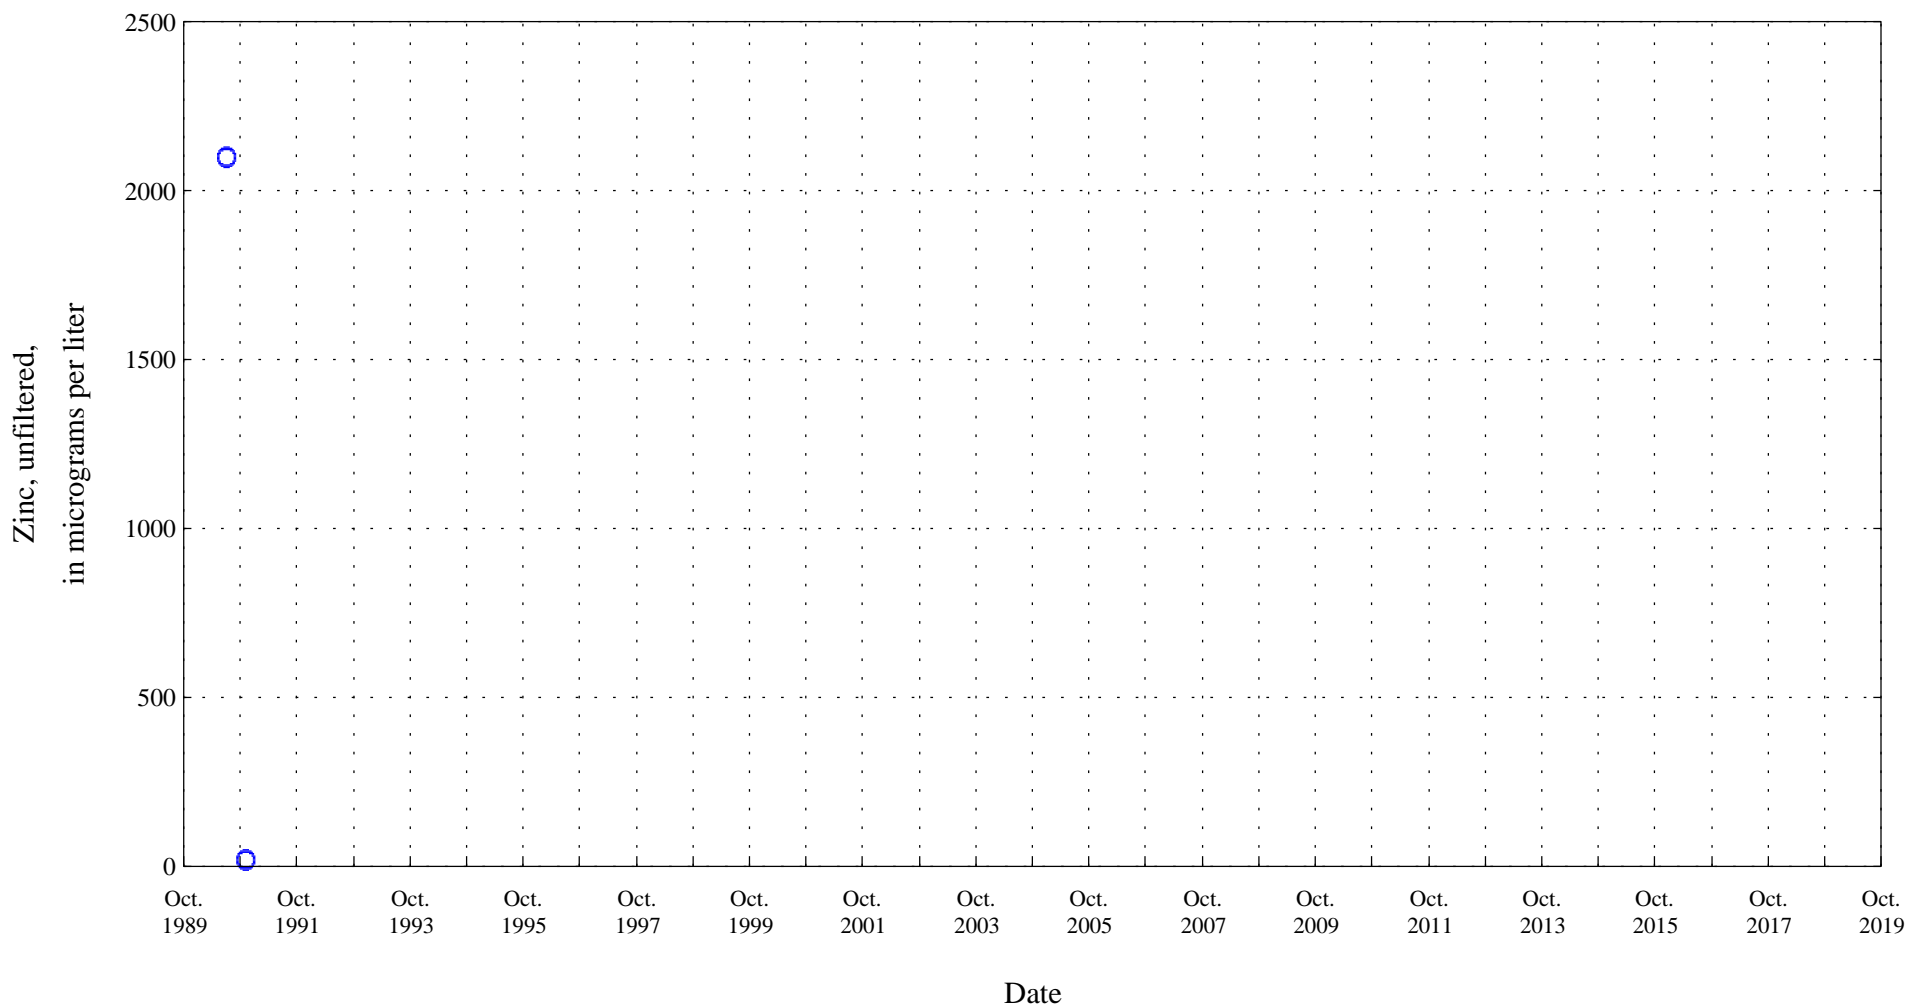
Aquatic Life Acute Standard 564
Aquatic Life Chronic Standard 428

Figure 26. Distribution of selected water-quality constituents relative to time for

Purgatoire River at Rock Crossing near Timpas, Co., station 07126485.

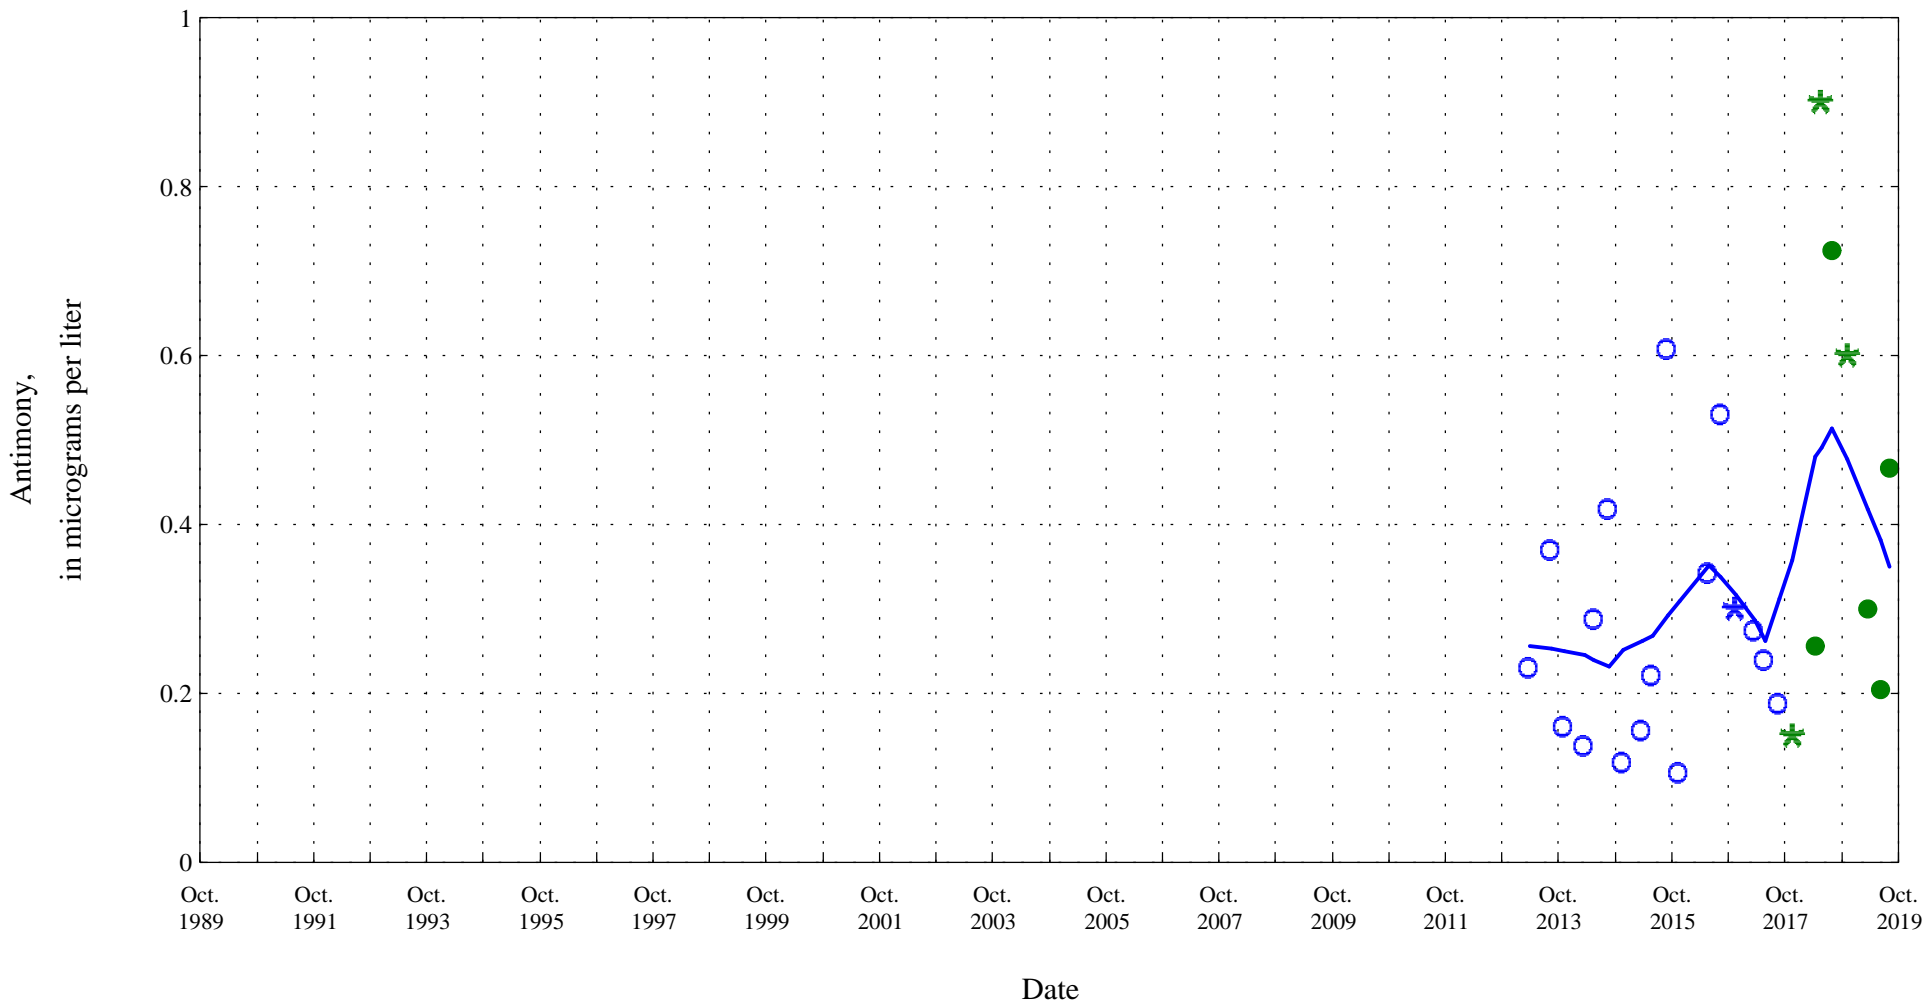
Figure 26. Distribution of selected water-quality constituents relative to time for

Purgatoire River at Rock Crossing near Timpas, Co., station 07126485.

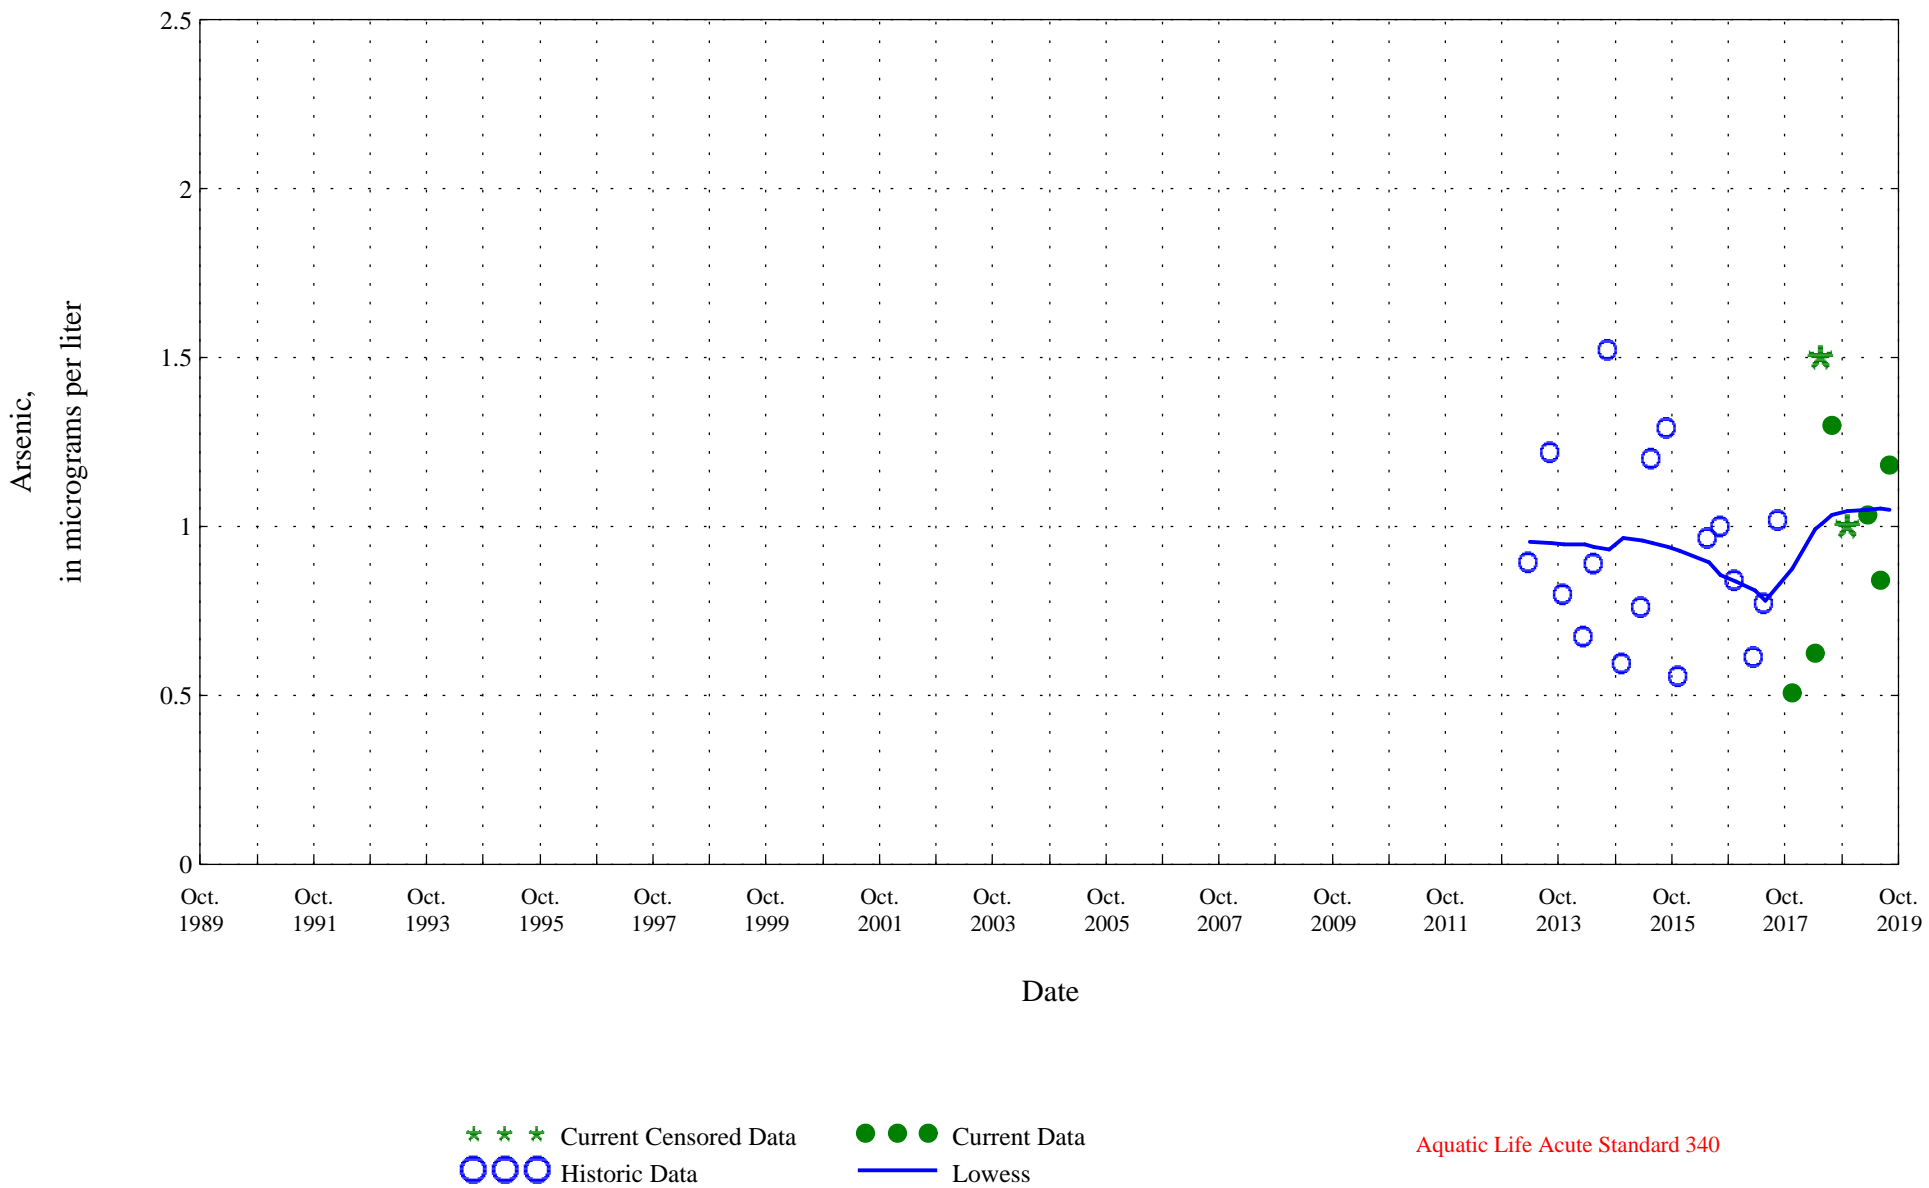
Water and Fish Chronic Standard 5.6

Figure 26. Distribution of selected water-quality constituents relative to time for

Purgatoire River at Rock Crossing near Timpas, Co., station 07126485.

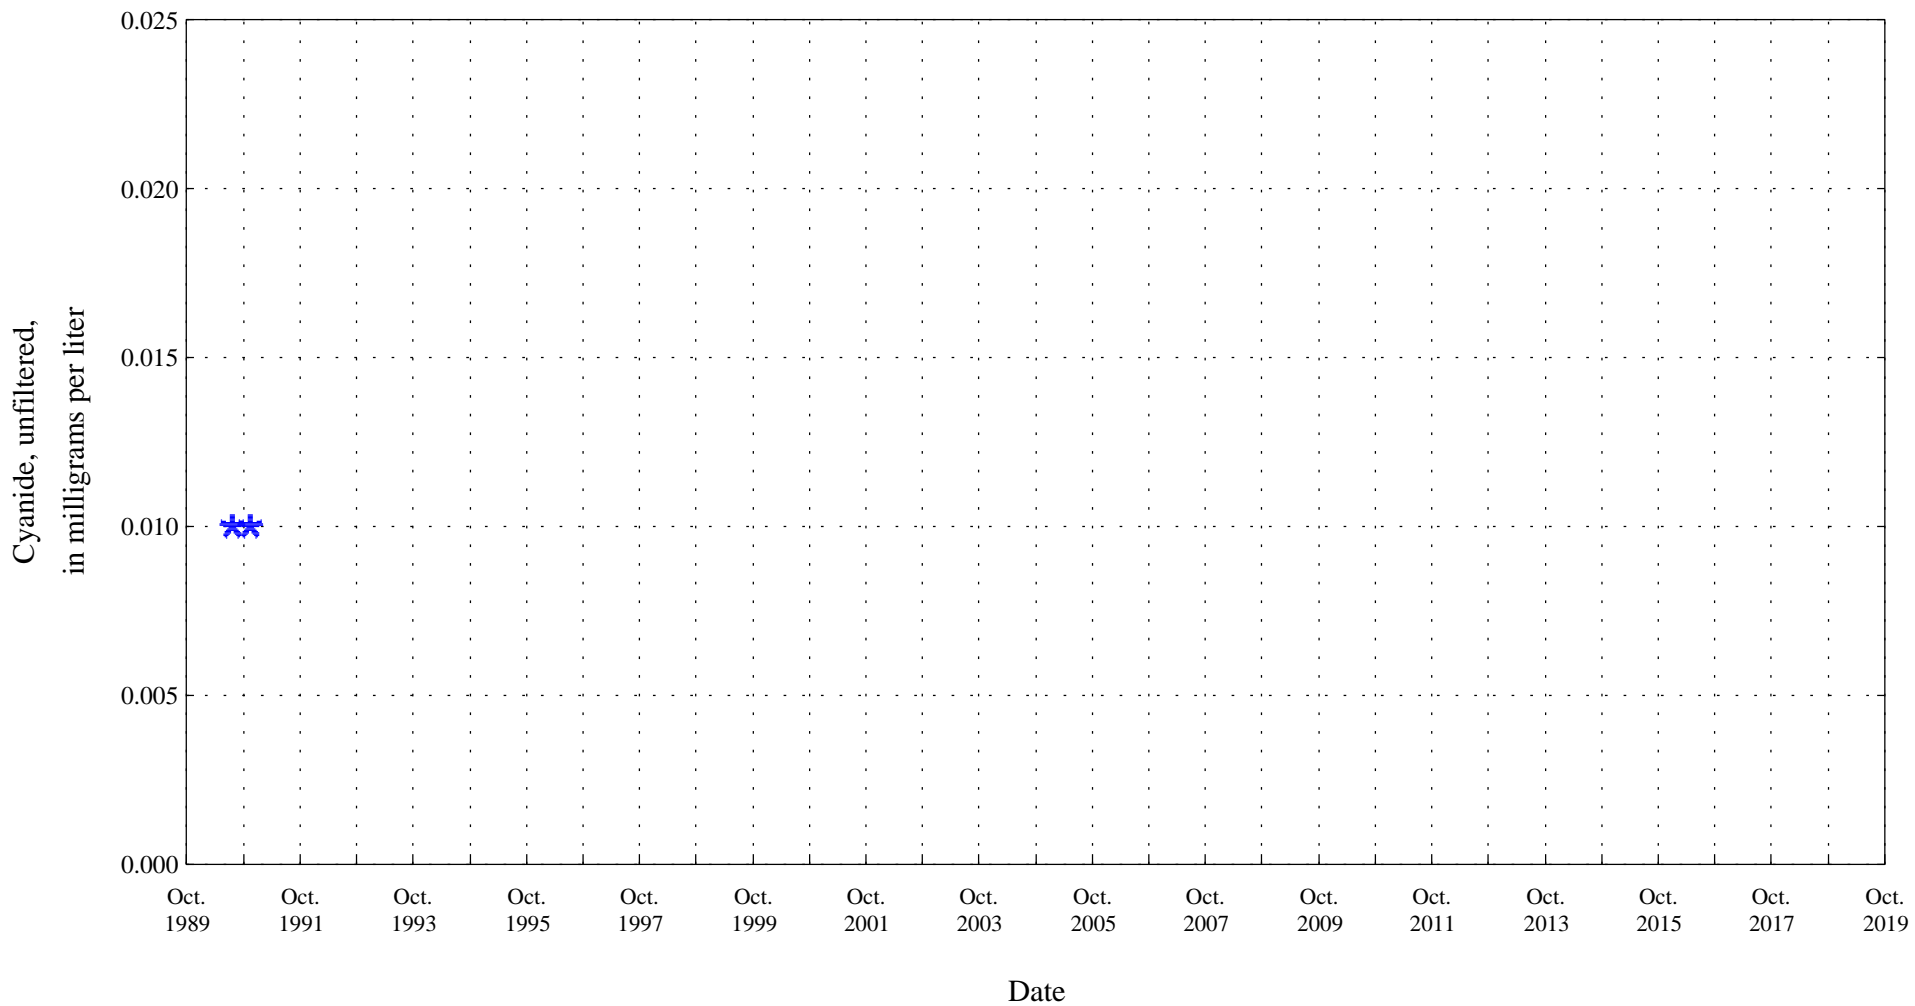
Figure 26. Distribution of selected water-quality constituents relative to time for

Purgatoire River at Rock Crossing near Timpas, Co., station 07126485.

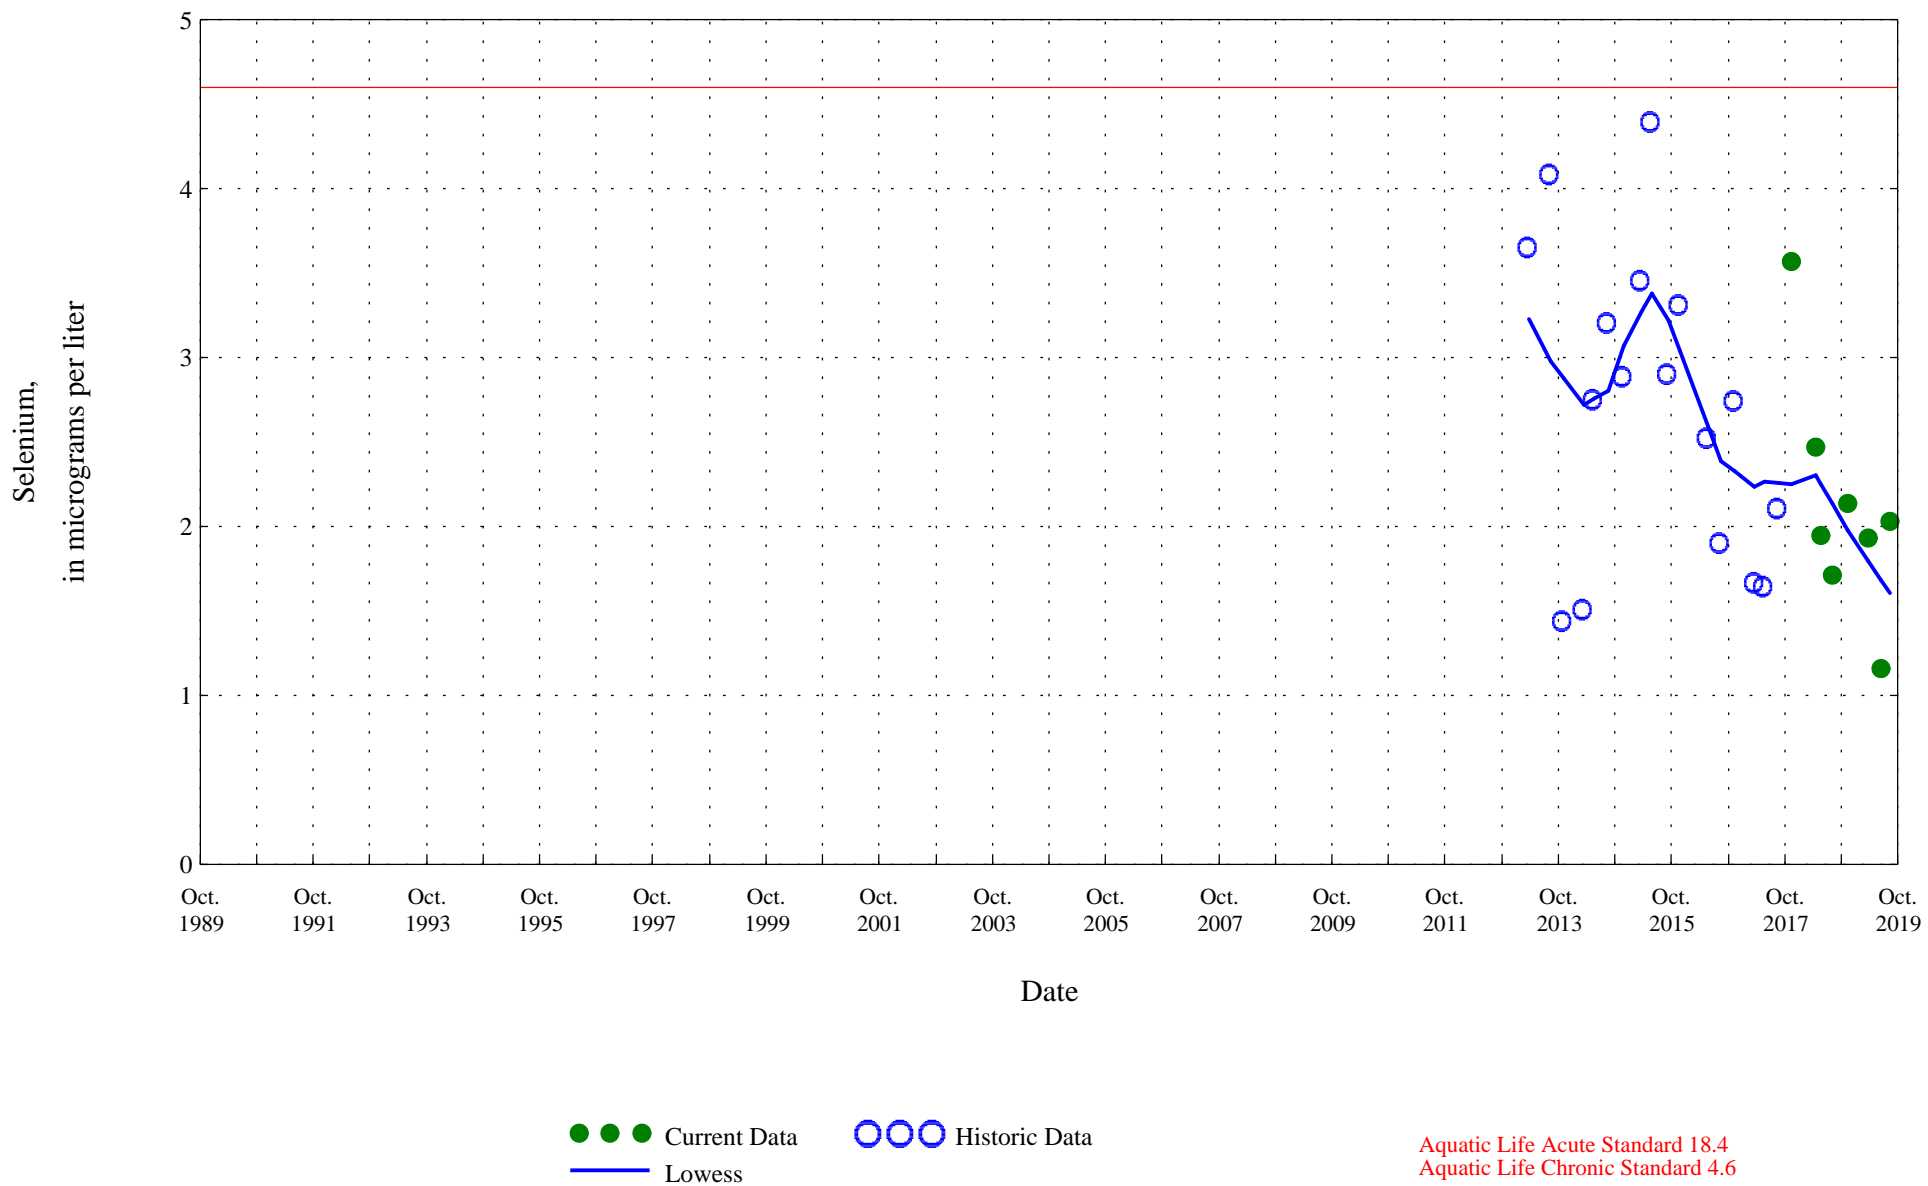
Figure 26. Distribution of selected water-quality constituents relative to time for

Purgatoire River at Rock Crossing near Timpas, Co., station 07126485.

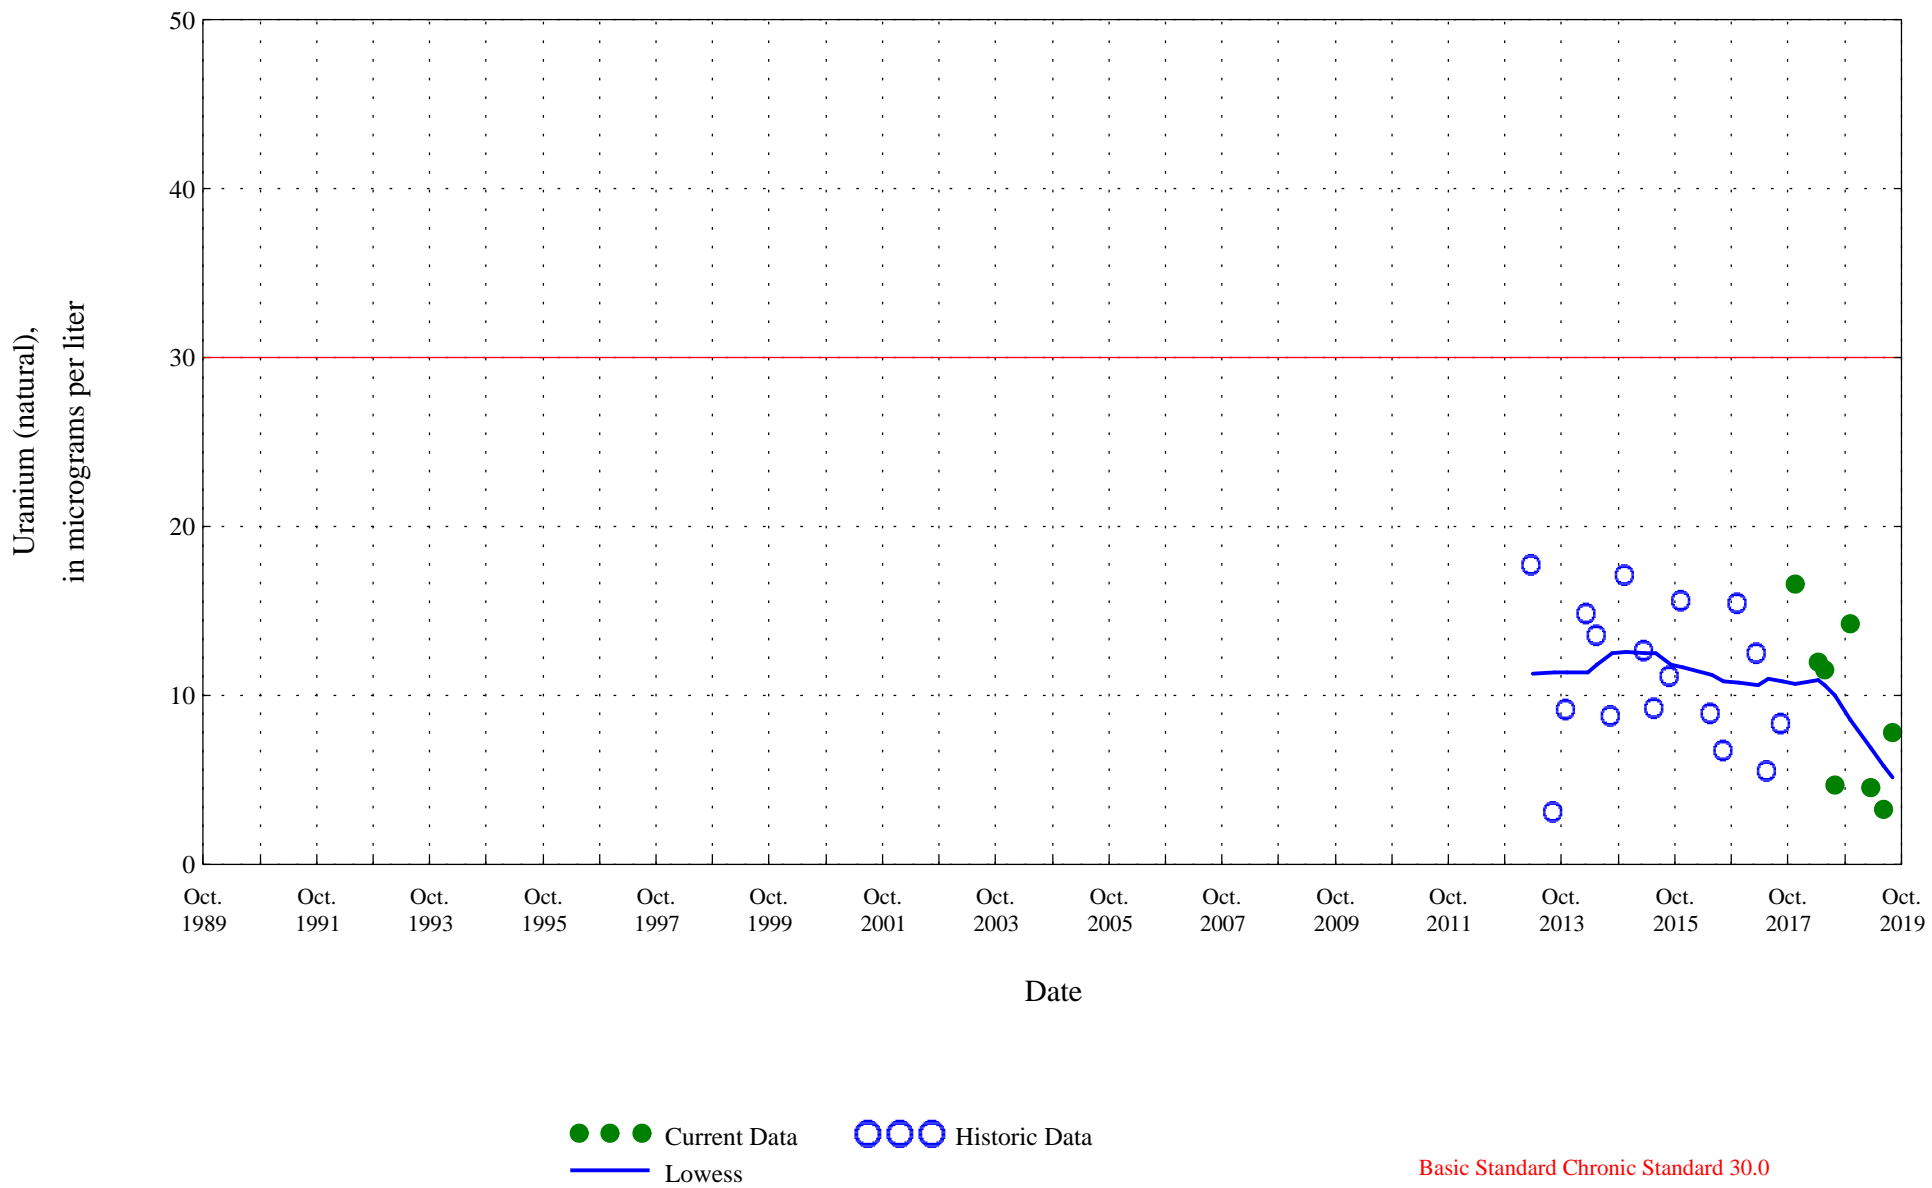
Figure 26. Distribution of selected water-quality constituents relative to time for

Purgatoire River at Rock Crossing near Timpas, Co., station 07126485.

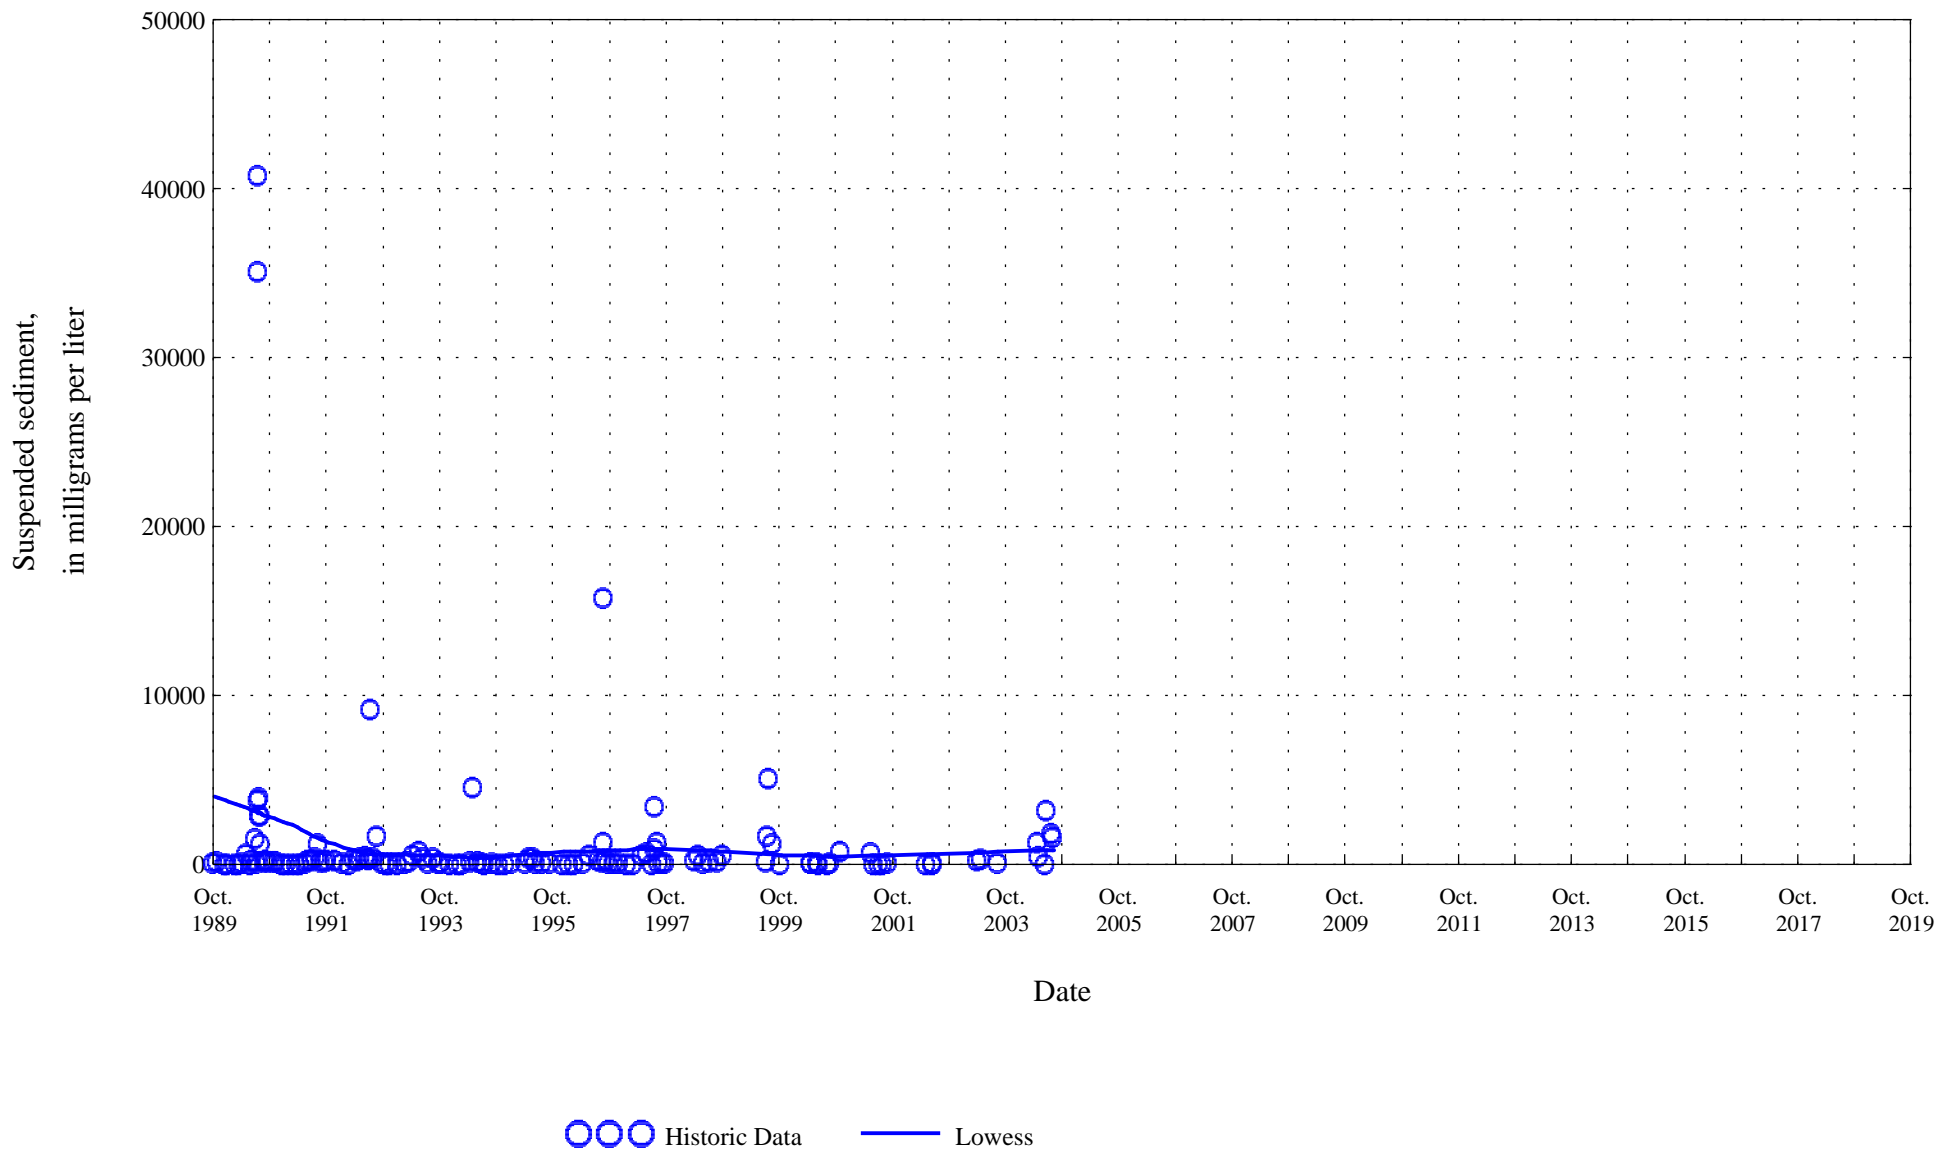
Figure 26. Distribution of selected water-quality constituents relative to time for

Purgatoire River at Rock Crossing near Timpas, Co., station 07126485.
