Figure 4. Distribution of selected water-quality constituents relative to time for Sunflower Drain at Highway 92 near Read, CO, station 384551107591901.

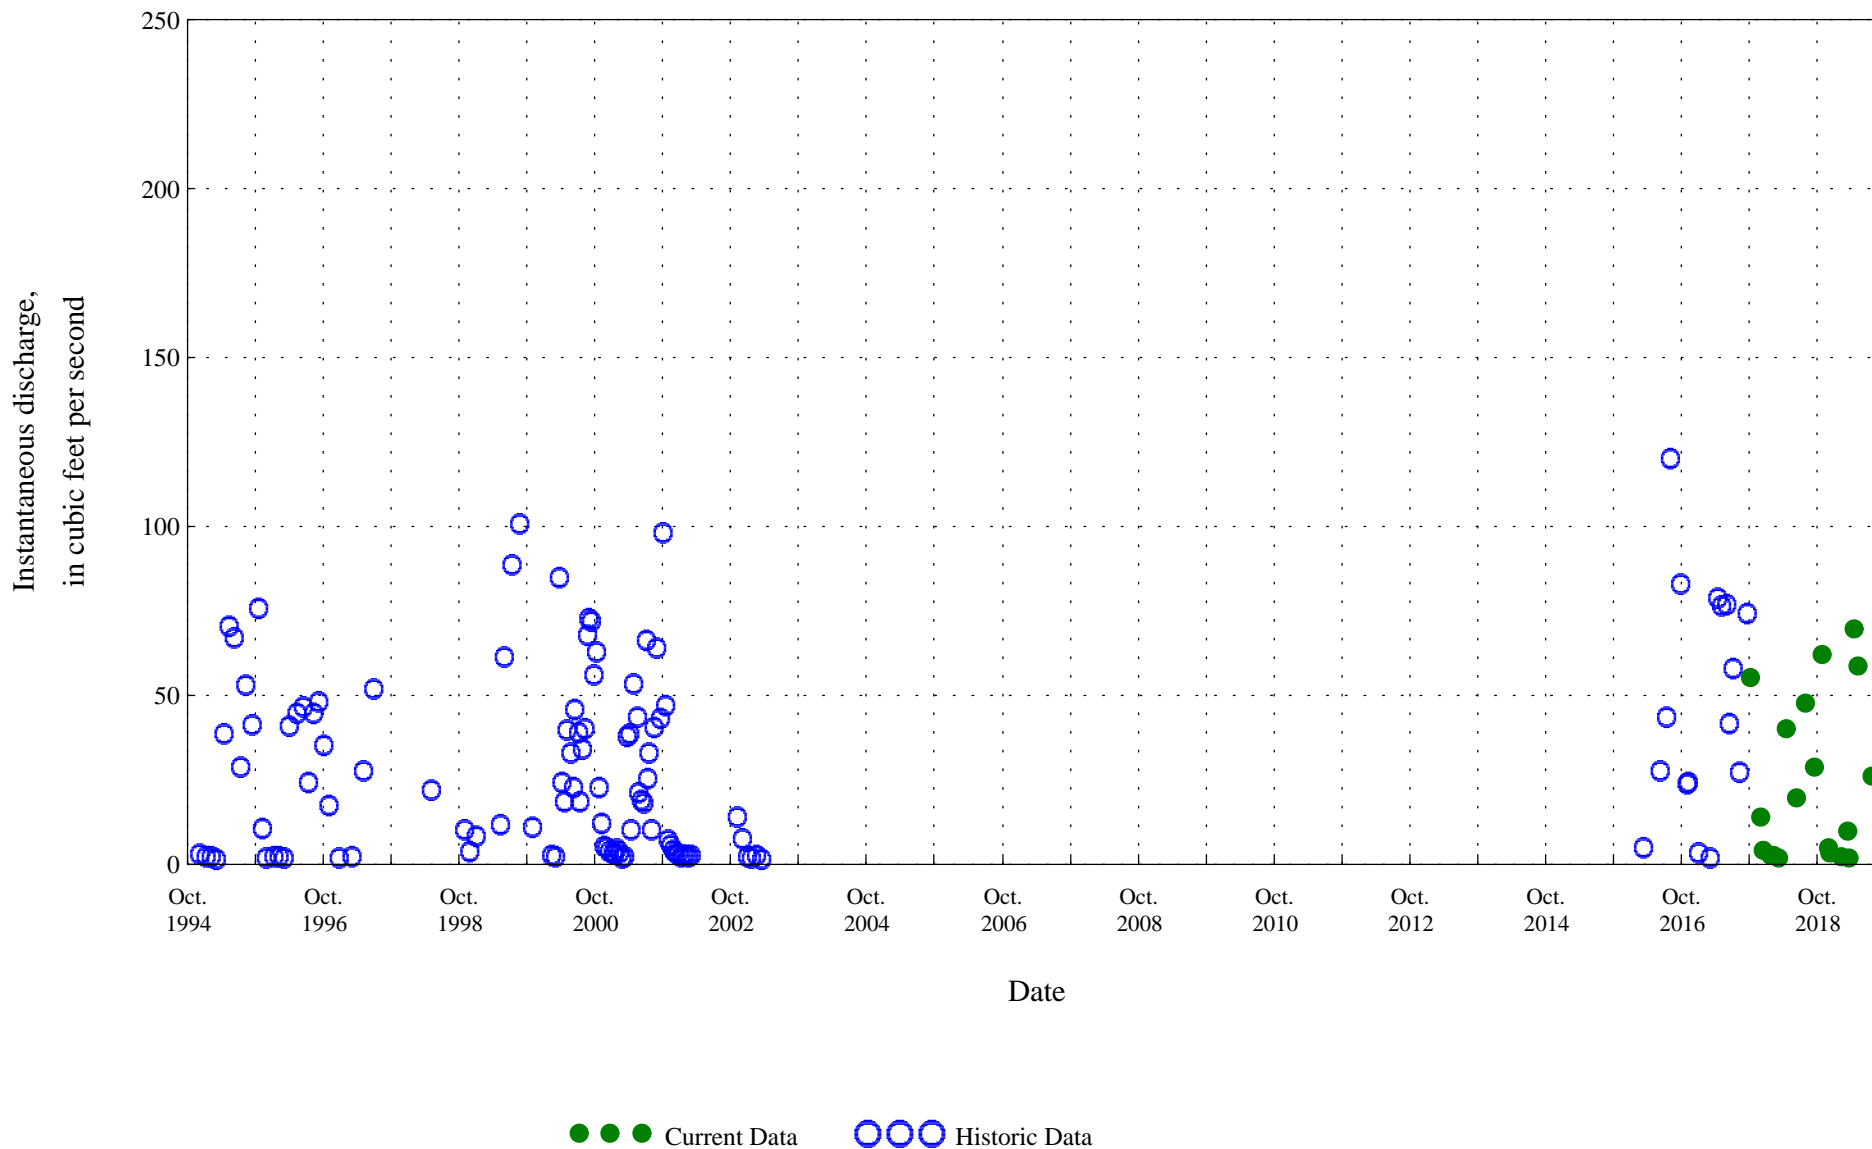
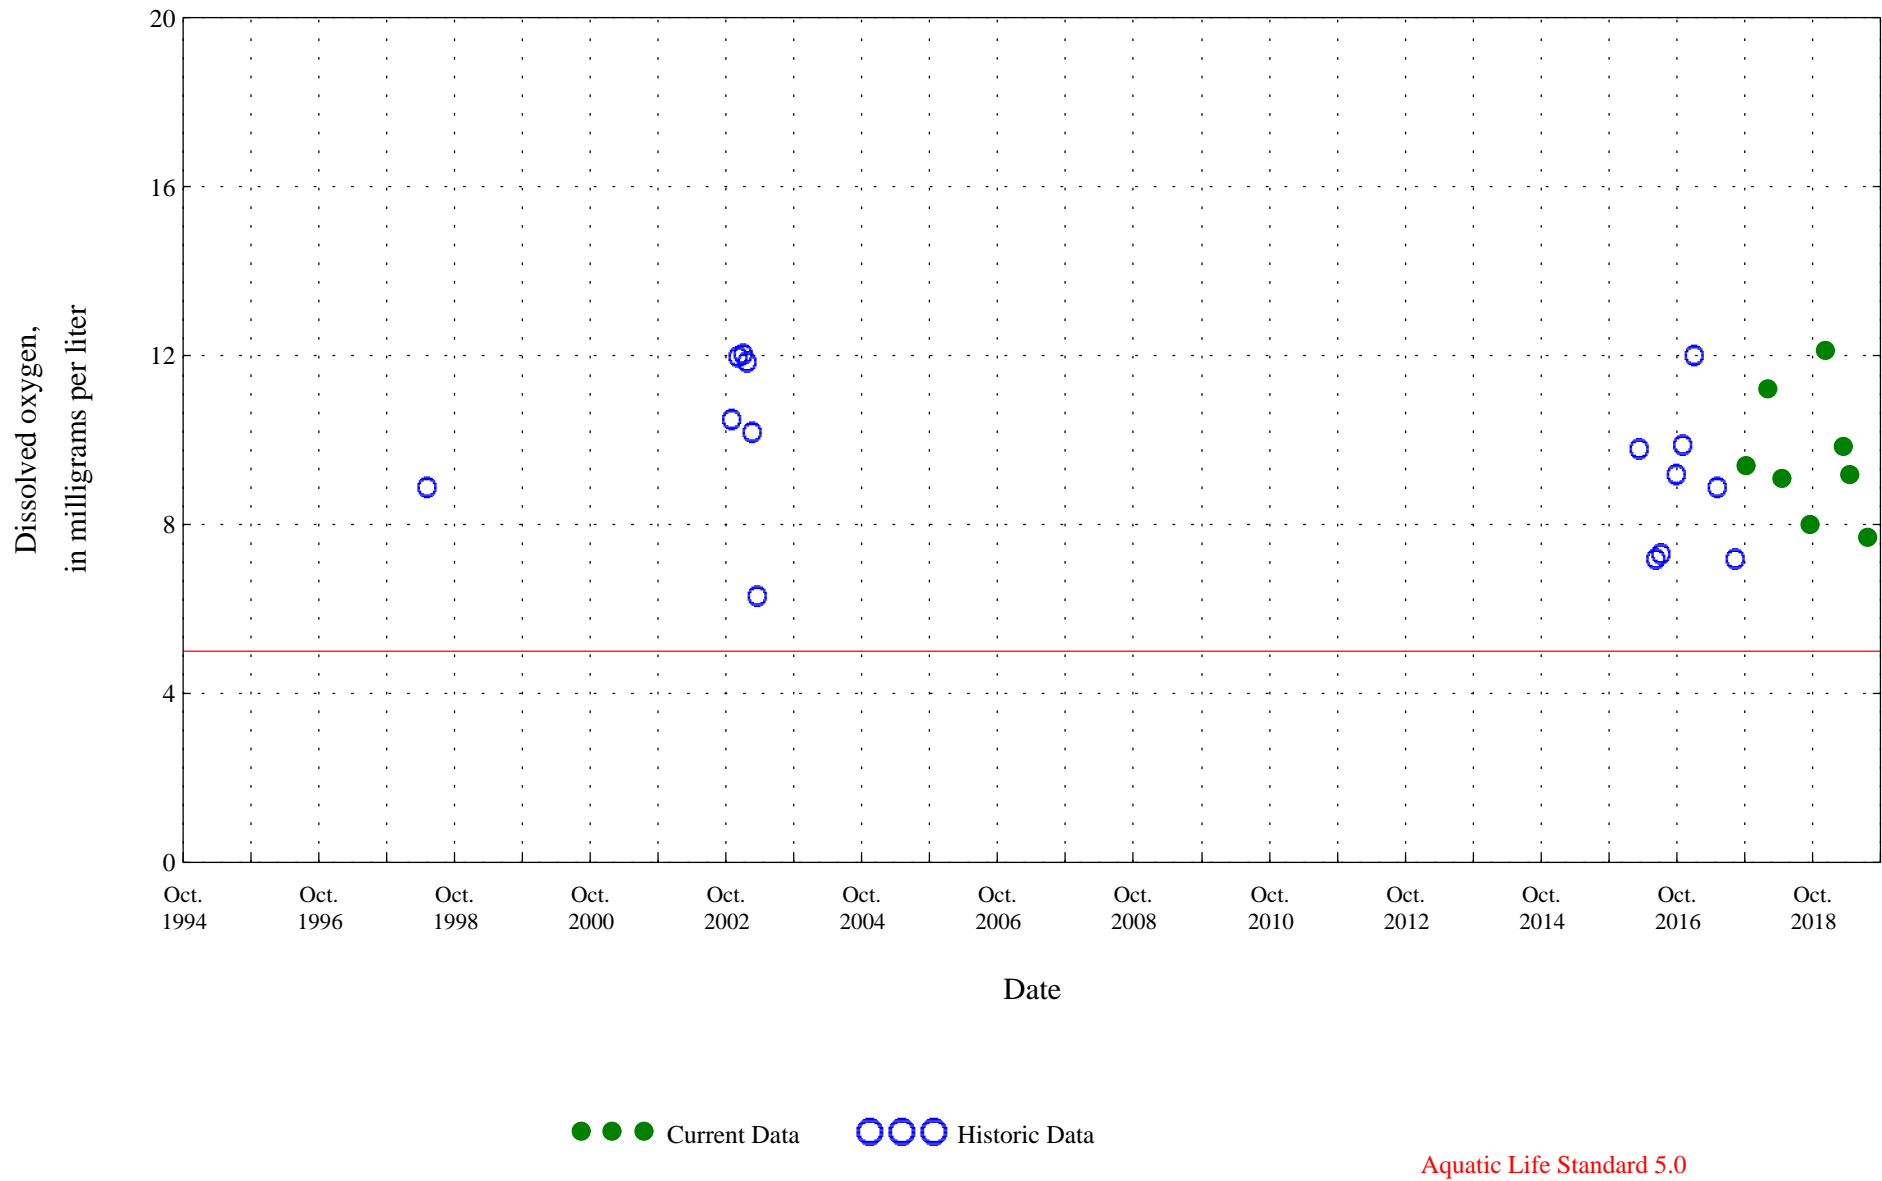
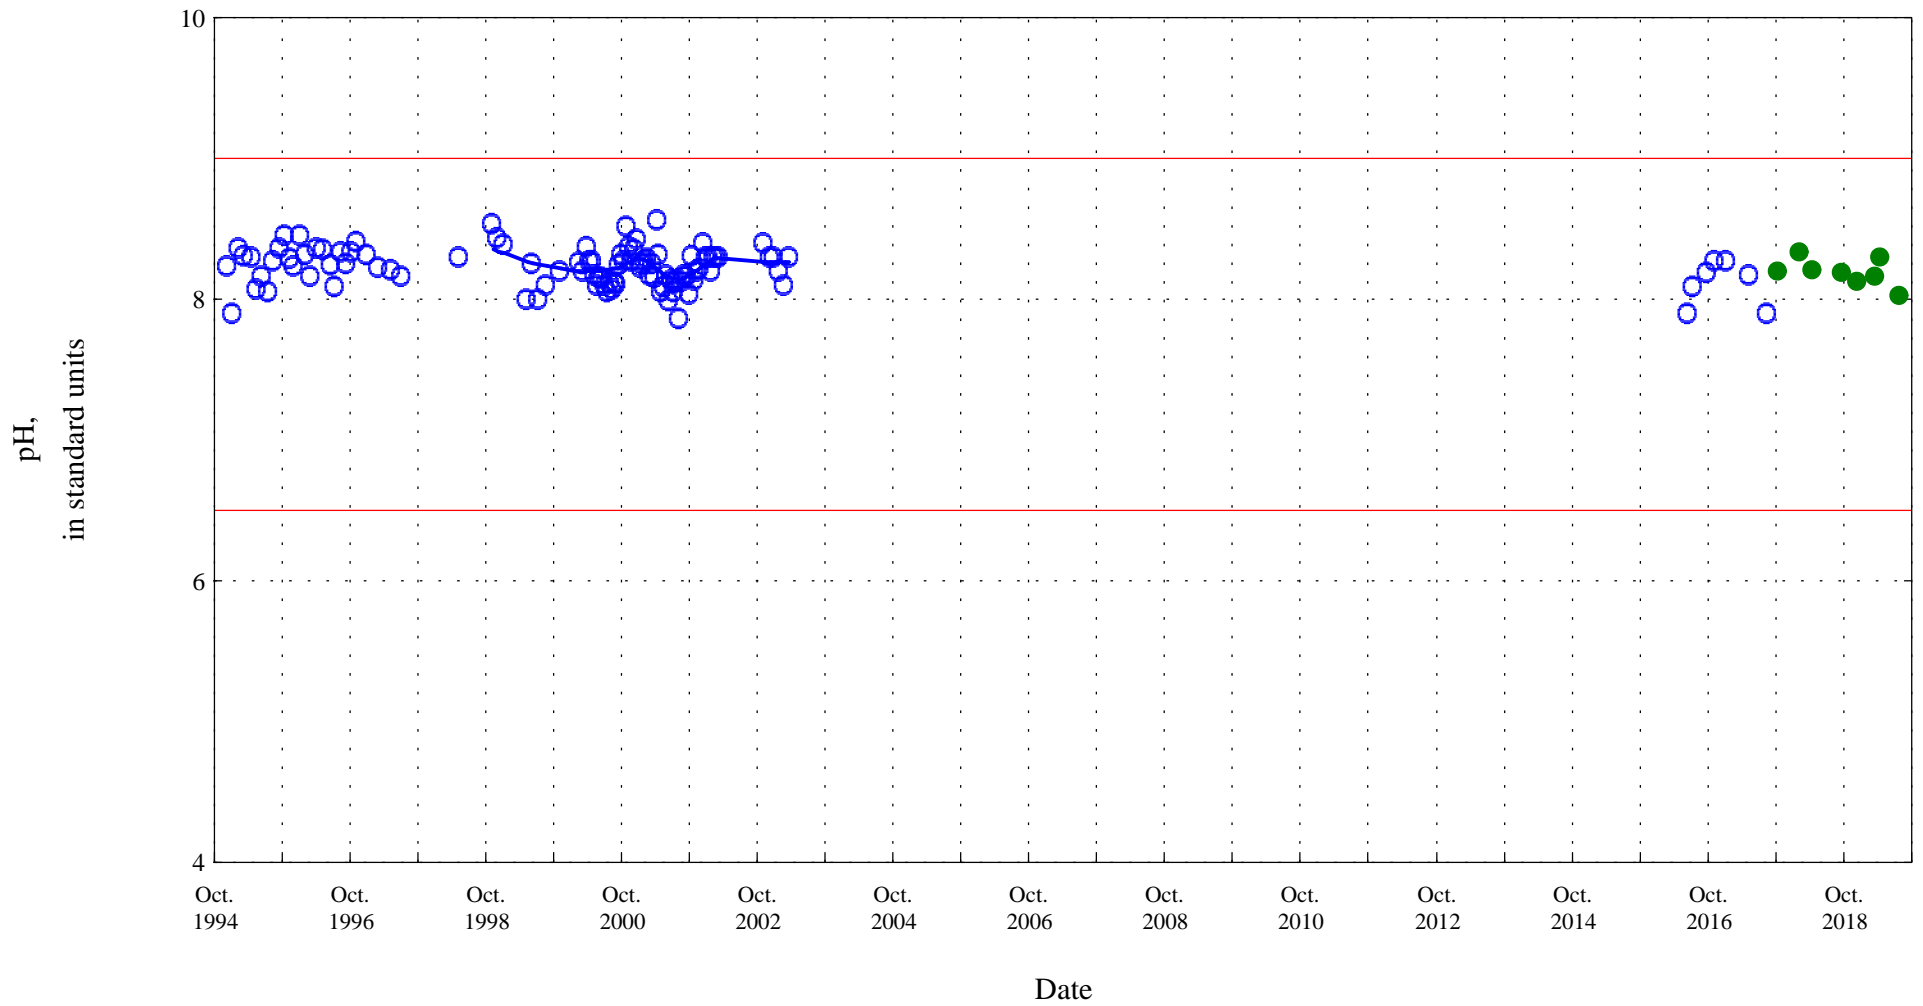
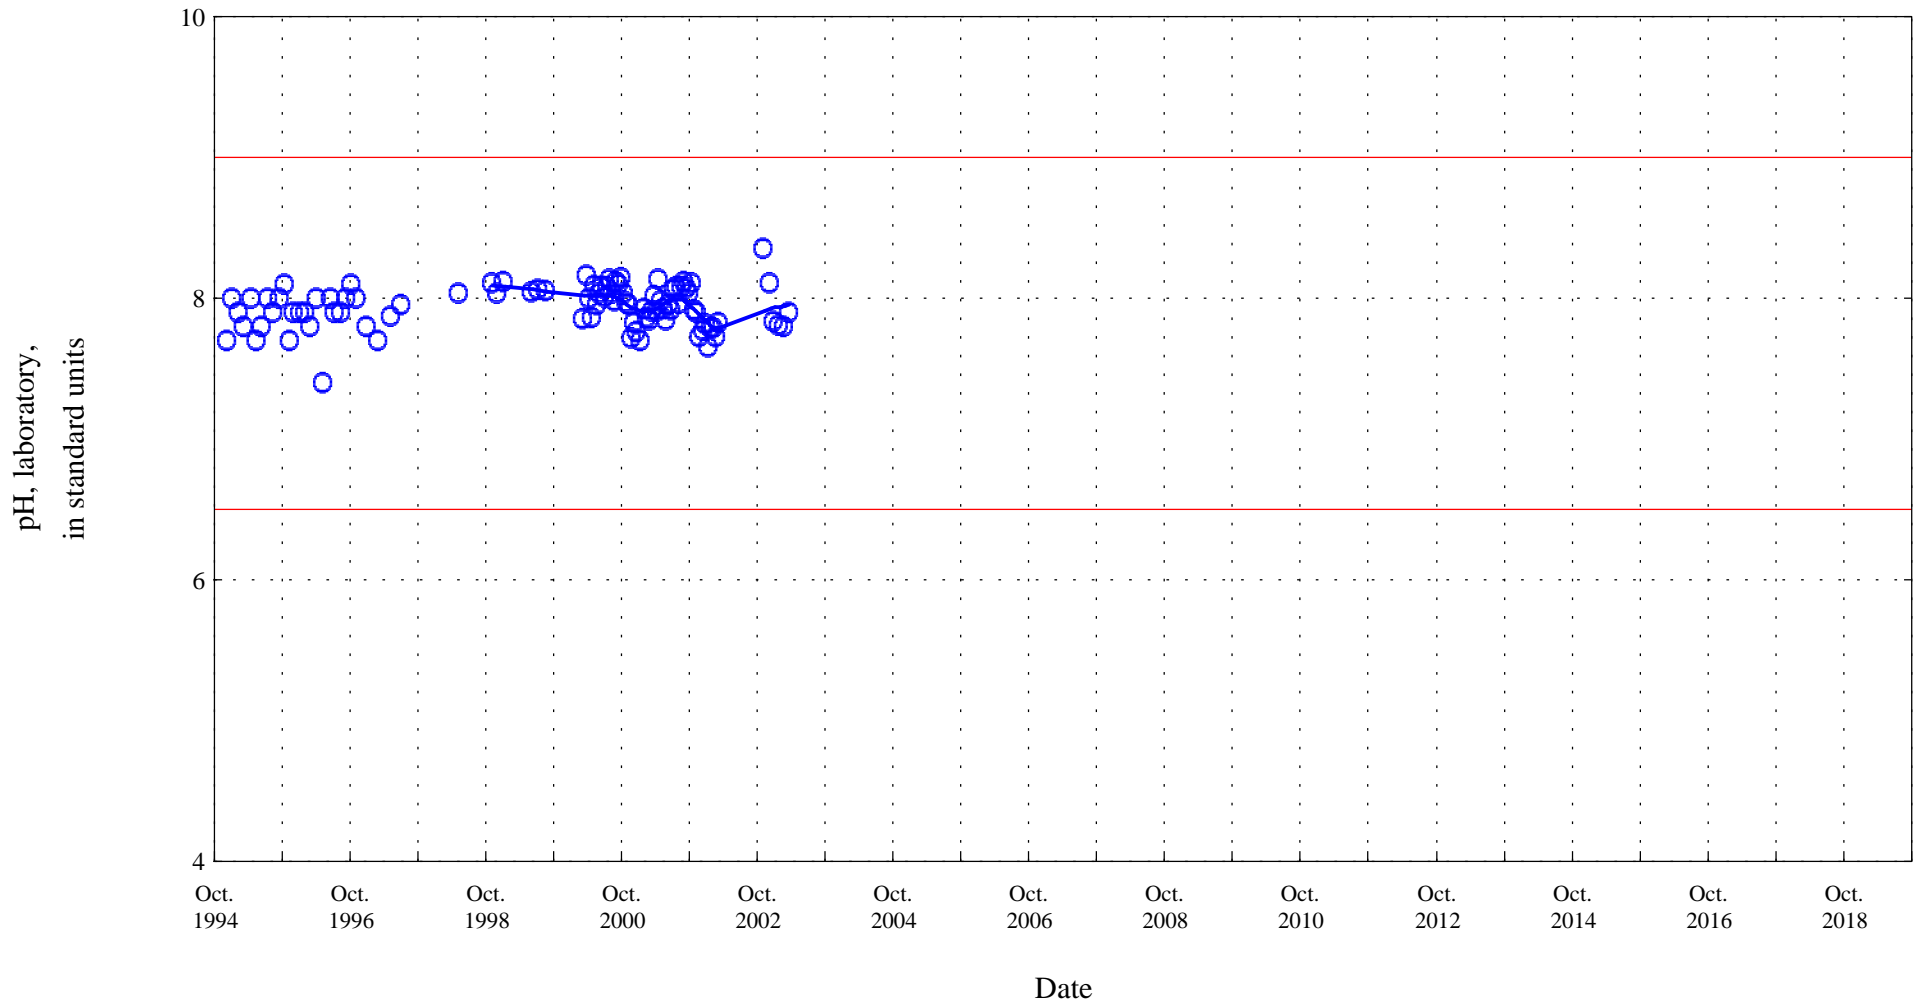
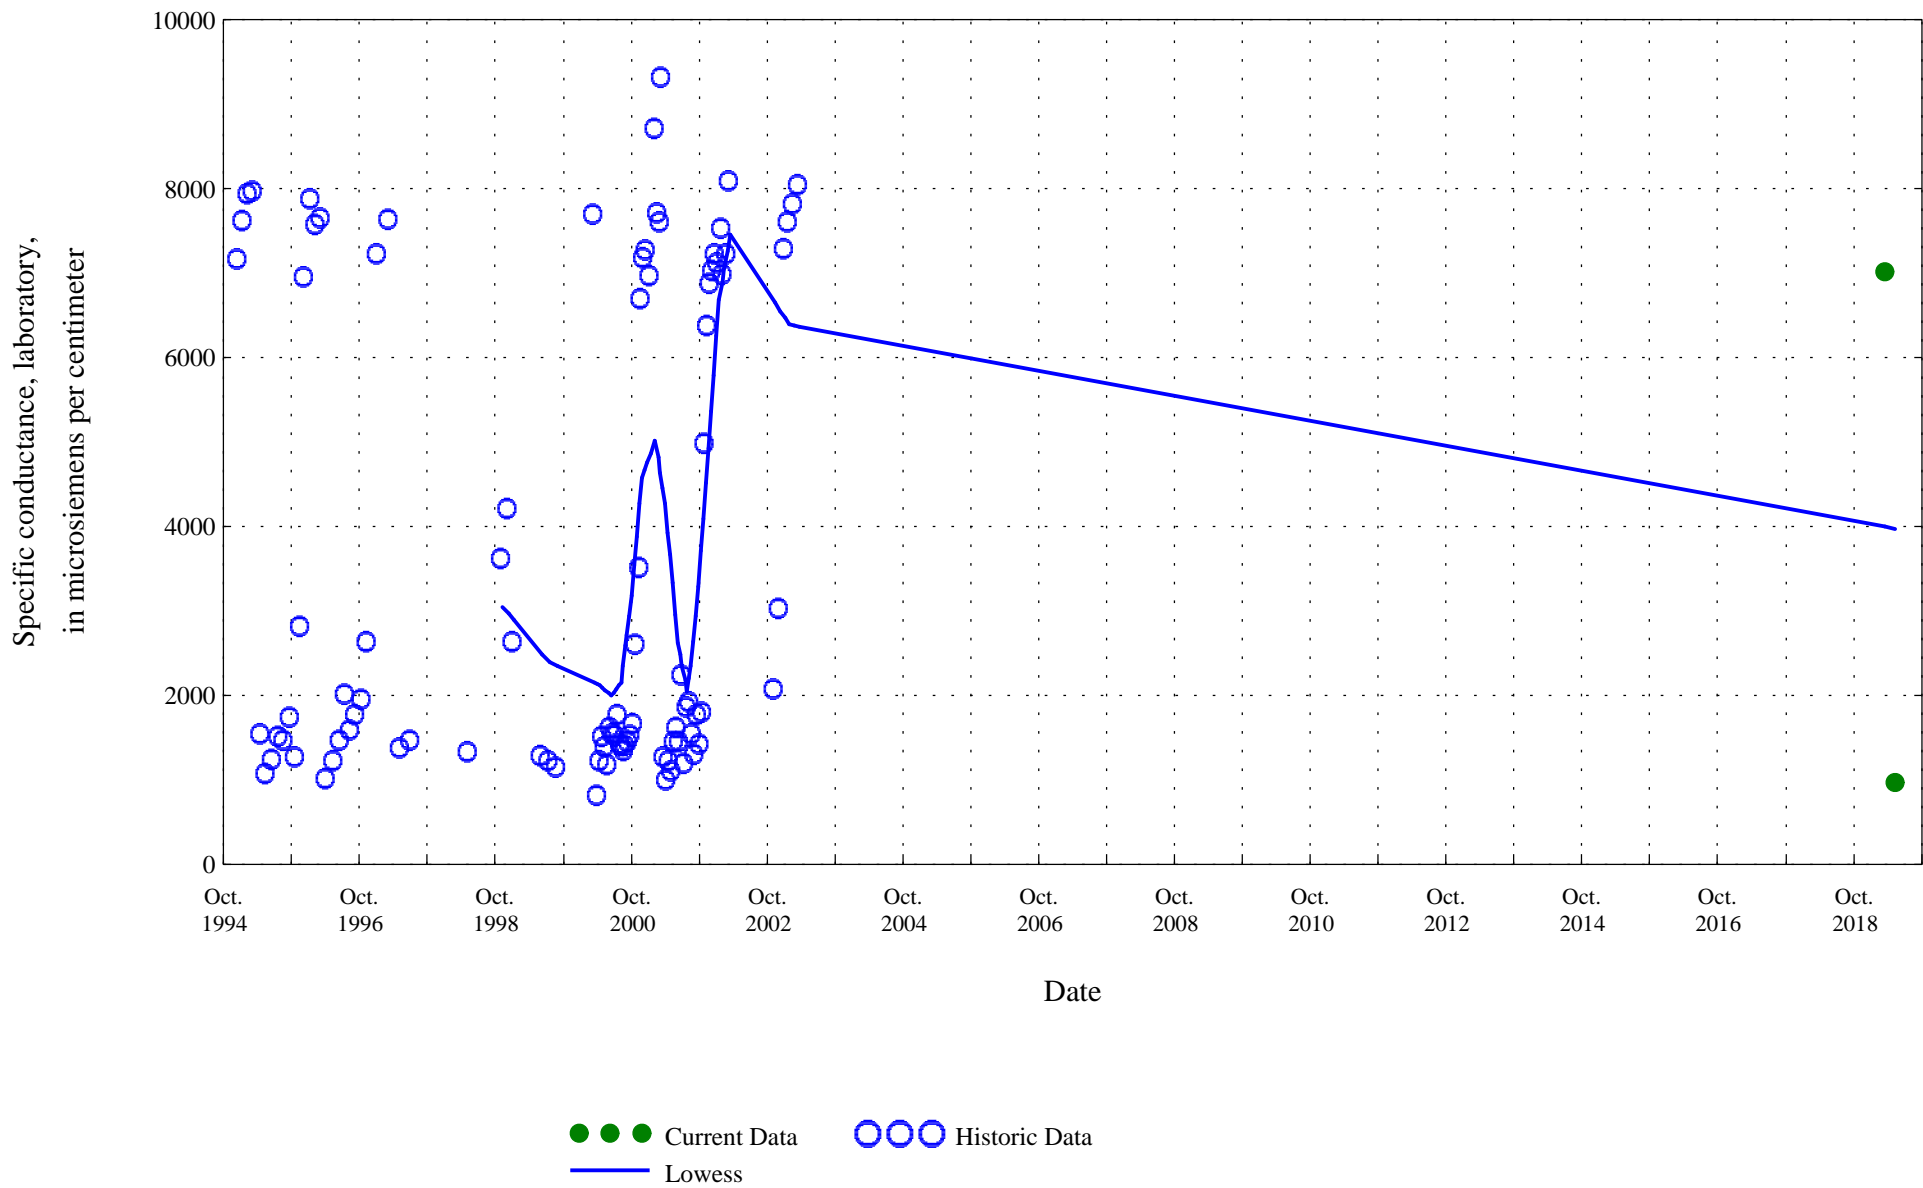
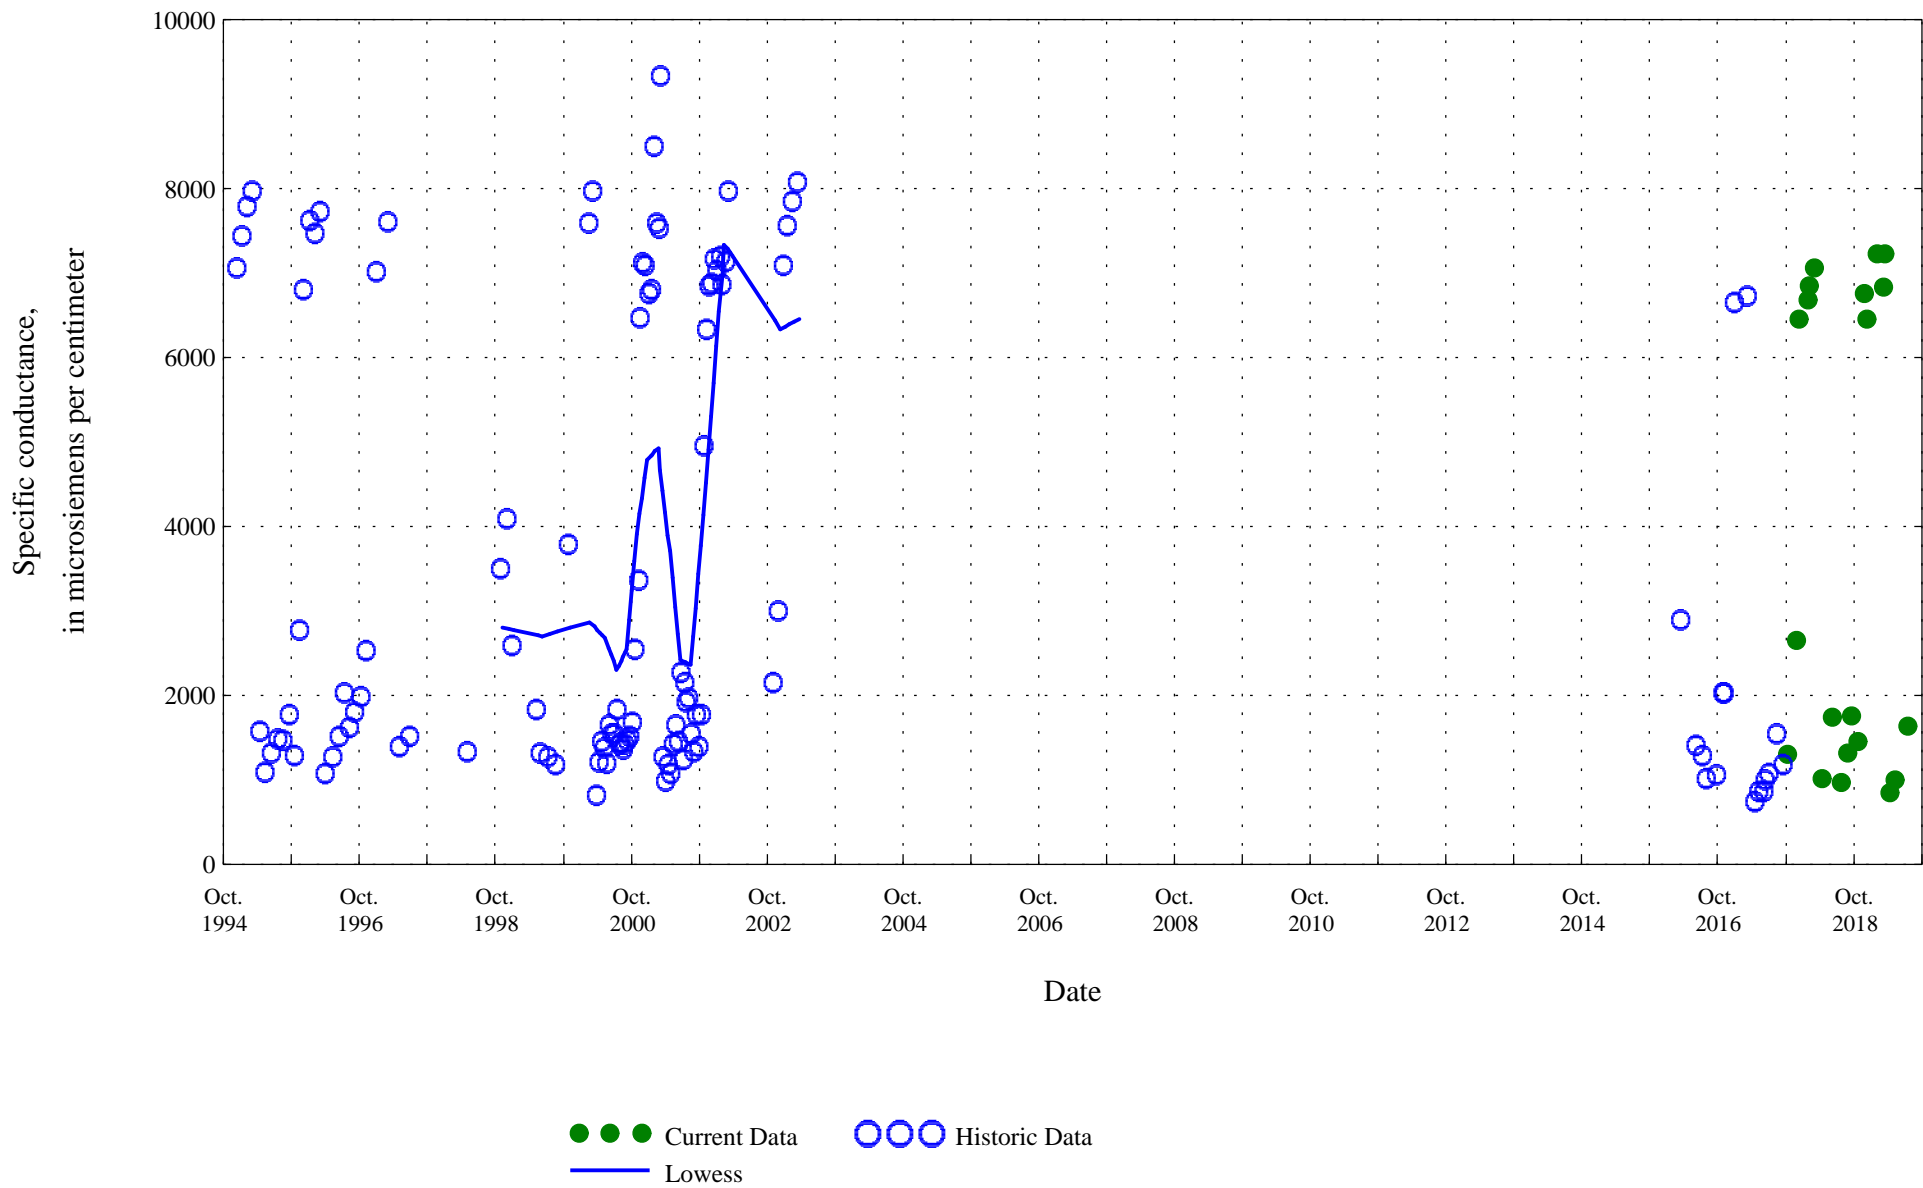
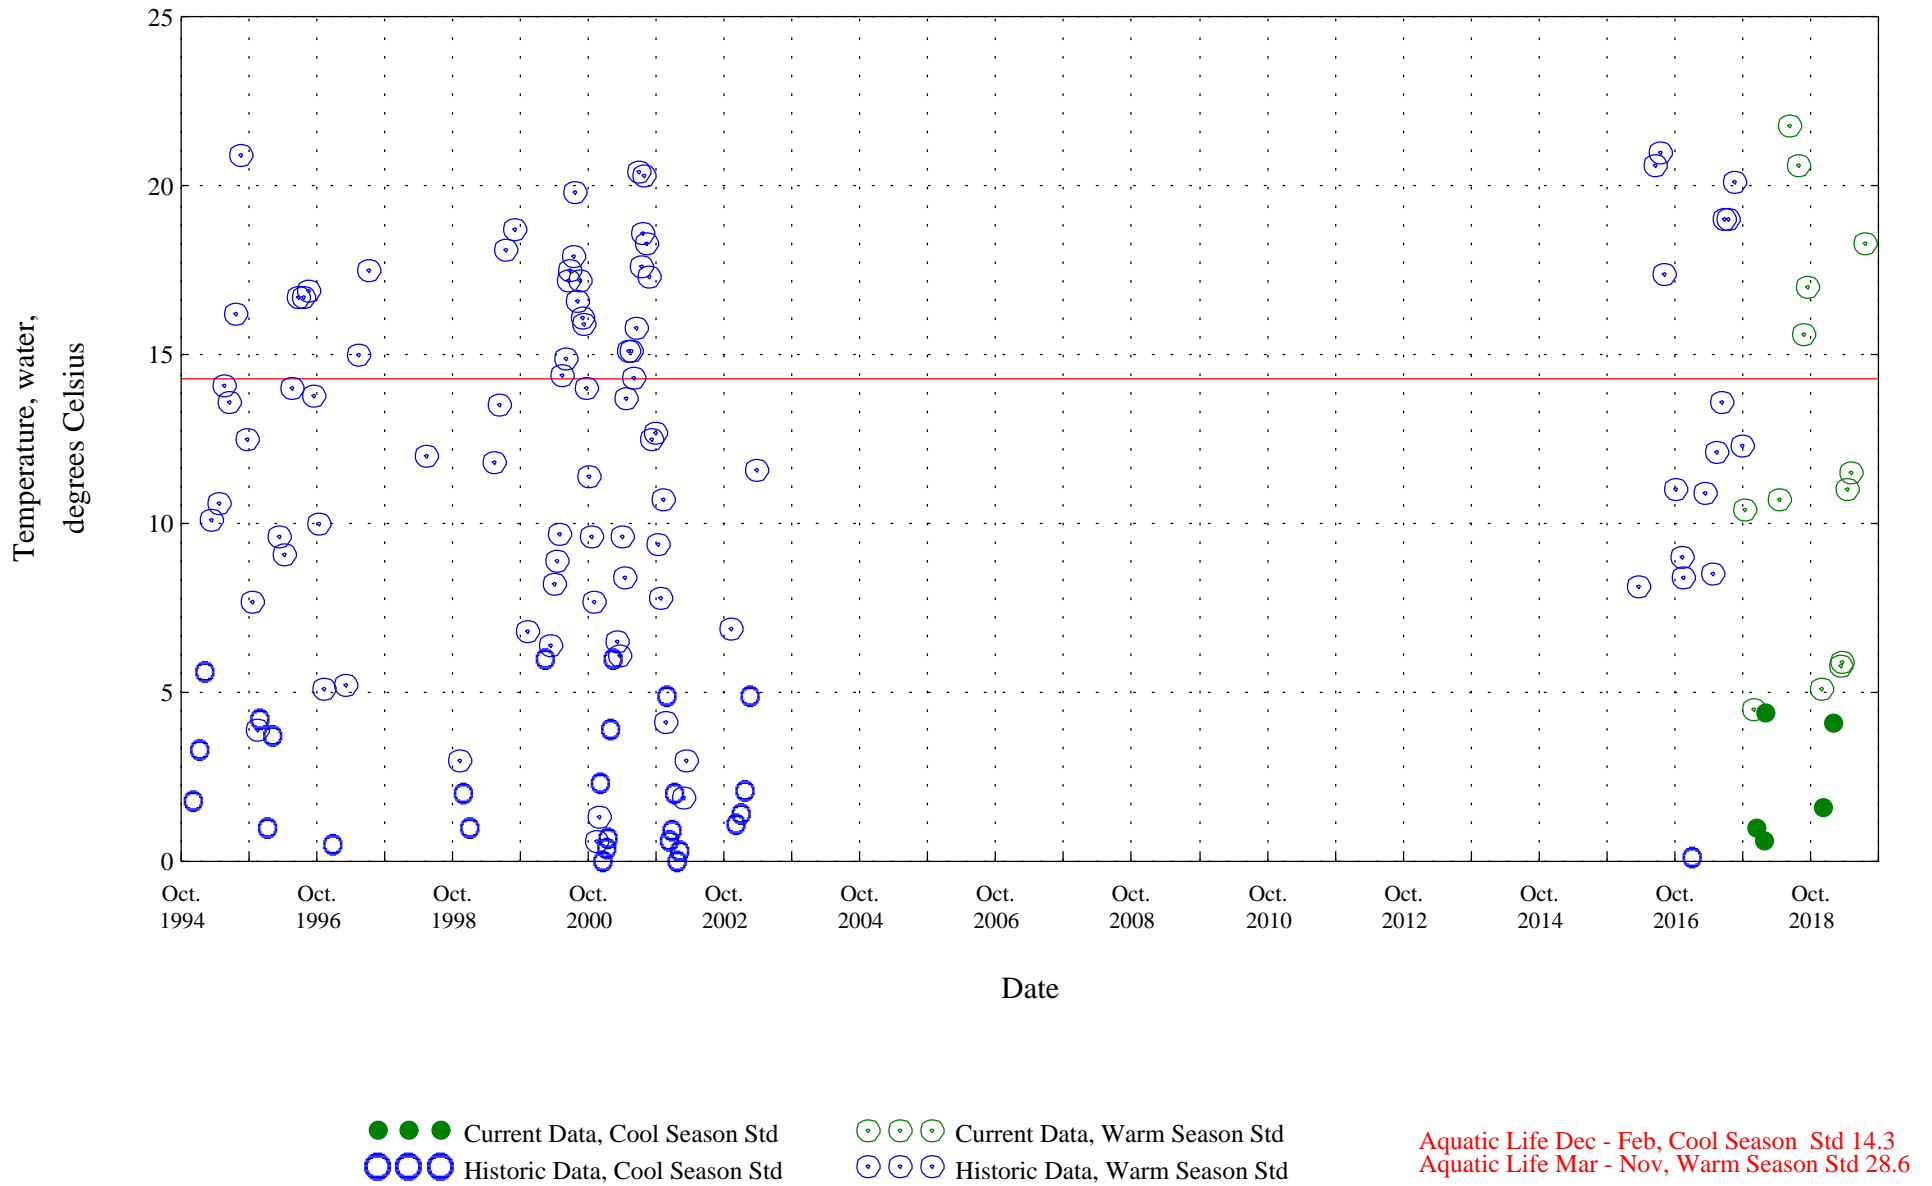
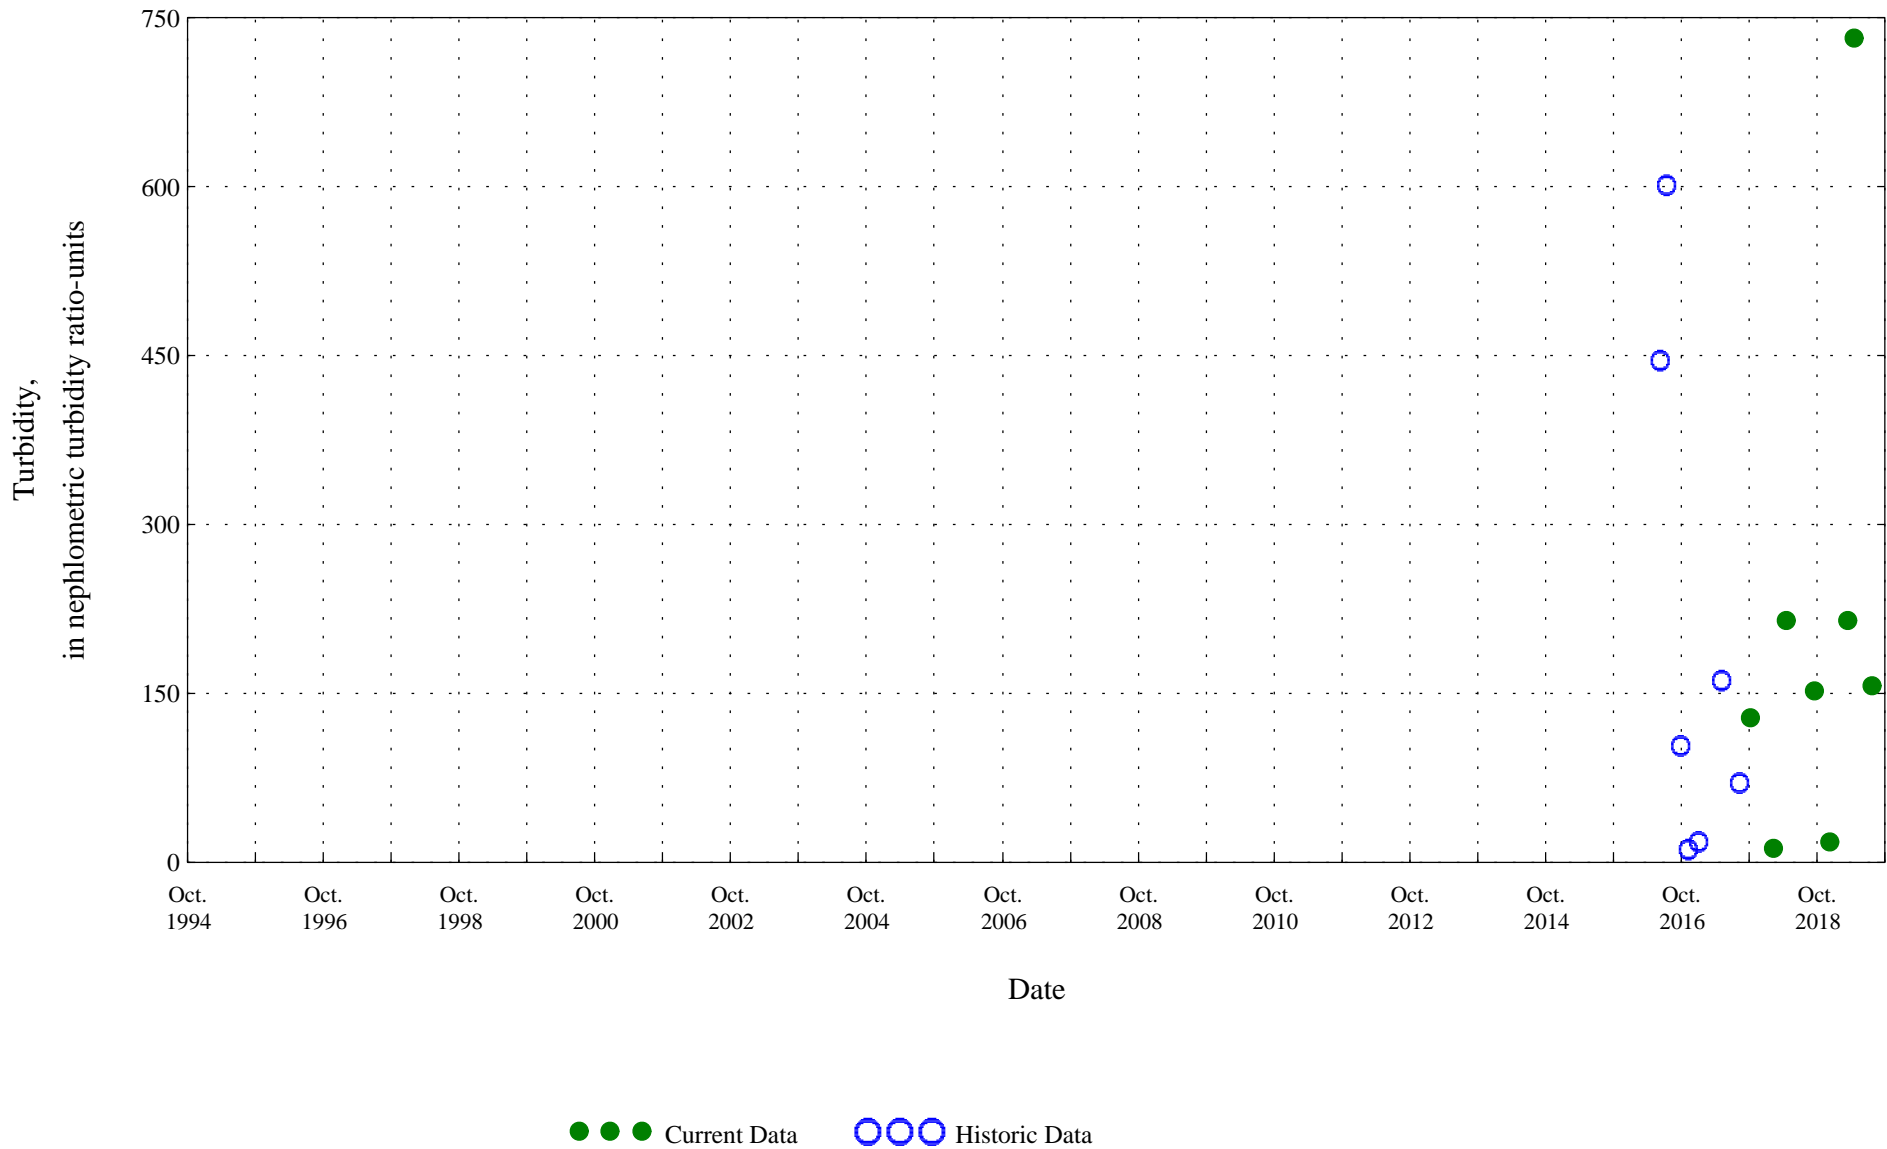
Aquatic Life Standard 6.5 to 9.0

Human Health Based Water Supply Chronic Standard 250

Human Health Based Water Supply Chronic Standard 2.0

Aquatic Life Acute Standard 4.2
 Aquatic Life Chronic Standard 1.7

Aquatic Life Chronic Standard 0.17

Human Health Based Water Supply Chronic Standard 300

Aquatic Life Acute Standard 4,738
Aquatic Life Chronic Standard 2,618

Aquatic Life Acute Standard 340

Agriculture Chronic Standard 750
