Figure 3. Distribution of selected water-quality constituents relative to time for

Piceance Creek below Ryan Gulch, near Rio Blanco, Co., station 09306200.

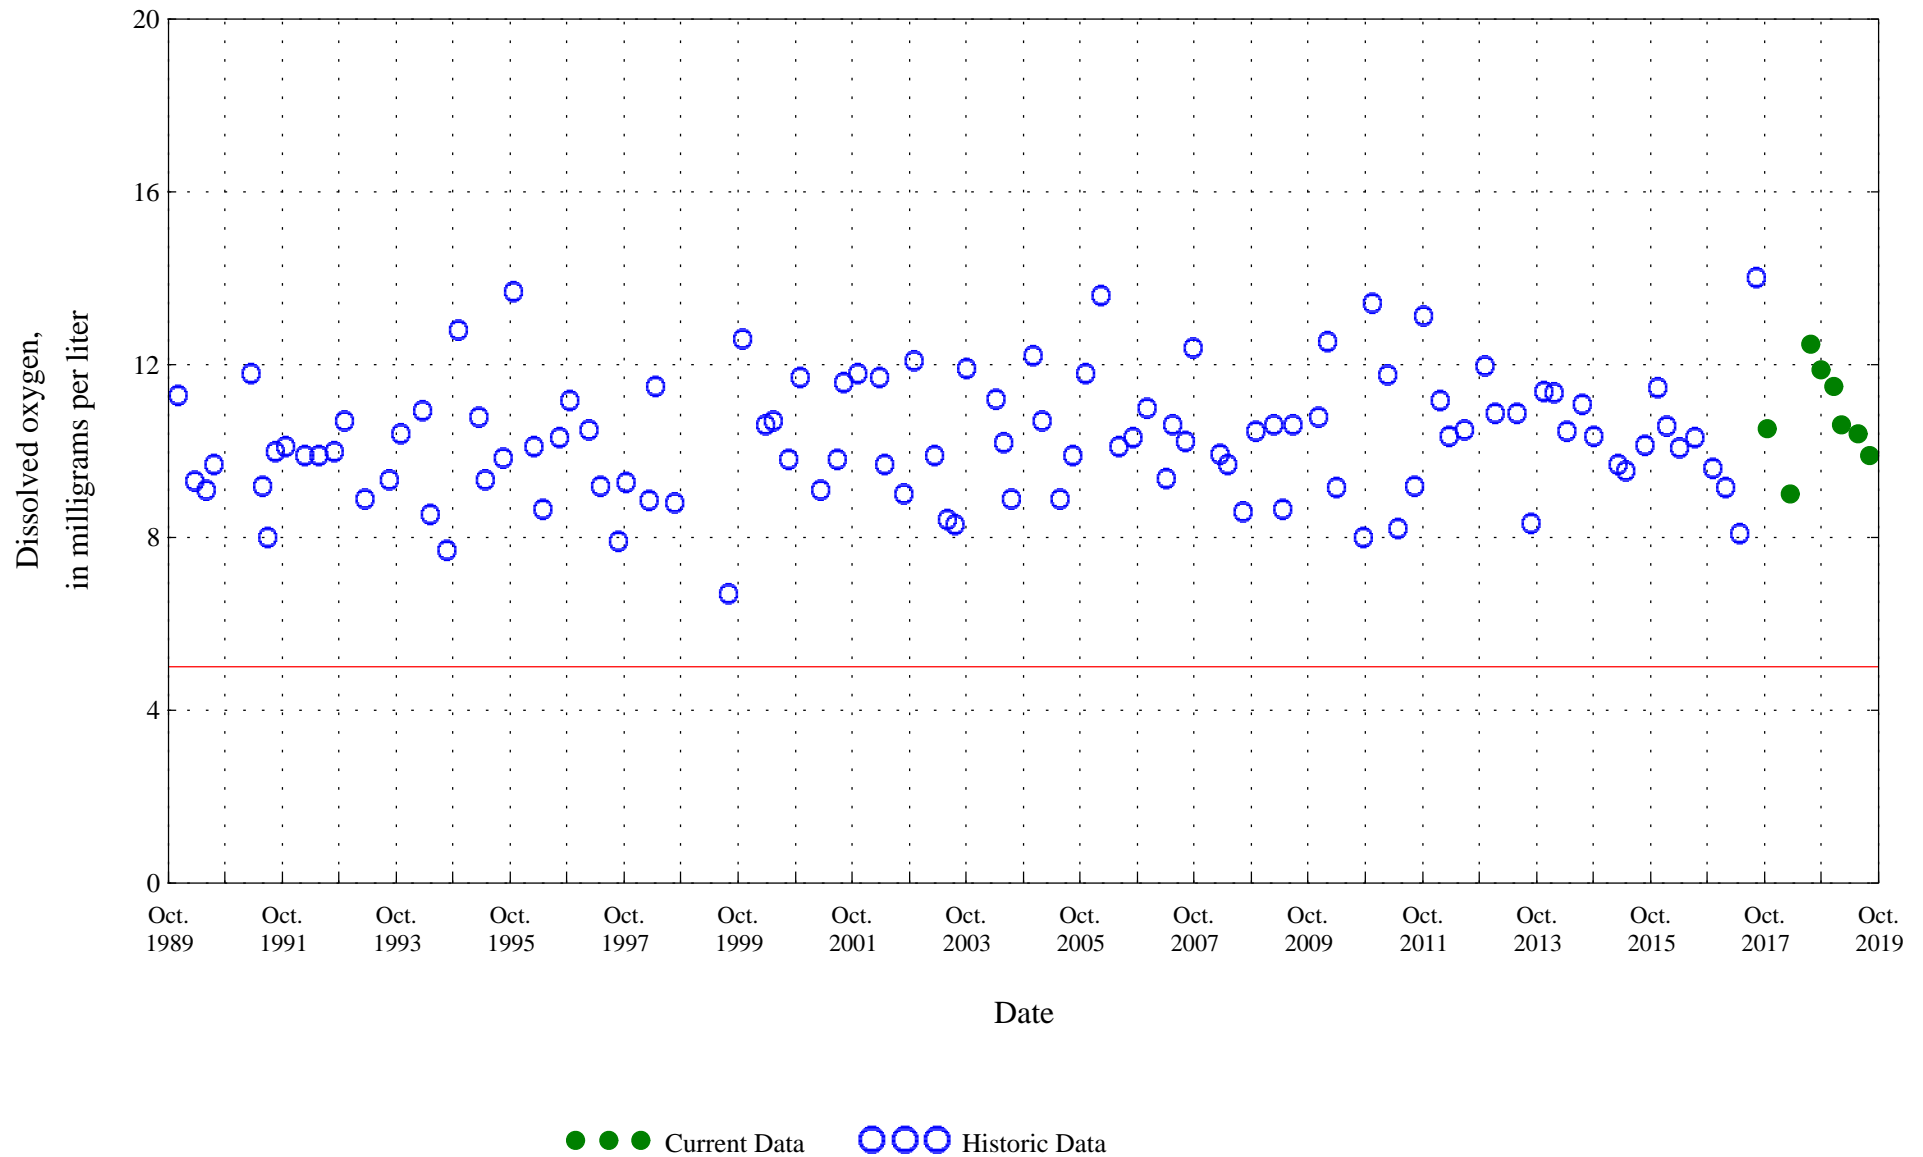
Figure 3. Distribution of selected water-quality constituents relative to time for

Piceance Creek below Ryan Gulch, near Rio Blanco, Co., station 09306200.

Aquatic Life Standard 5.0

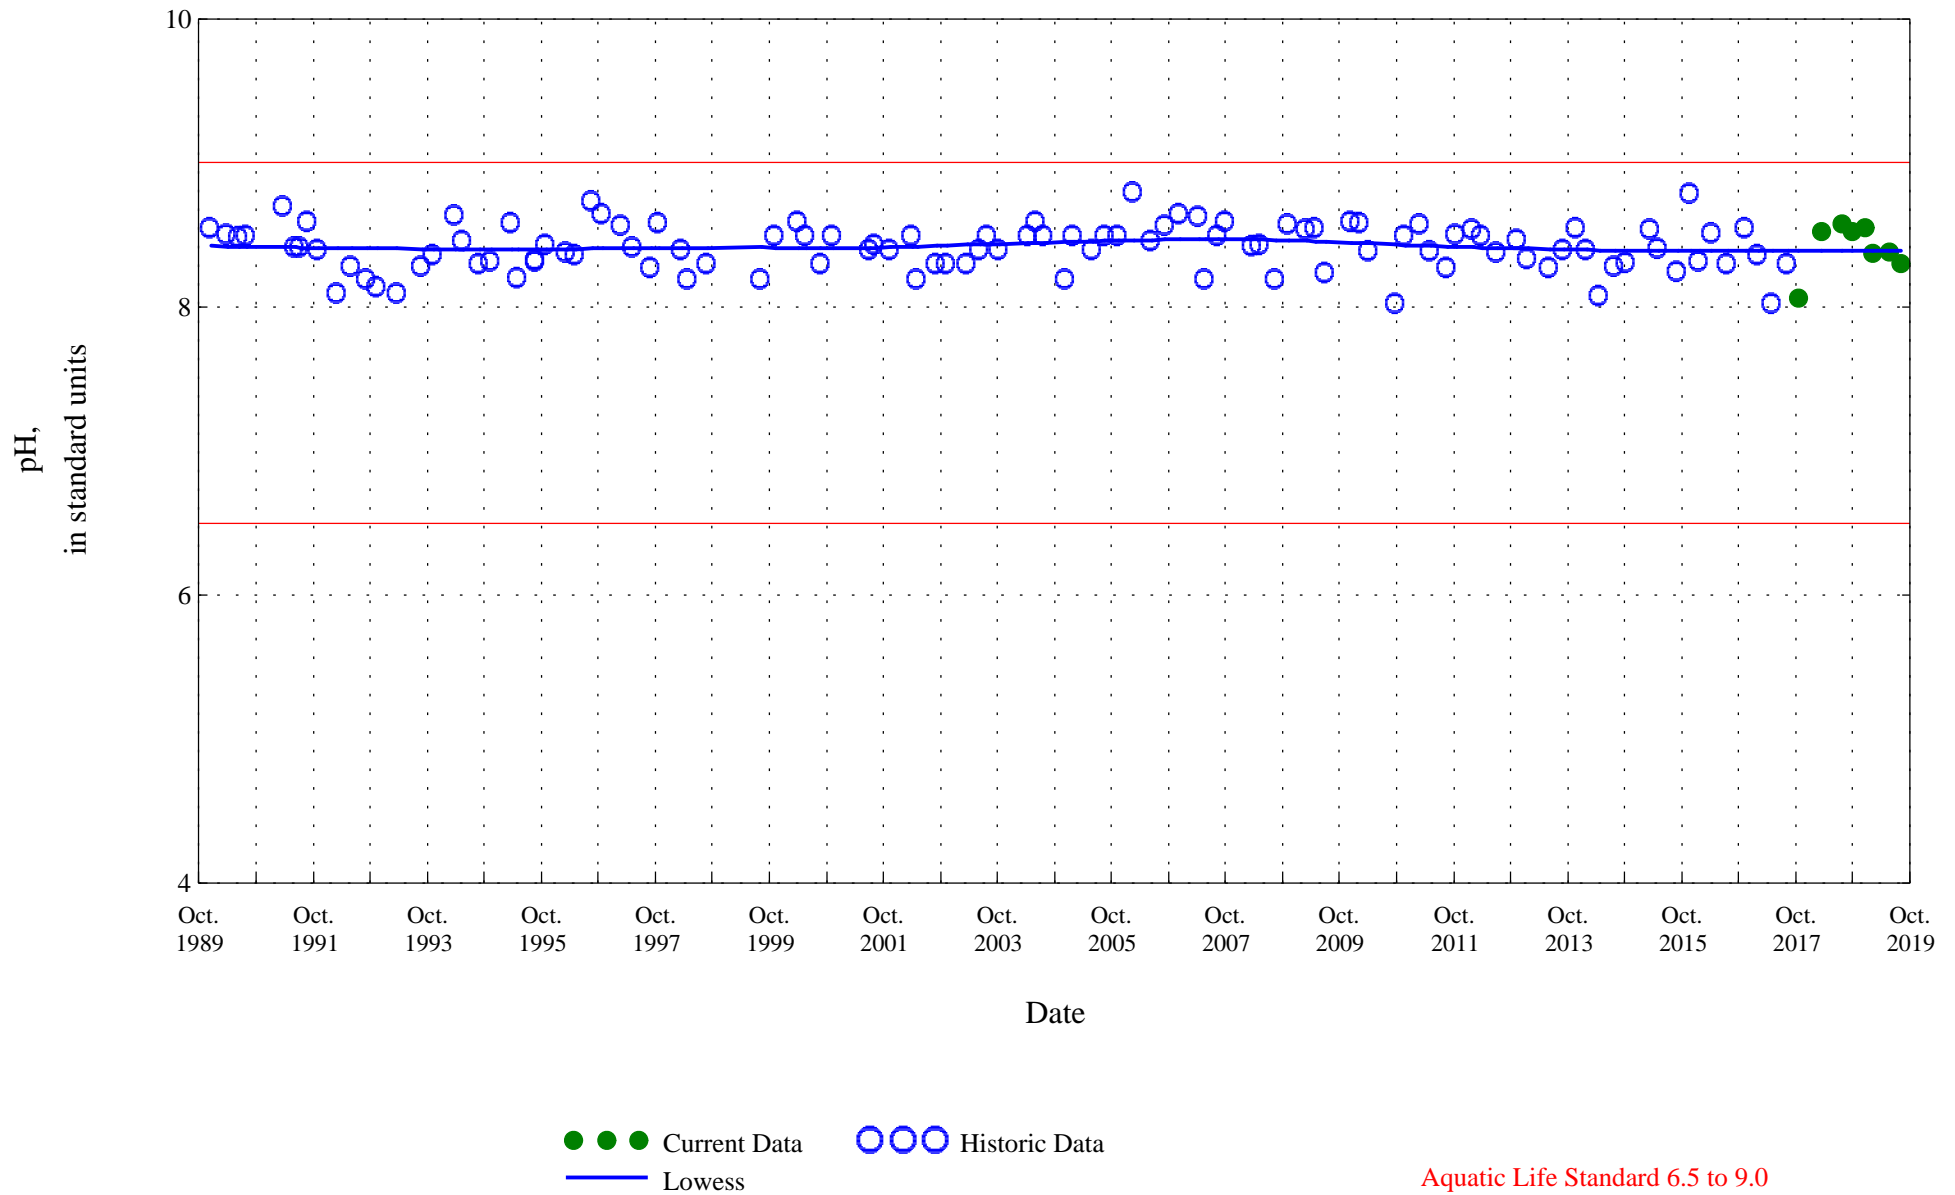
Figure 3. Distribution of selected water-quality constituents relative to time for

Piceance Creek below Ryan Gulch, near Rio Blanco, Co., station 09306200.

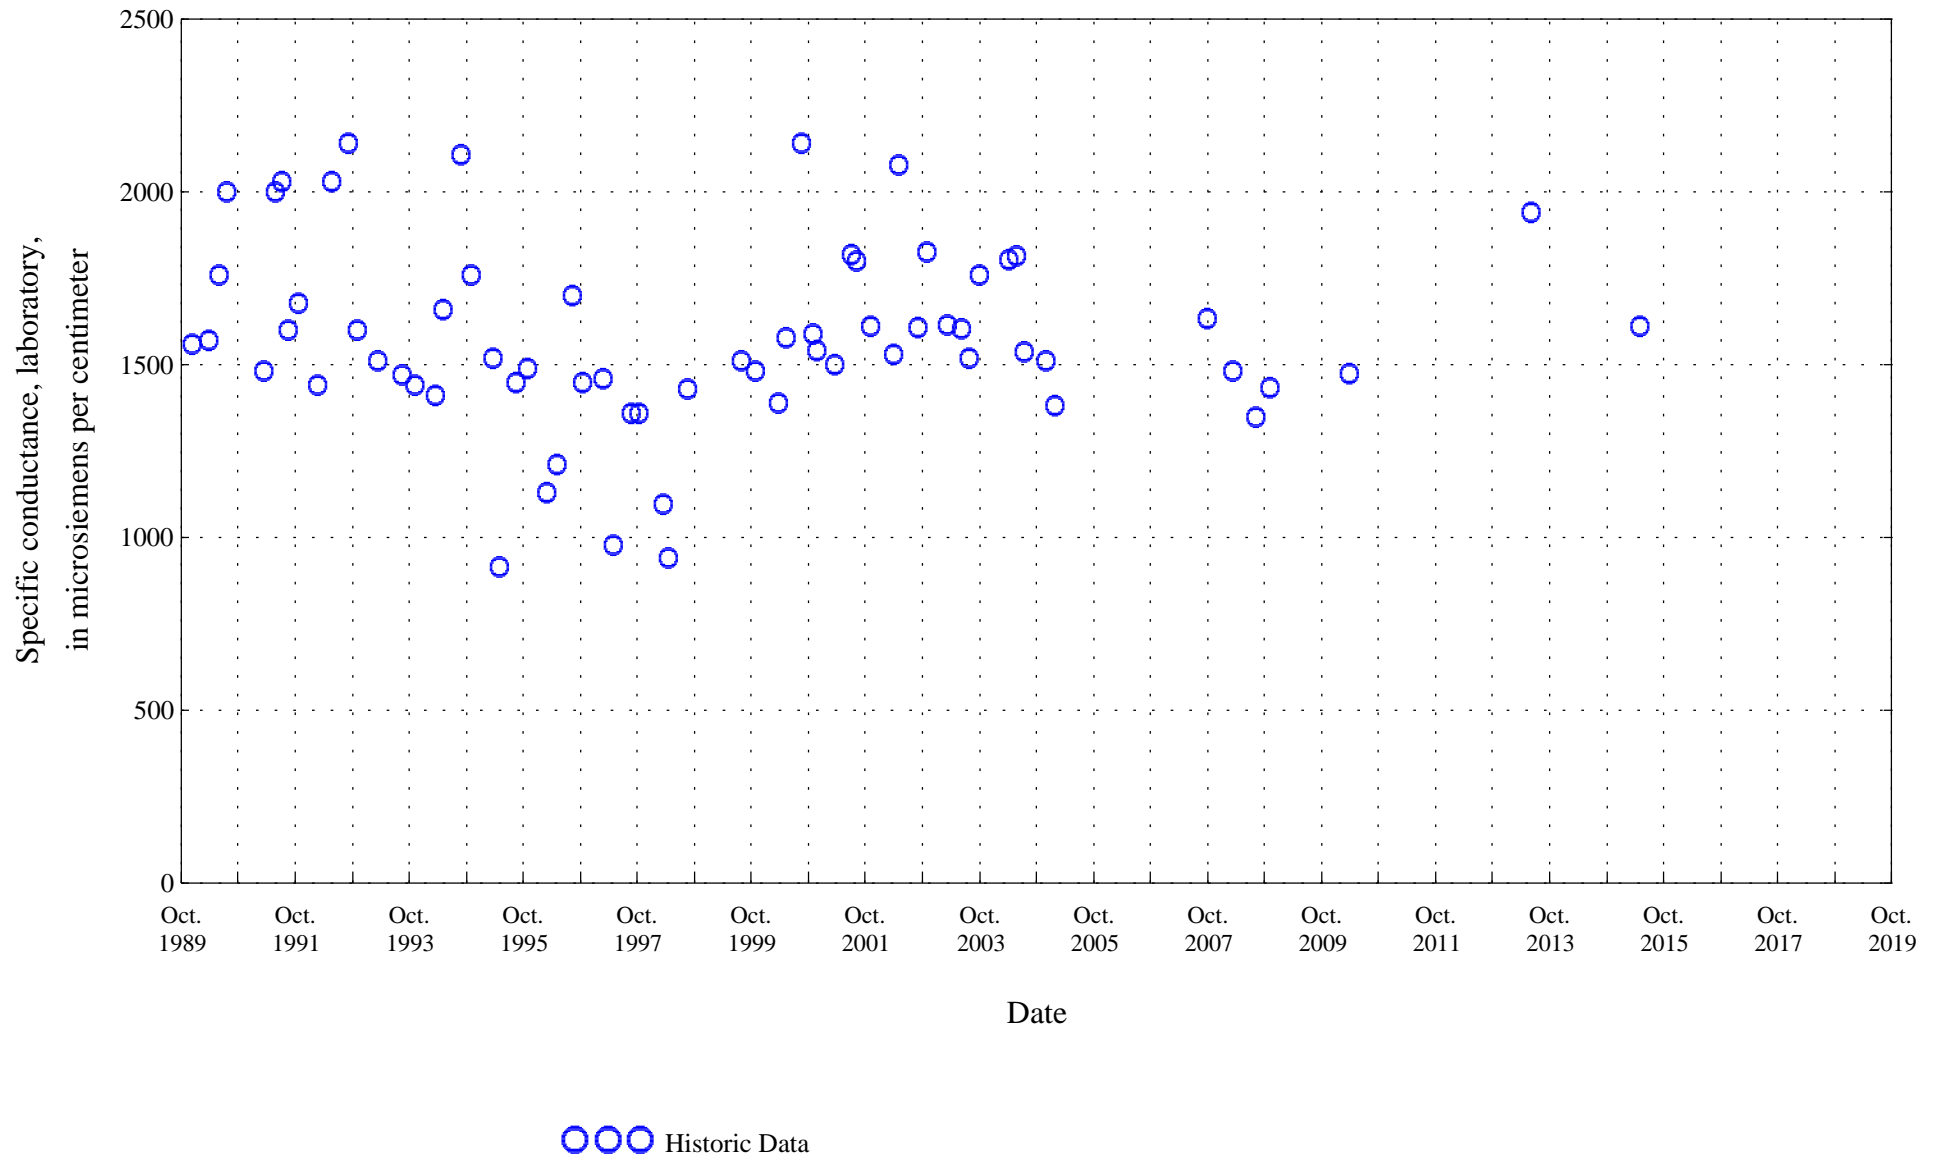
Figure 3. Distribution of selected water-quality constituents relative to time for

Piceance Creek below Ryan Gulch, near Rio Blanco, Co., station 09306200.

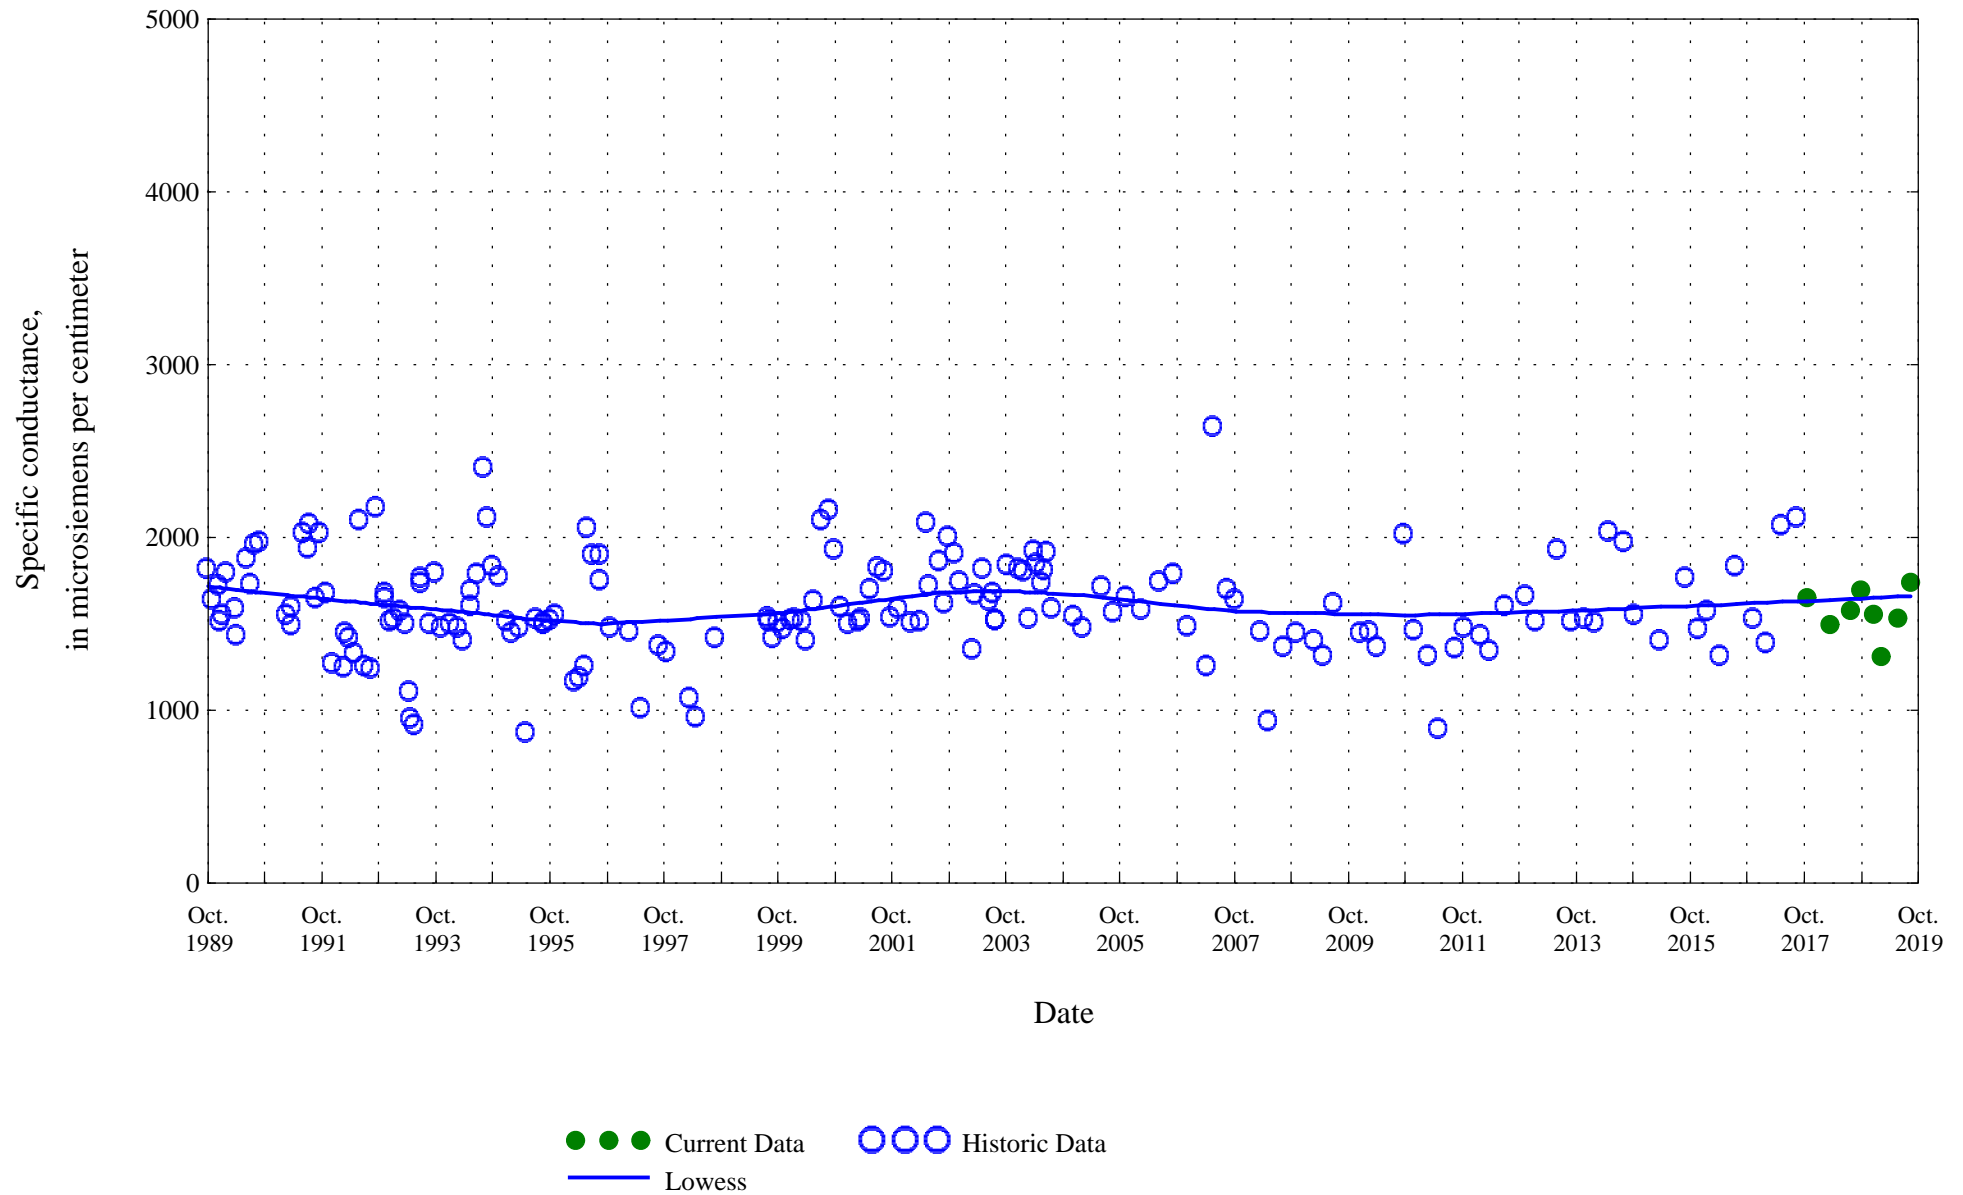
Figure 3. Distribution of selected water-quality constituents relative to time for

Piceance Creek below Ryan Gulch, near Rio Blanco, Co., station 09306200.

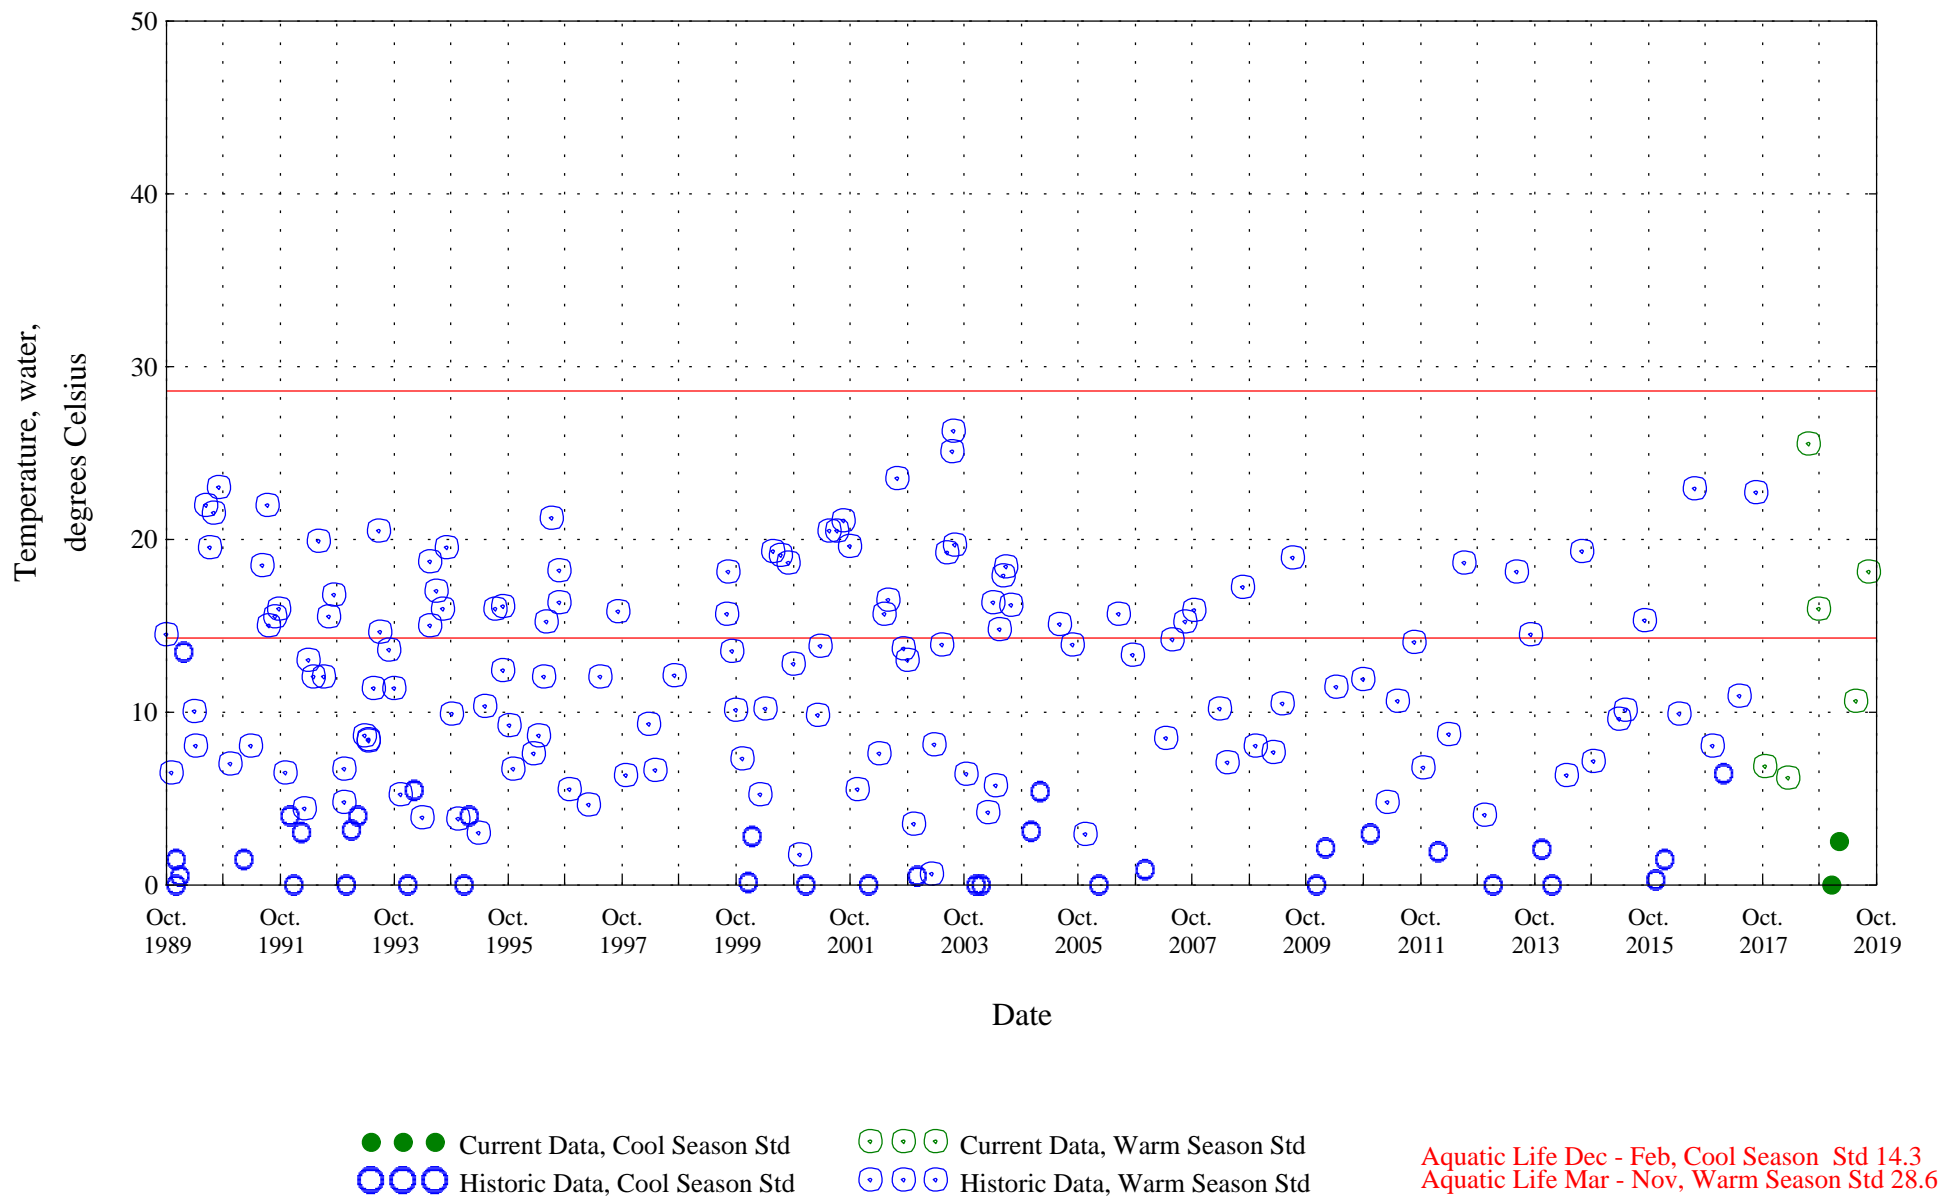
Figure 3. Distribution of selected water-quality constituents relative to time for

Piceance Creek below Ryan Gulch, near Rio Blanco, Co., station 09306200.

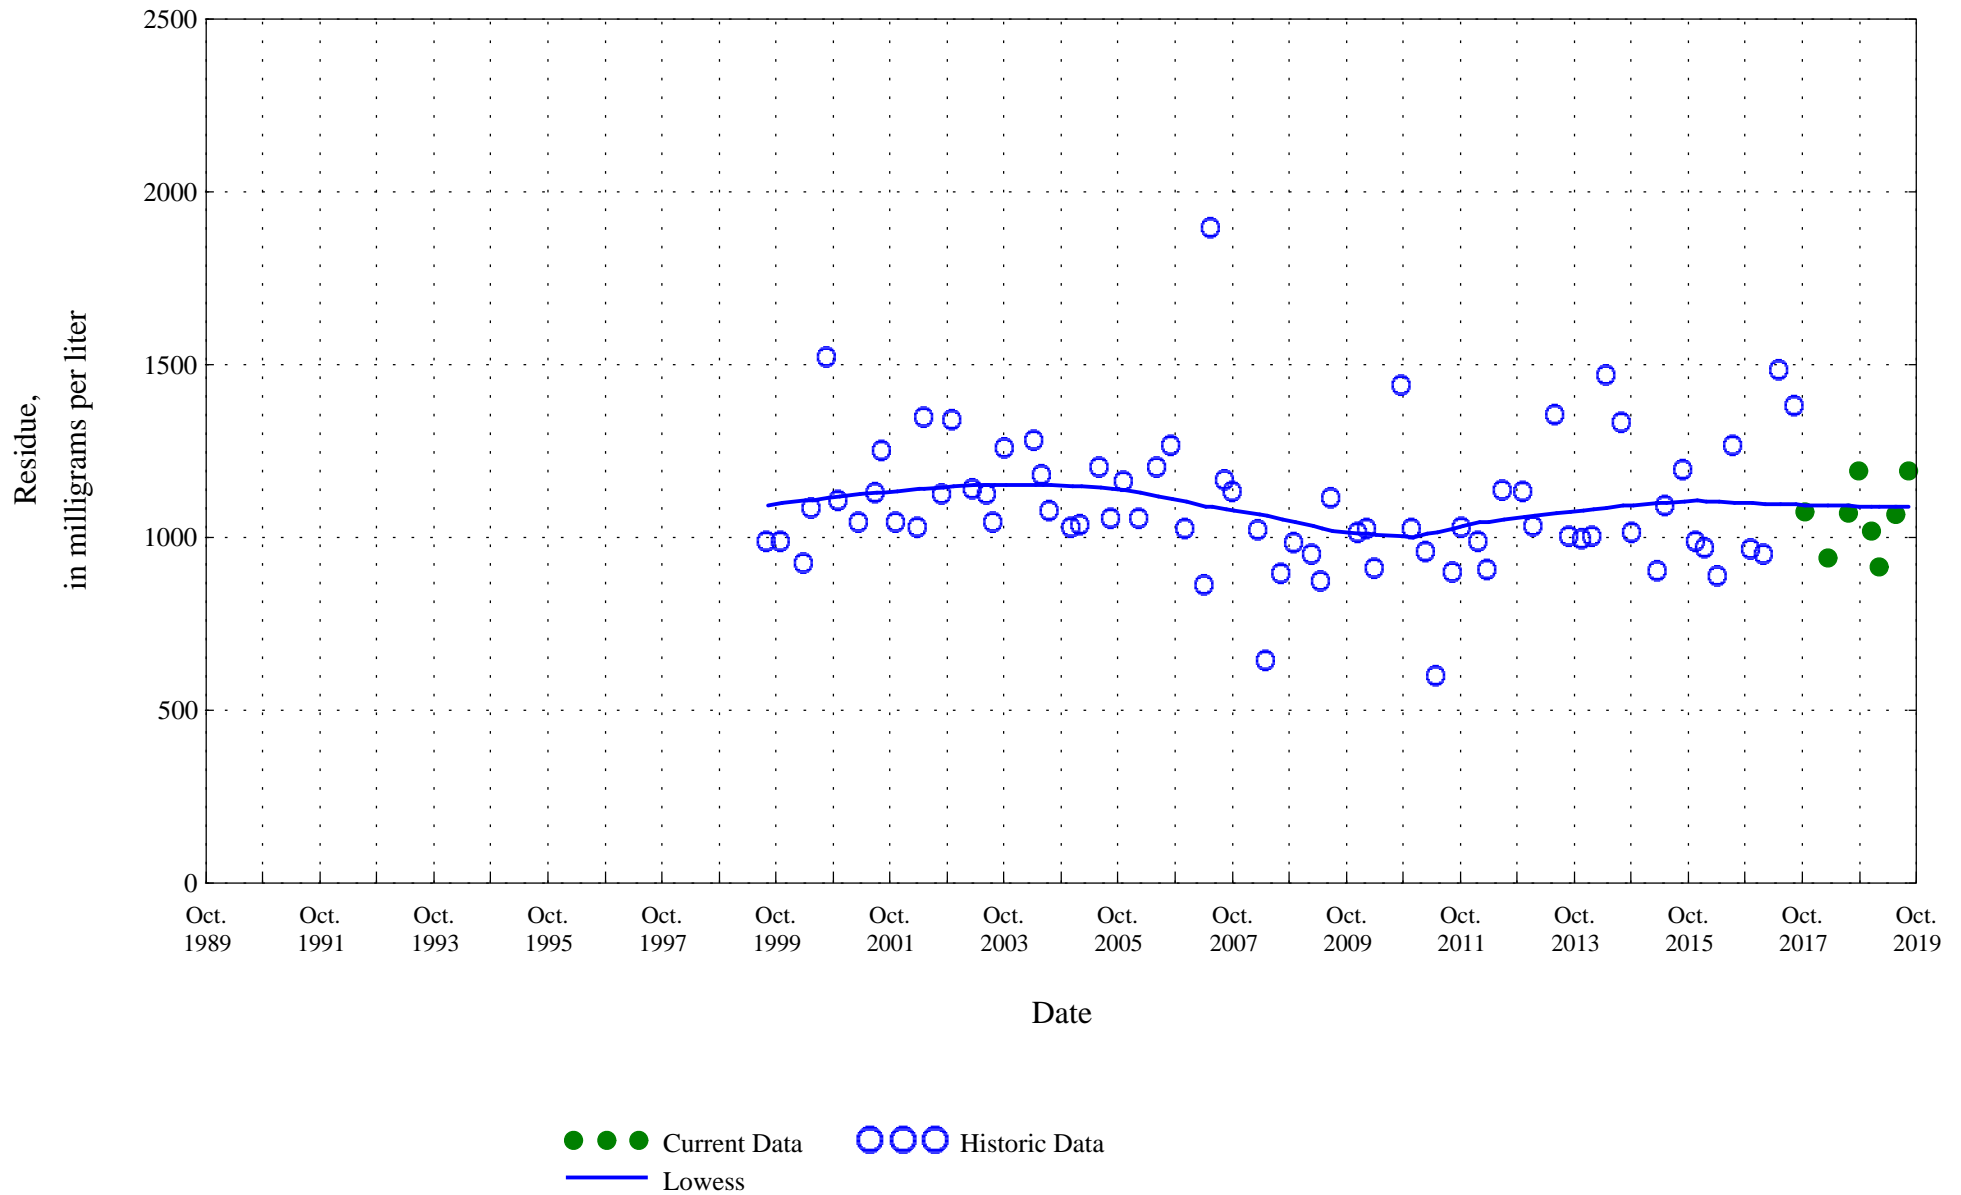
Figure 3. Distribution of selected water-quality constituents relative to time for

Piceance Creek below Ryan Gulch, near Rio Blanco, Co., station 09306200.

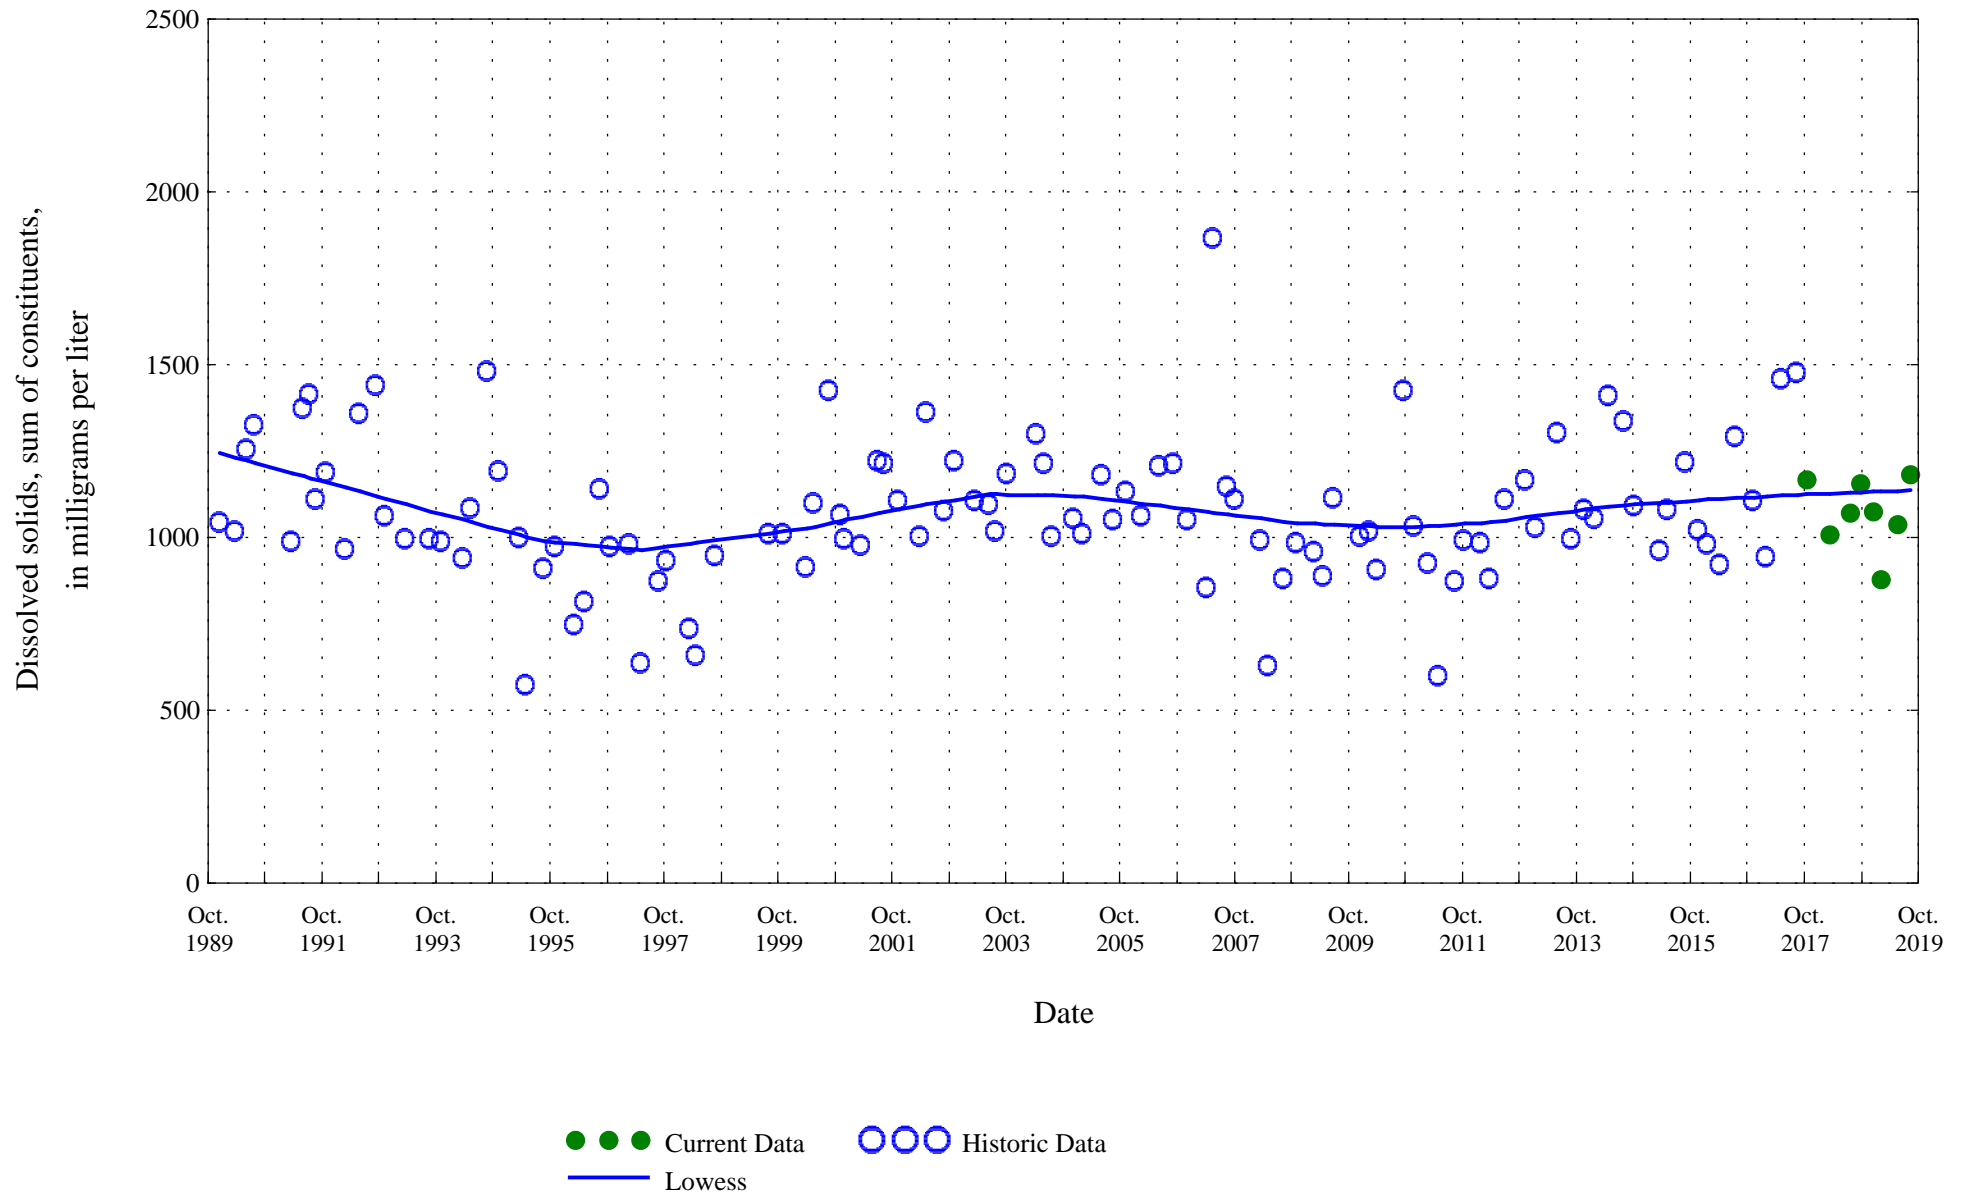
Figure 3. Distribution of selected water-quality constituents relative to time for

Piceance Creek below Ryan Gulch, near Rio Blanco, Co., station 09306200.

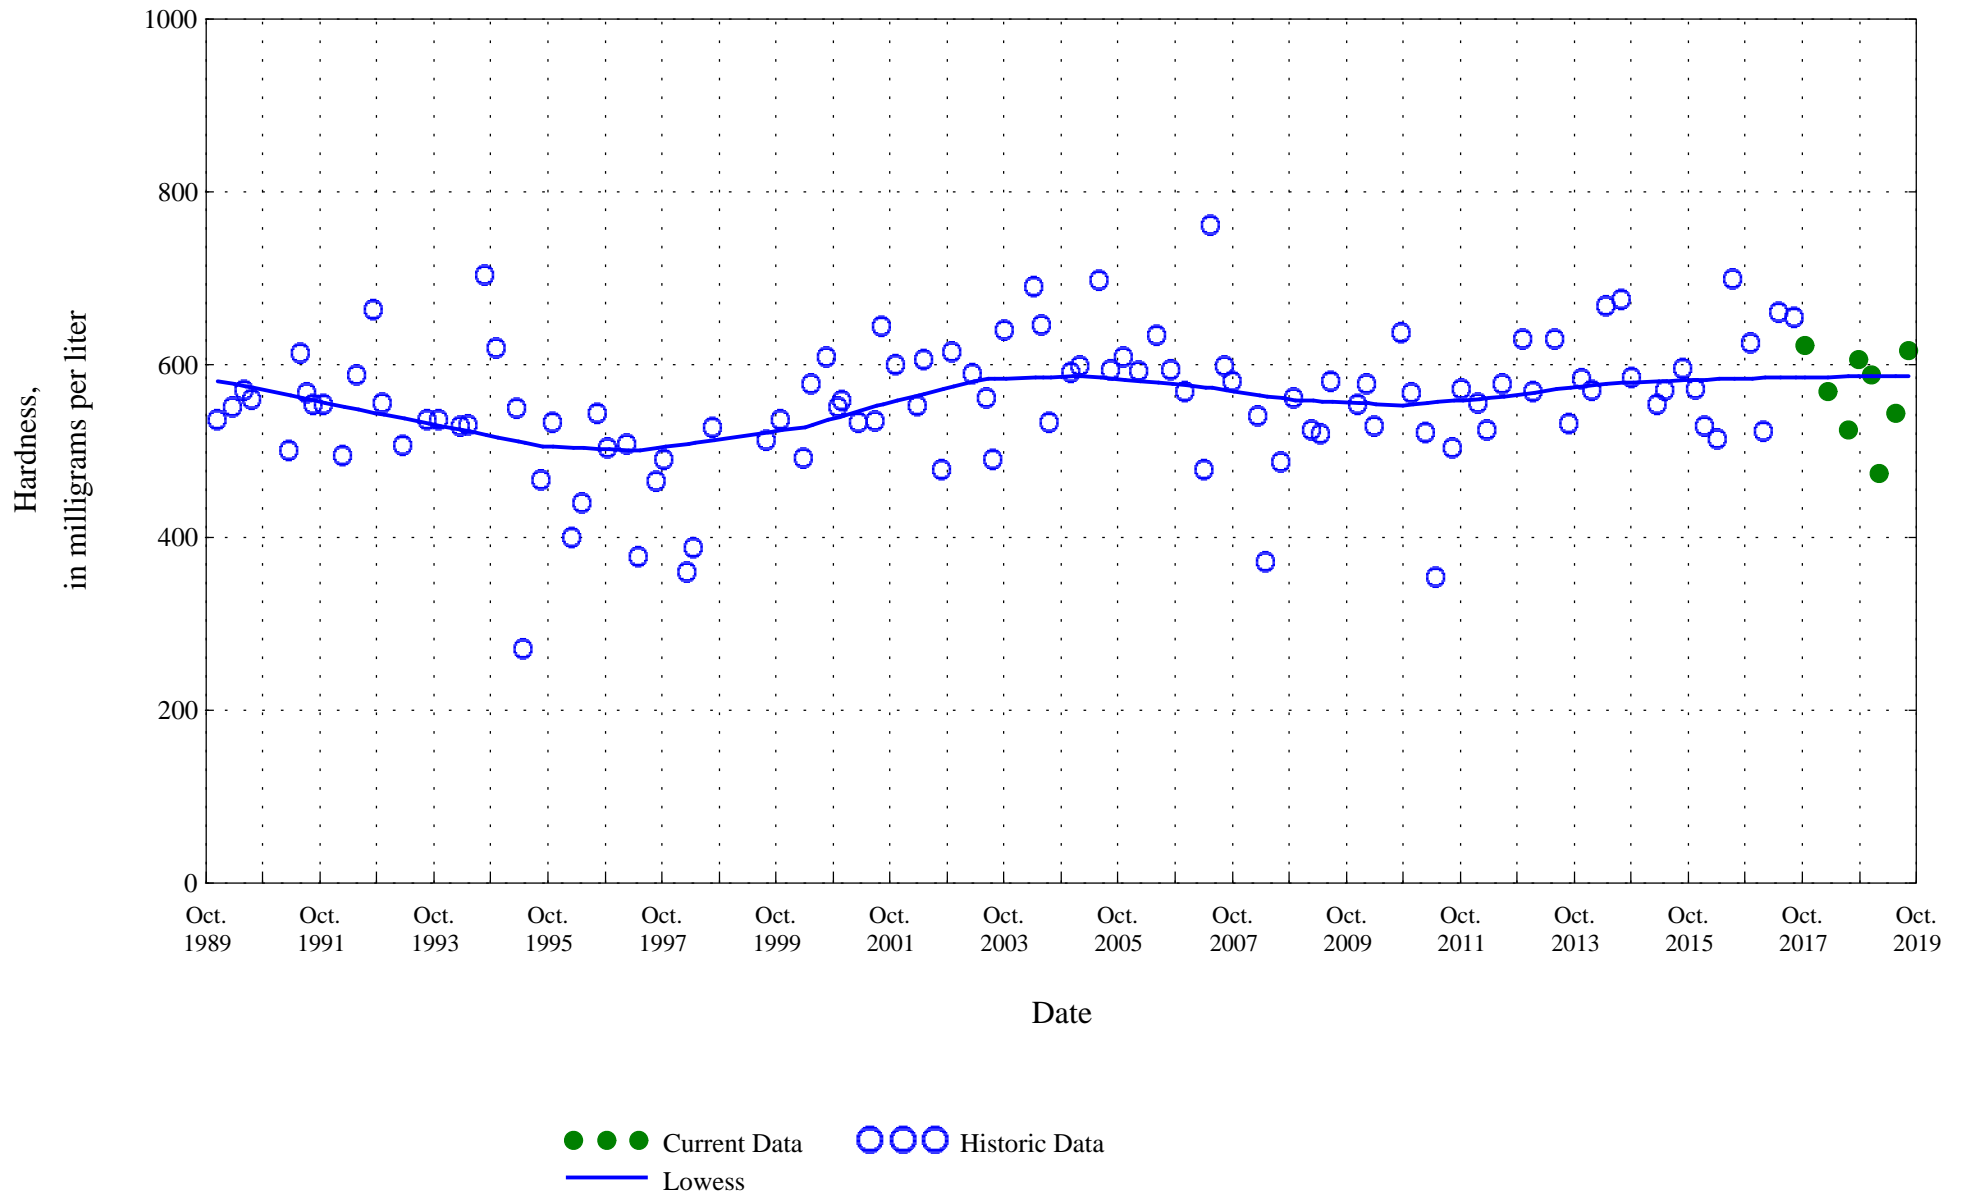
Figure 3. Distribution of selected water-quality constituents relative to time for

Piceance Creek below Ryan Gulch, near Rio Blanco, Co., station 09306200.

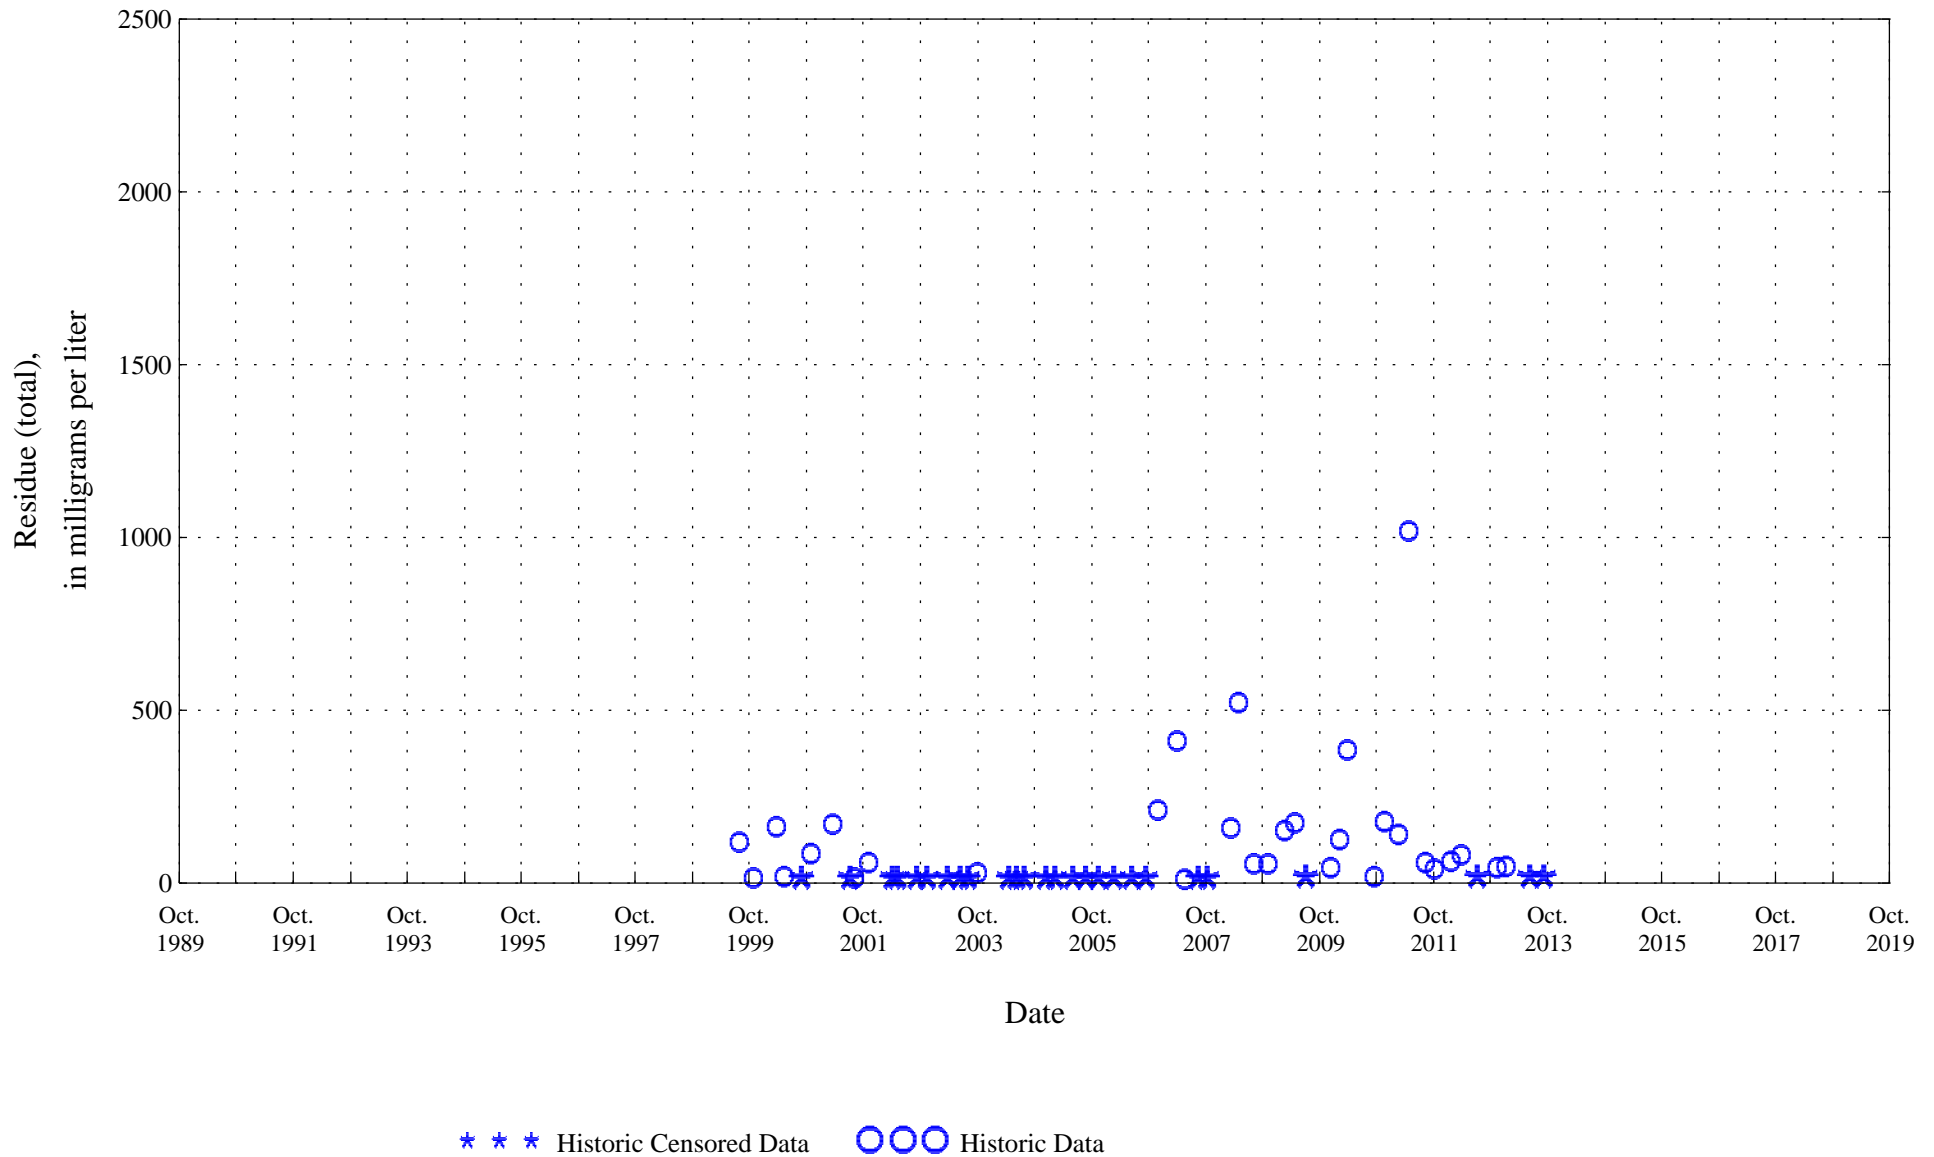
Figure 3. Distribution of selected water-quality constituents relative to time for

Piceance Creek below Ryan Gulch, near Rio Blanco, Co., station 09306200.

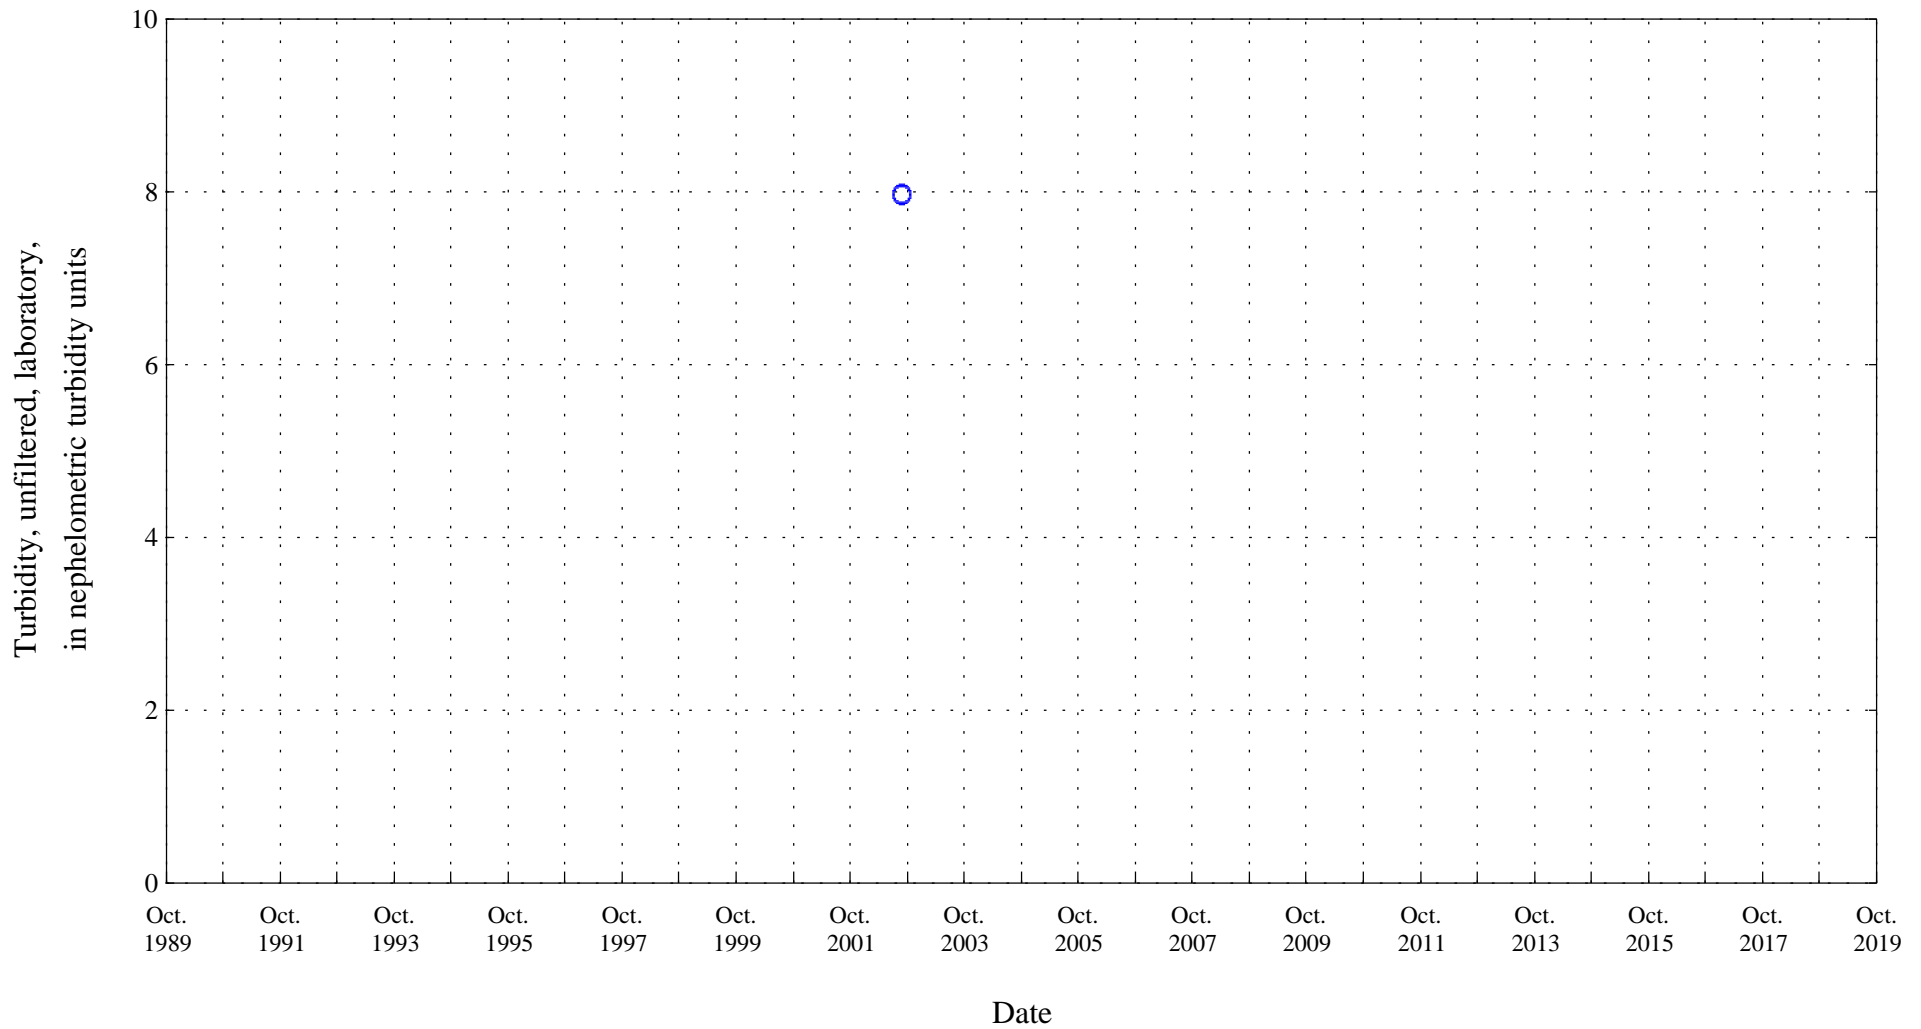
Figure 3. Distribution of selected water-quality constituents relative to time for

Piceance Creek below Ryan Gulch, near Rio Blanco, Co., station 09306200.

○ ○ ○ Historic Data
