Figure 3. Distribution of selected water-quality constituents relative to time for

Piceance Creek below Ryan Gulch, near Rio Blanco, Co., station 09306200.

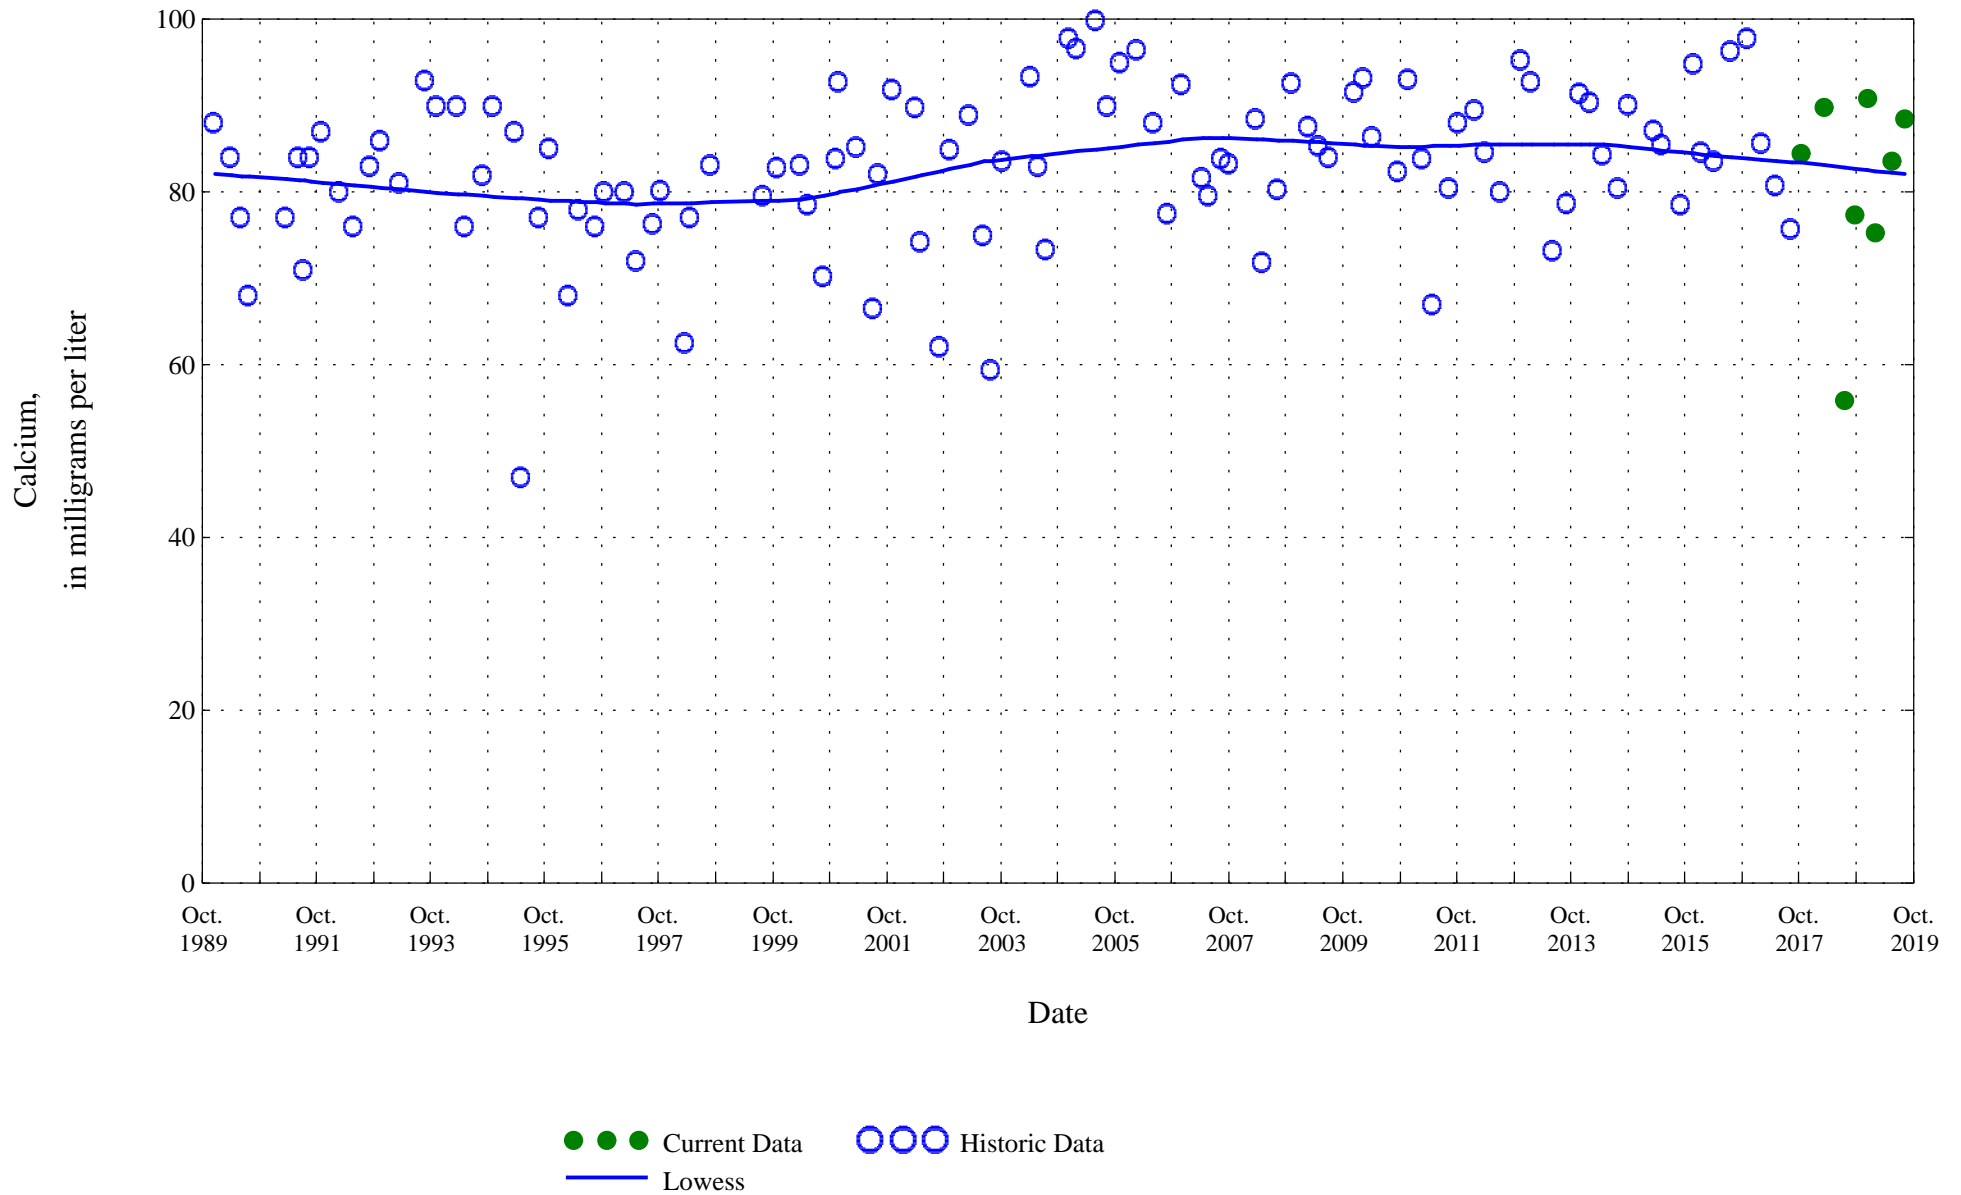
Figure 3. Distribution of selected water-quality constituents relative to time for

Piceance Creek below Ryan Gulch, near Rio Blanco, Co., station 09306200.

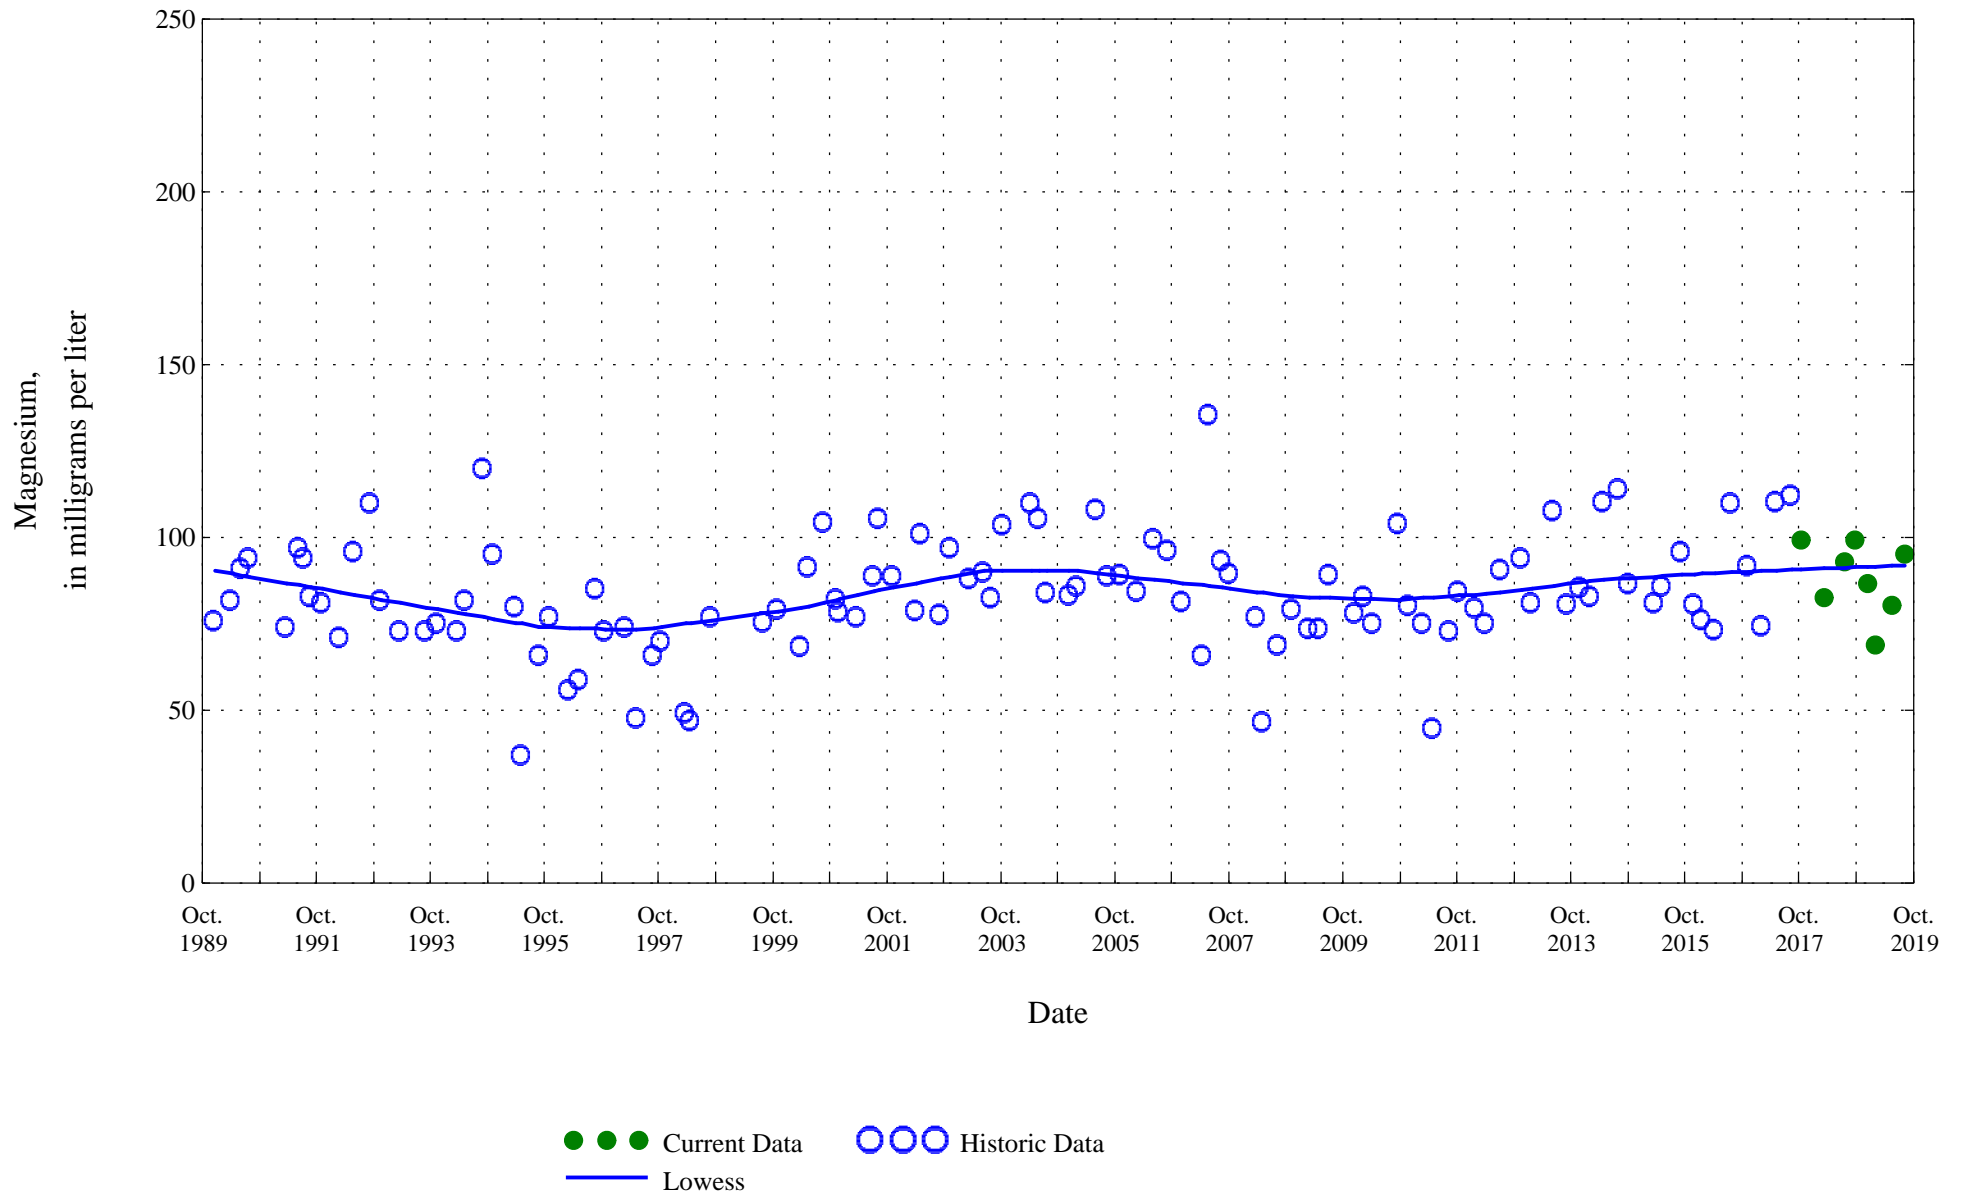
Figure 3. Distribution of selected water-quality constituents relative to time for

Piceance Creek below Ryan Gulch, near Rio Blanco, Co., station 09306200.

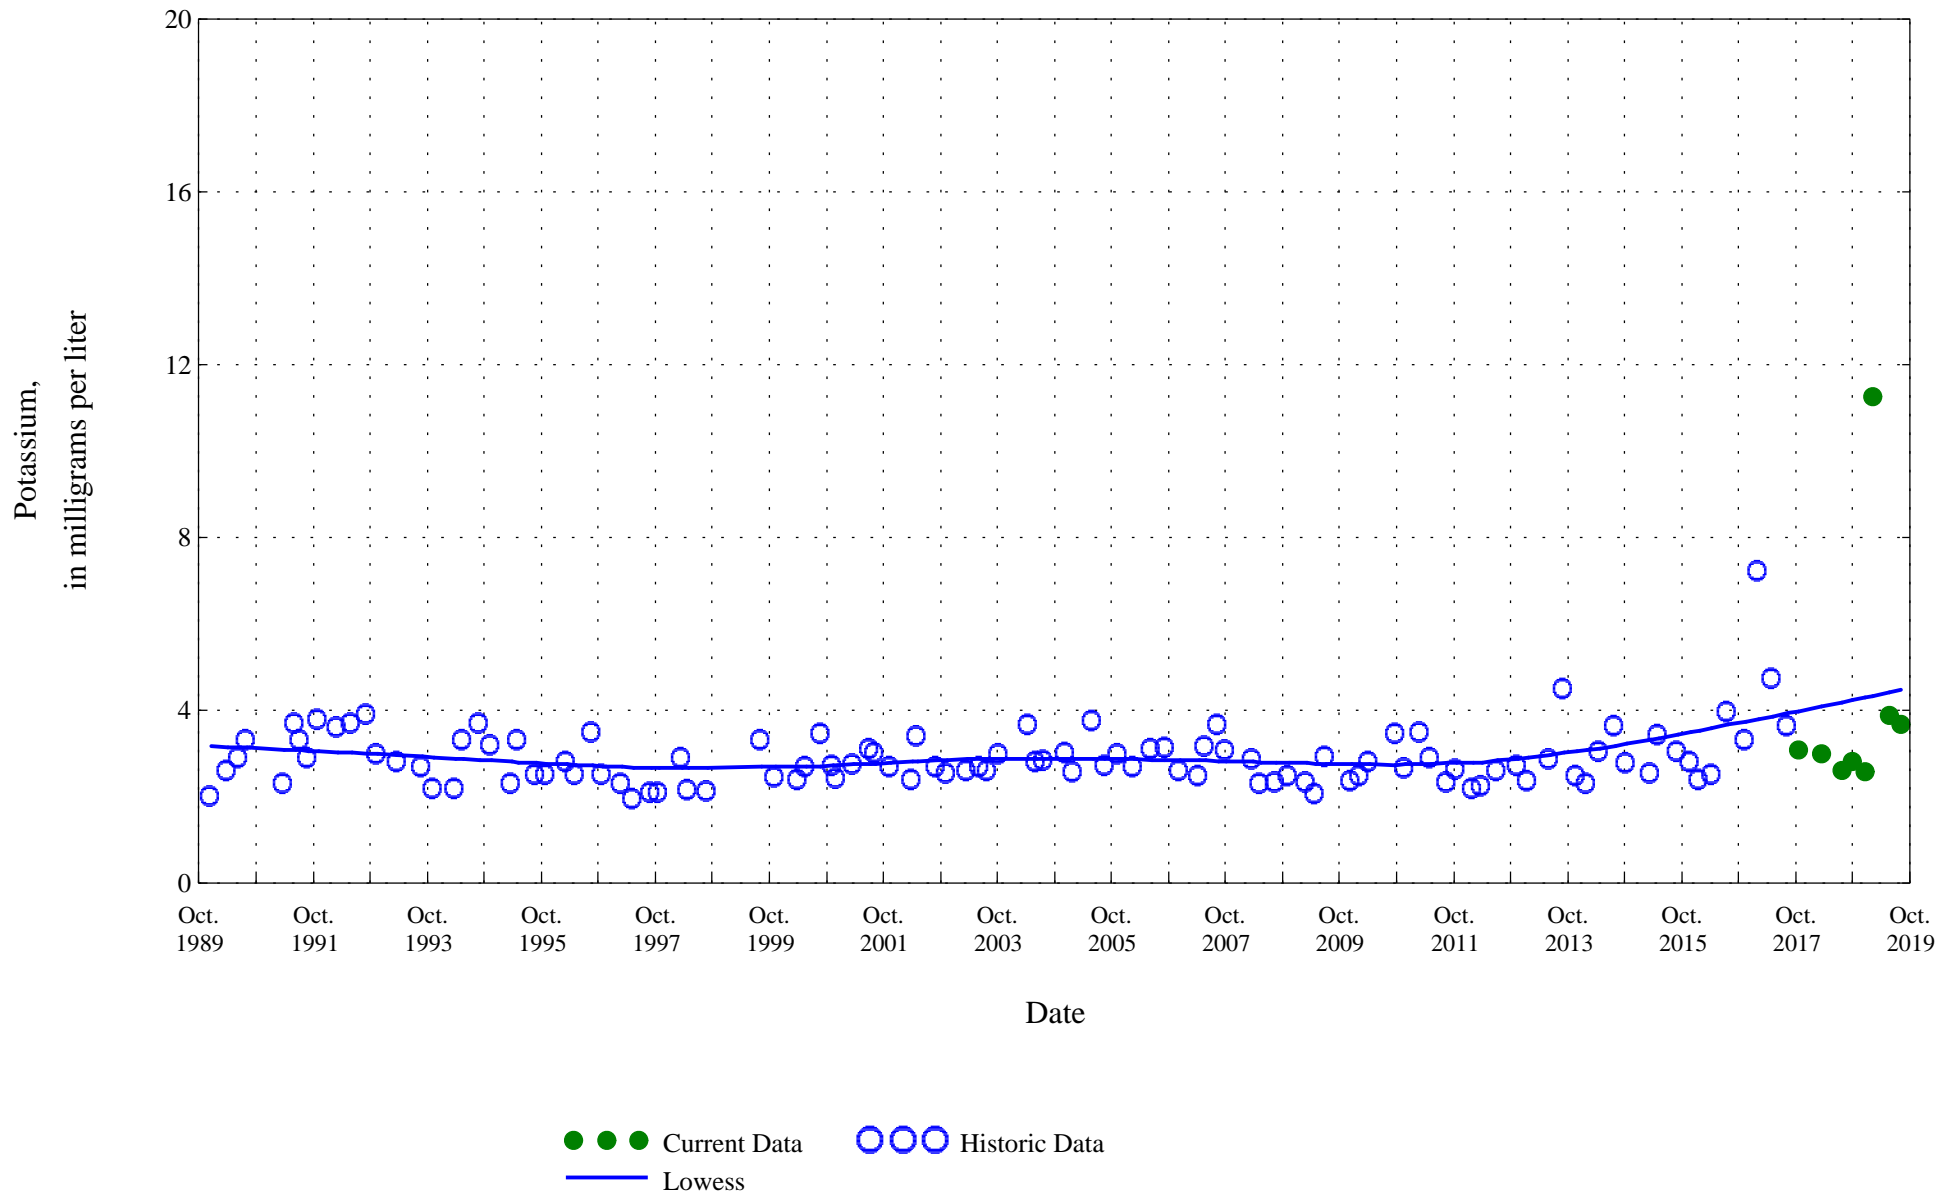
Figure 3. Distribution of selected water-quality constituents relative to time for

Piceance Creek below Ryan Gulch, near Rio Blanco, Co., station 09306200.

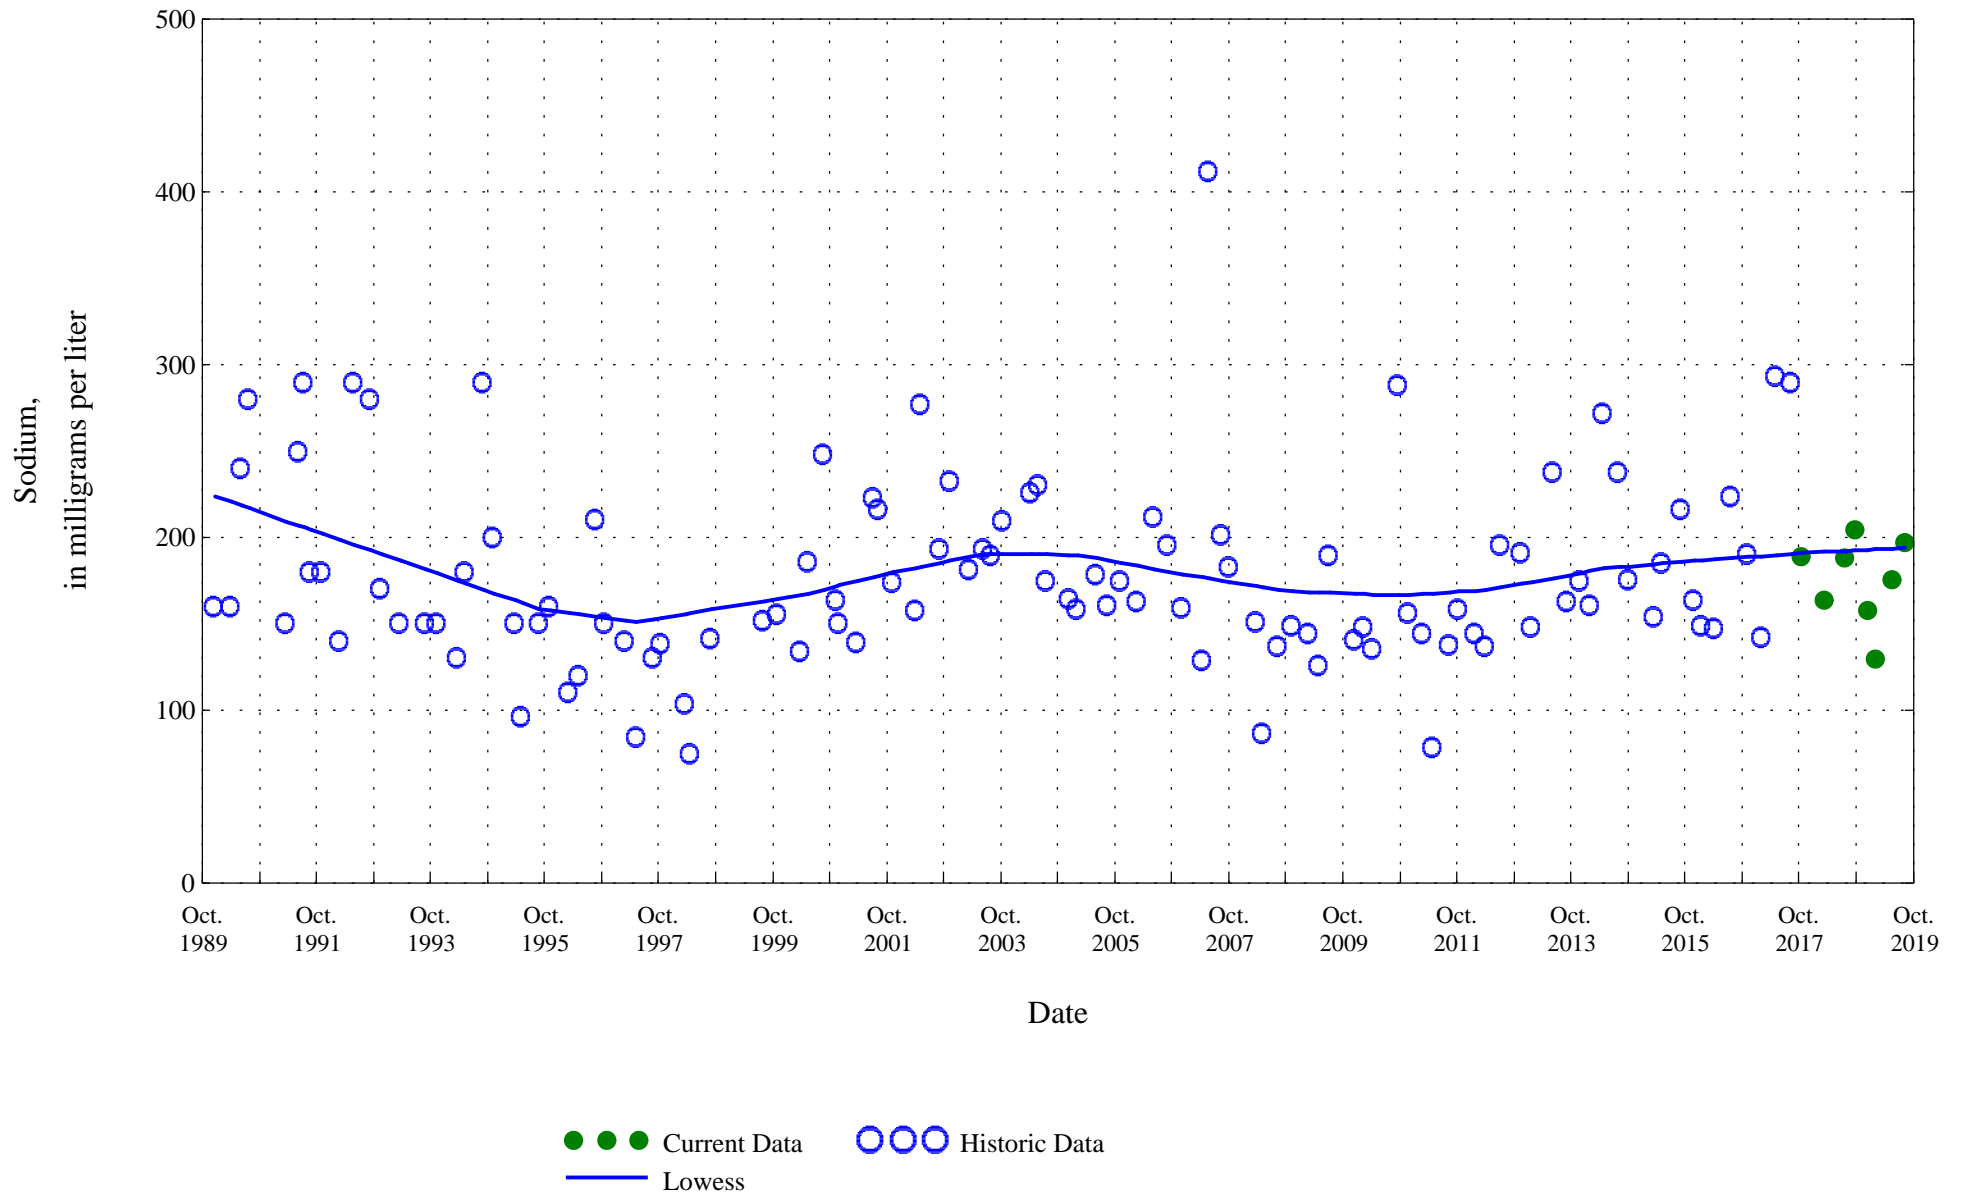
Figure 3. Distribution of selected water-quality constituents relative to time for

Piceance Creek below Ryan Gulch, near Rio Blanco, Co., station 09306200.

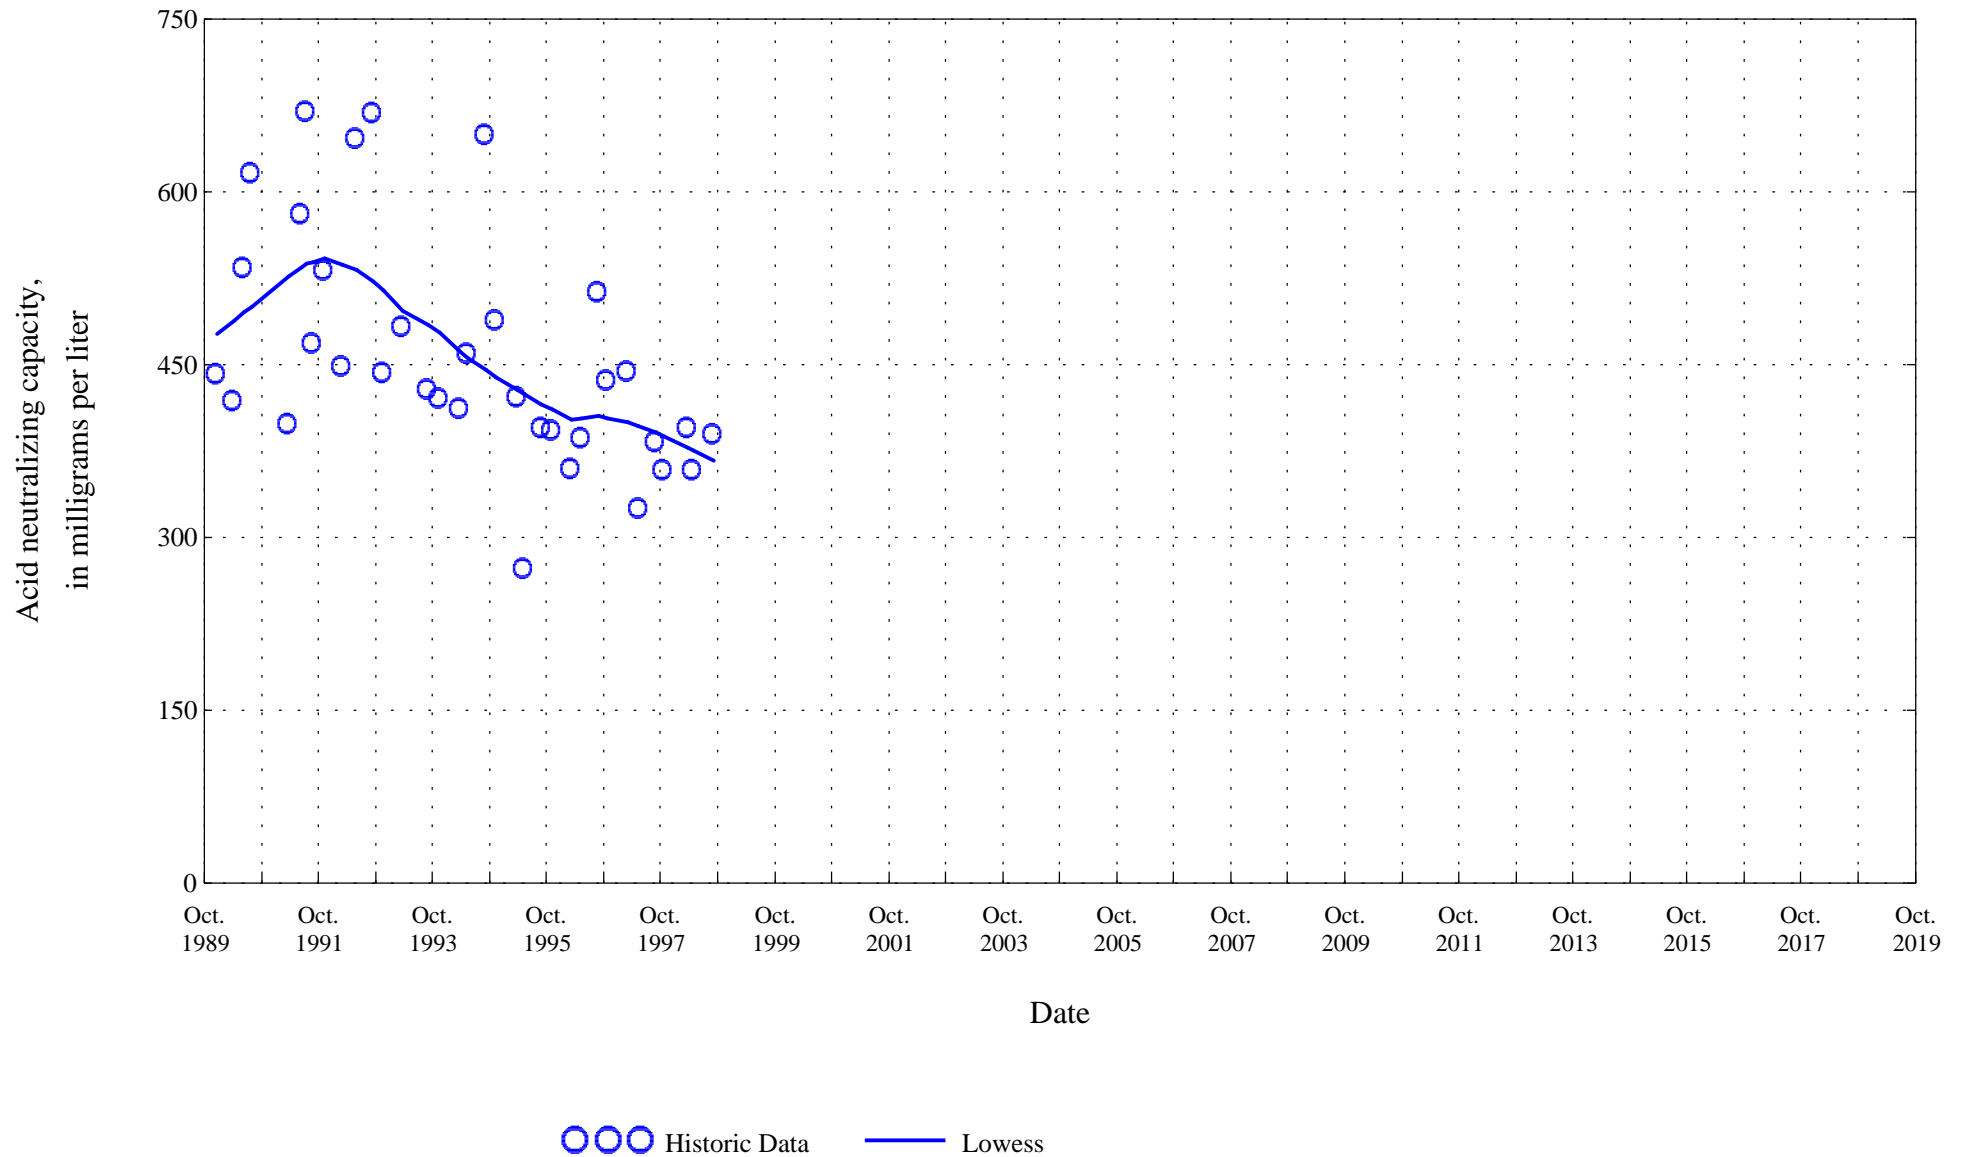
Figure 3. Distribution of selected water-quality constituents relative to time for

Piceance Creek below Ryan Gulch, near Rio Blanco, Co., station 09306200.

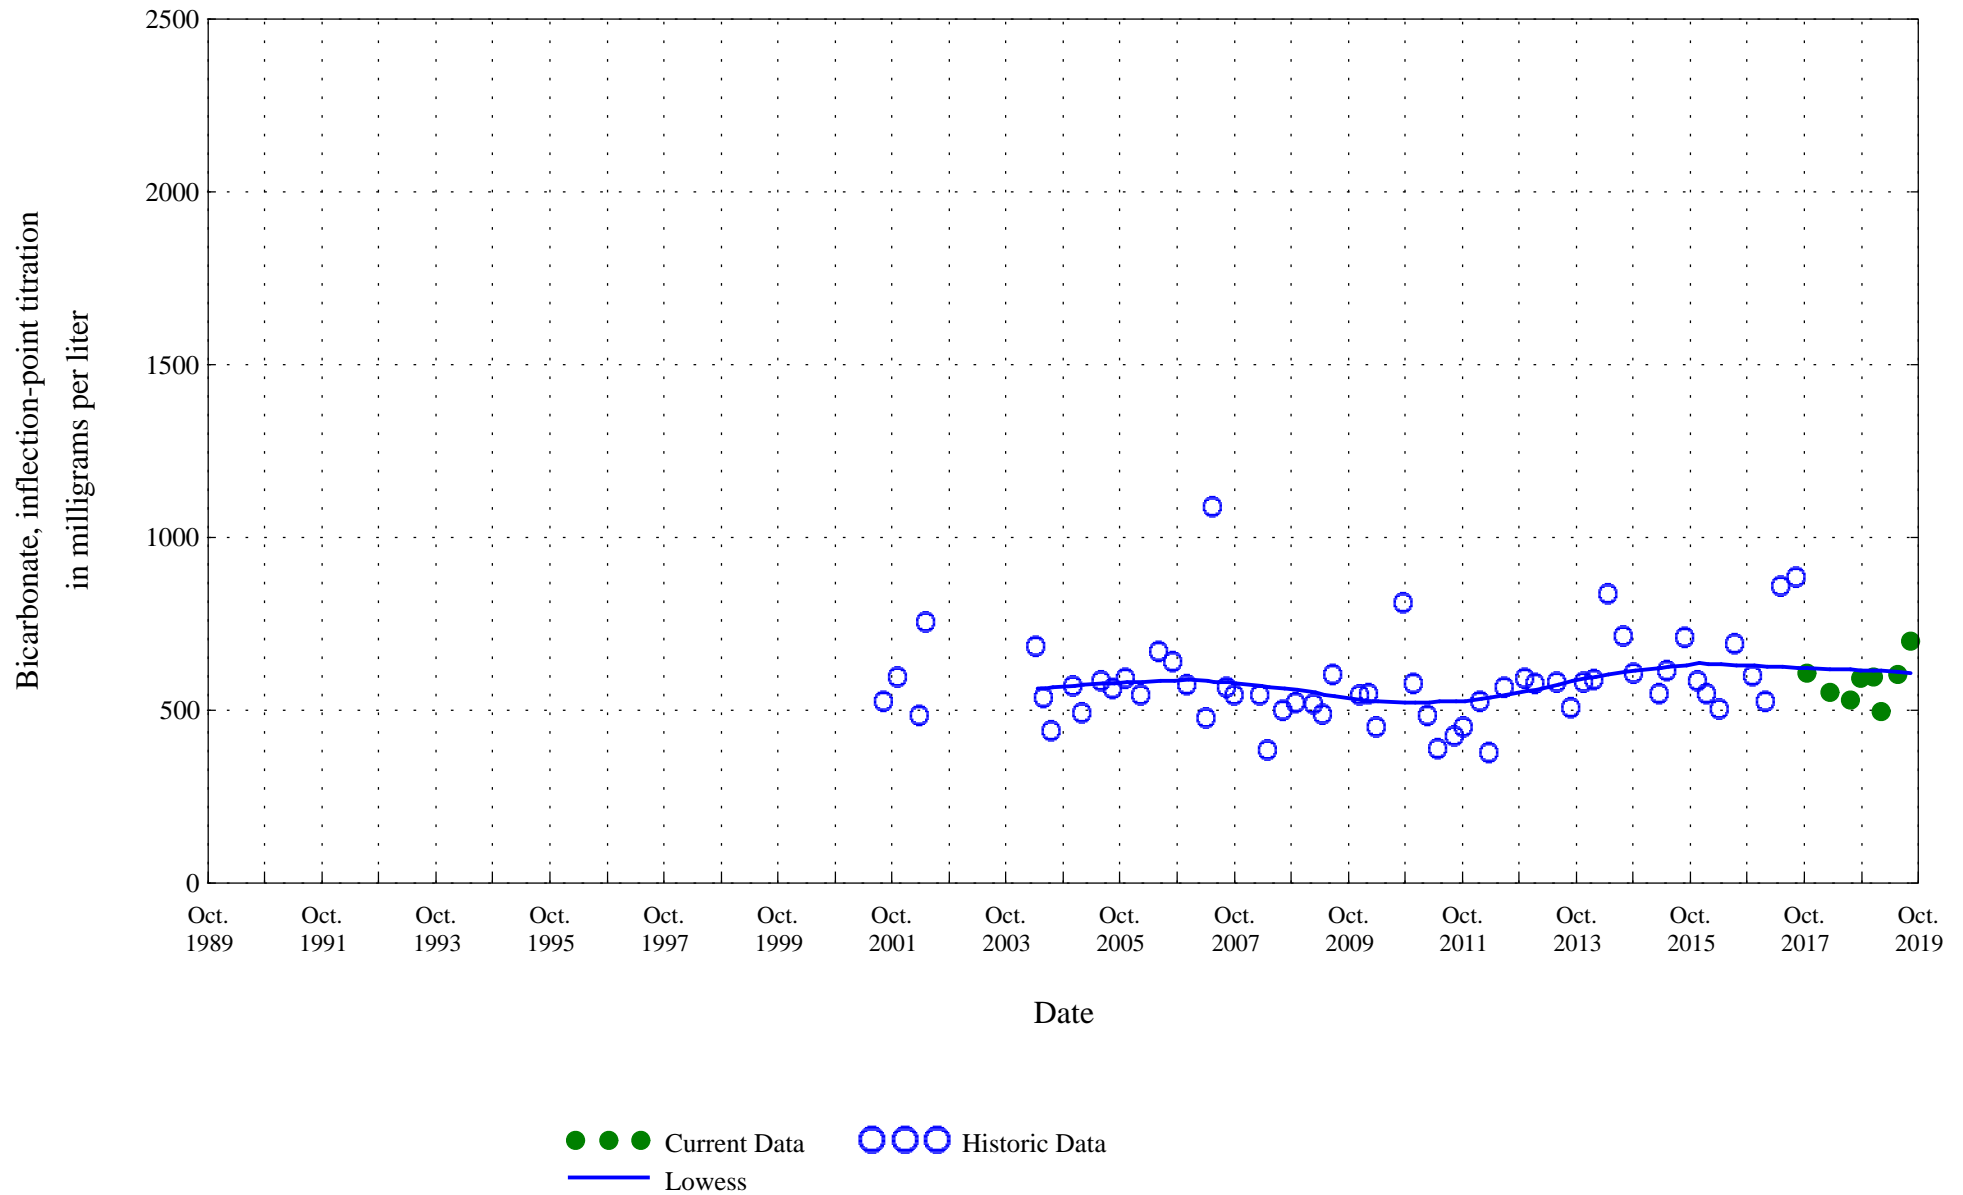
Figure 3. Distribution of selected water-quality constituents relative to time for

Piceance Creek below Ryan Gulch, near Rio Blanco, Co., station 09306200.

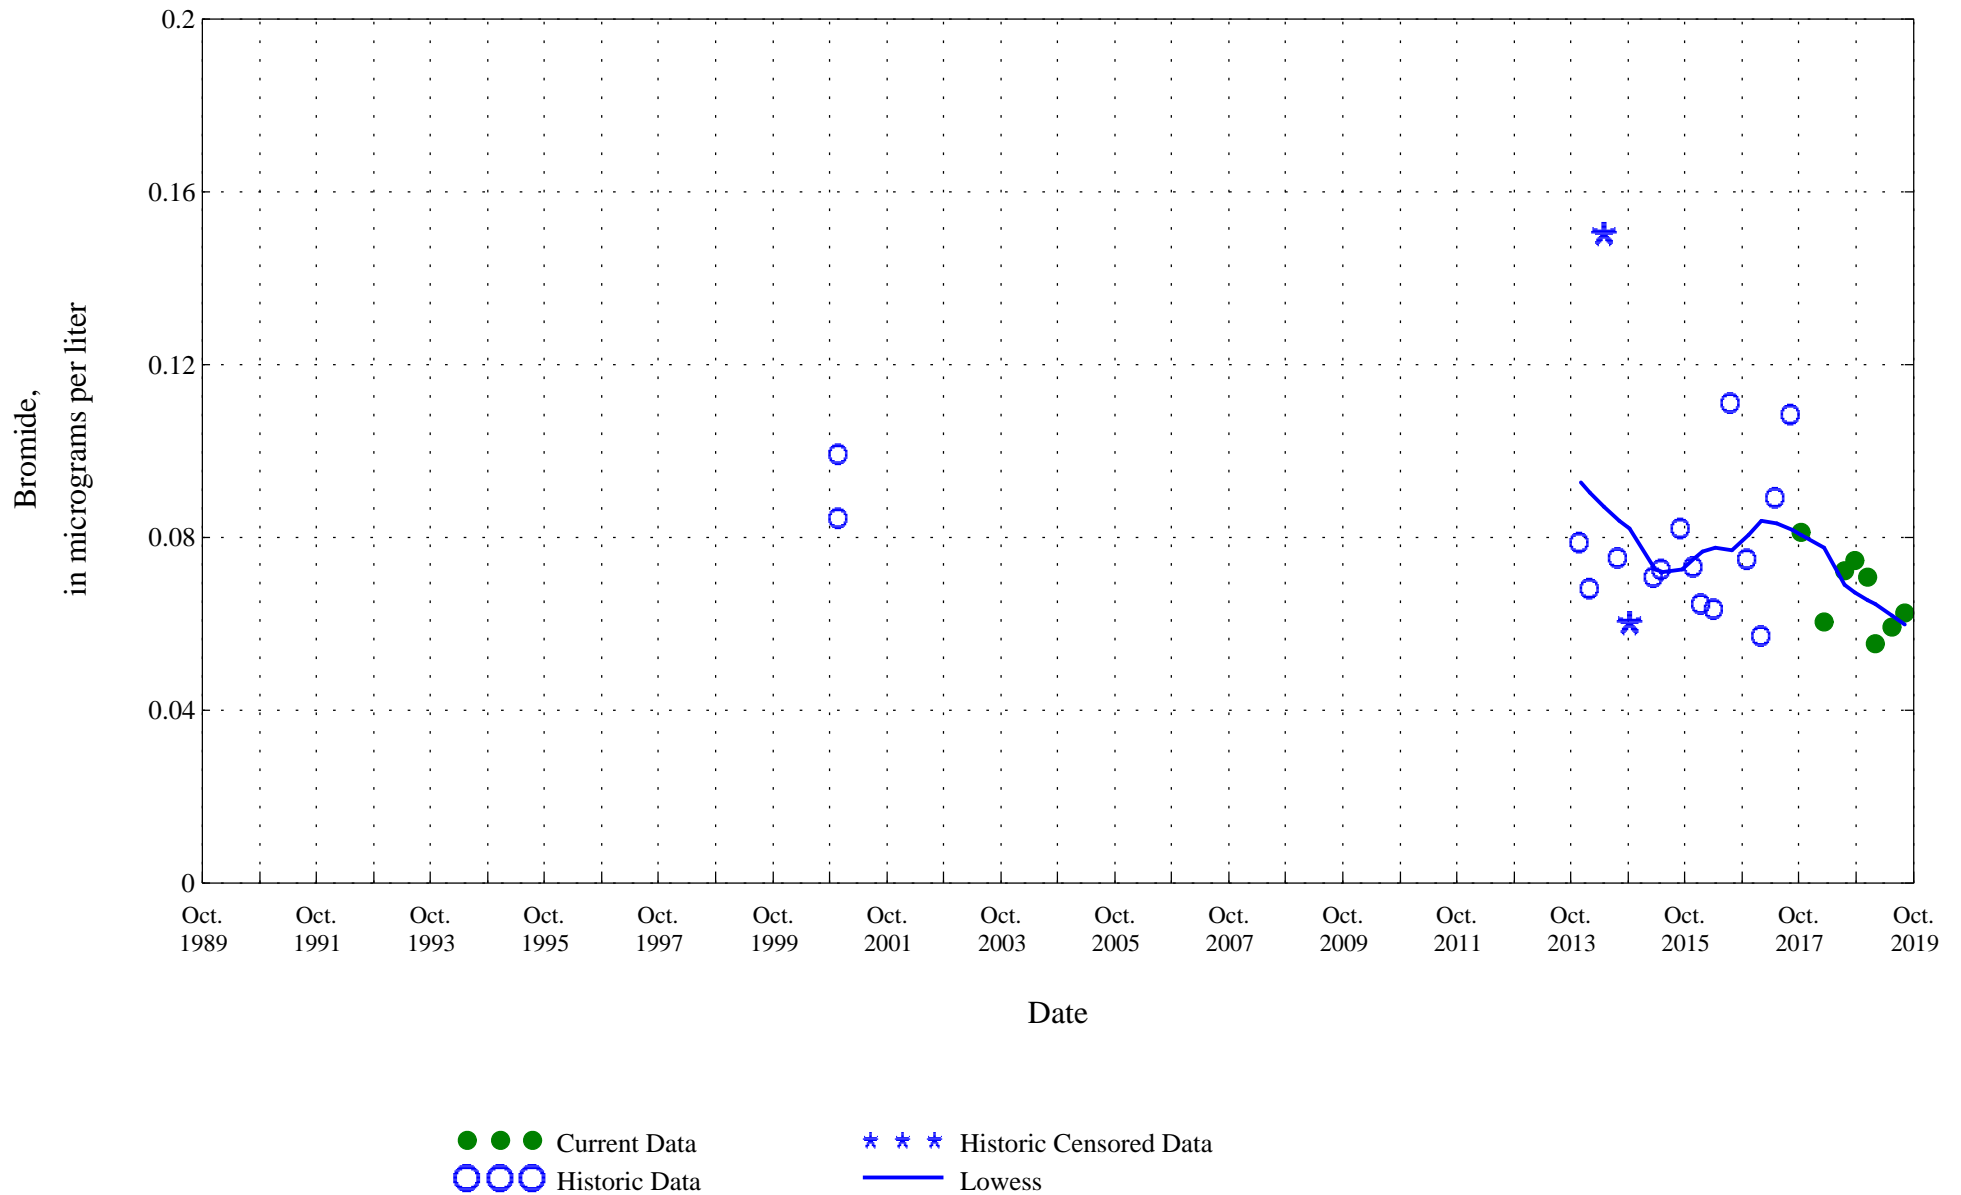
Figure 3. Distribution of selected water-quality constituents relative to time for

Piceance Creek below Ryan Gulch, near Rio Blanco, Co., station 09306200.

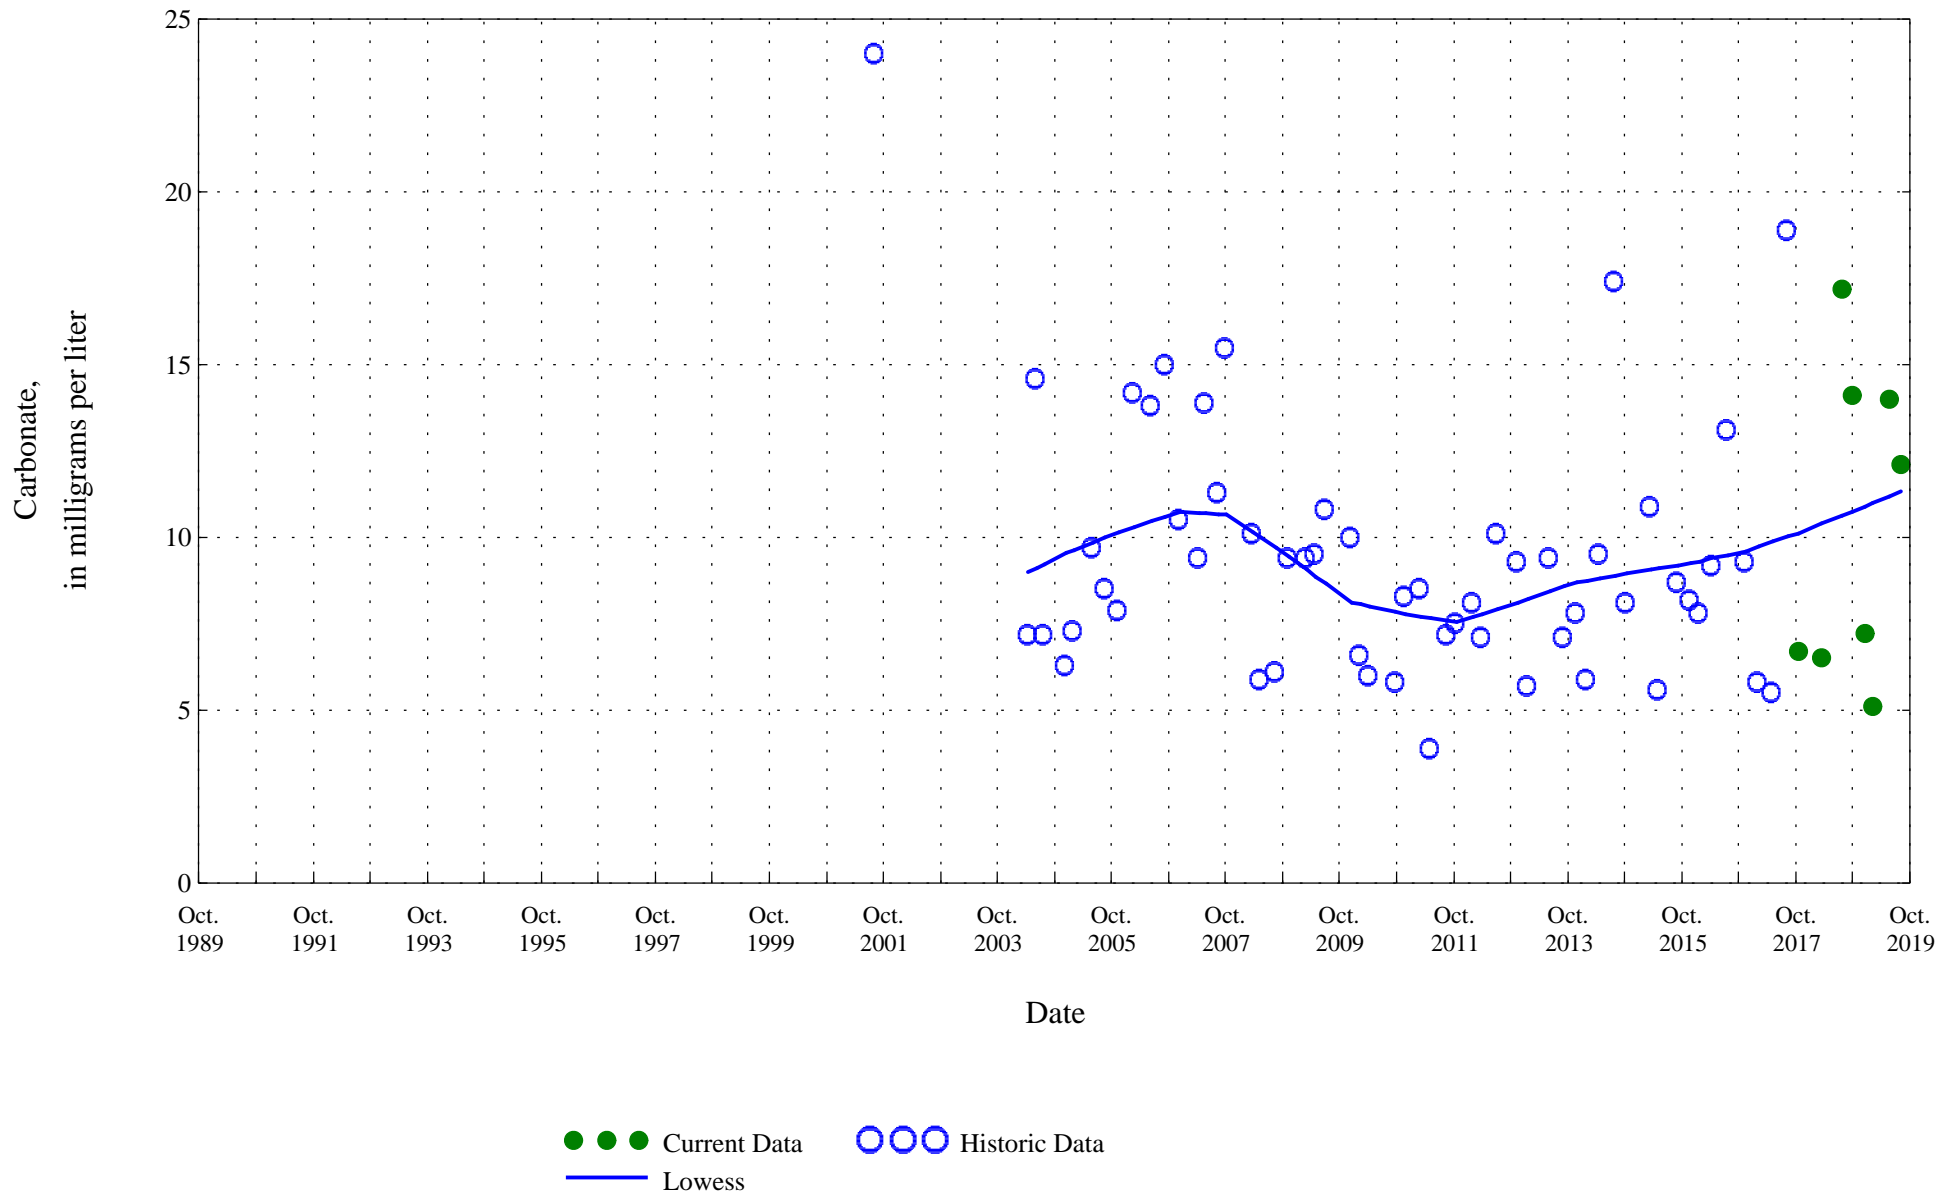
Figure 3. Distribution of selected water-quality constituents relative to time for

Piceance Creek below Ryan Gulch, near Rio Blanco, Co., station 09306200.

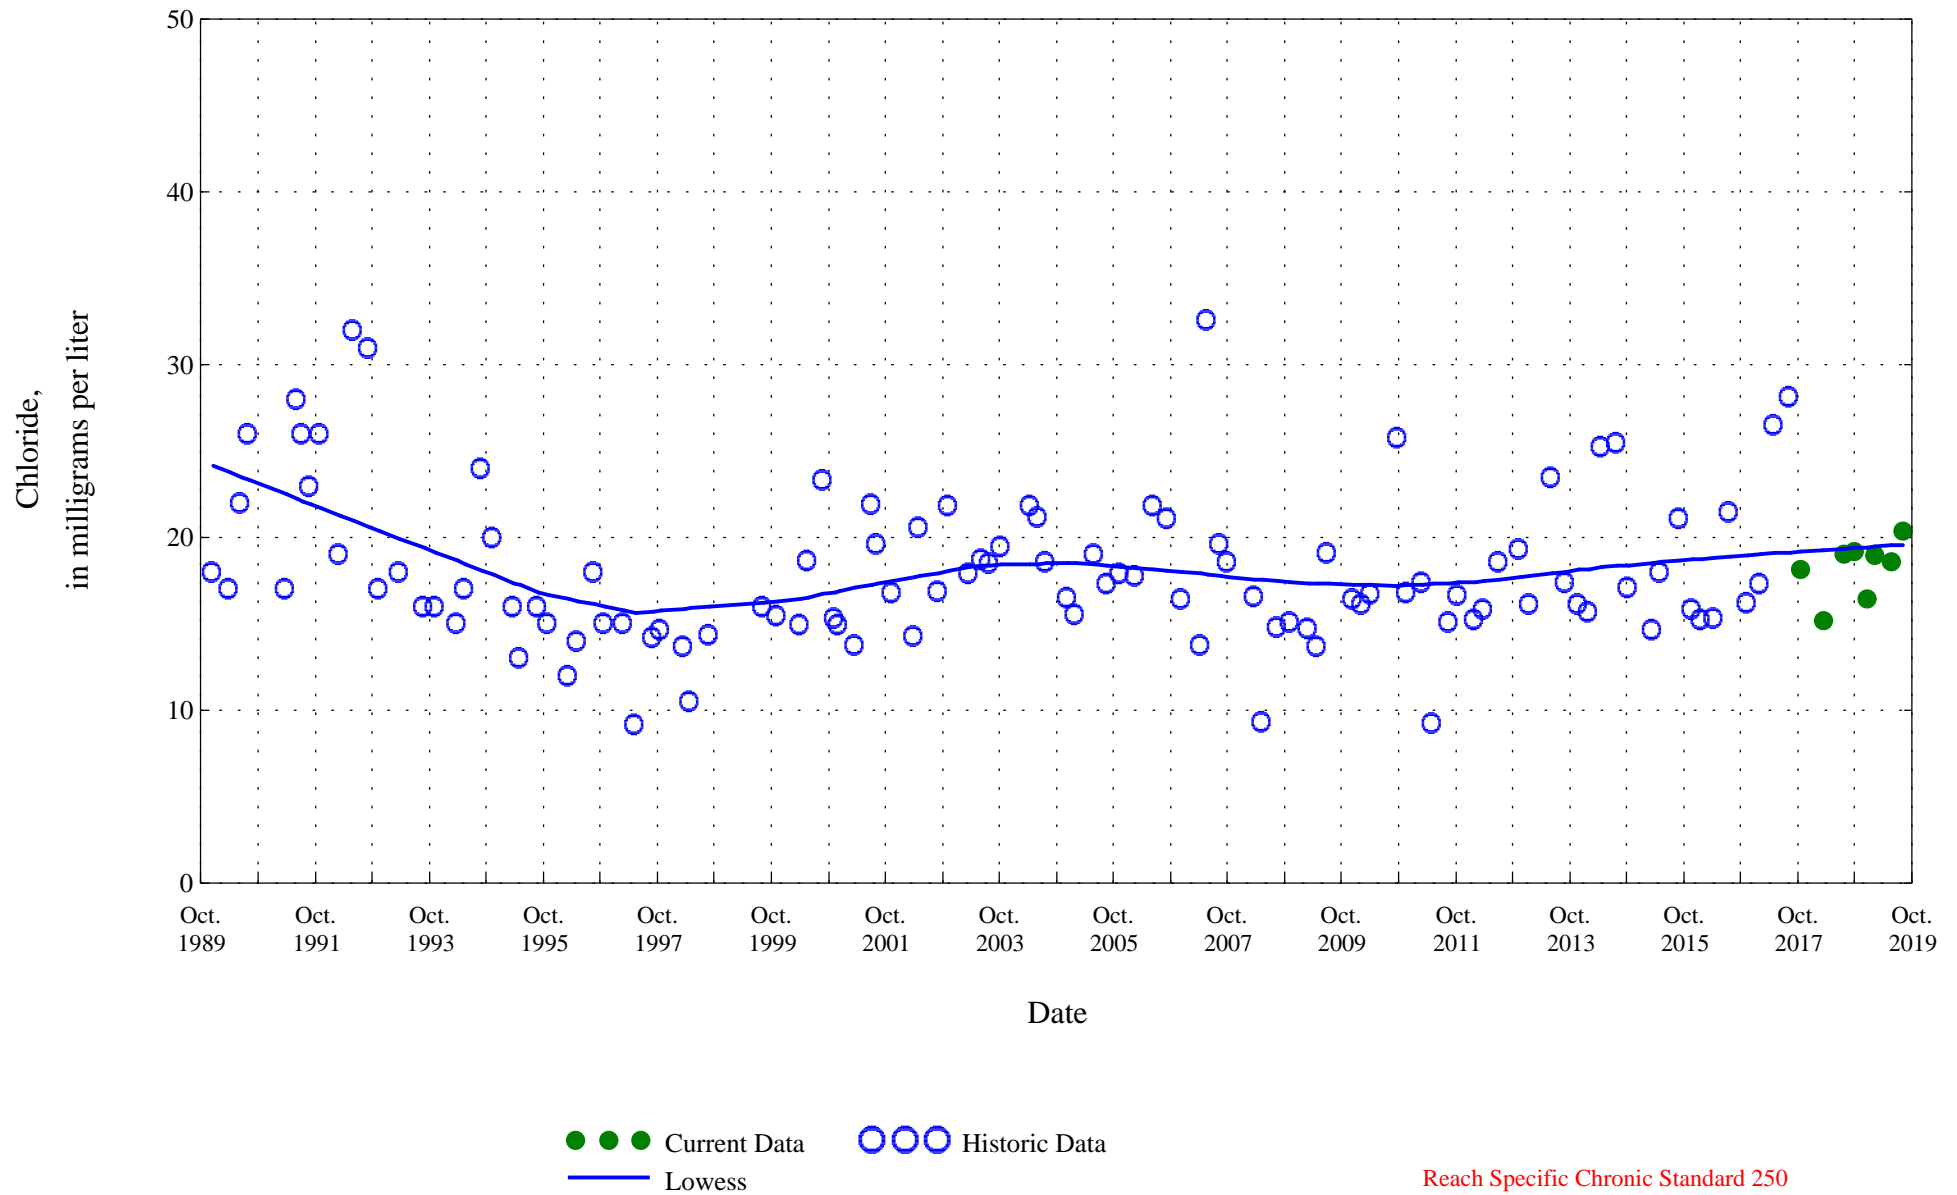
Figure 3. Distribution of selected water-quality constituents relative to time for

Piceance Creek below Ryan Gulch, near Rio Blanco, Co., station 09306200.
