Figure 3. Distribution of selected water-quality constituents relative to time for

Piceance Creek below Ryan Gulch, near Rio Blanco, Co., station 09306200.

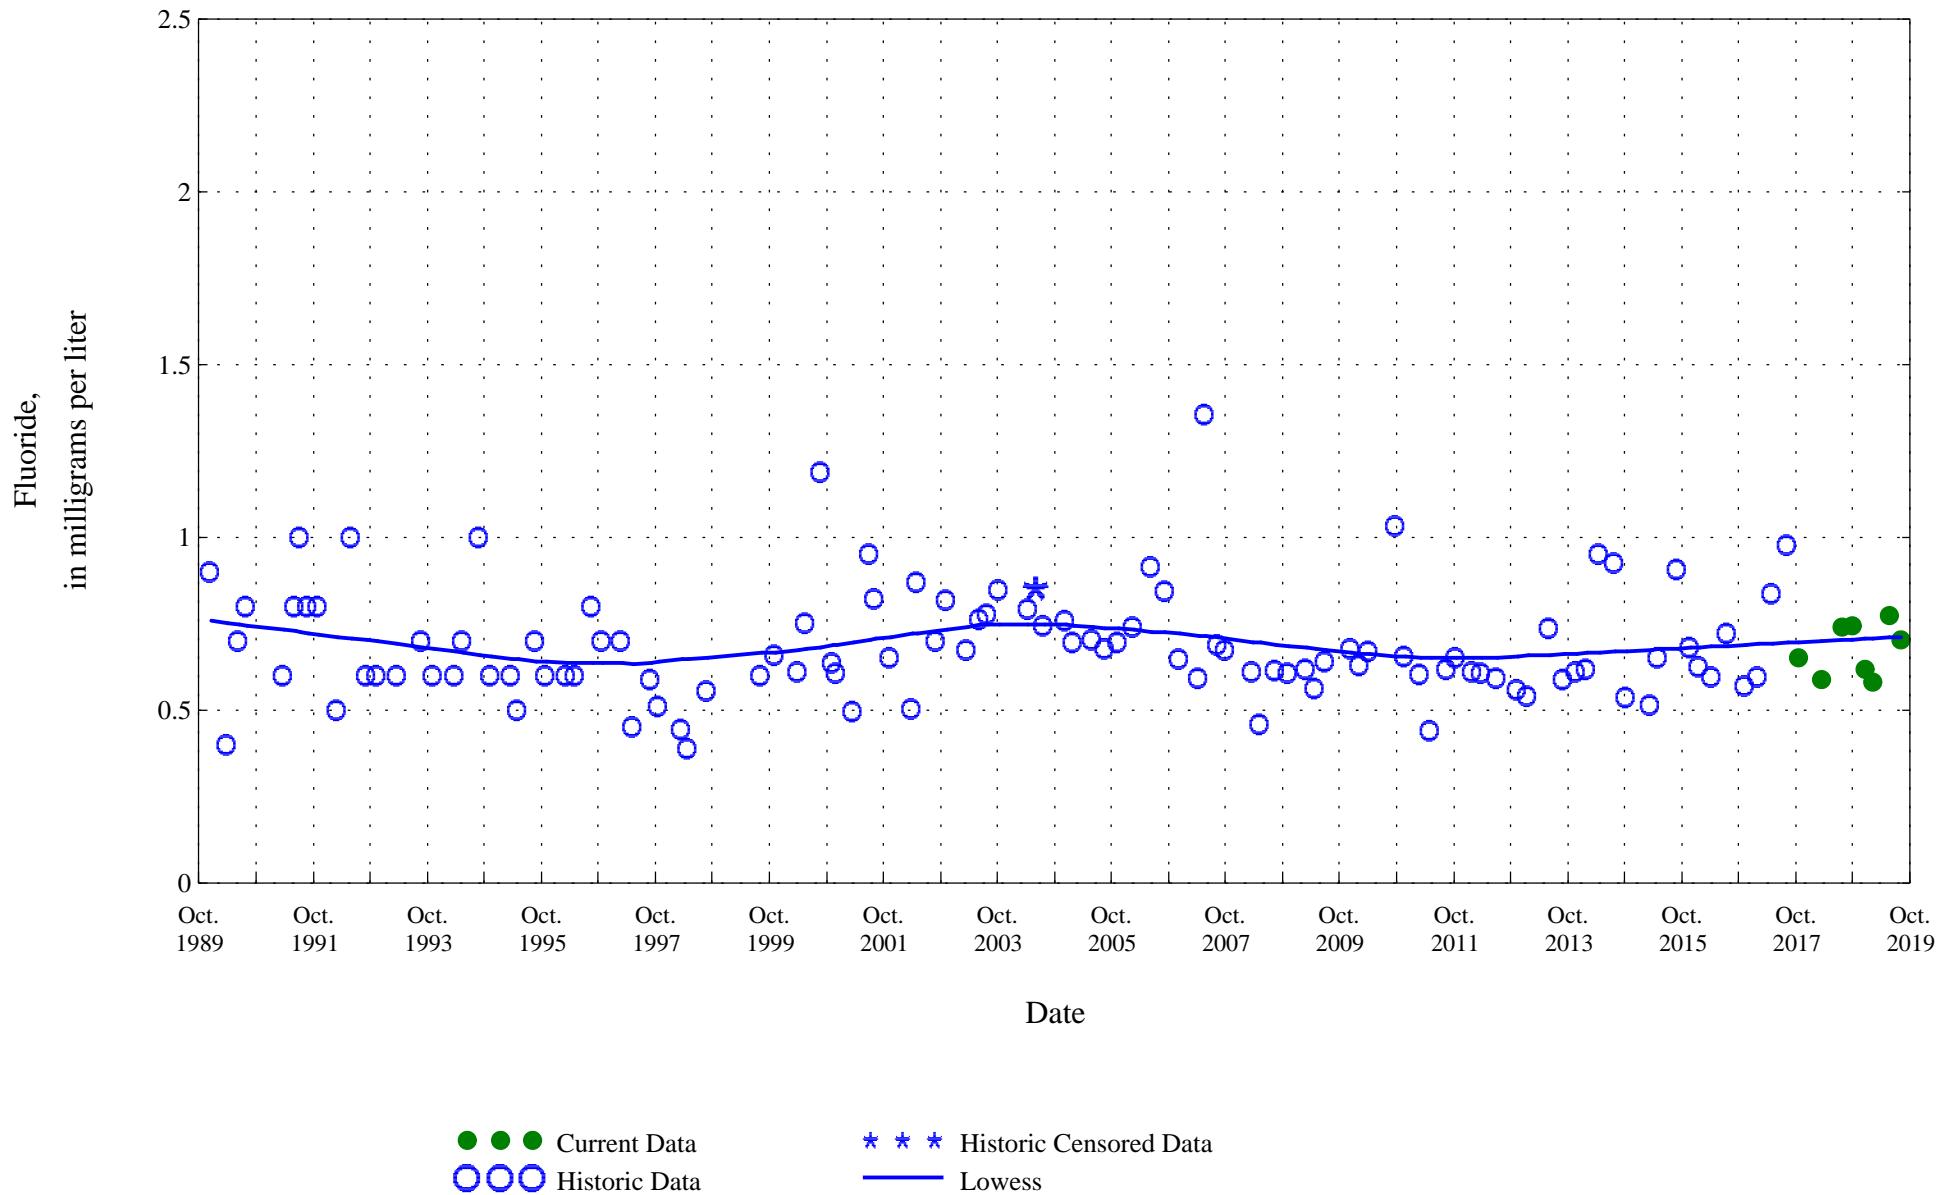
Piceance Creek below Ryan Gulch, near Rio Blanco, Co., station 09306200.

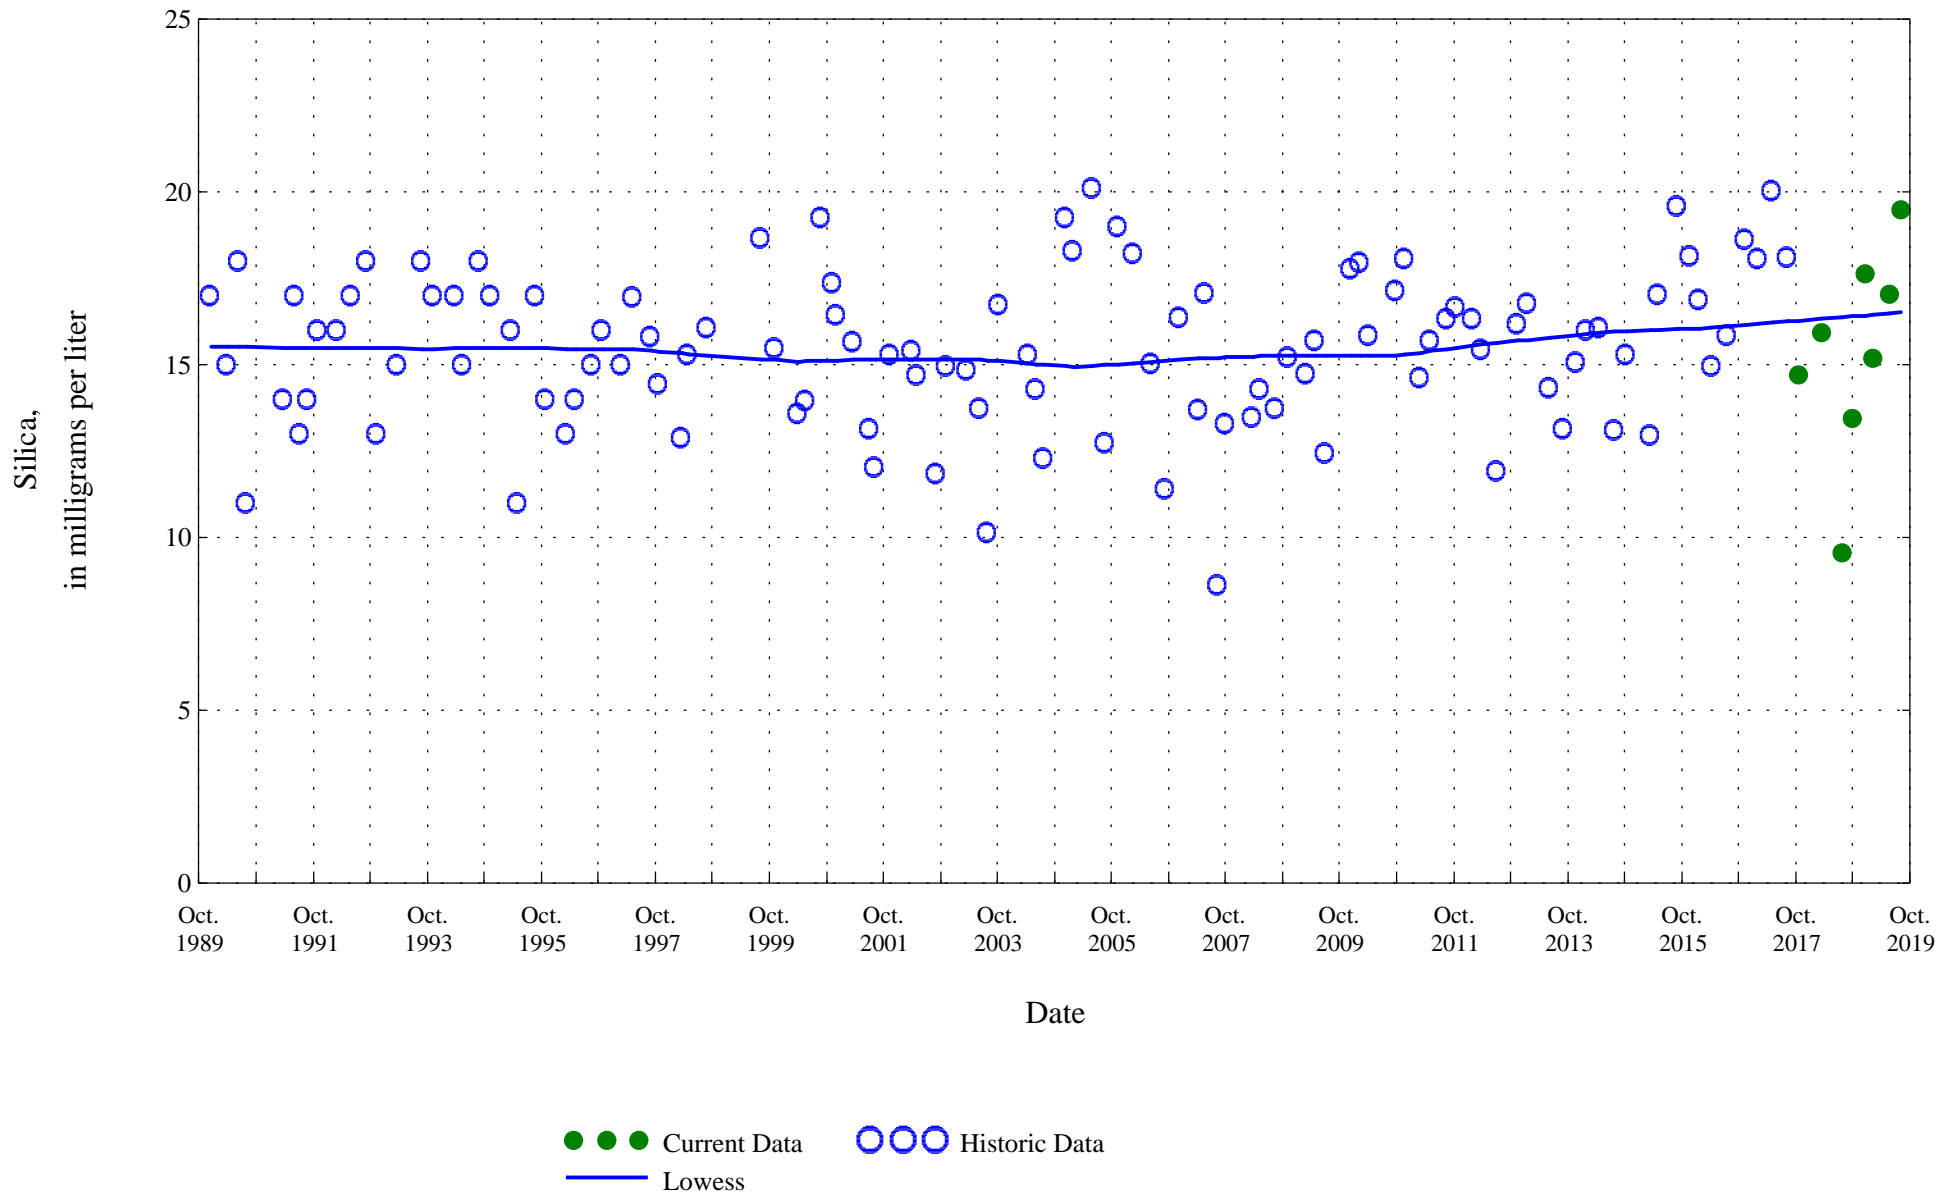
Figure 3. Distribution of selected water-quality constituents relative to time for

Piceance Creek below Ryan Gulch, near Rio Blanco, Co., station 09306200.

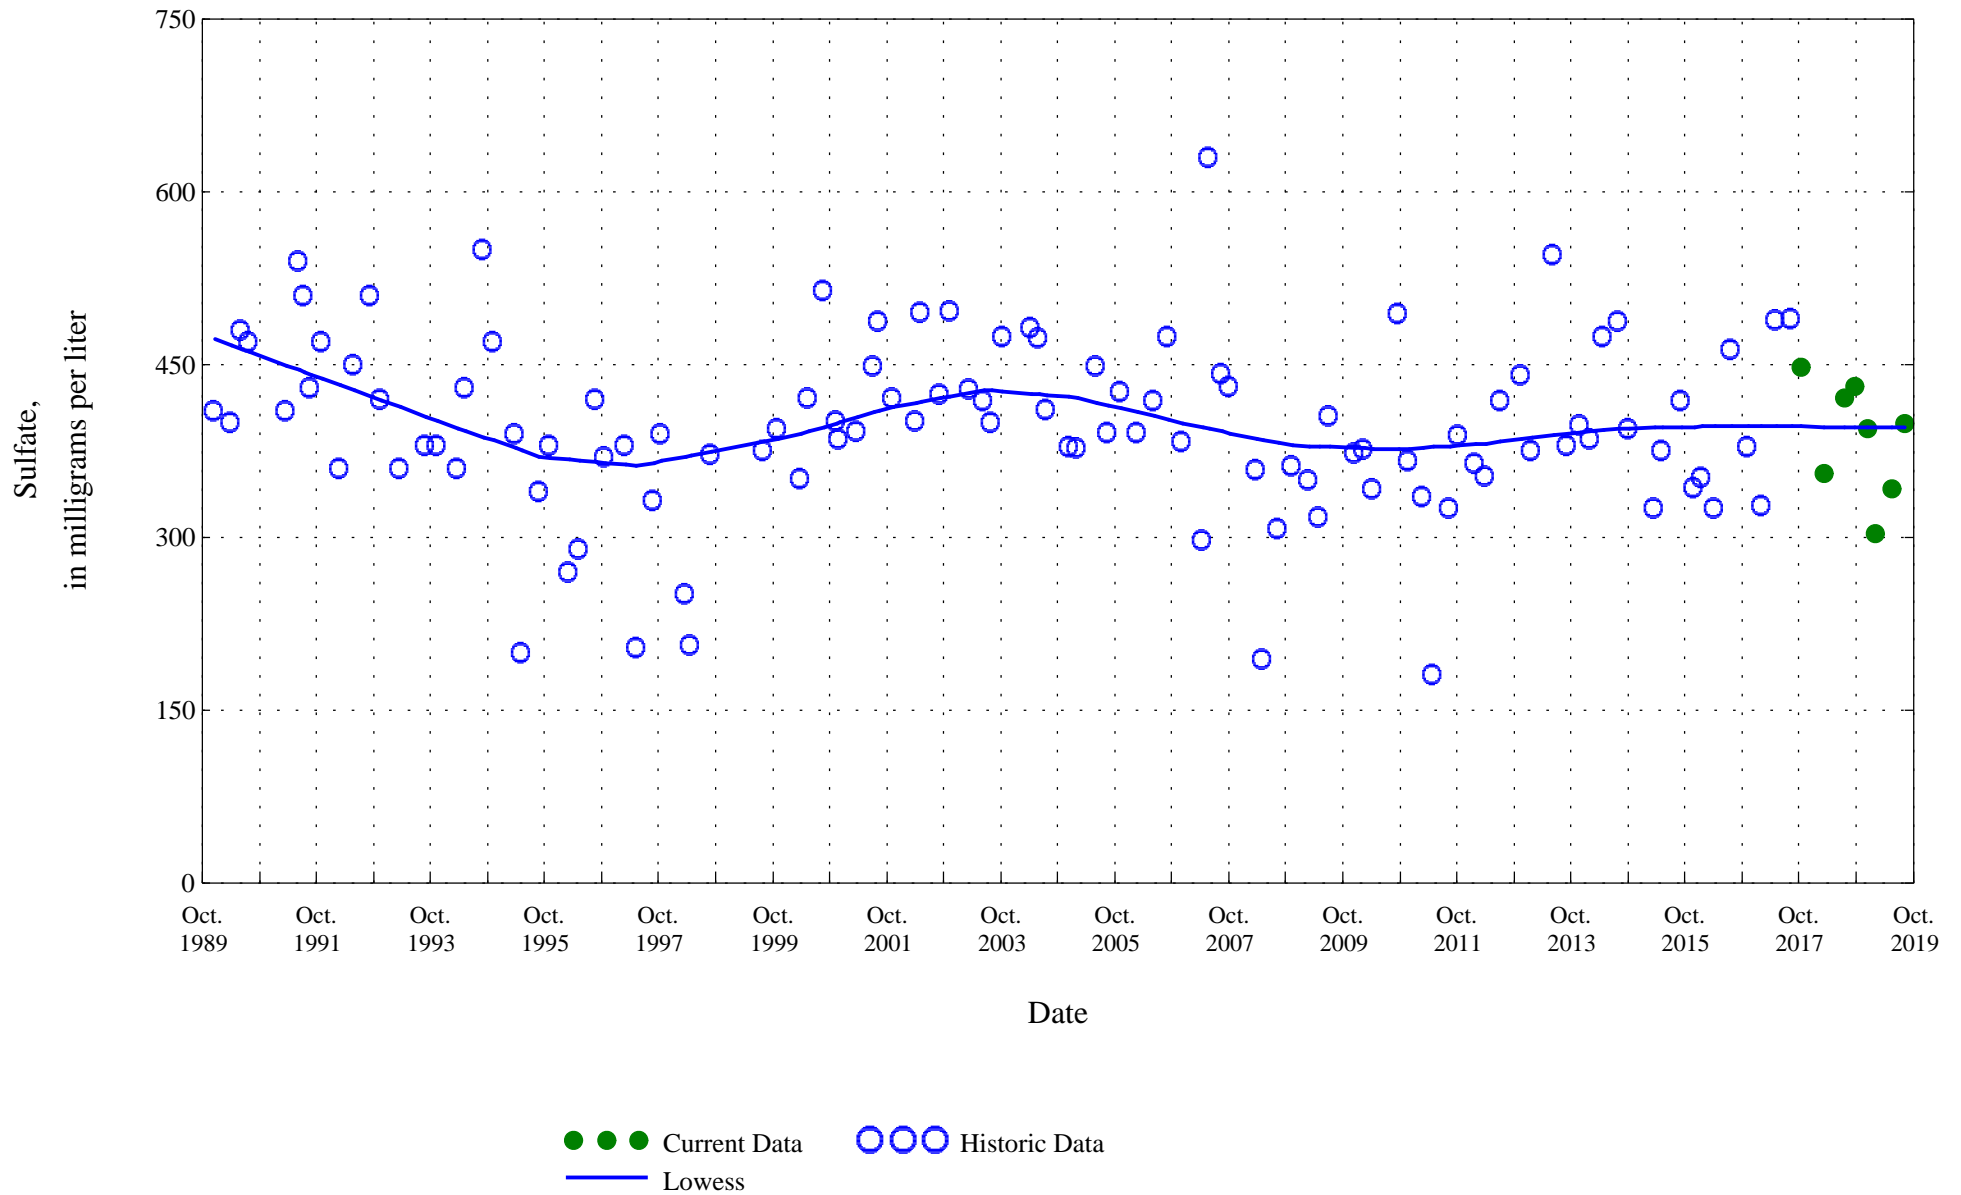
Figure 3. Distribution of selected water-quality constituents relative to time for

Piceance Creek below Ryan Gulch, near Rio Blanco, Co., station 09306200.

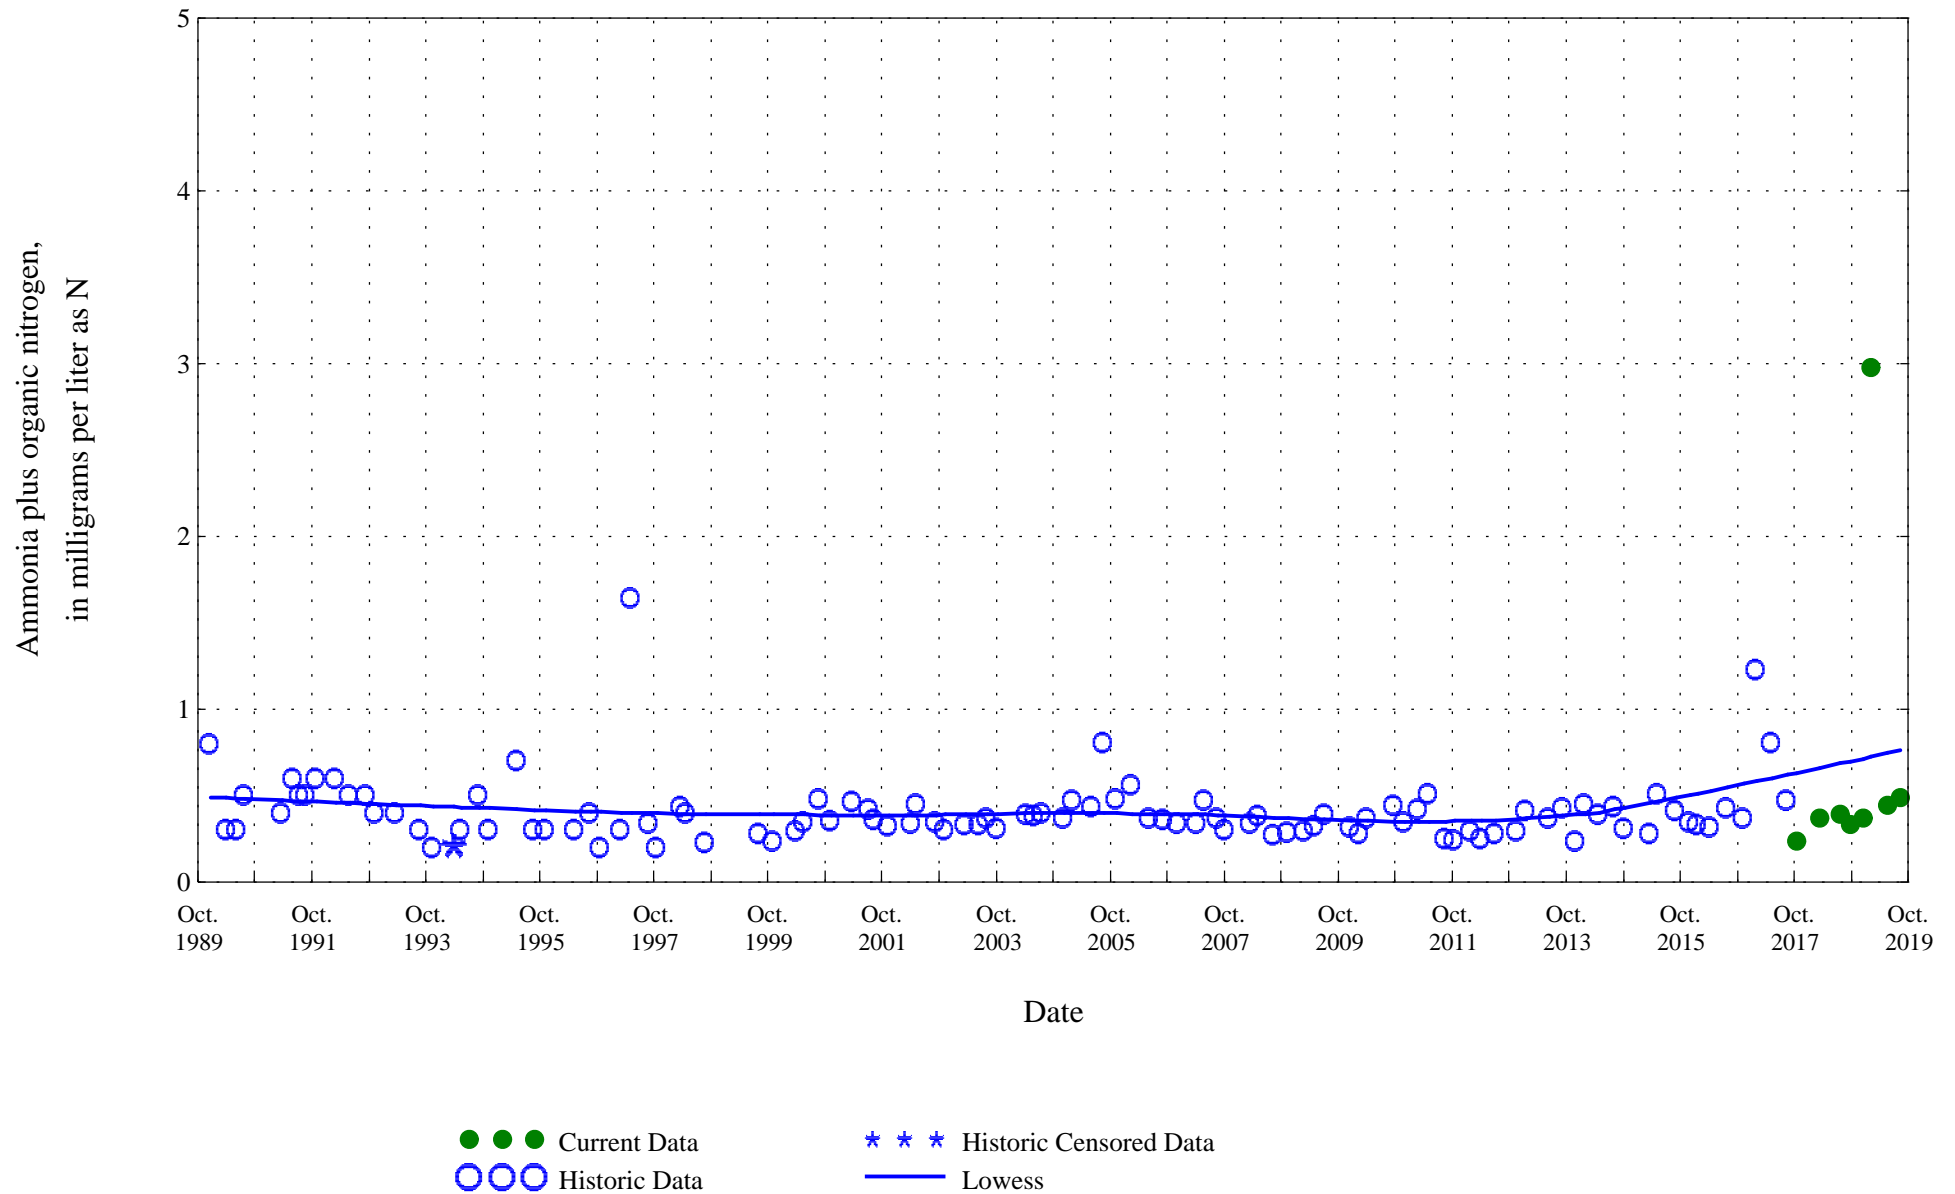
Figure 3. Distribution of selected water-quality constituents relative to time for

Piceance Creek below Ryan Gulch, near Rio Blanco, Co., station 09306200.

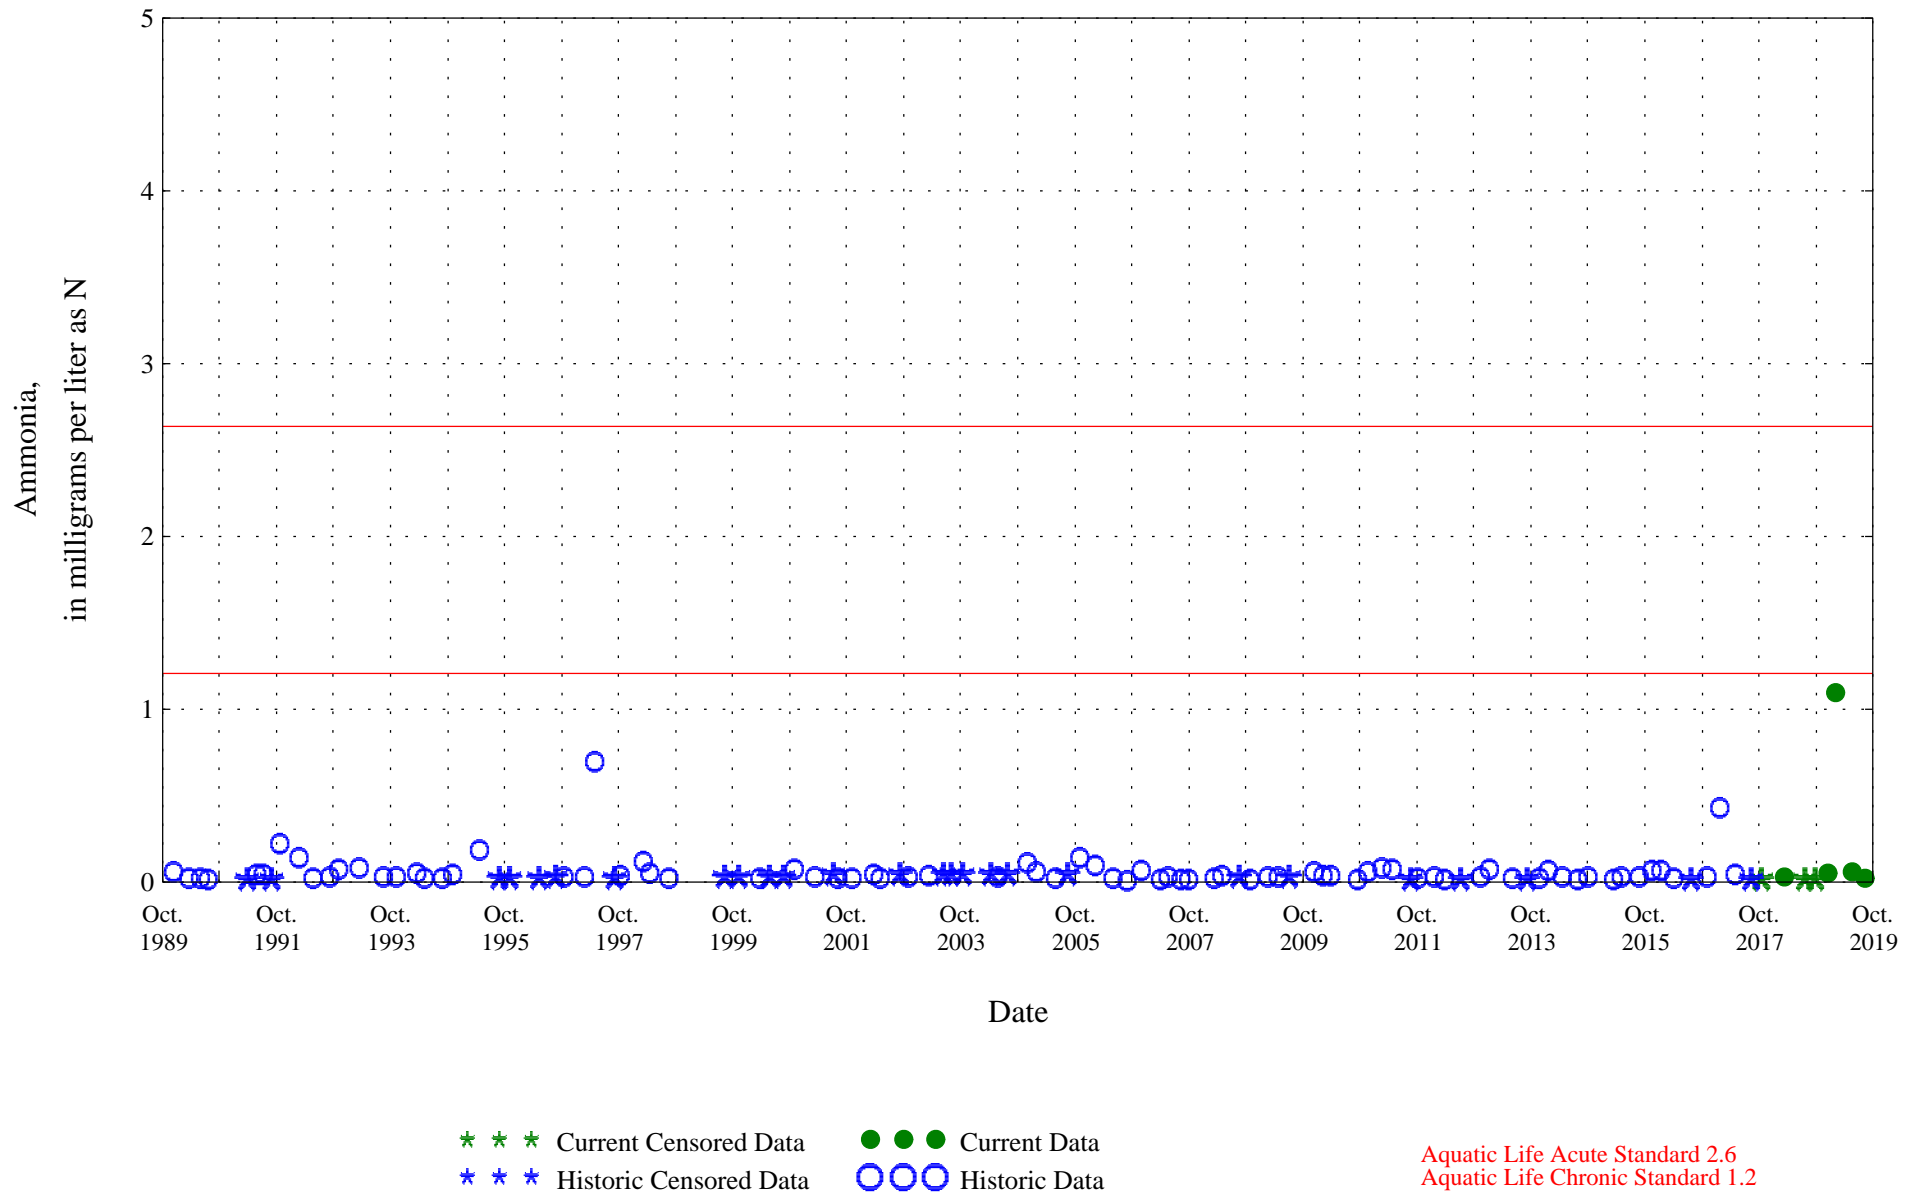
Figure 3. Distribution of selected water-quality constituents relative to time for

Piceance Creek below Ryan Gulch, near Rio Blanco, Co., station 09306200.

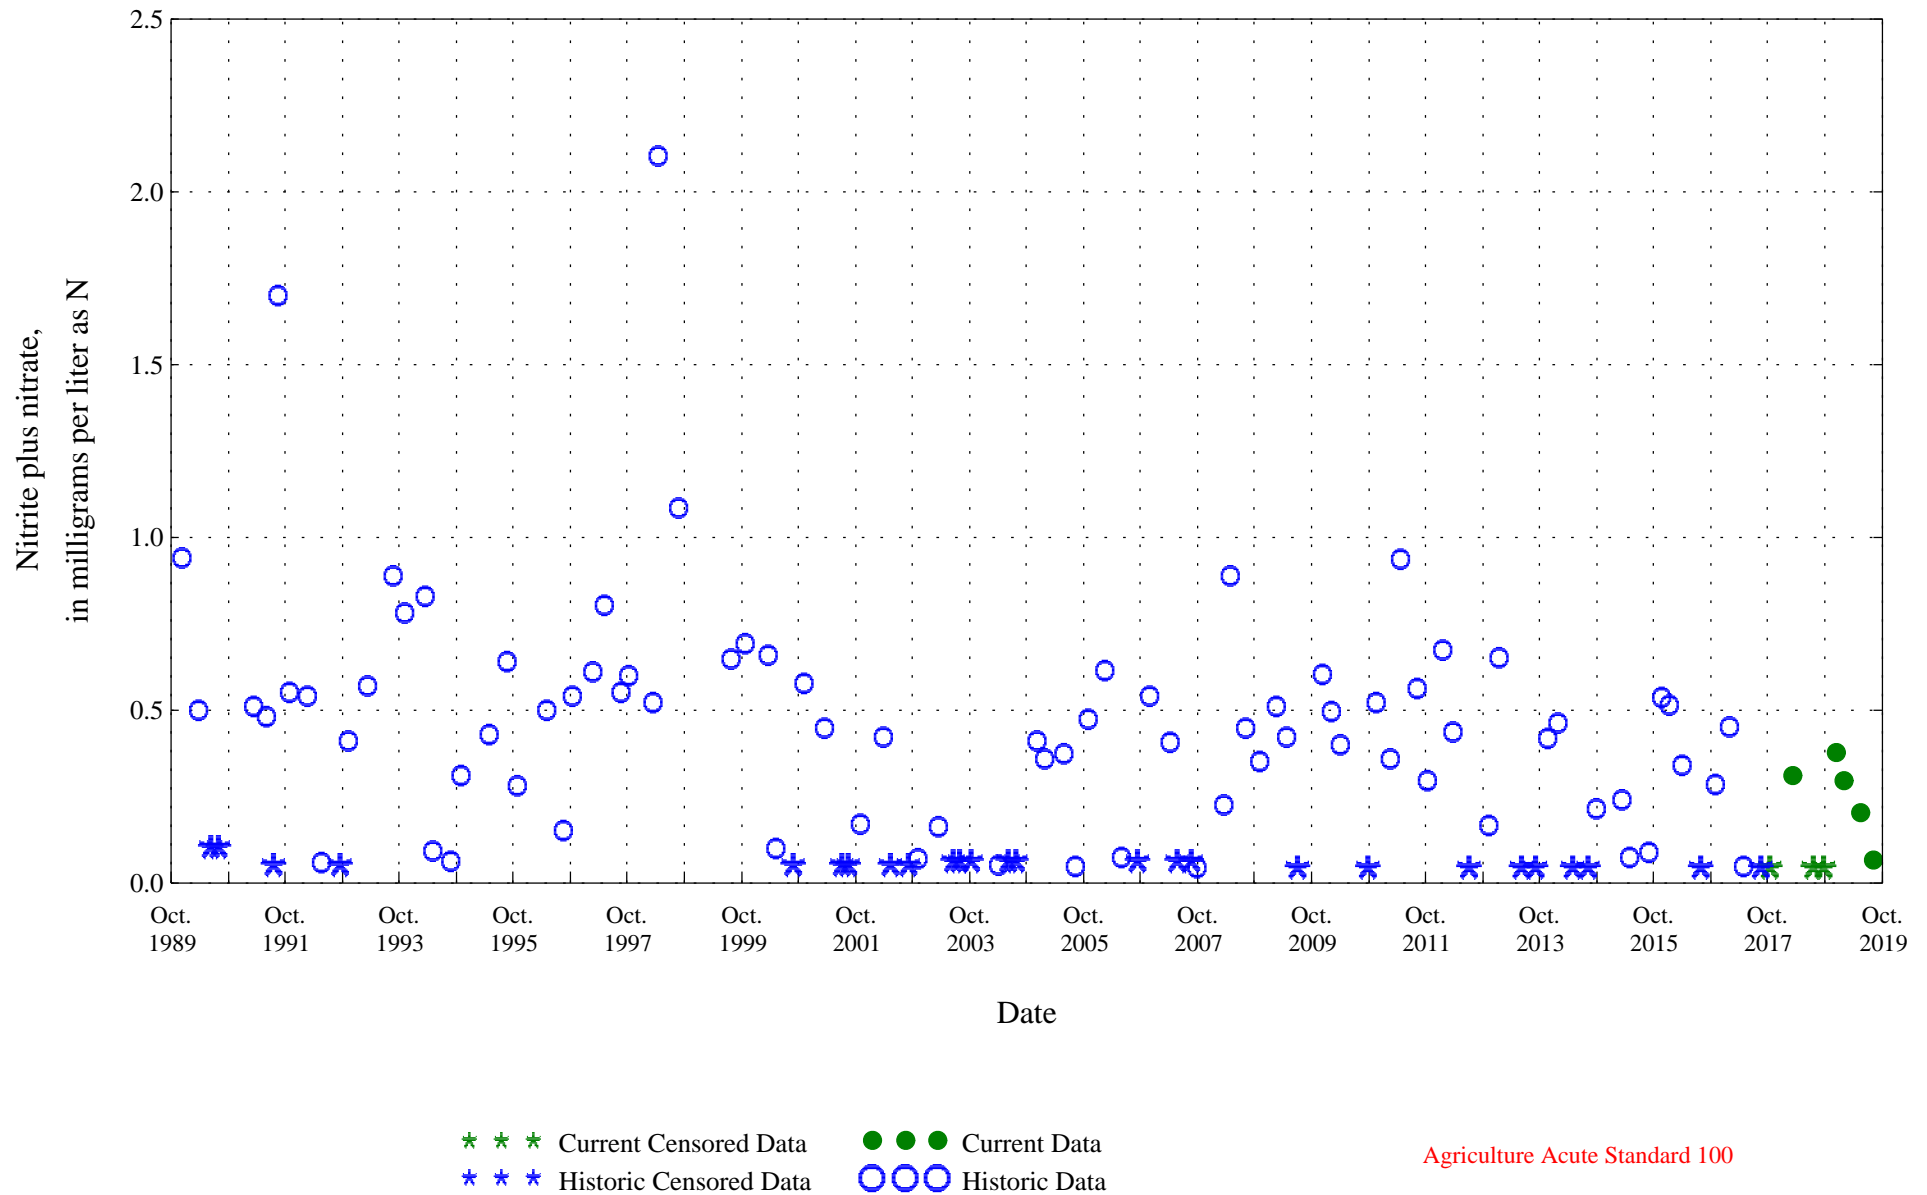
Figure 3. Distribution of selected water-quality constituents relative to time for

Piceance Creek below Ryan Gulch, near Rio Blanco, Co., station 09306200.

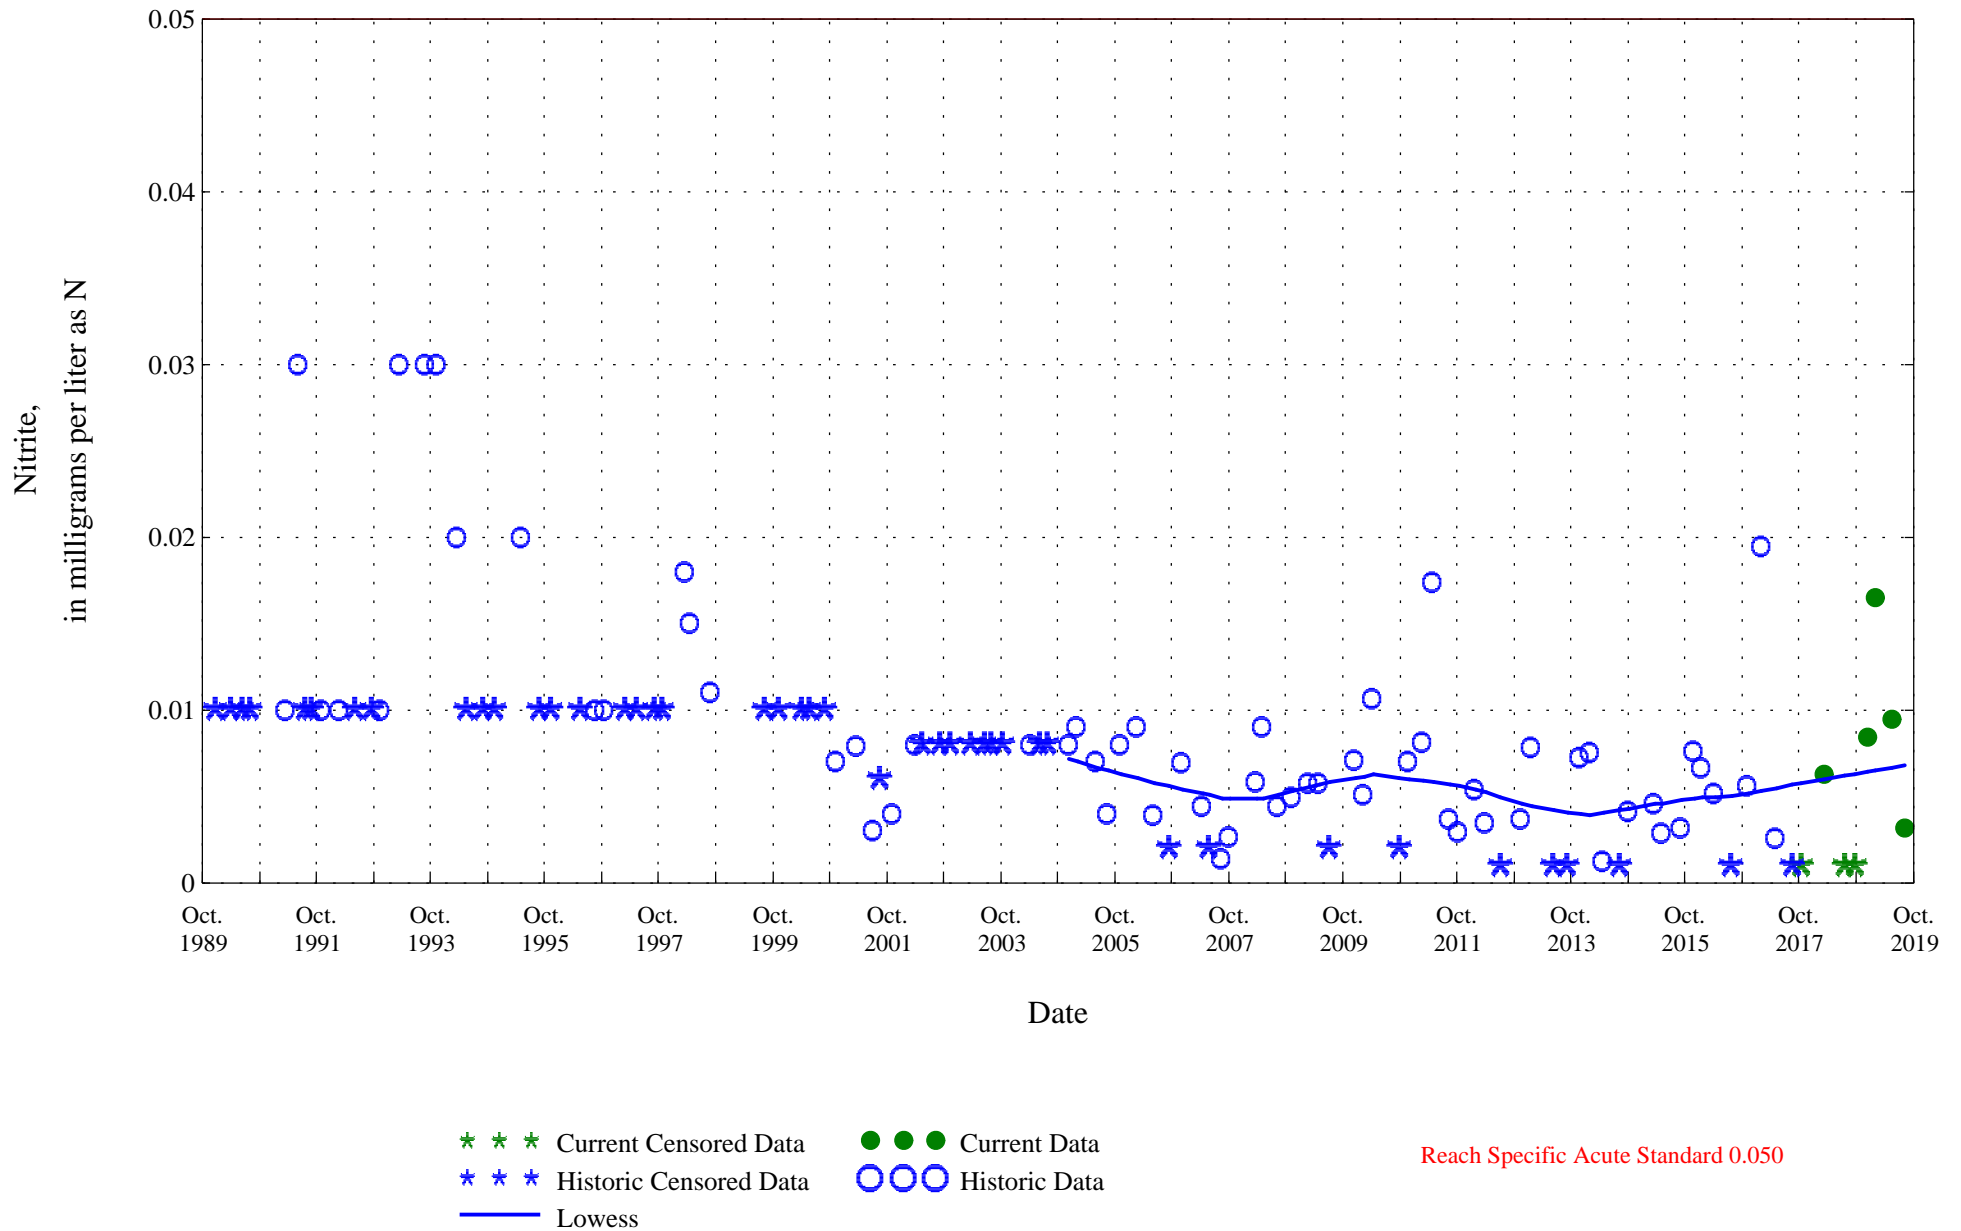
Piceance Creek below Ryan Gulch, near Rio Blanco, Co., station 09306200.

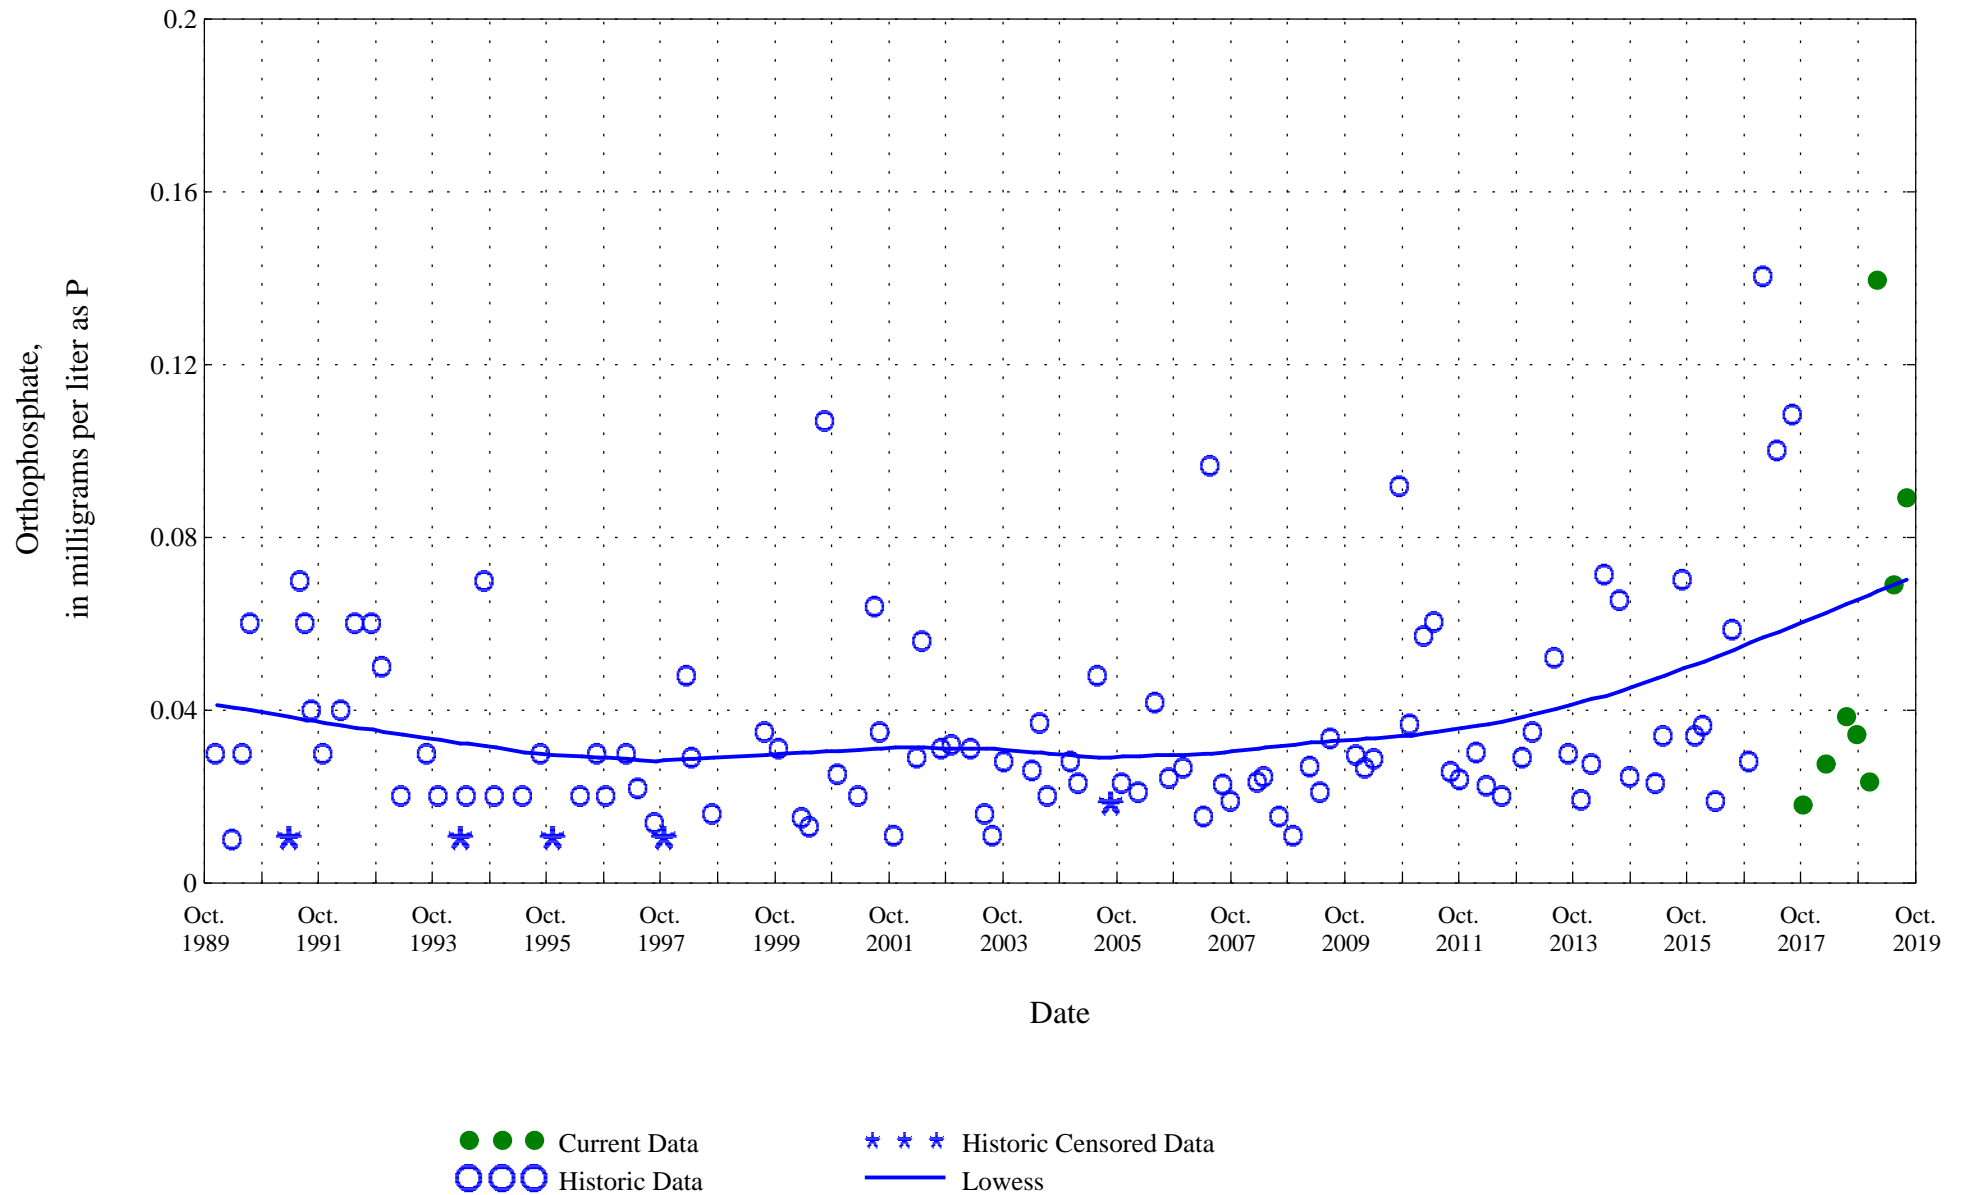
Piceance Creek below Ryan Gulch, near Rio Blanco, Co., station 09306200.

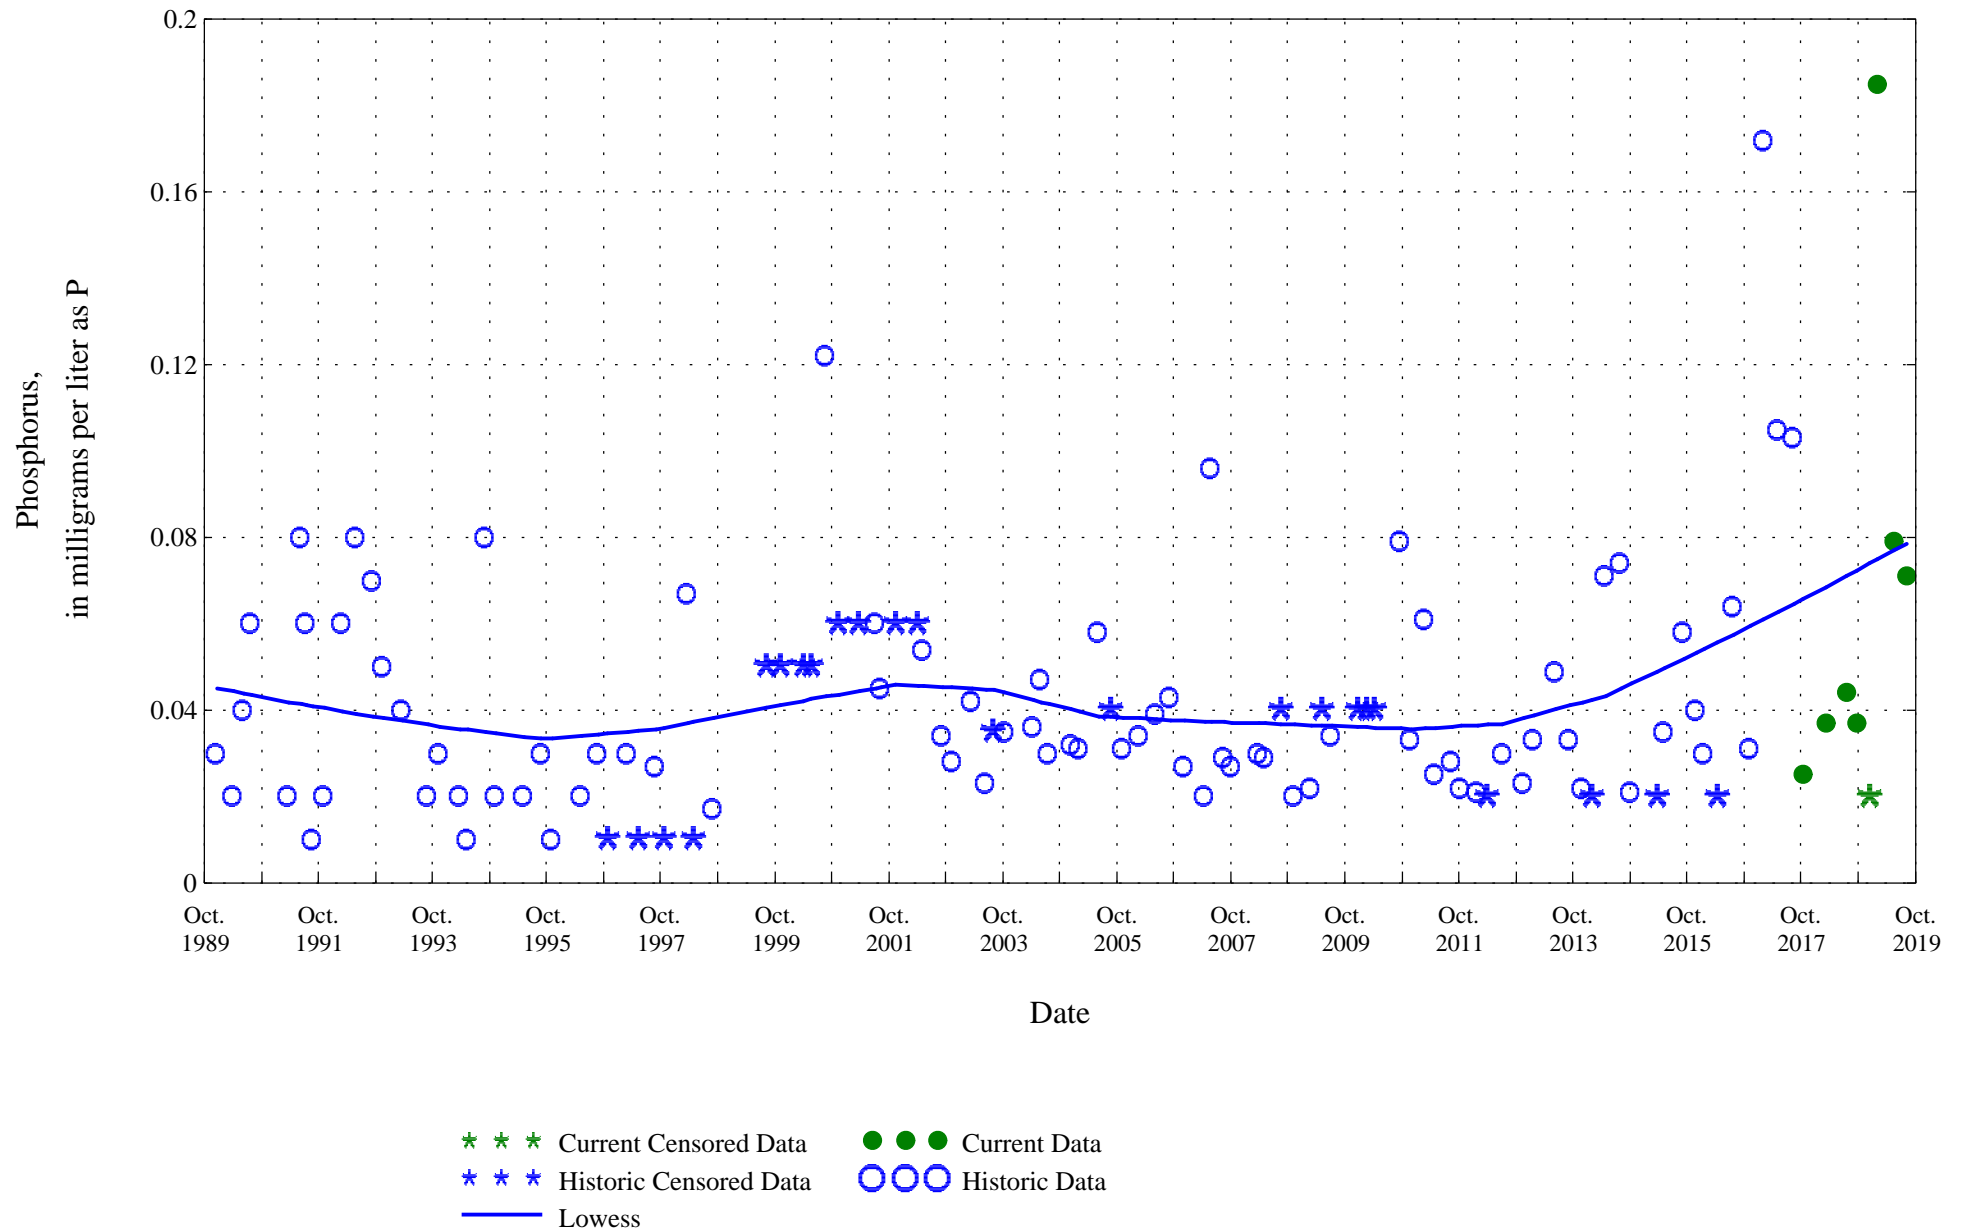
Figure 3. Distribution of selected water-quality constituents relative to time for

Piceance Creek below Ryan Gulch, near Rio Blanco, Co., station 09306200.
