Figure 3. Distribution of selected water-quality constituents relative to time for

Piceance Creek below Ryan Gulch, near Rio Blanco, Co., station 09306200.

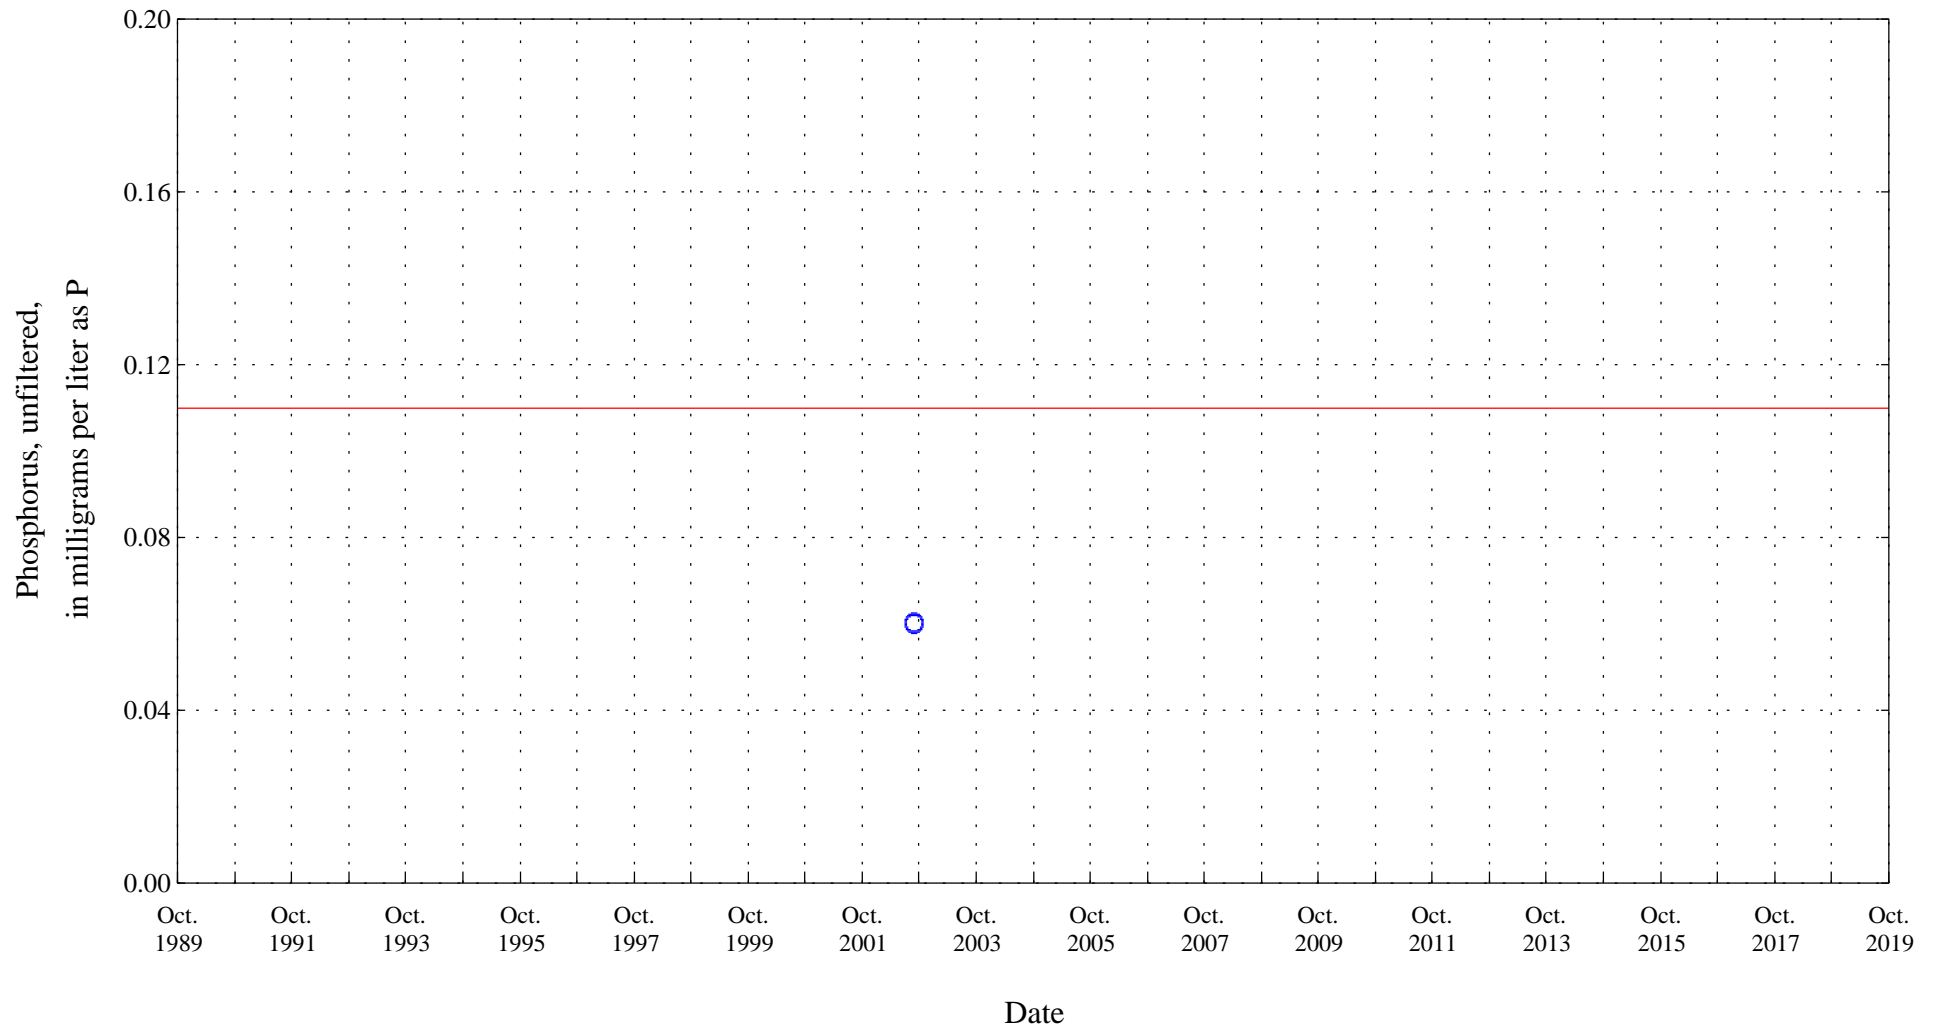
Figure 3. Distribution of selected water-quality constituents relative to time for

Piceance Creek below Ryan Gulch, near Rio Blanco, Co., station 09306200.

○ ○ ○ Historic Data

Aquatic Life Chronic Standard 0.11

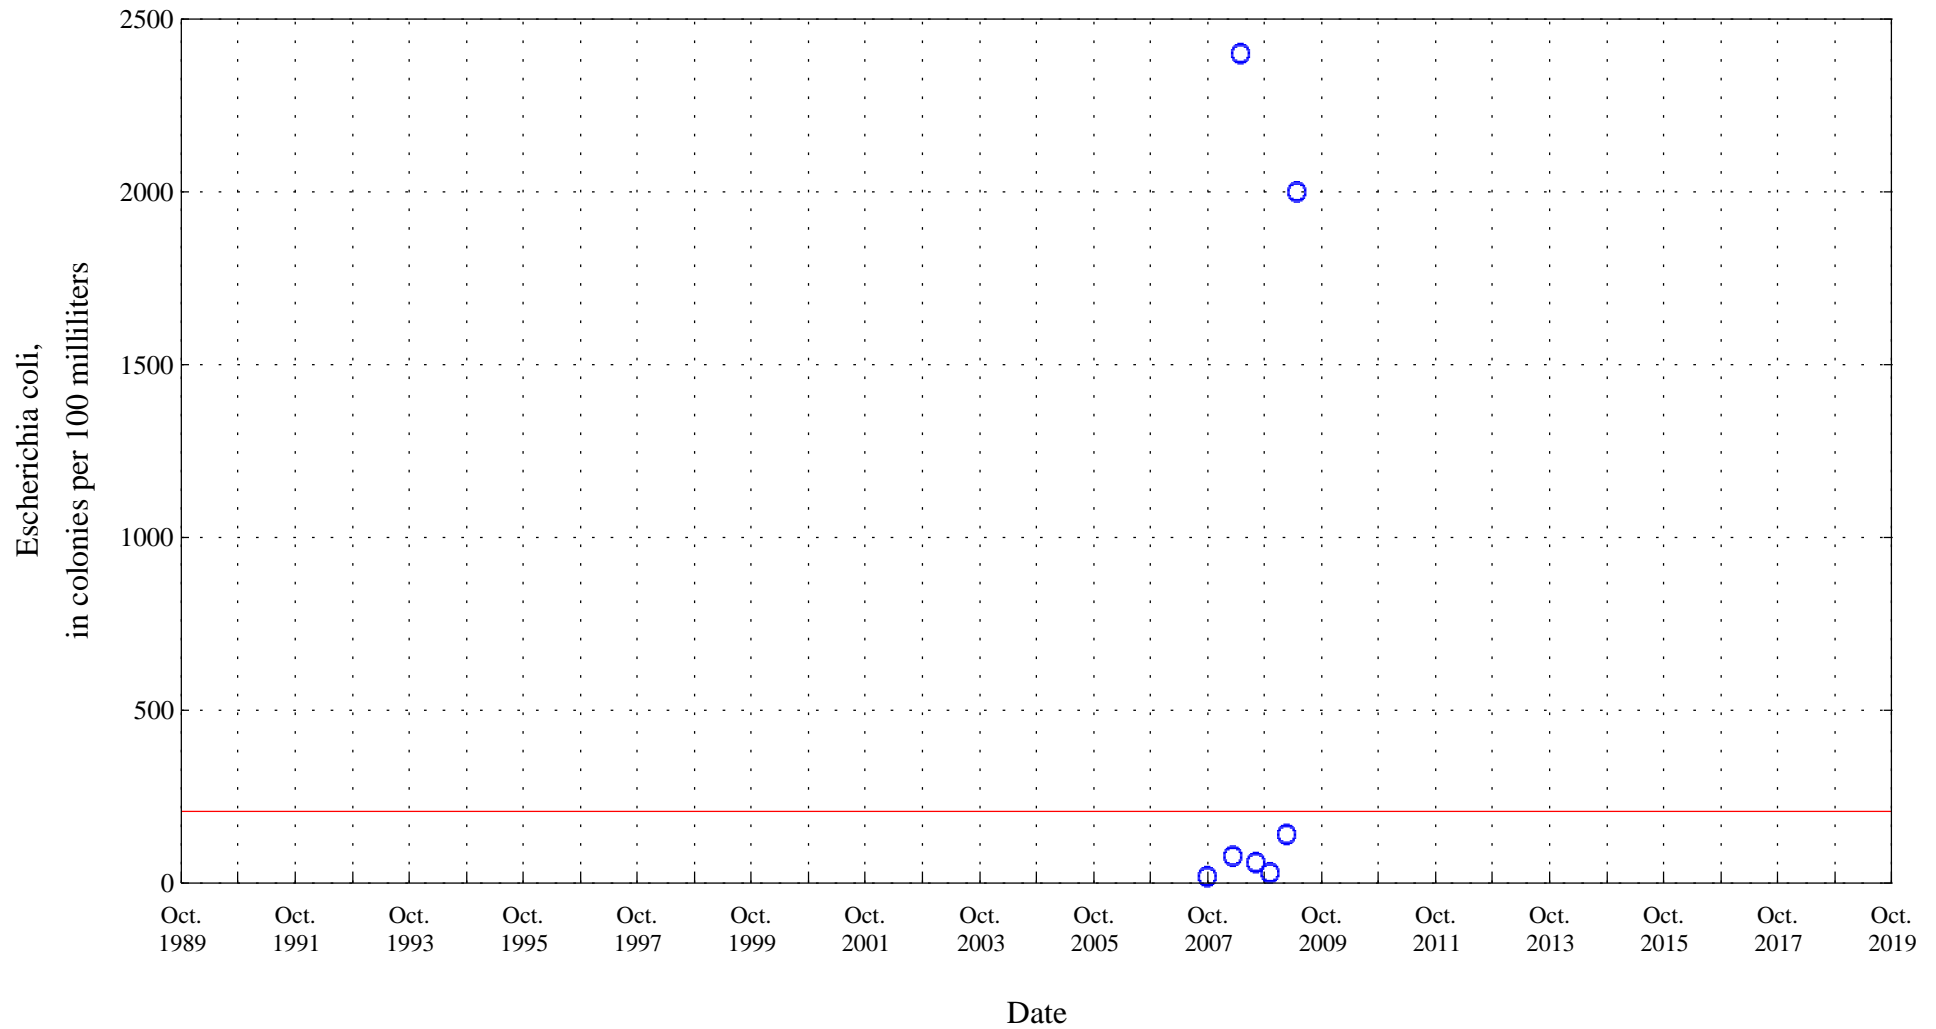
Figure 3. Distribution of selected water-quality constituents relative to time for

Piceance Creek below Ryan Gulch, near Rio Blanco, Co., station 09306200.

○ ○ ○ Historic Data

Recreation P Standard 205

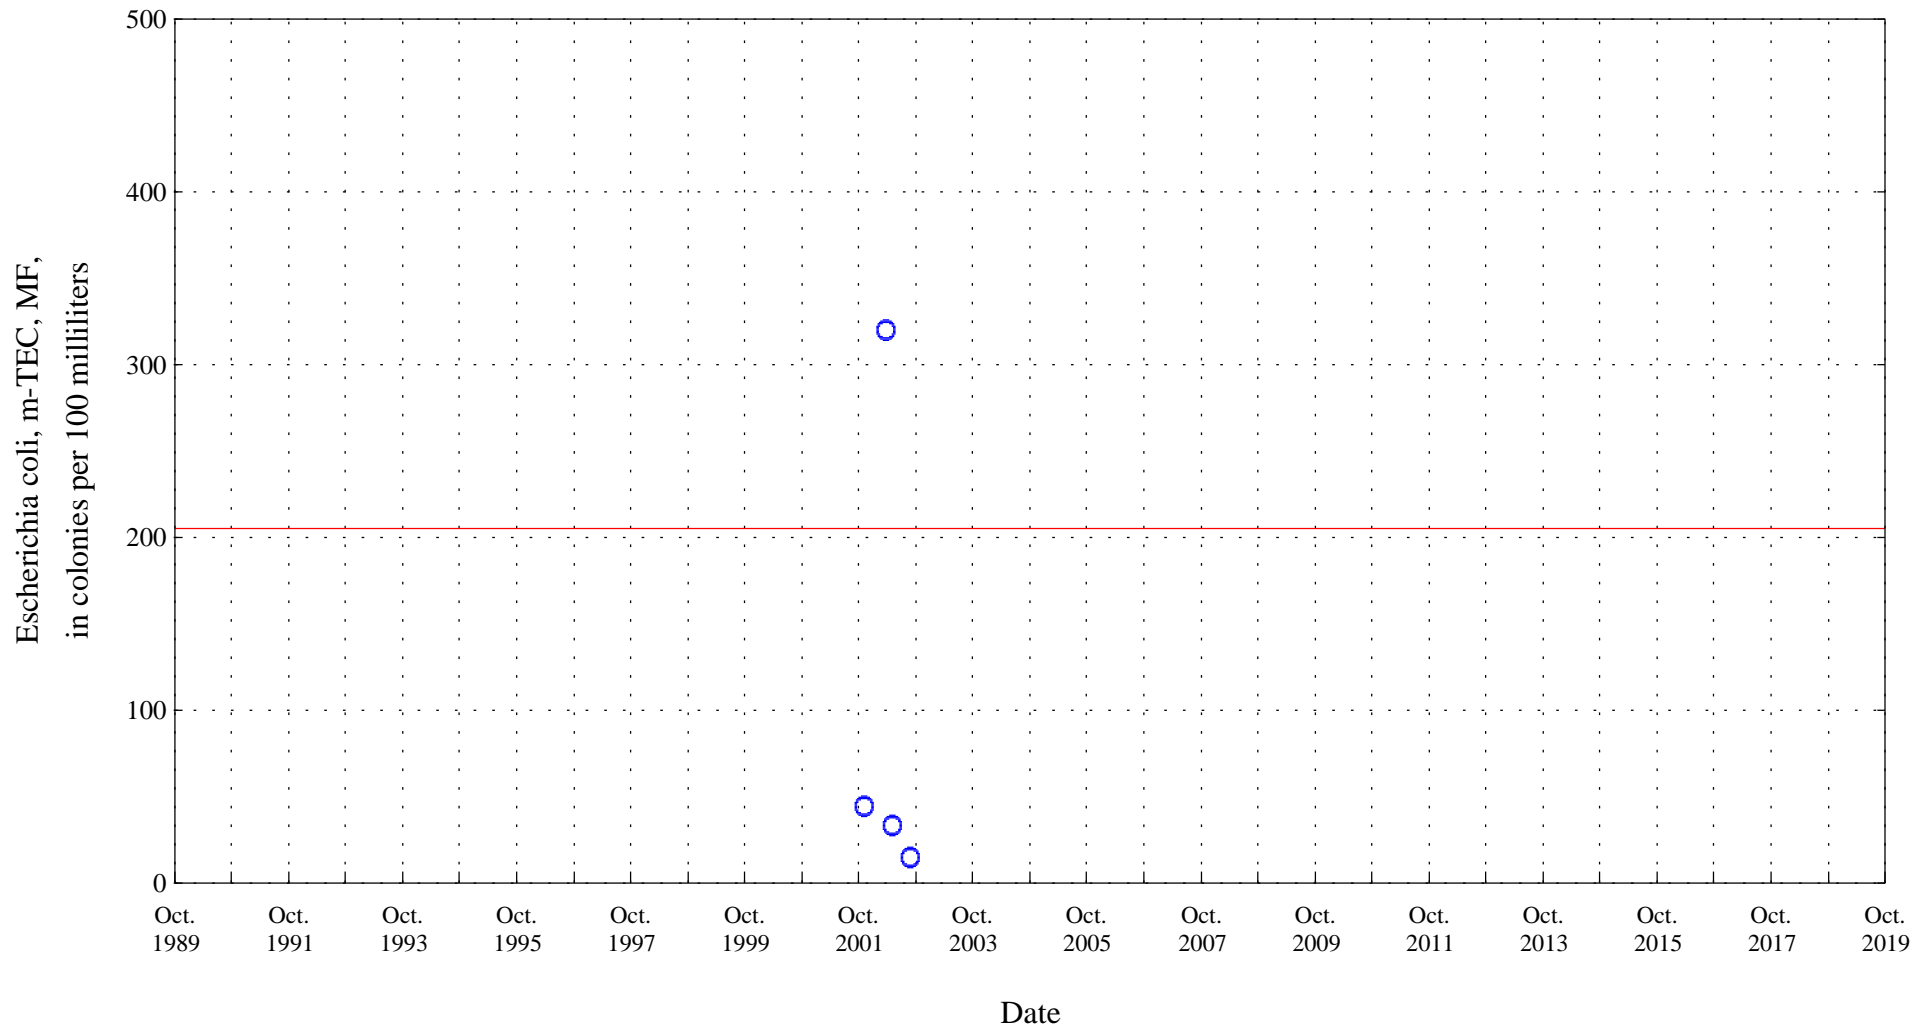
Figure 3. Distribution of selected water-quality constituents relative to time for

Piceance Creek below Ryan Gulch, near Rio Blanco, Co., station 09306200.

○ ○ ○ Historic Data

Recreation P Standard 205

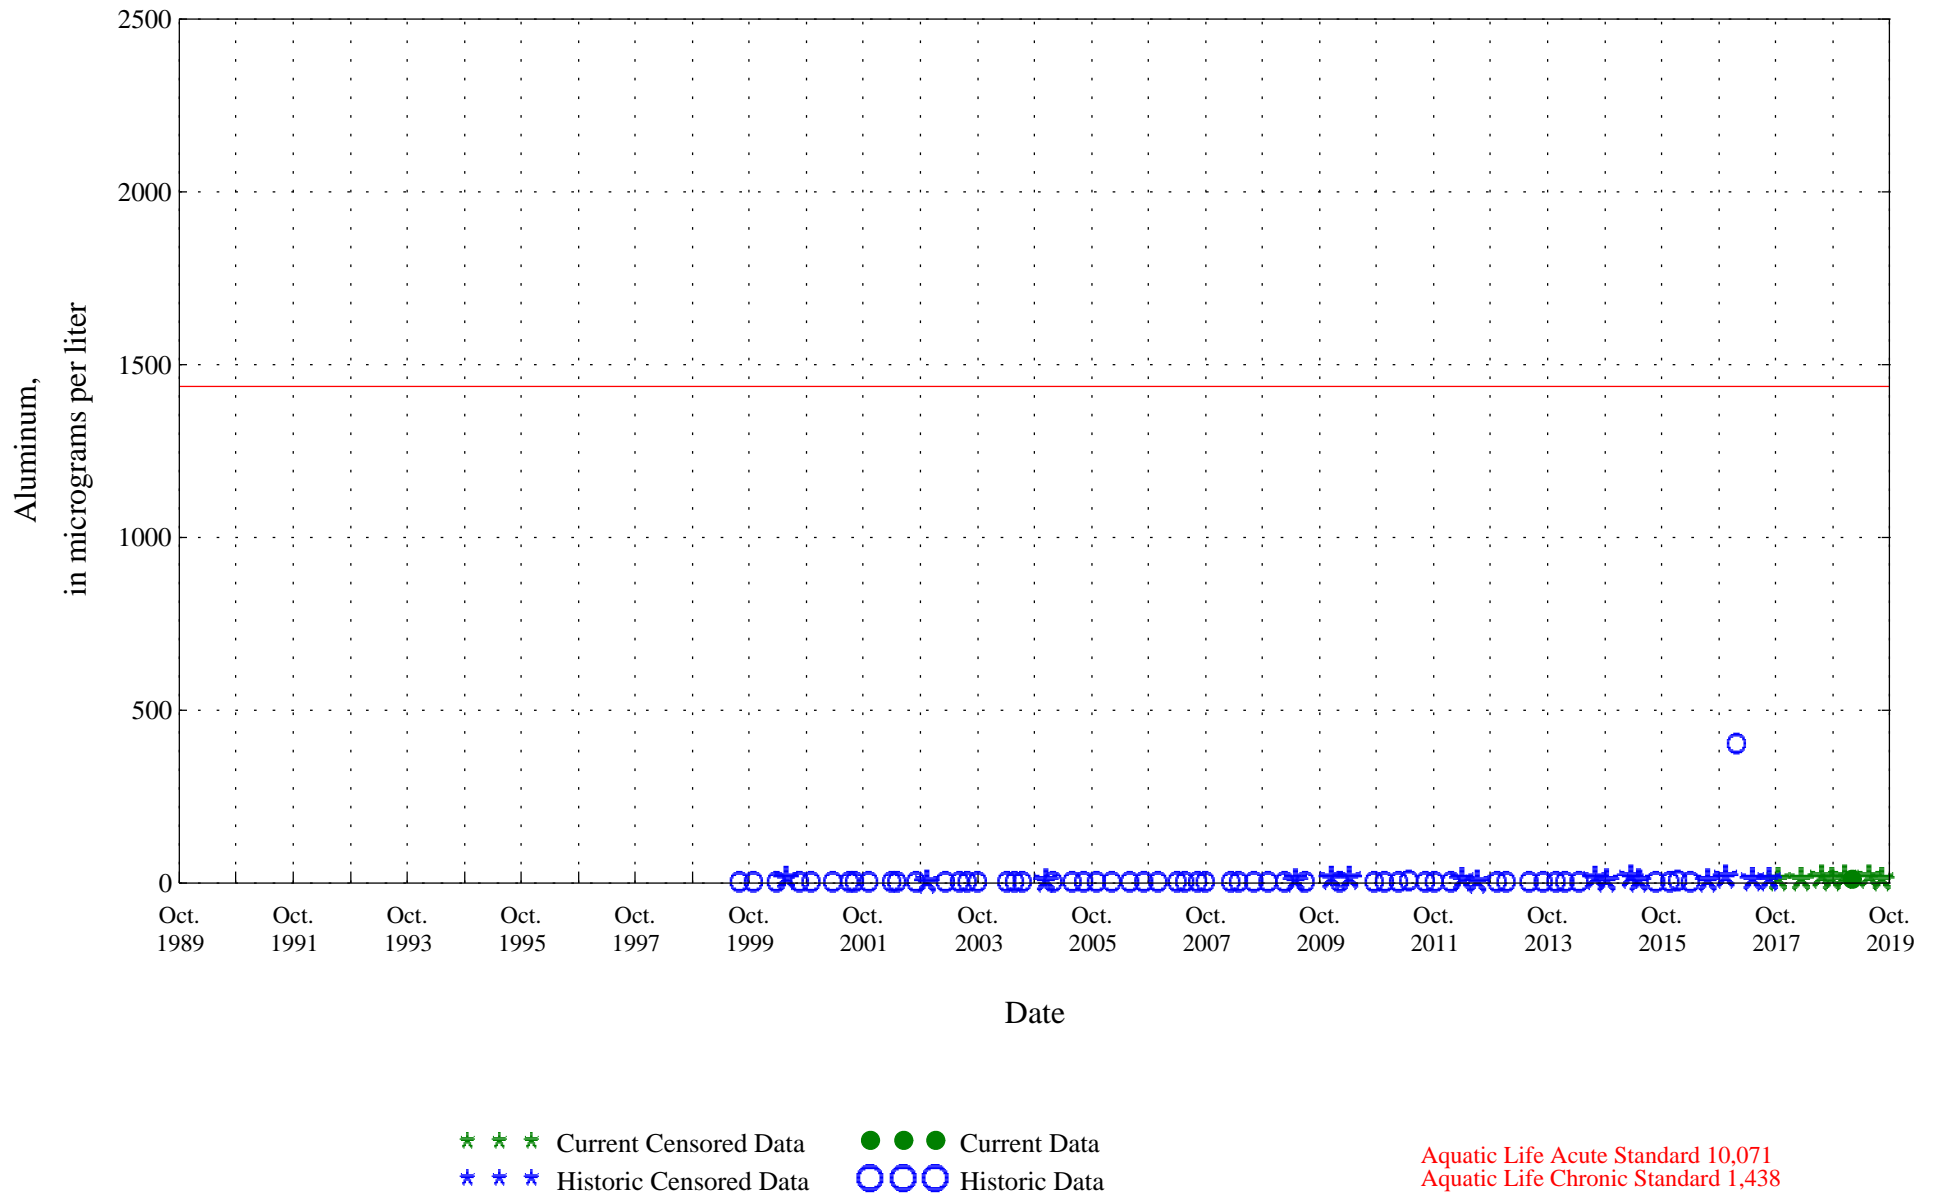
Figure 3. Distribution of selected water-quality constituents relative to time for

Piceance Creek below Ryan Gulch, near Rio Blanco, Co., station 09306200.

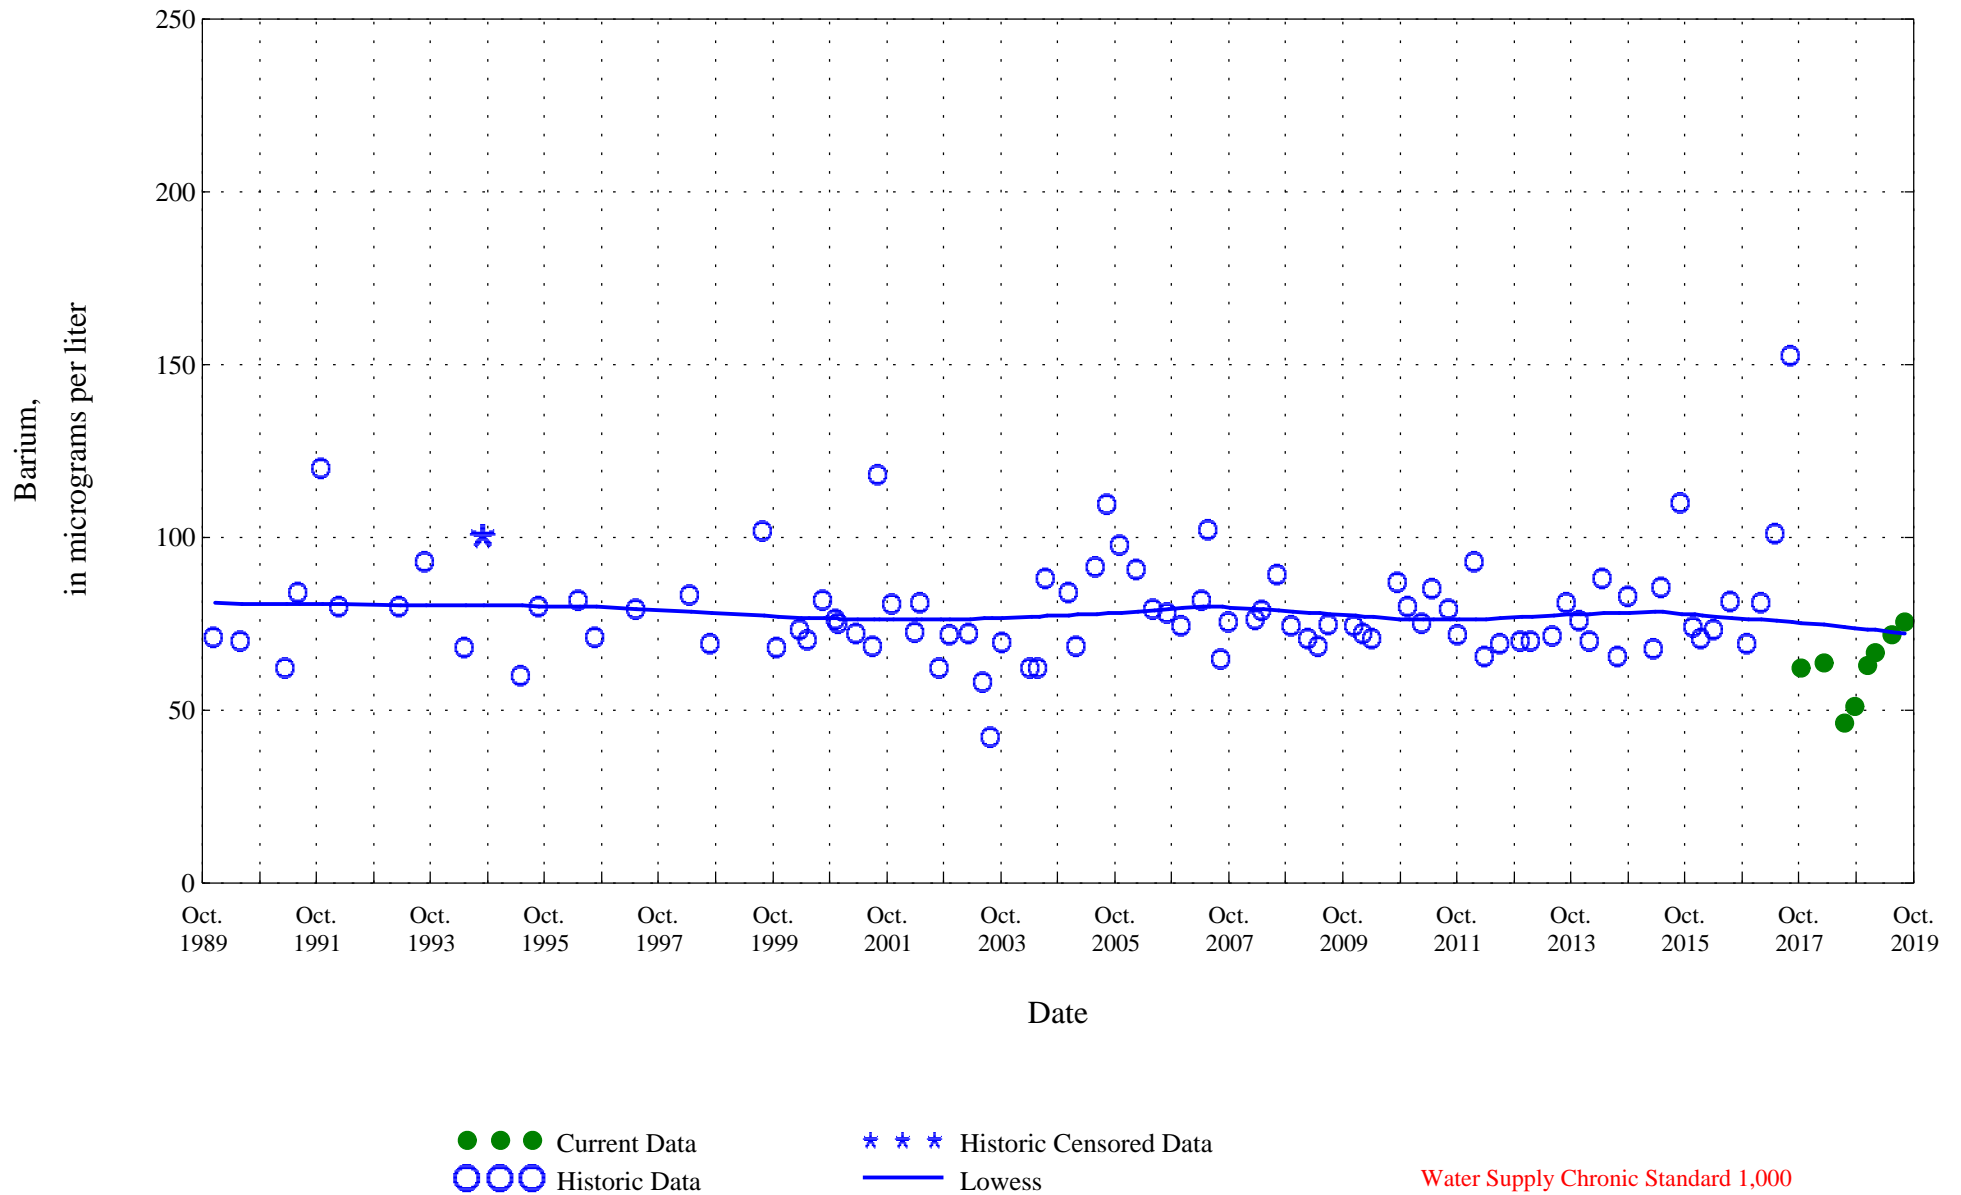
Figure 3. Distribution of selected water-quality constituents relative to time for

Piceance Creek below Ryan Gulch, near Rio Blanco, Co., station 09306200.

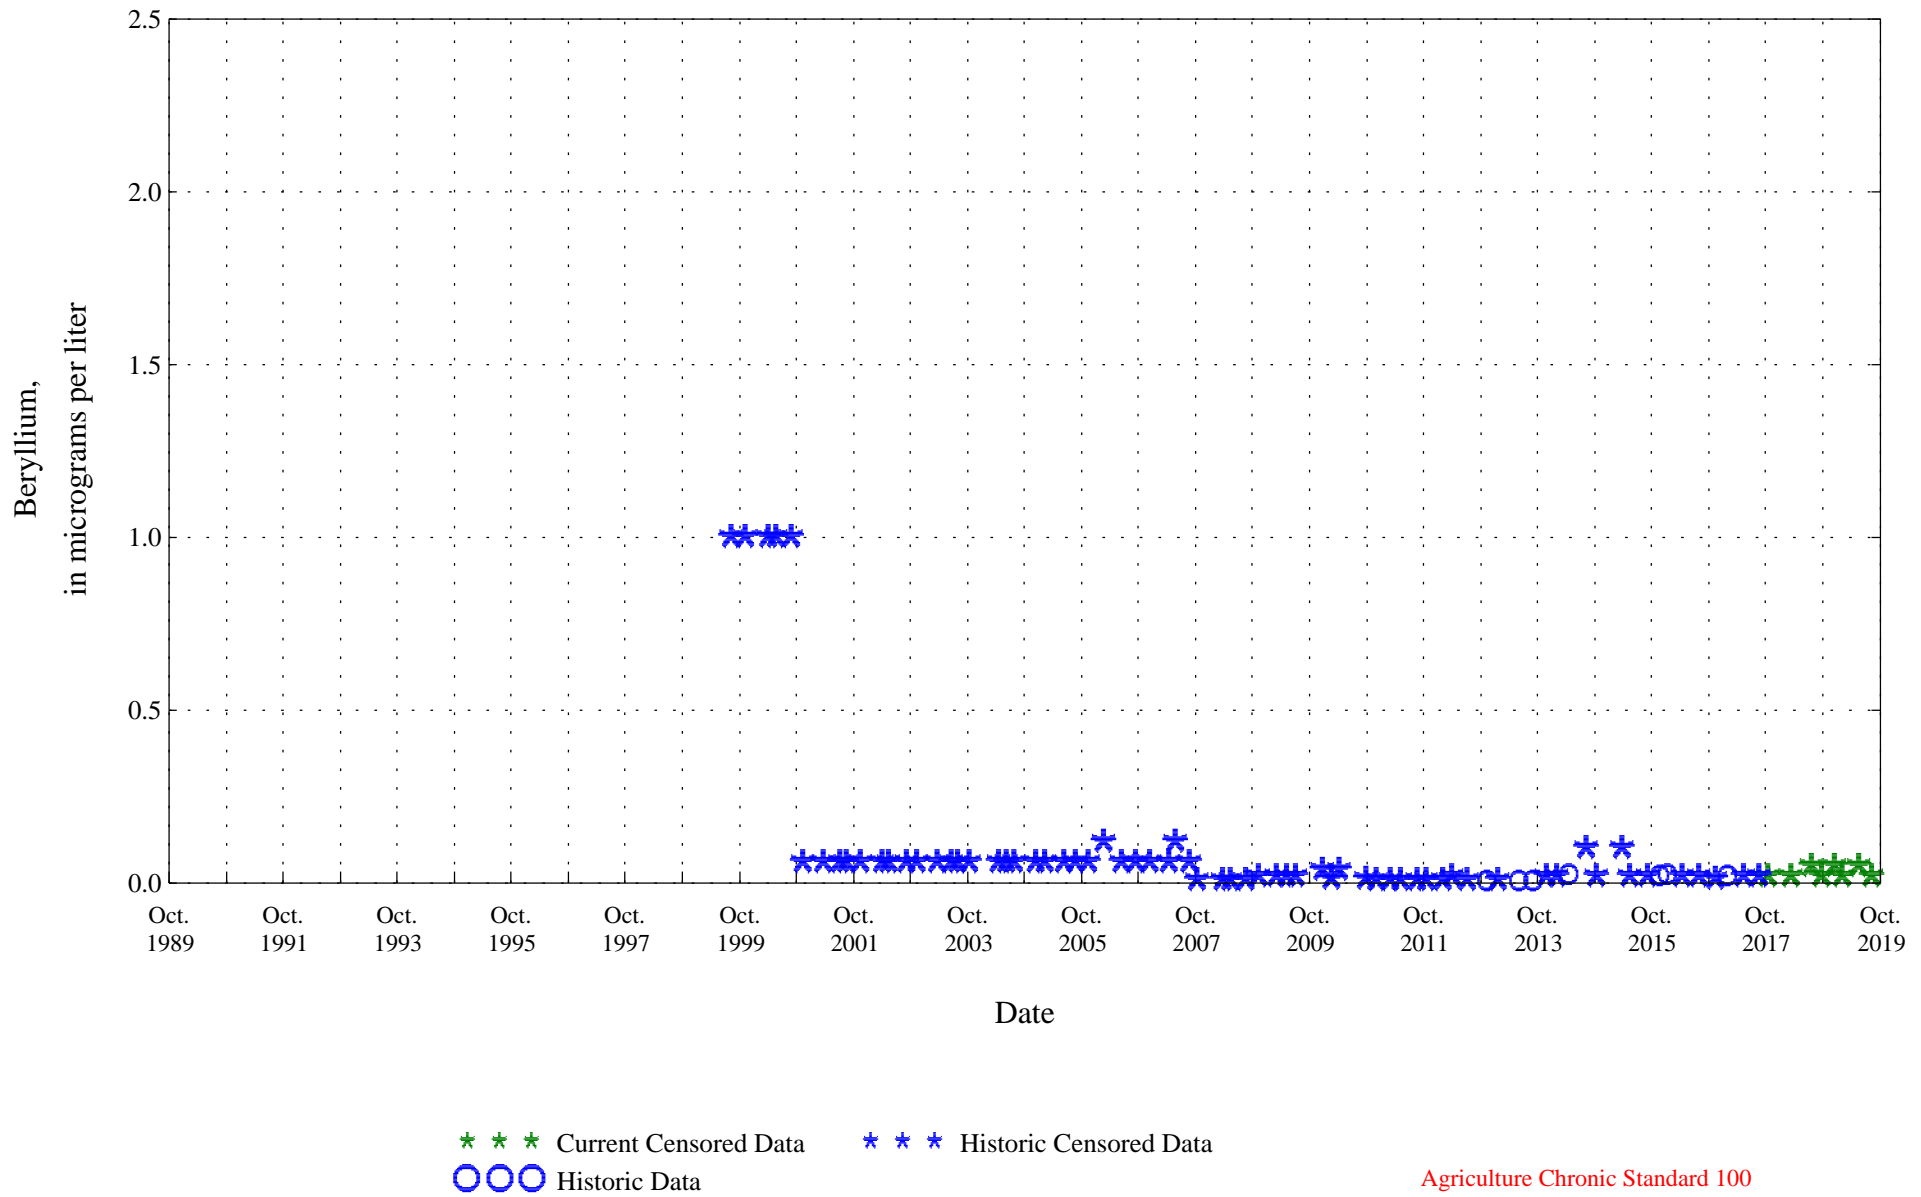
Figure 3. Distribution of selected water-quality constituents relative to time for

Piceance Creek below Ryan Gulch, near Rio Blanco, Co., station 09306200.

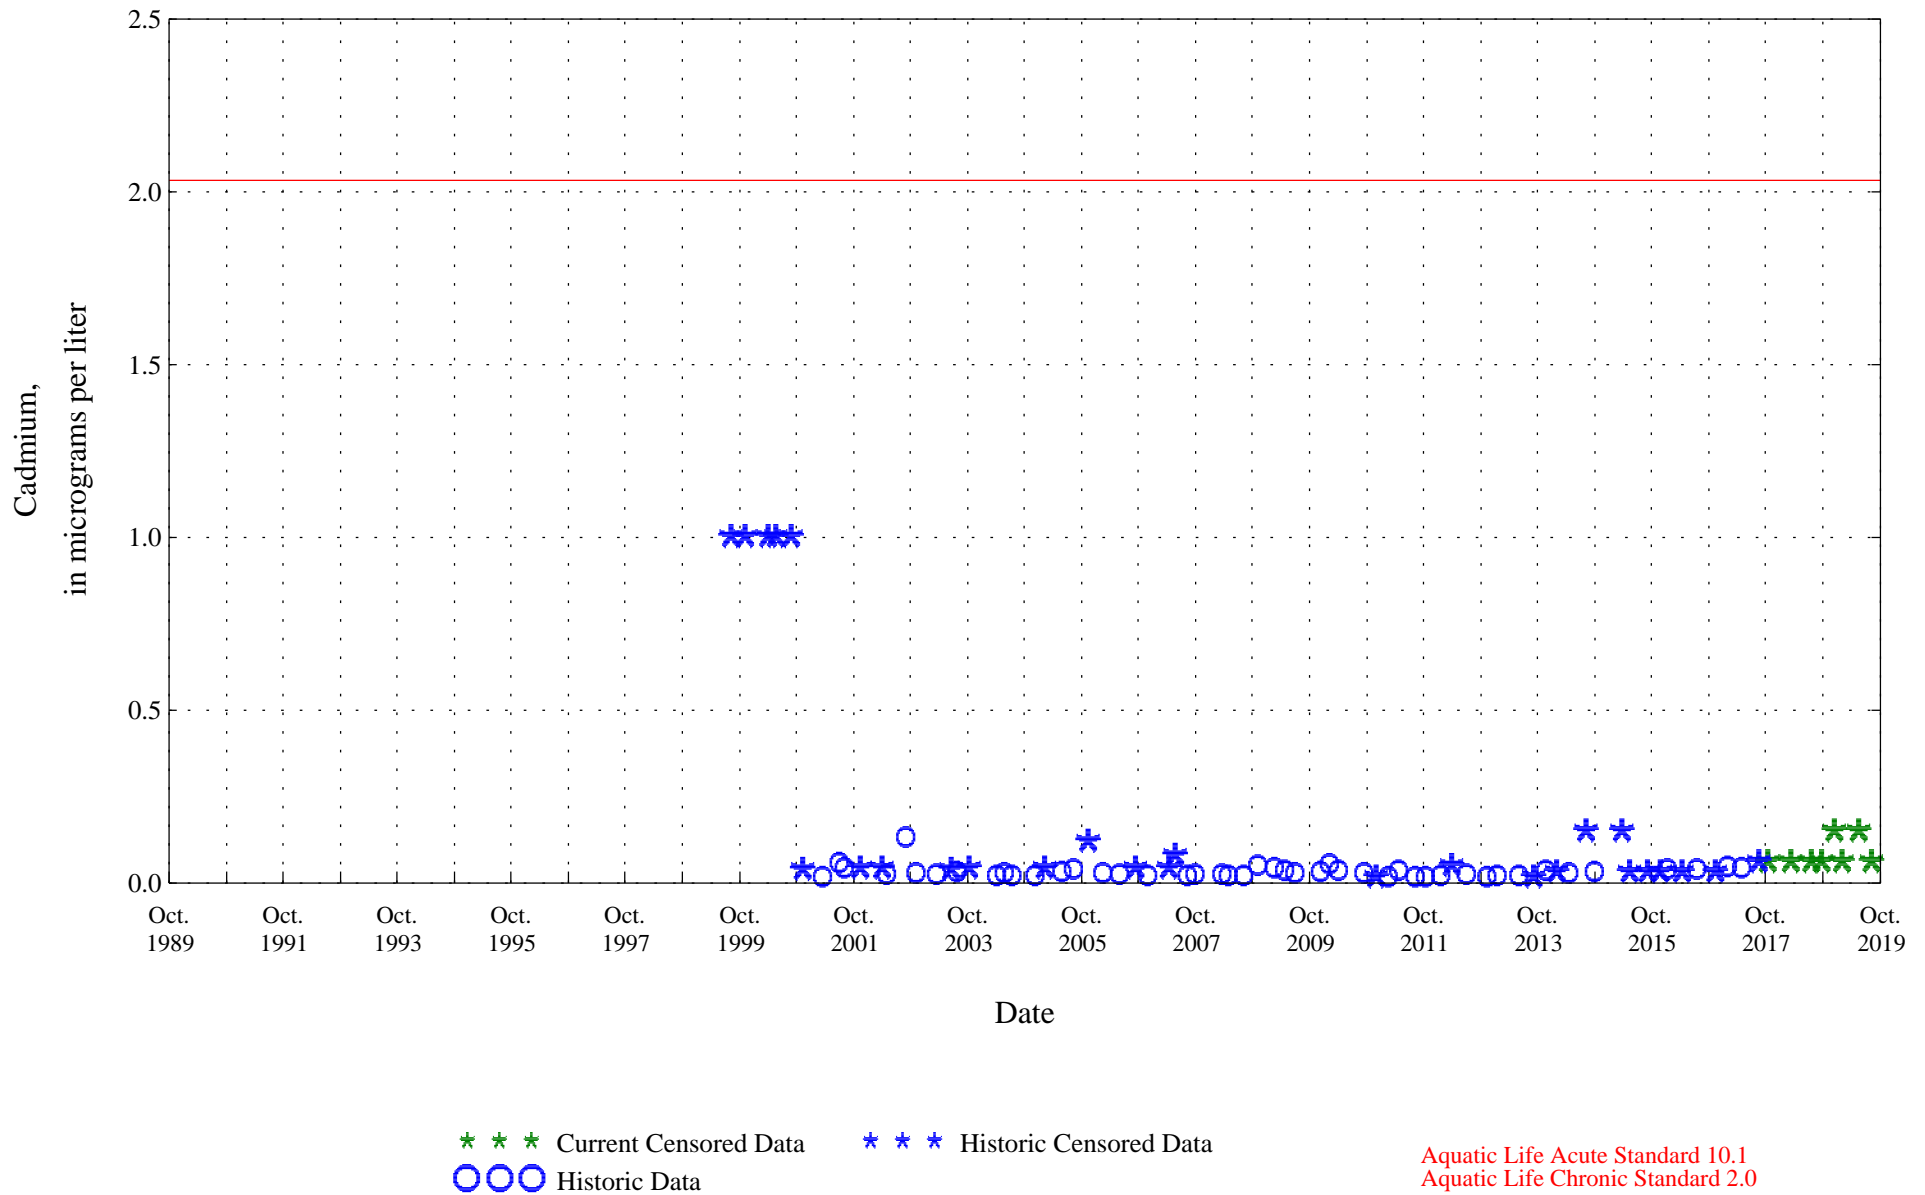
Figure 3. Distribution of selected water-quality constituents relative to time for

Piceance Creek below Ryan Gulch, near Rio Blanco, Co., station 09306200.

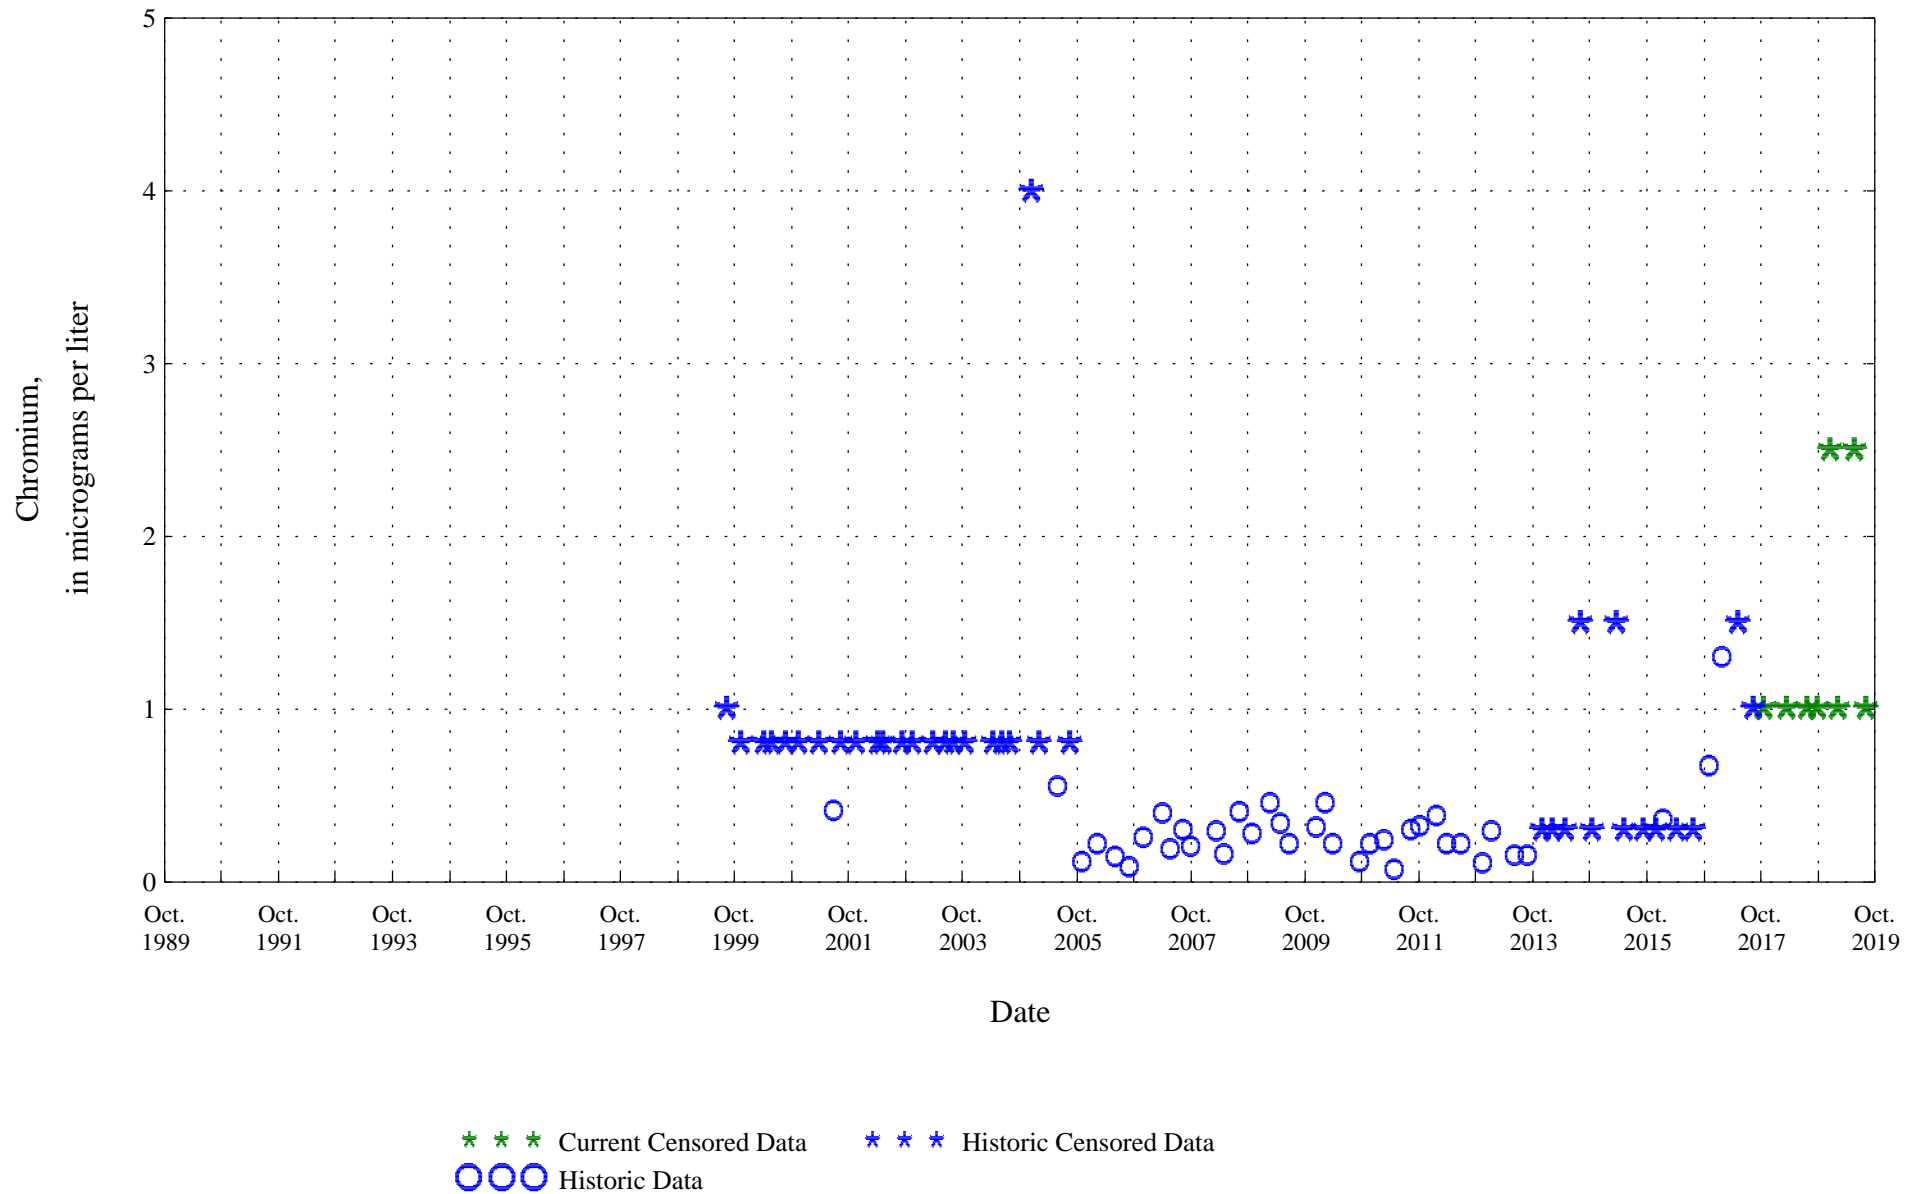
Figure 3. Distribution of selected water-quality constituents relative to time for

Piceance Creek below Ryan Gulch, near Rio Blanco, Co., station 09306200.

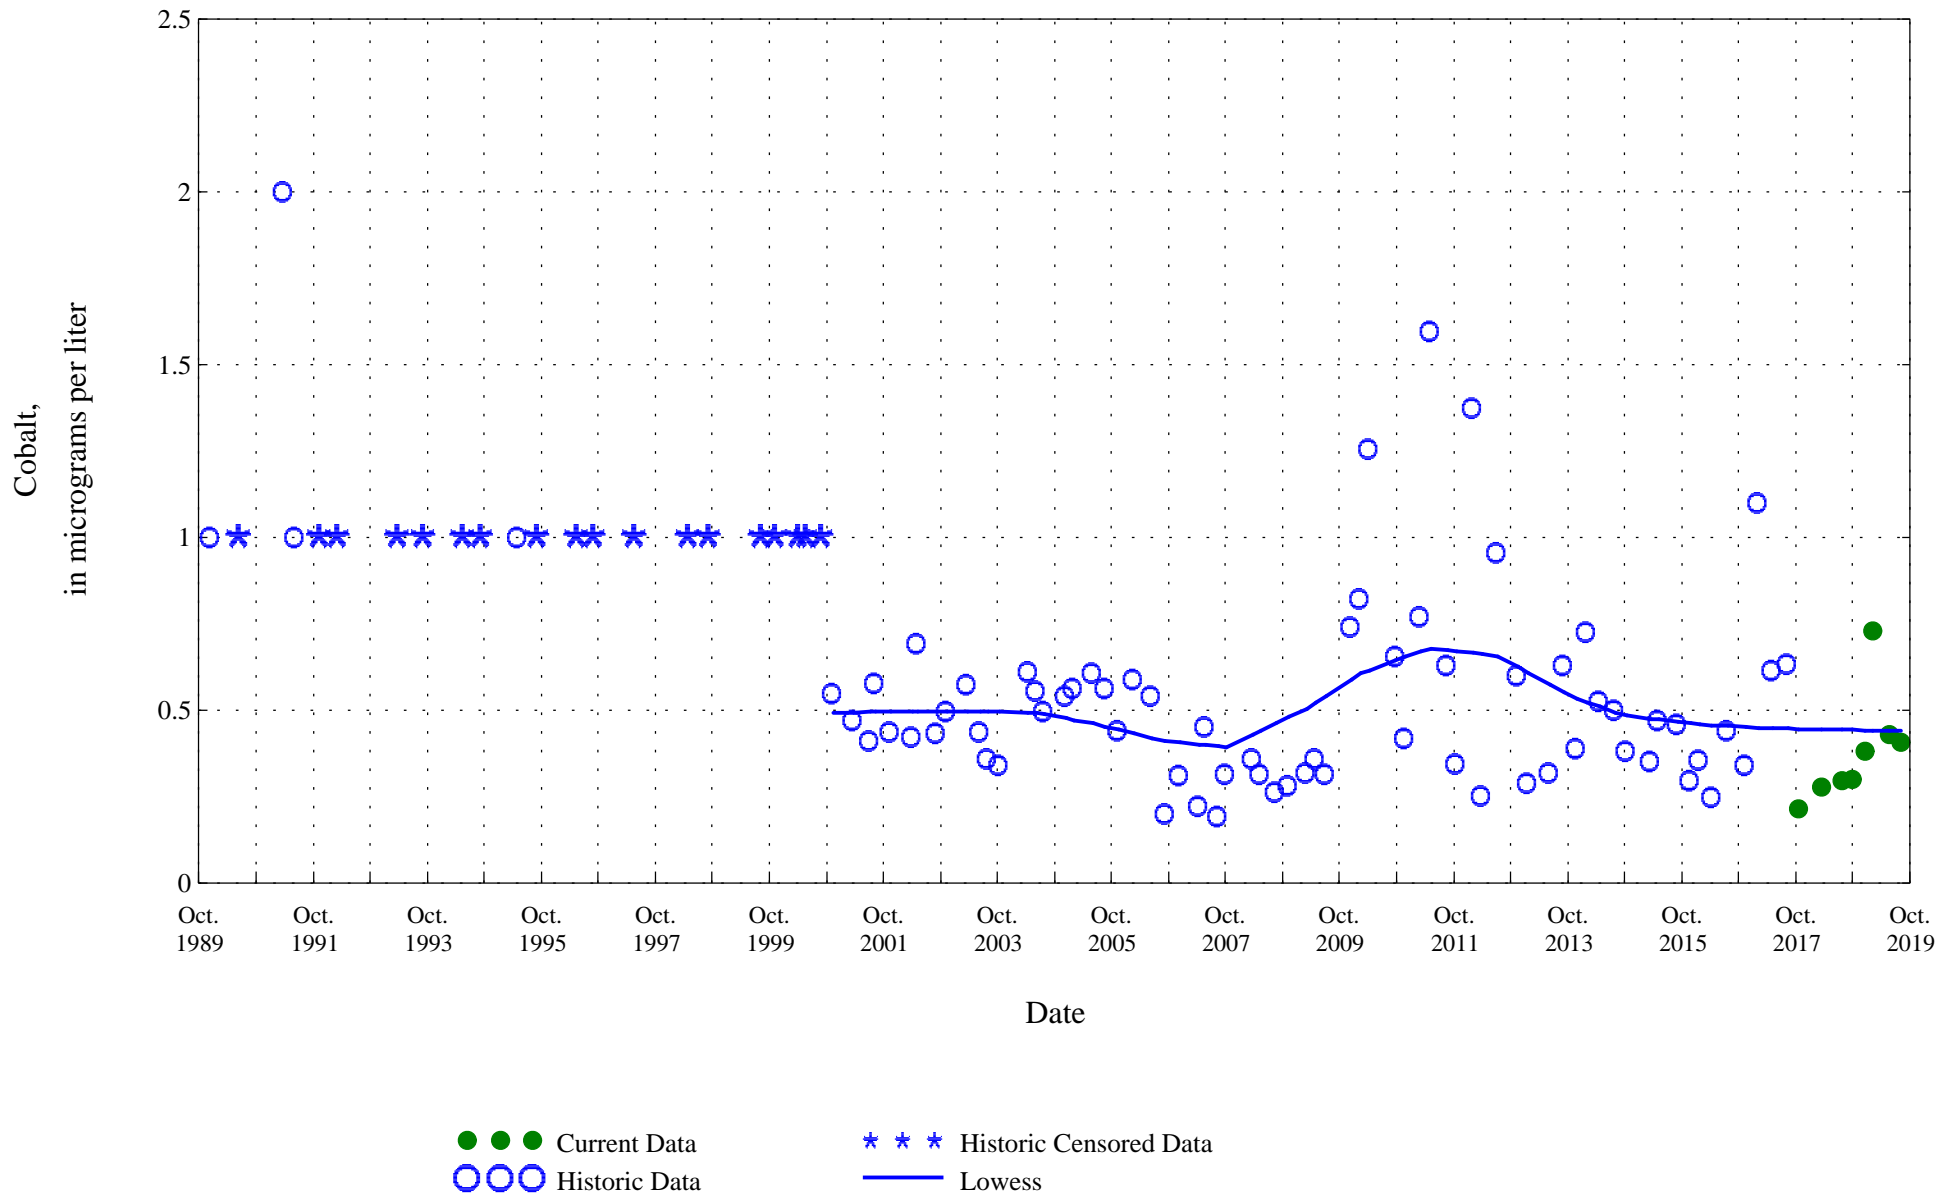
Figure 3. Distribution of selected water-quality constituents relative to time for

Piceance Creek below Ryan Gulch, near Rio Blanco, Co., station 09306200.

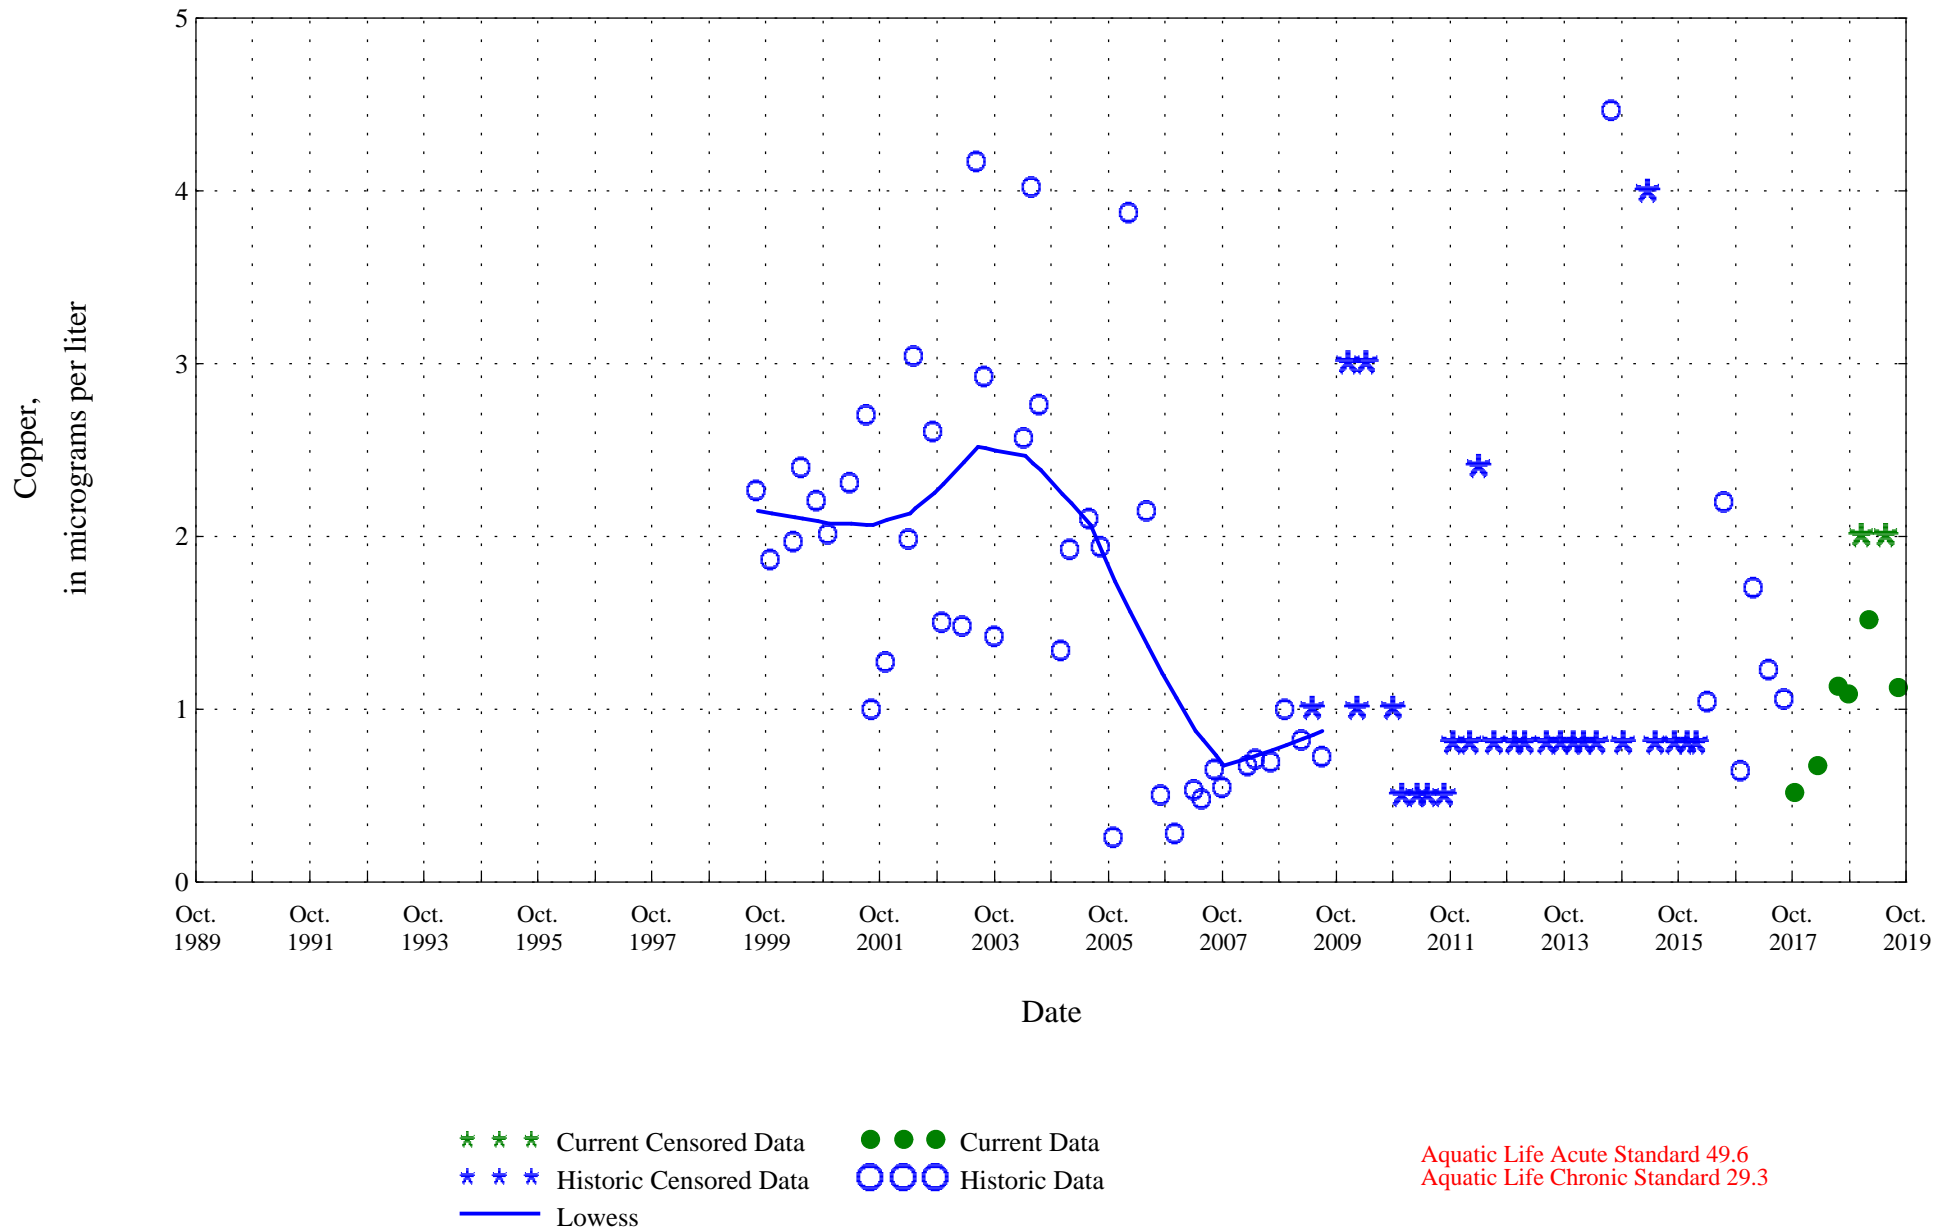
Figure 3. Distribution of selected water-quality constituents relative to time for

Piceance Creek below Ryan Gulch, near Rio Blanco, Co., station 09306200.
