Figure 3. Distribution of selected water-quality constituents relative to time for

Piceance Creek below Ryan Gulch, near Rio Blanco, Co., station 09306200.

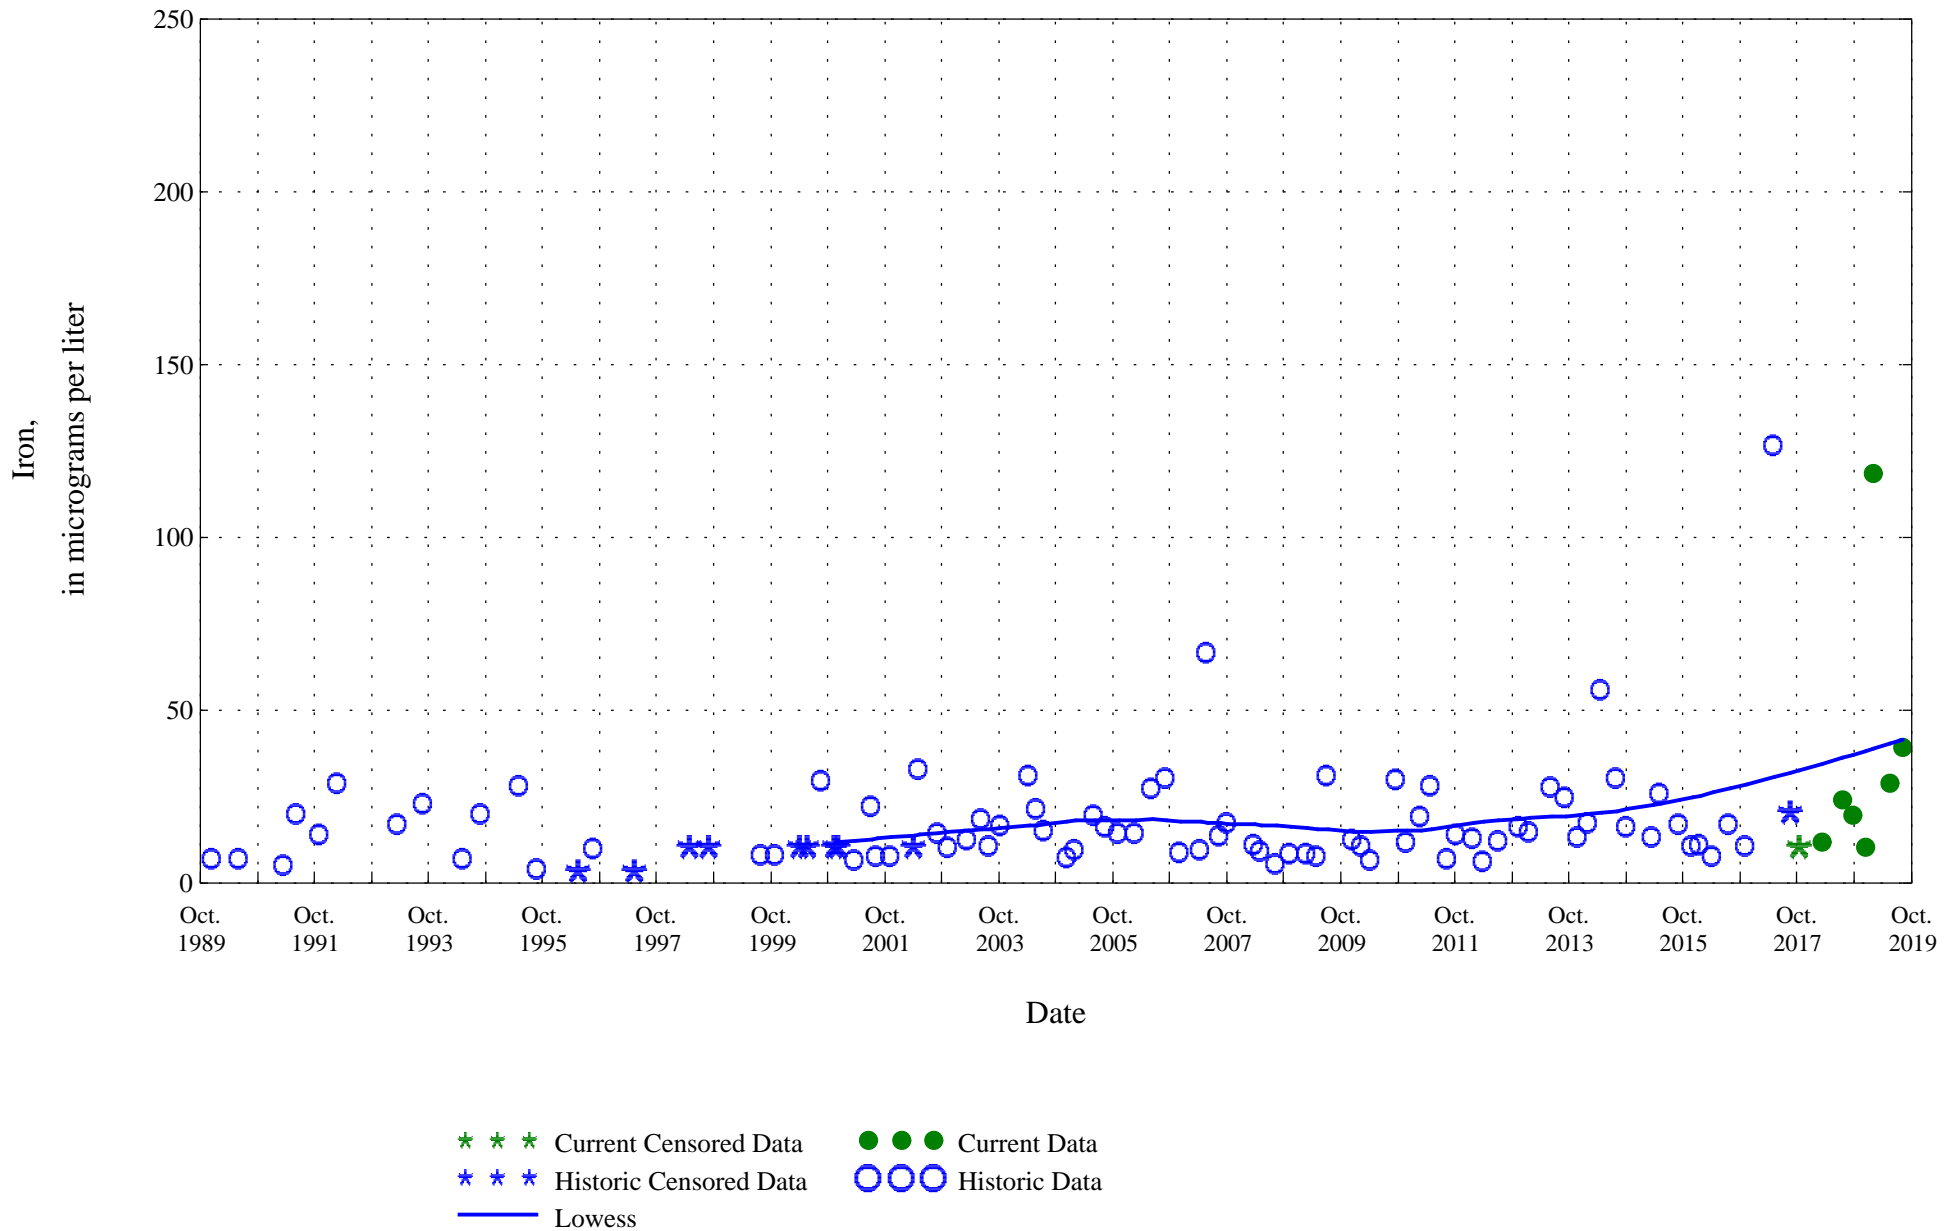
Figure 3. Distribution of selected water-quality constituents relative to time for

Piceance Creek below Ryan Gulch, near Rio Blanco, Co., station 09306200.

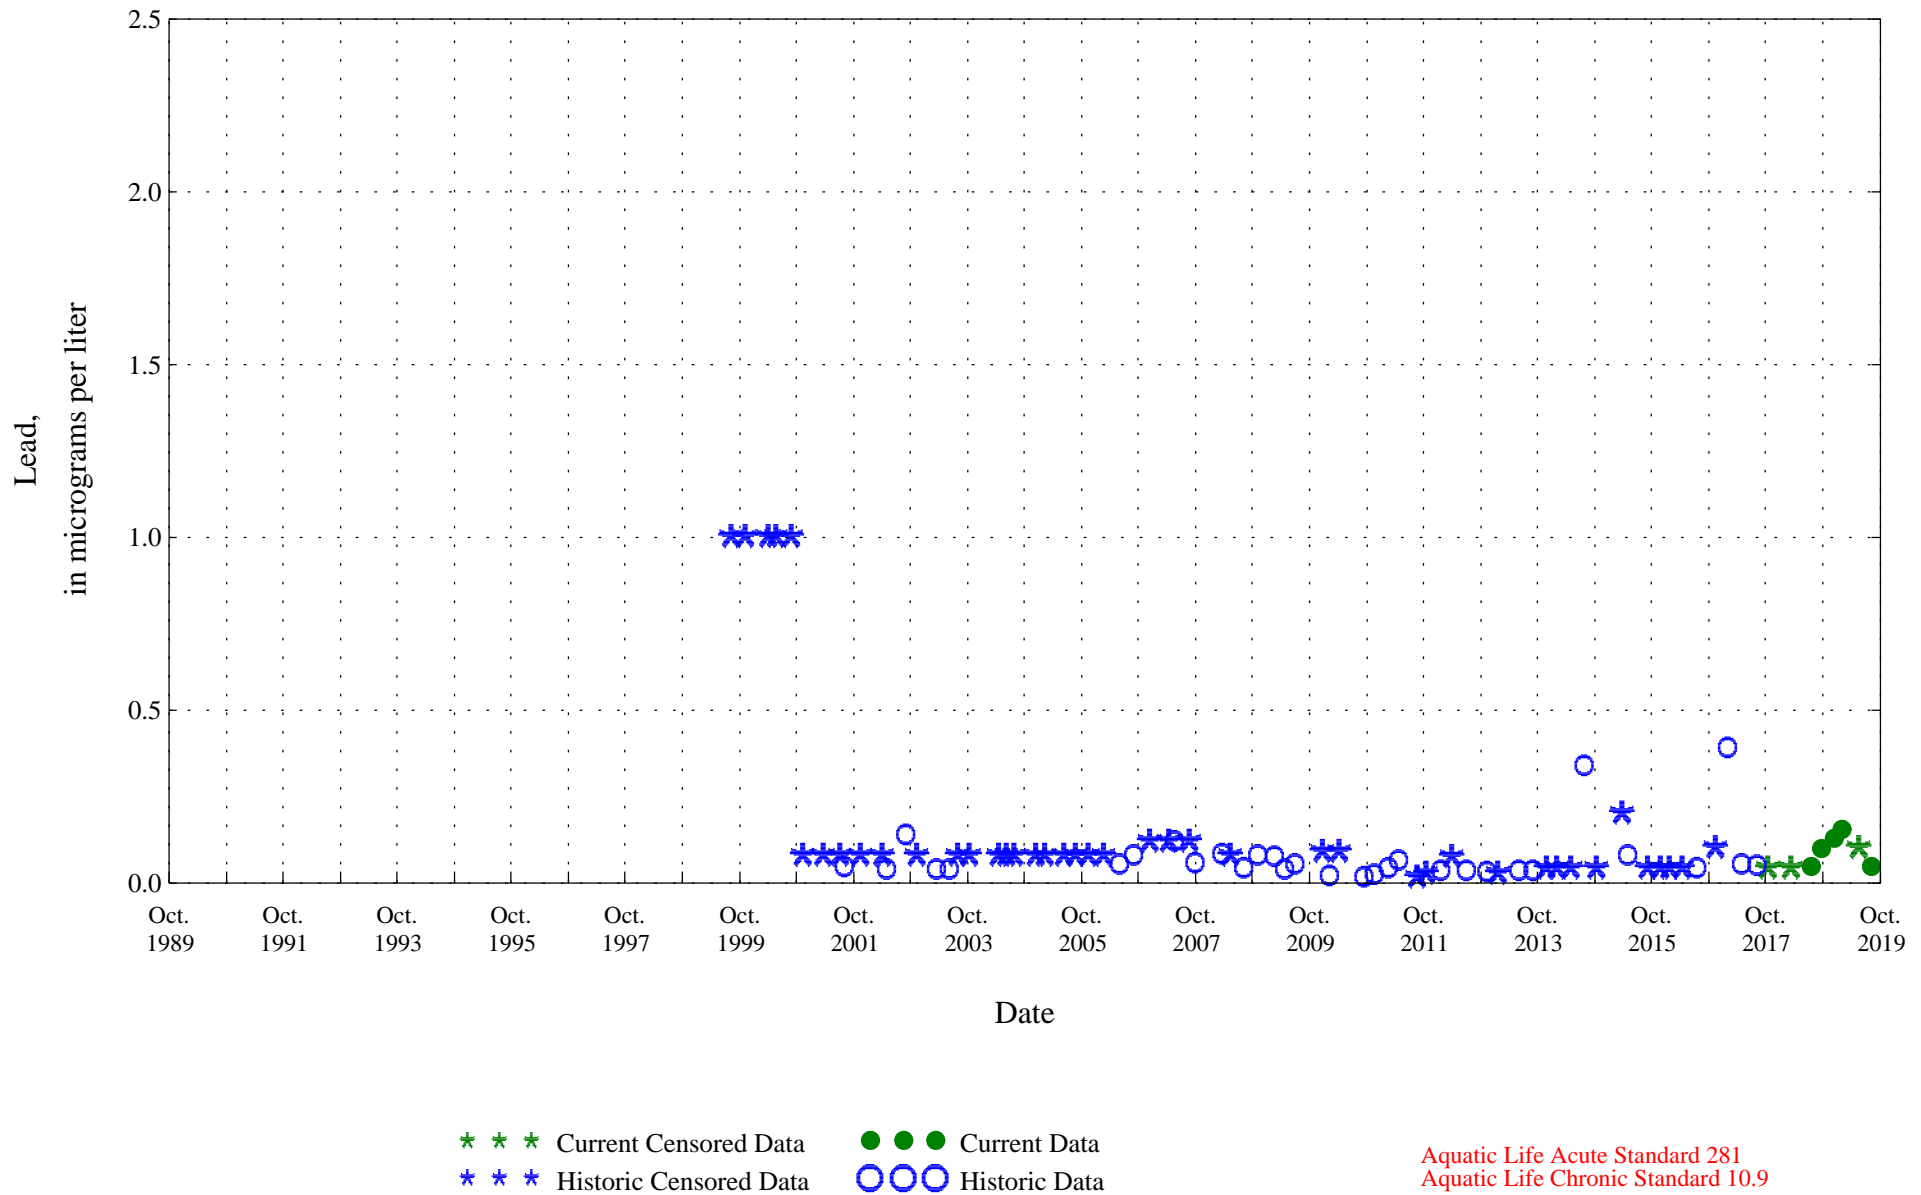
Figure 3. Distribution of selected water-quality constituents relative to time for

Piceance Creek below Ryan Gulch, near Rio Blanco, Co., station 09306200.

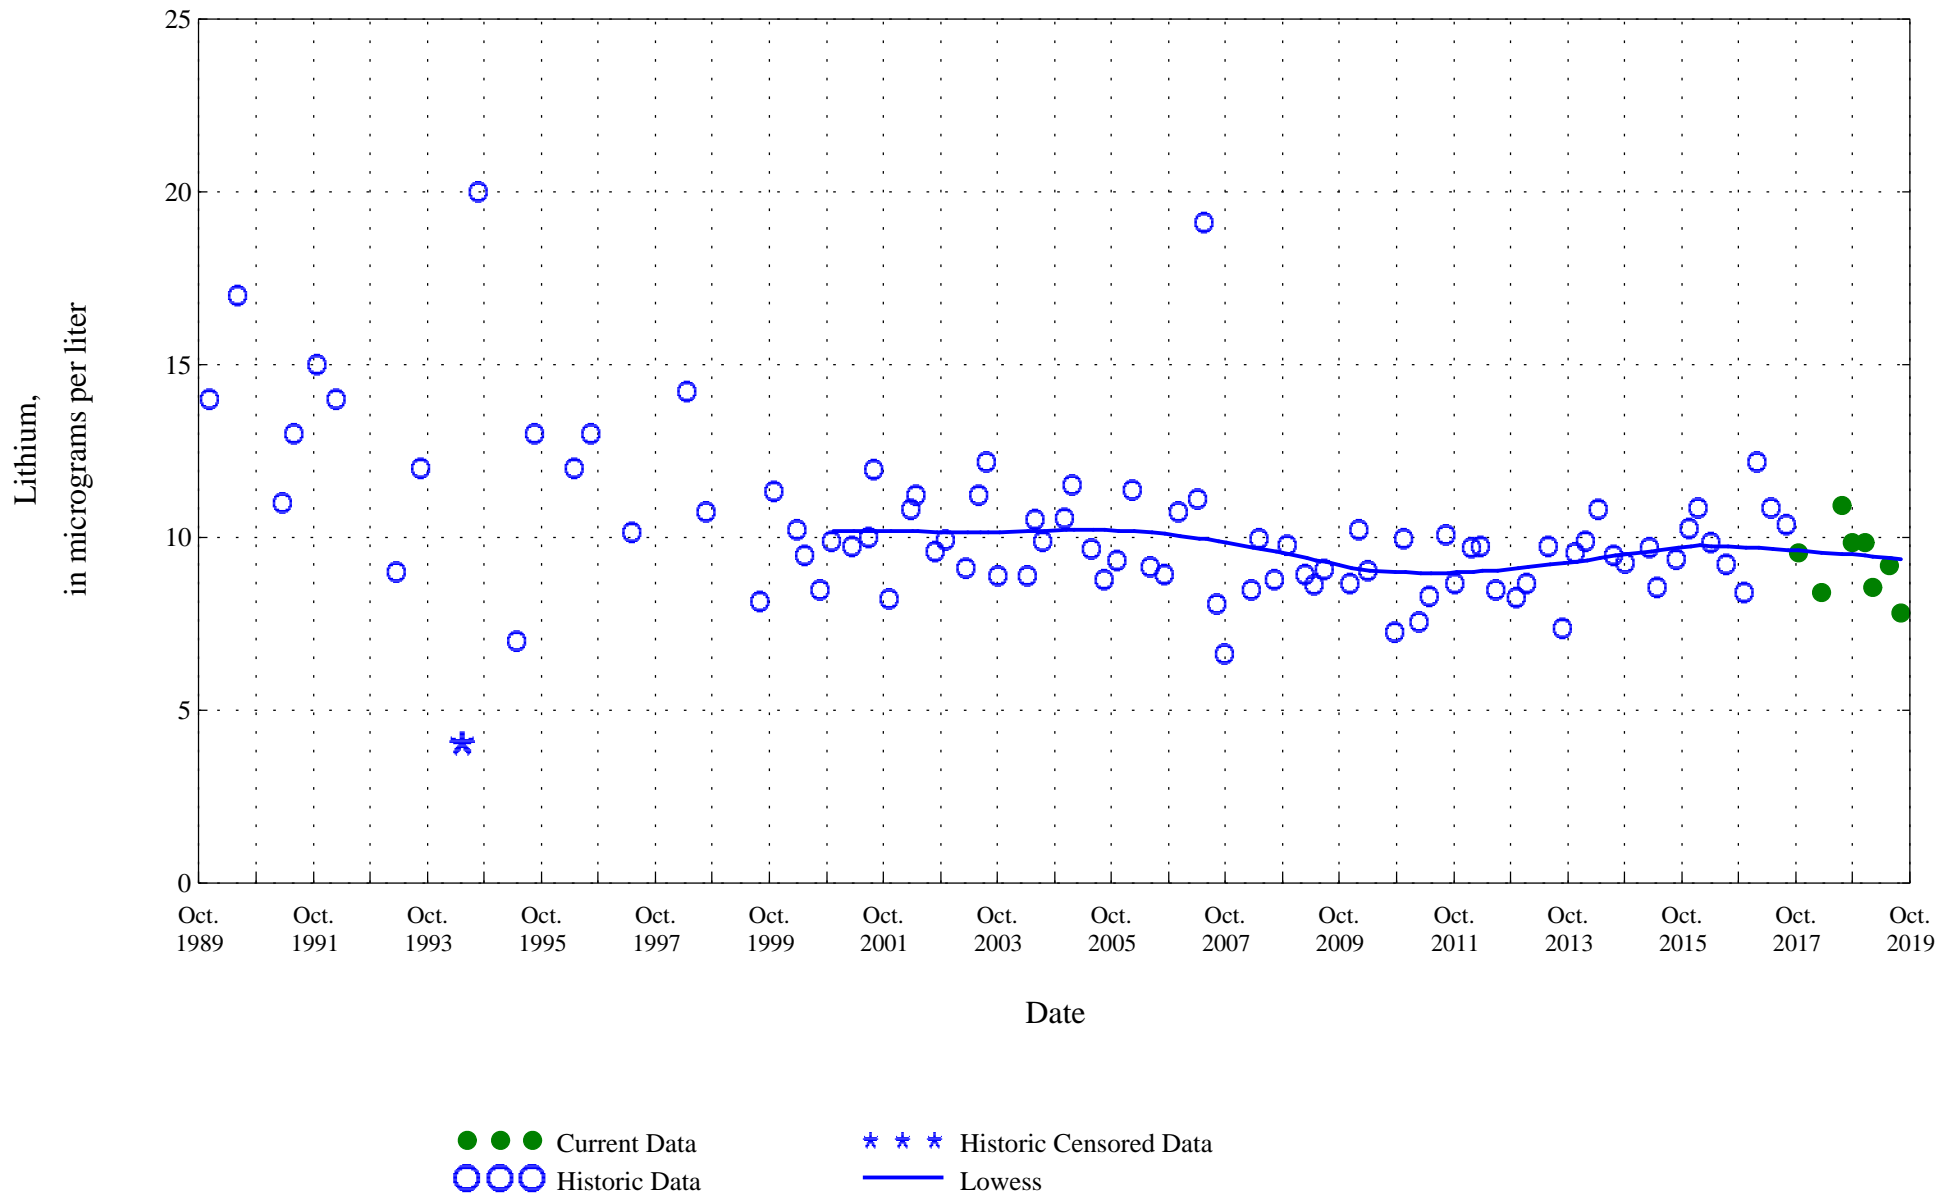
Figure 3. Distribution of selected water-quality constituents relative to time for

Piceance Creek below Ryan Gulch, near Rio Blanco, Co., station 09306200.

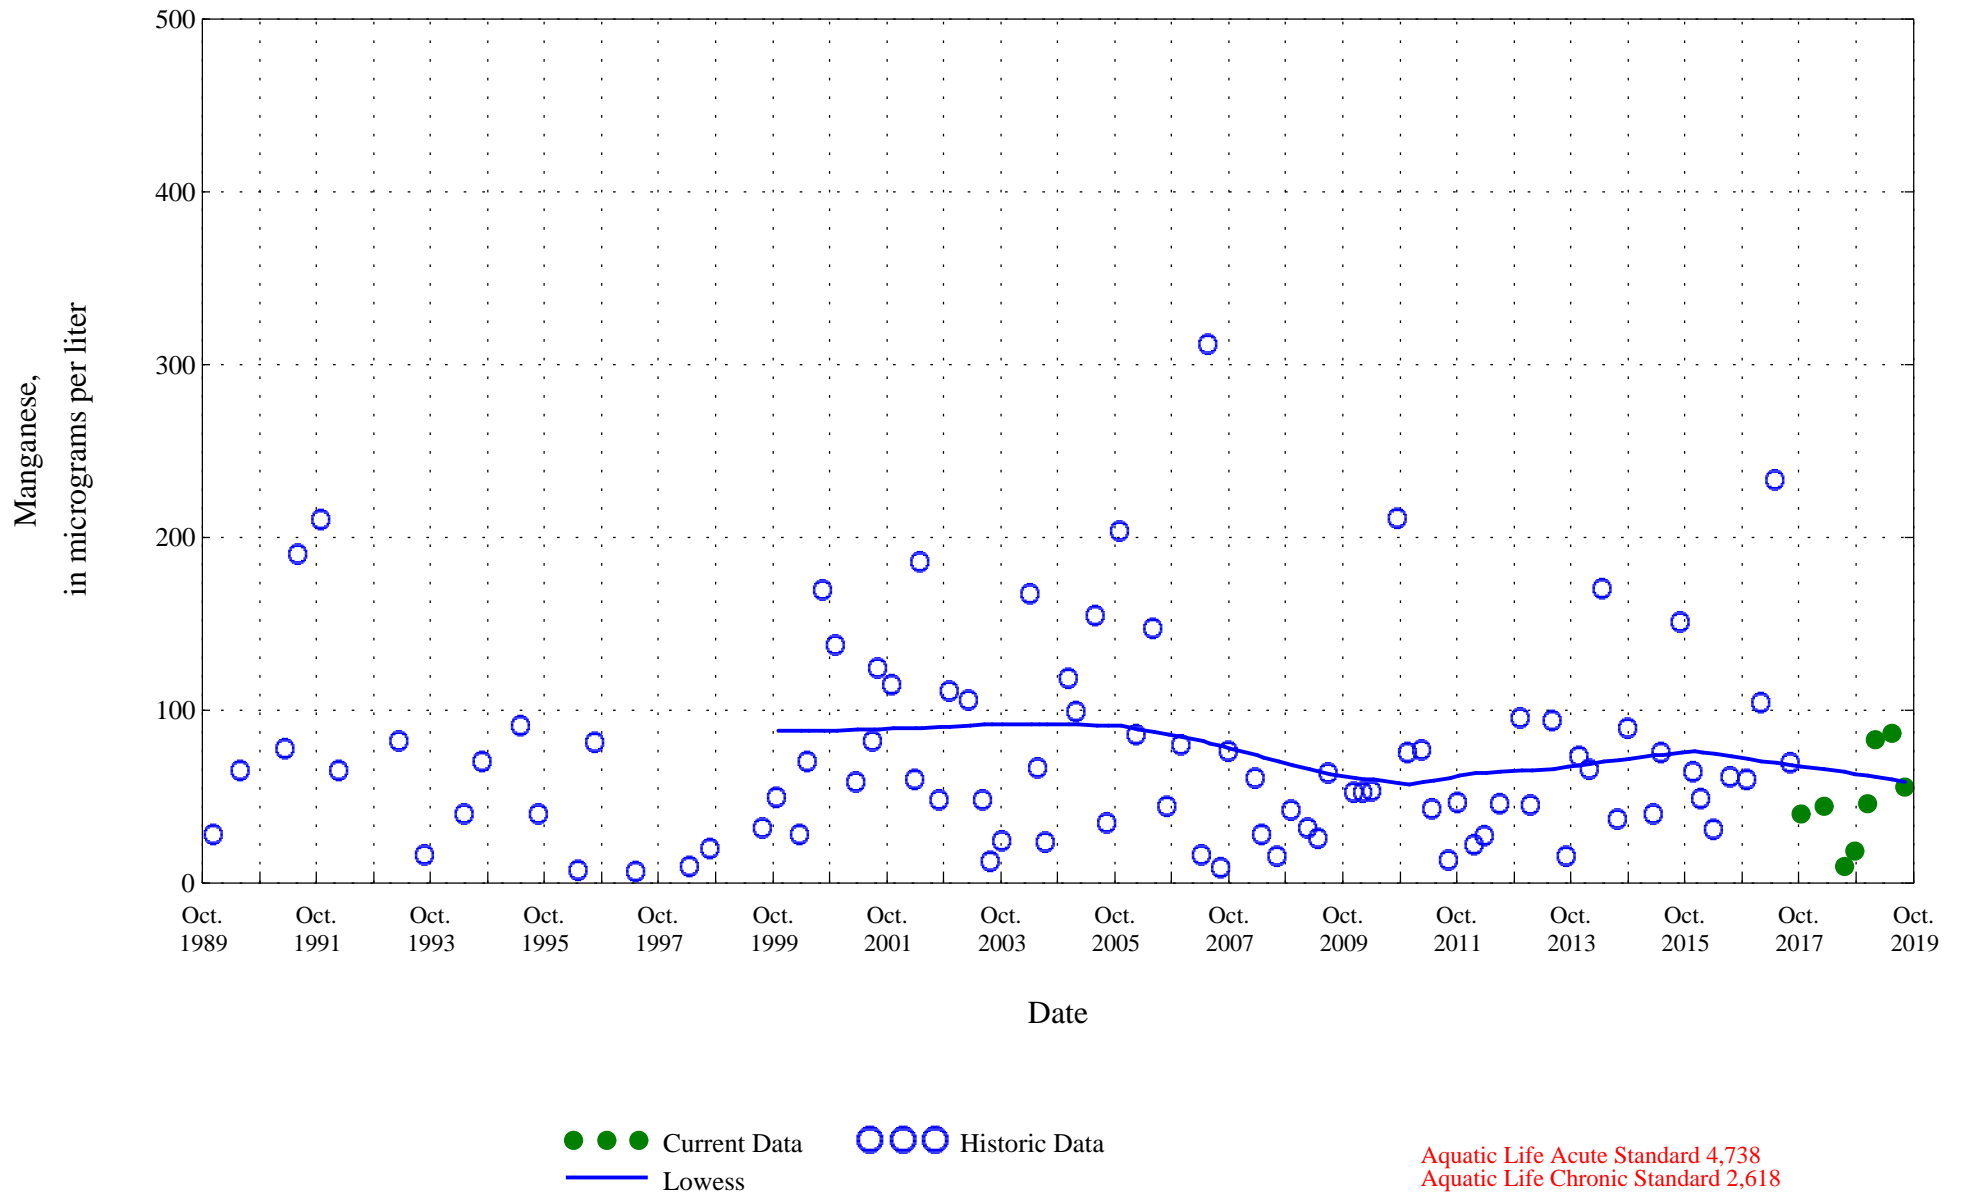
Figure 3. Distribution of selected water-quality constituents relative to time for

Piceance Creek below Ryan Gulch, near Rio Blanco, Co., station 09306200.

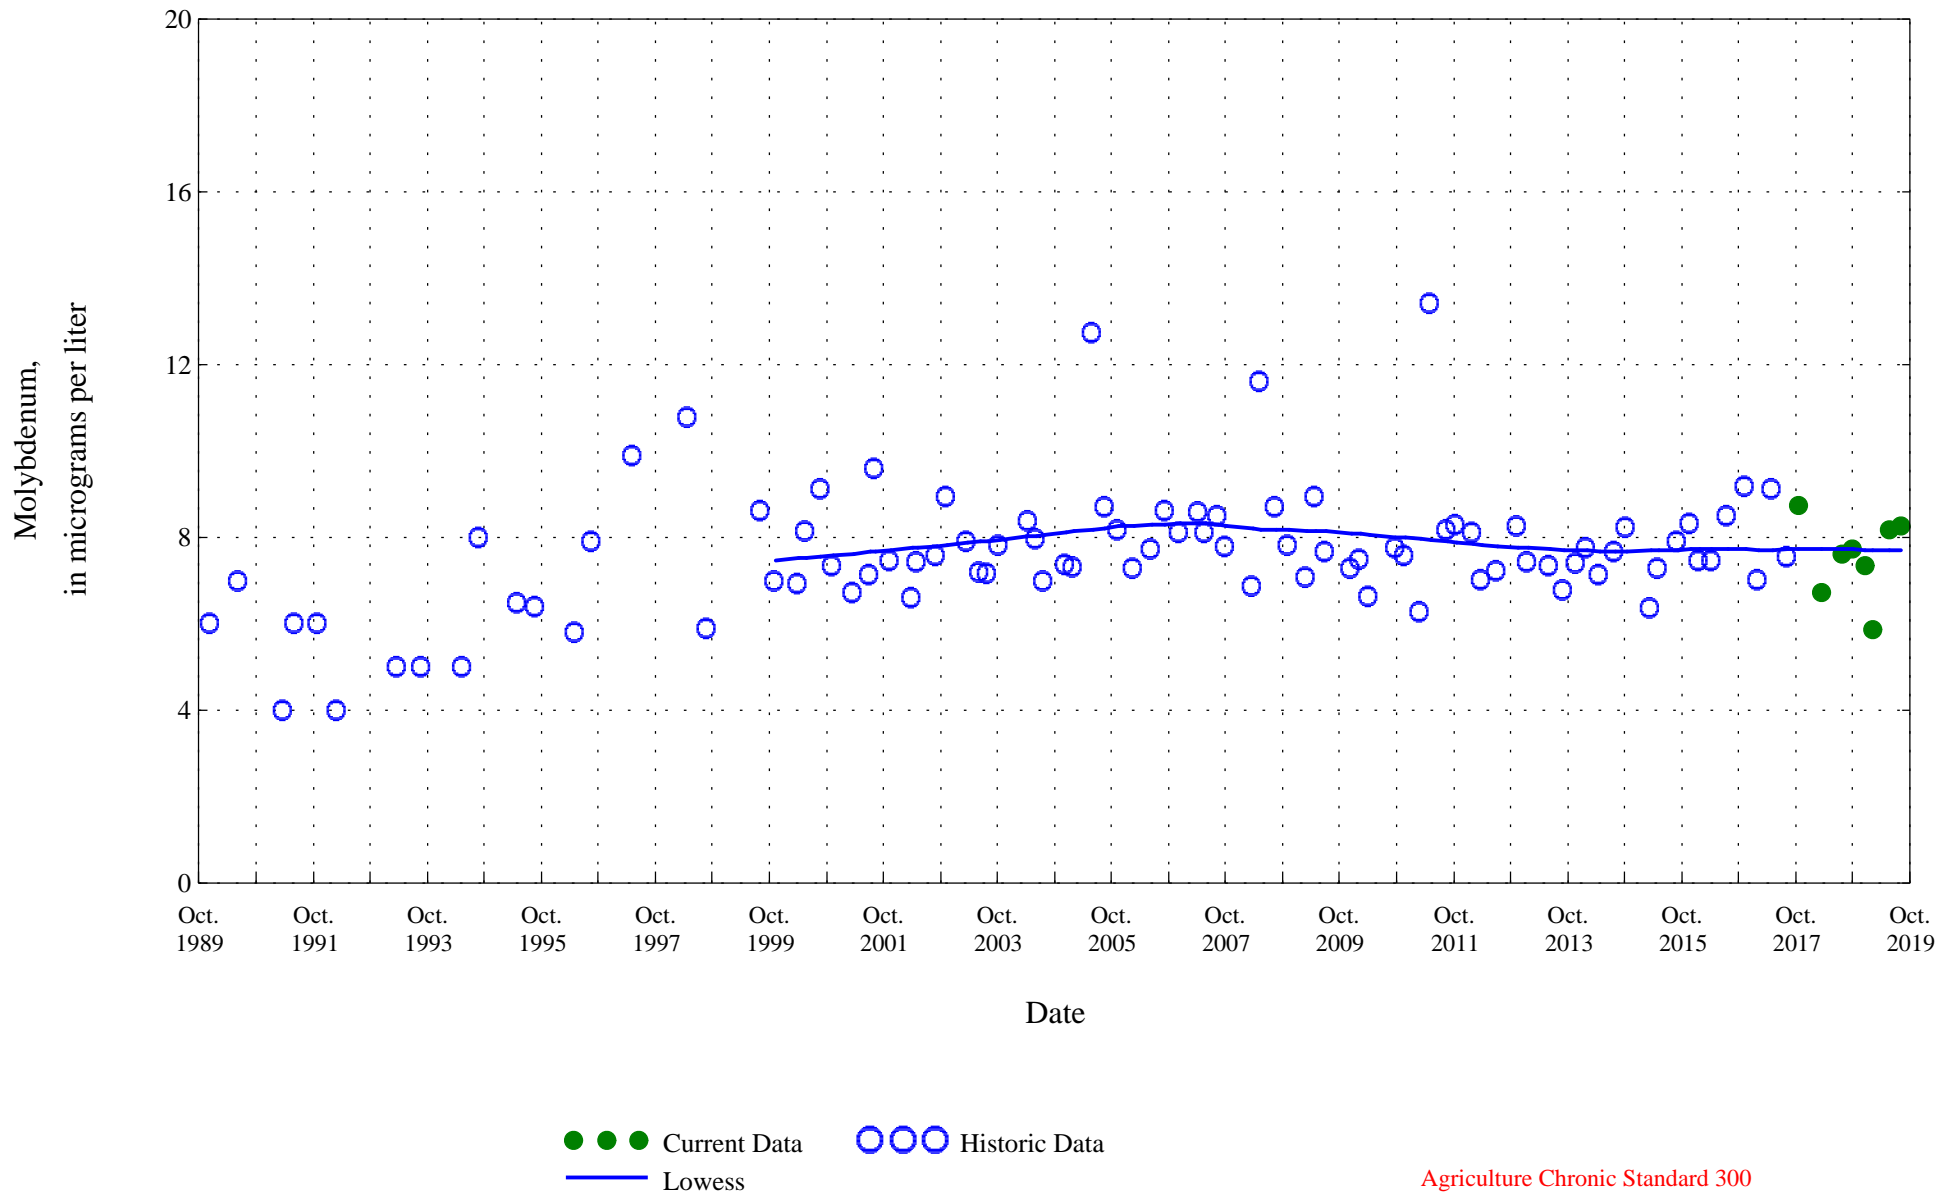
Figure 3. Distribution of selected water-quality constituents relative to time for

Piceance Creek below Ryan Gulch, near Rio Blanco, Co., station 09306200.

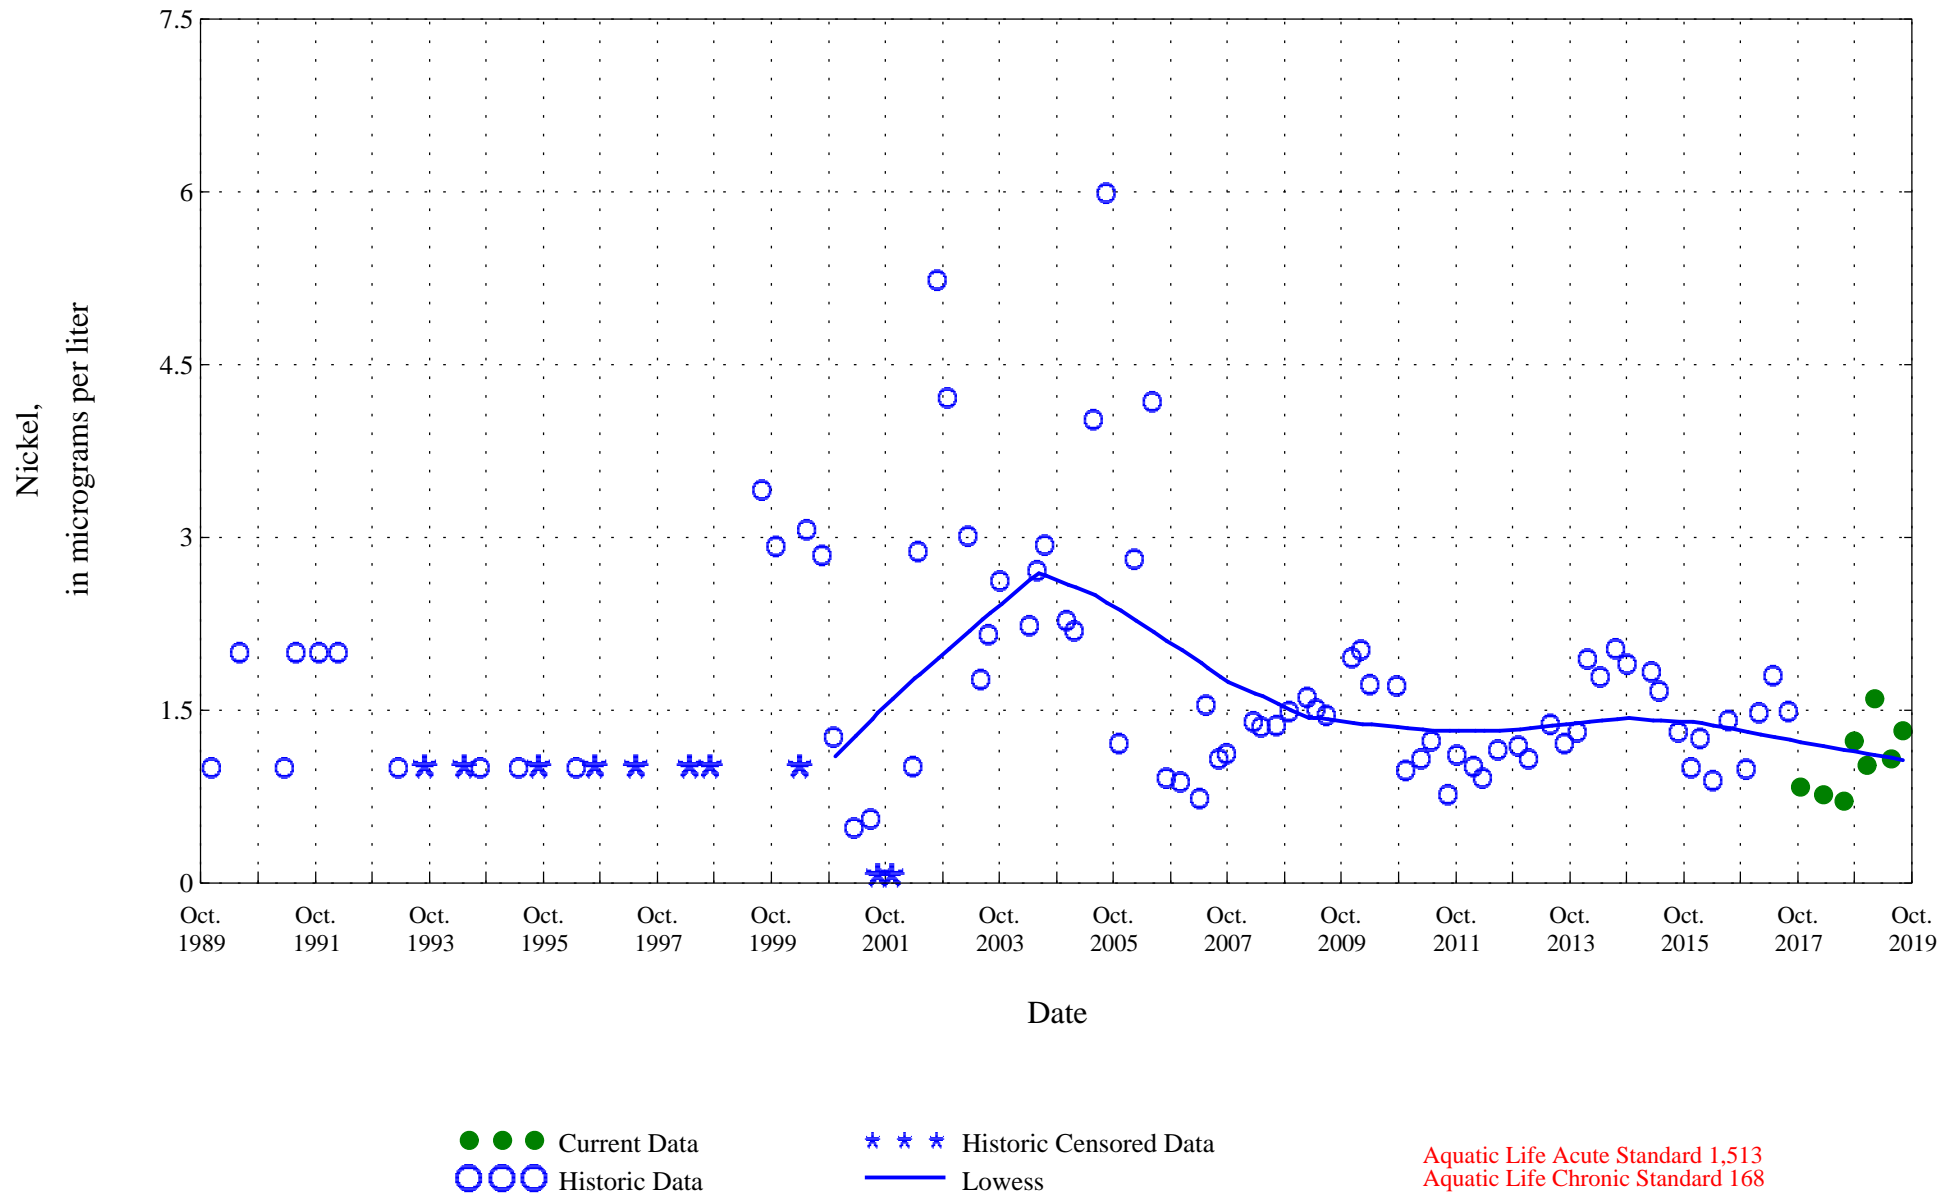
Figure 3. Distribution of selected water-quality constituents relative to time for

Piceance Creek below Ryan Gulch, near Rio Blanco, Co., station 09306200.

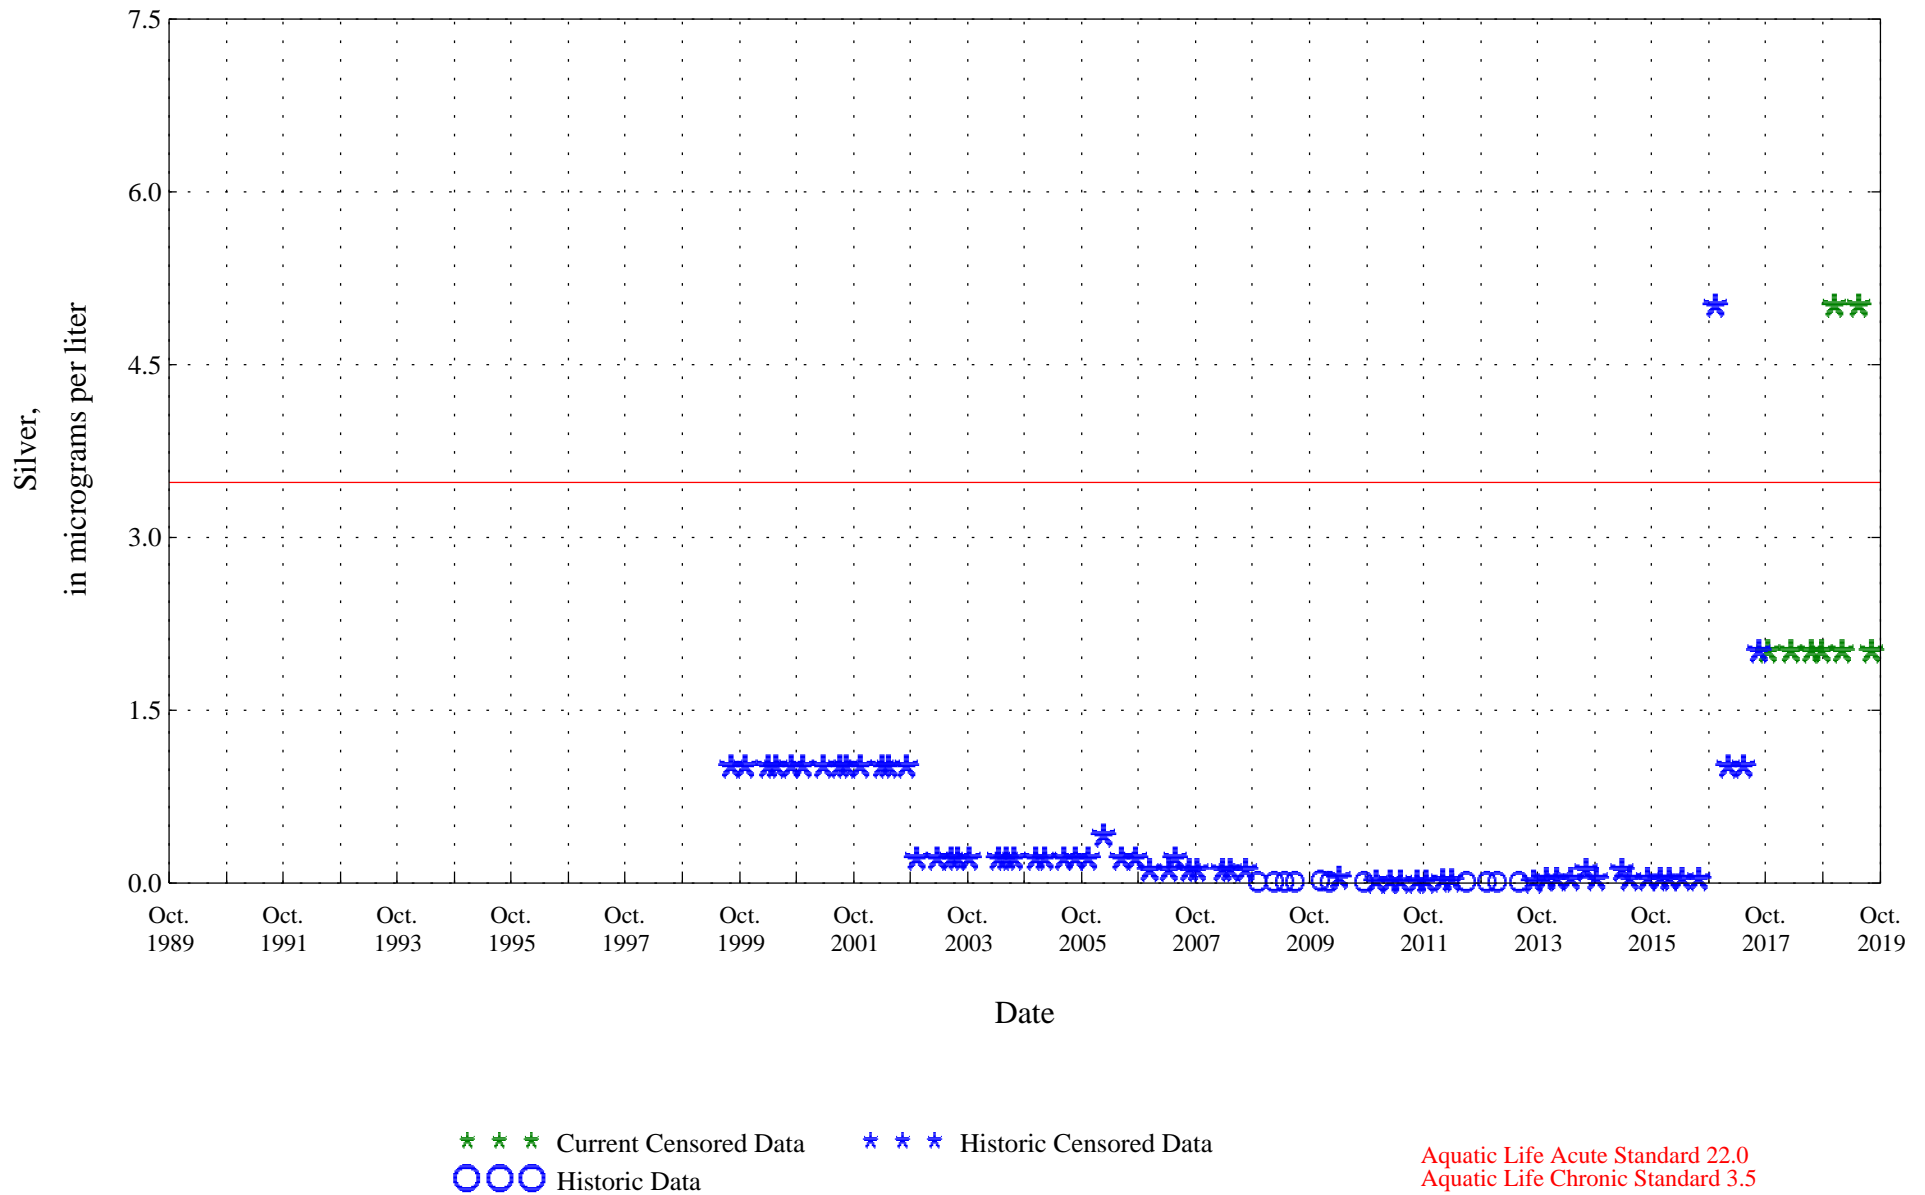
Figure 3. Distribution of selected water-quality constituents relative to time for

Piceance Creek below Ryan Gulch, near Rio Blanco, Co., station 09306200.

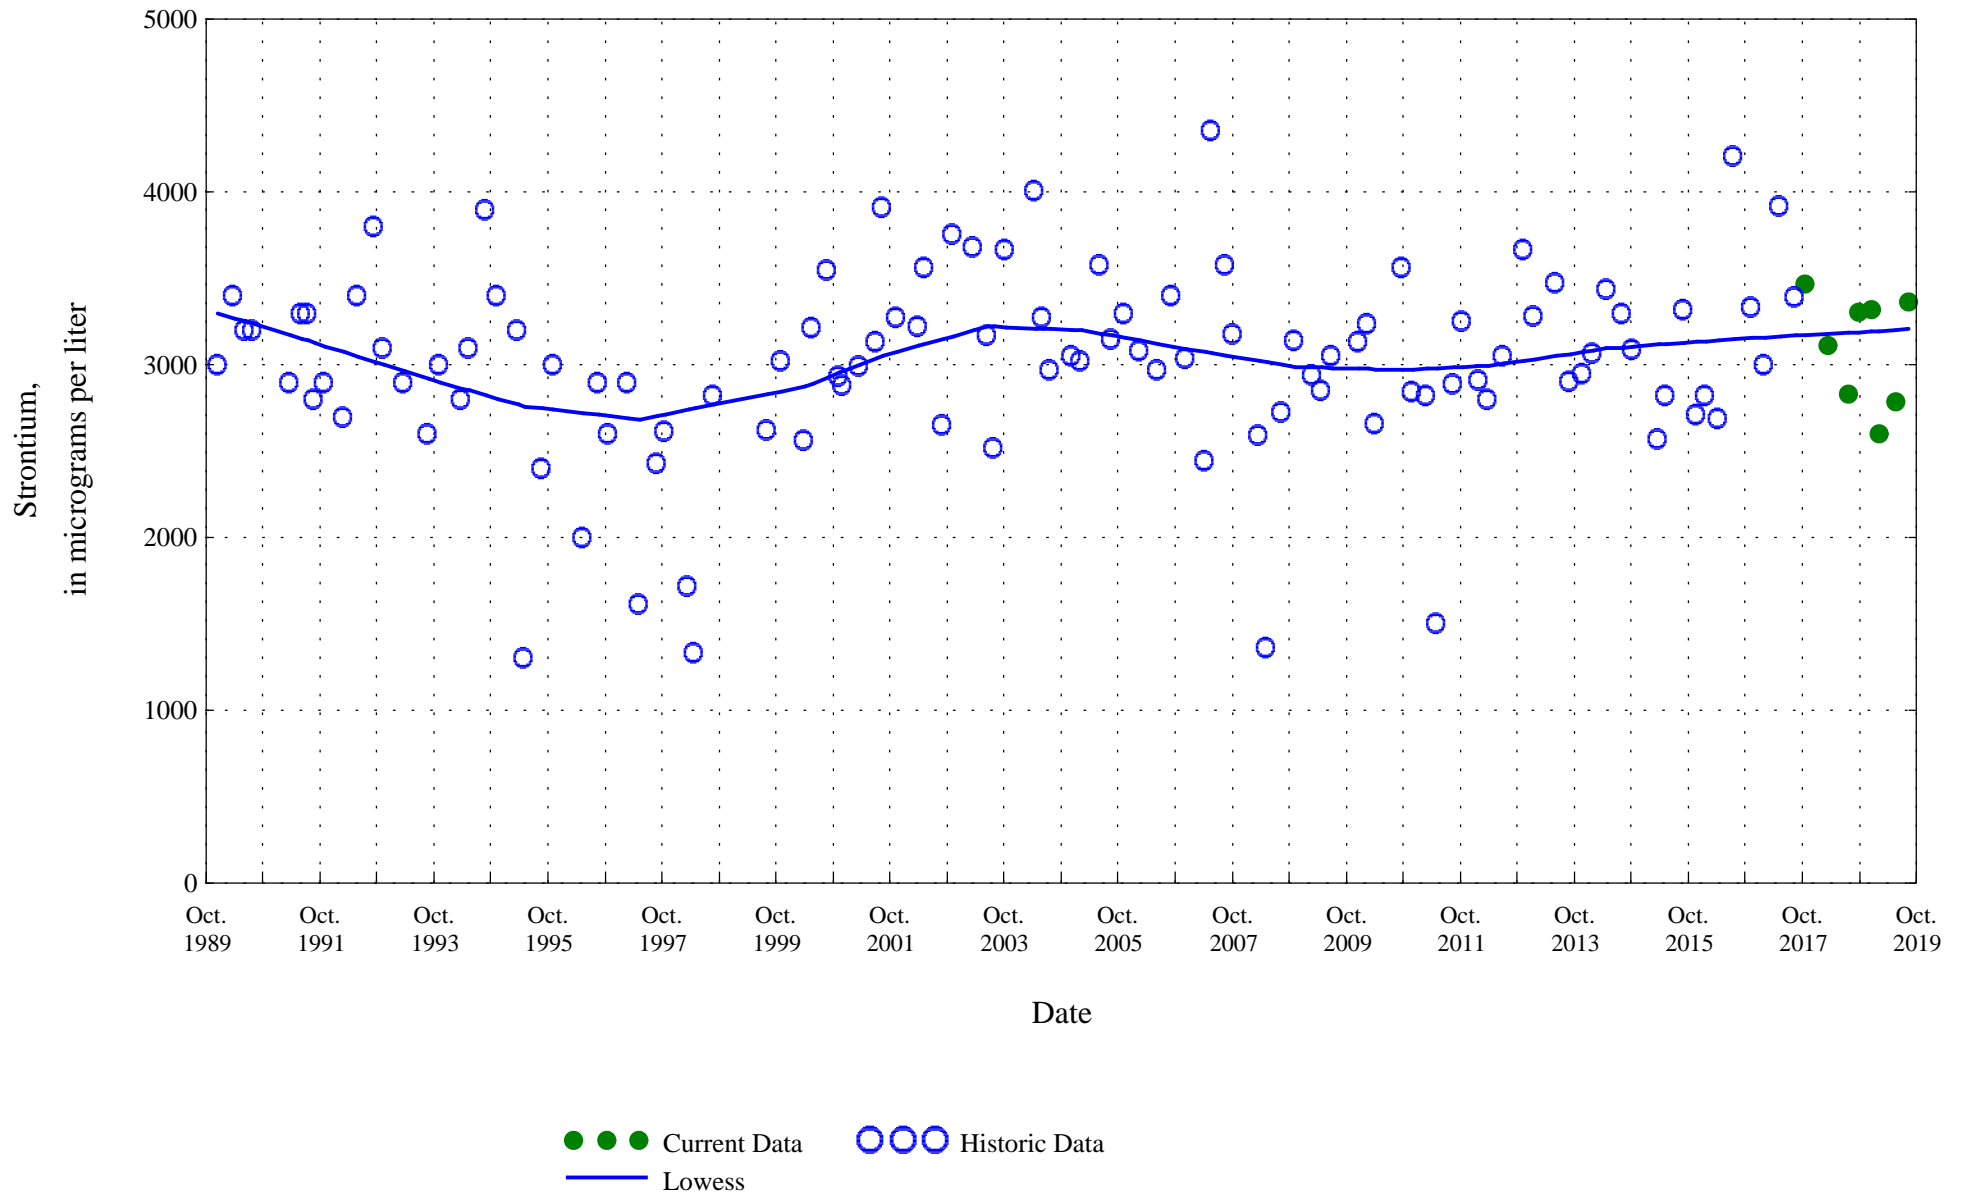
Figure 3. Distribution of selected water-quality constituents relative to time for

Piceance Creek below Ryan Gulch, near Rio Blanco, Co., station 09306200.

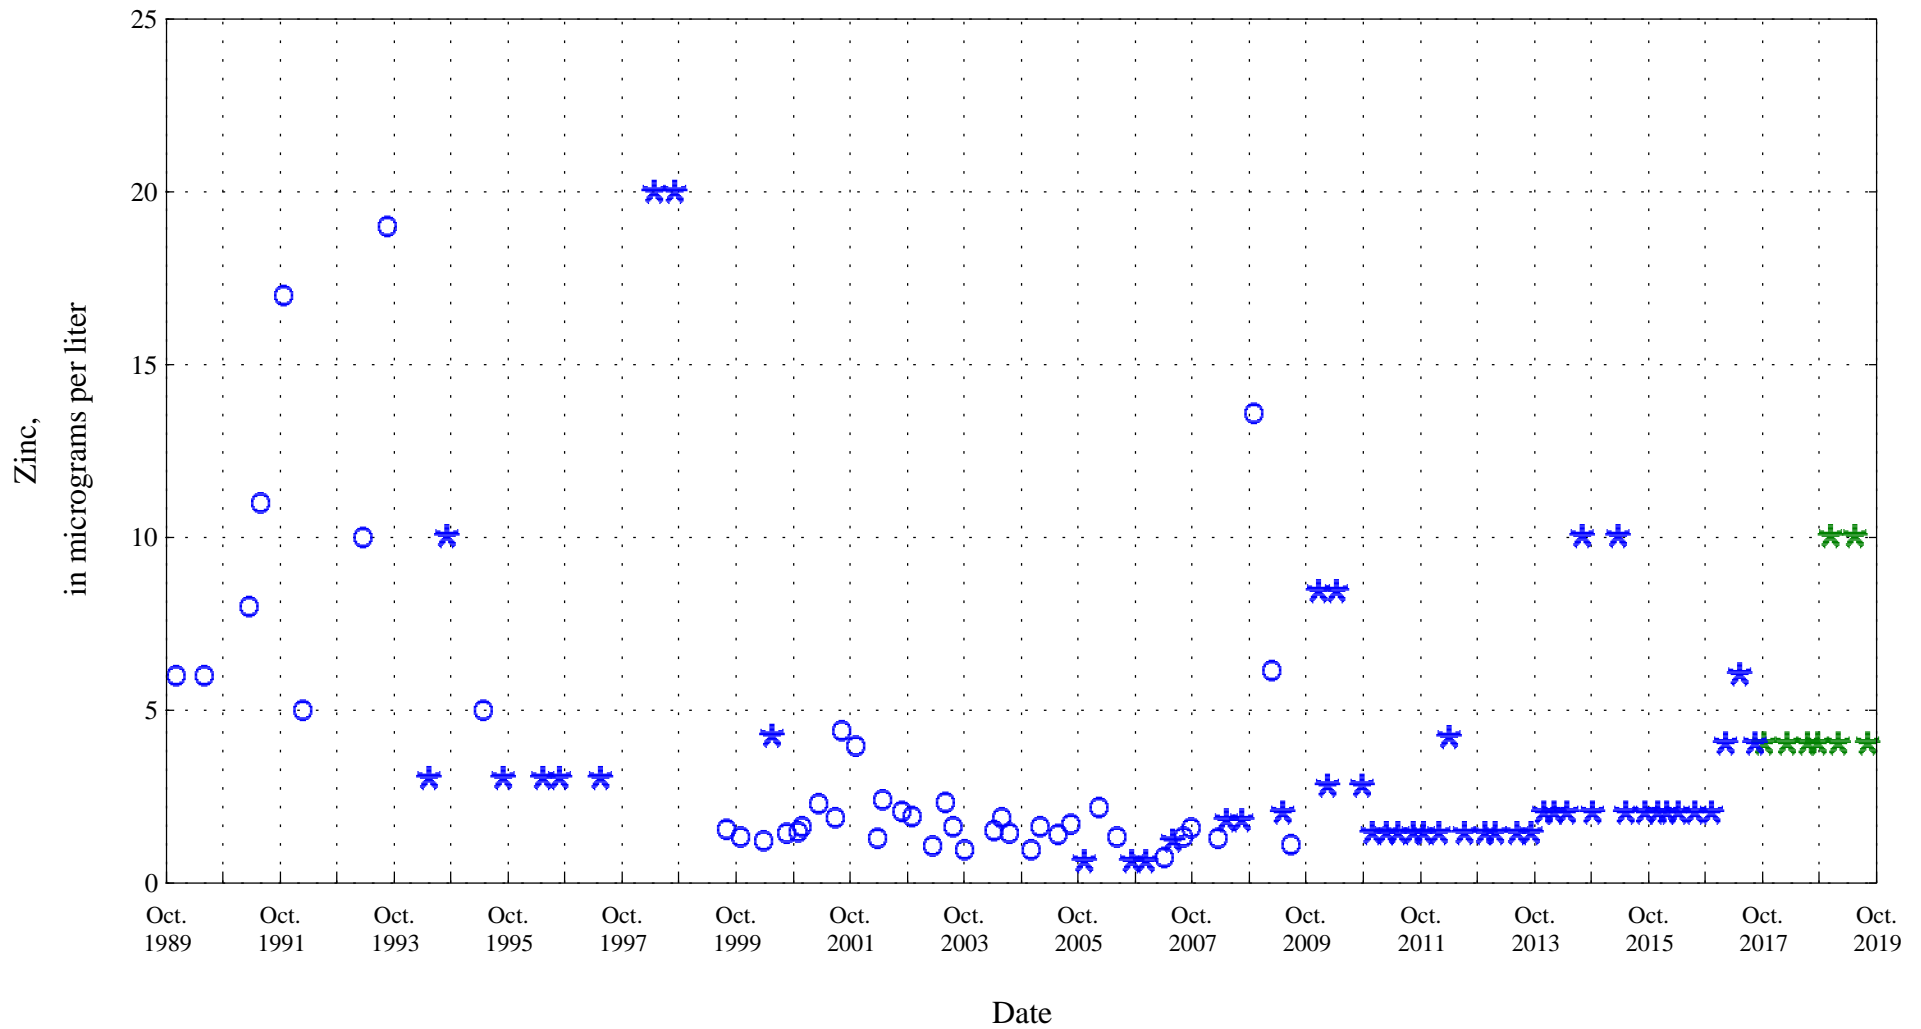
Figure 3. Distribution of selected water-quality constituents relative to time for

Piceance Creek below Ryan Gulch, near Rio Blanco, Co., station 09306200.

* * * Current Censored Data * * * Historic Censored Data
○ ○ ○ Historic Data

— Aquatic Life Acute Standard 564
— Aquatic Life Chronic Standard 428
