Figure 3. Distribution of selected water-quality constituents relative to time for

Piceance Creek below Ryan Gulch, near Rio Blanco, Co., station 09306200.

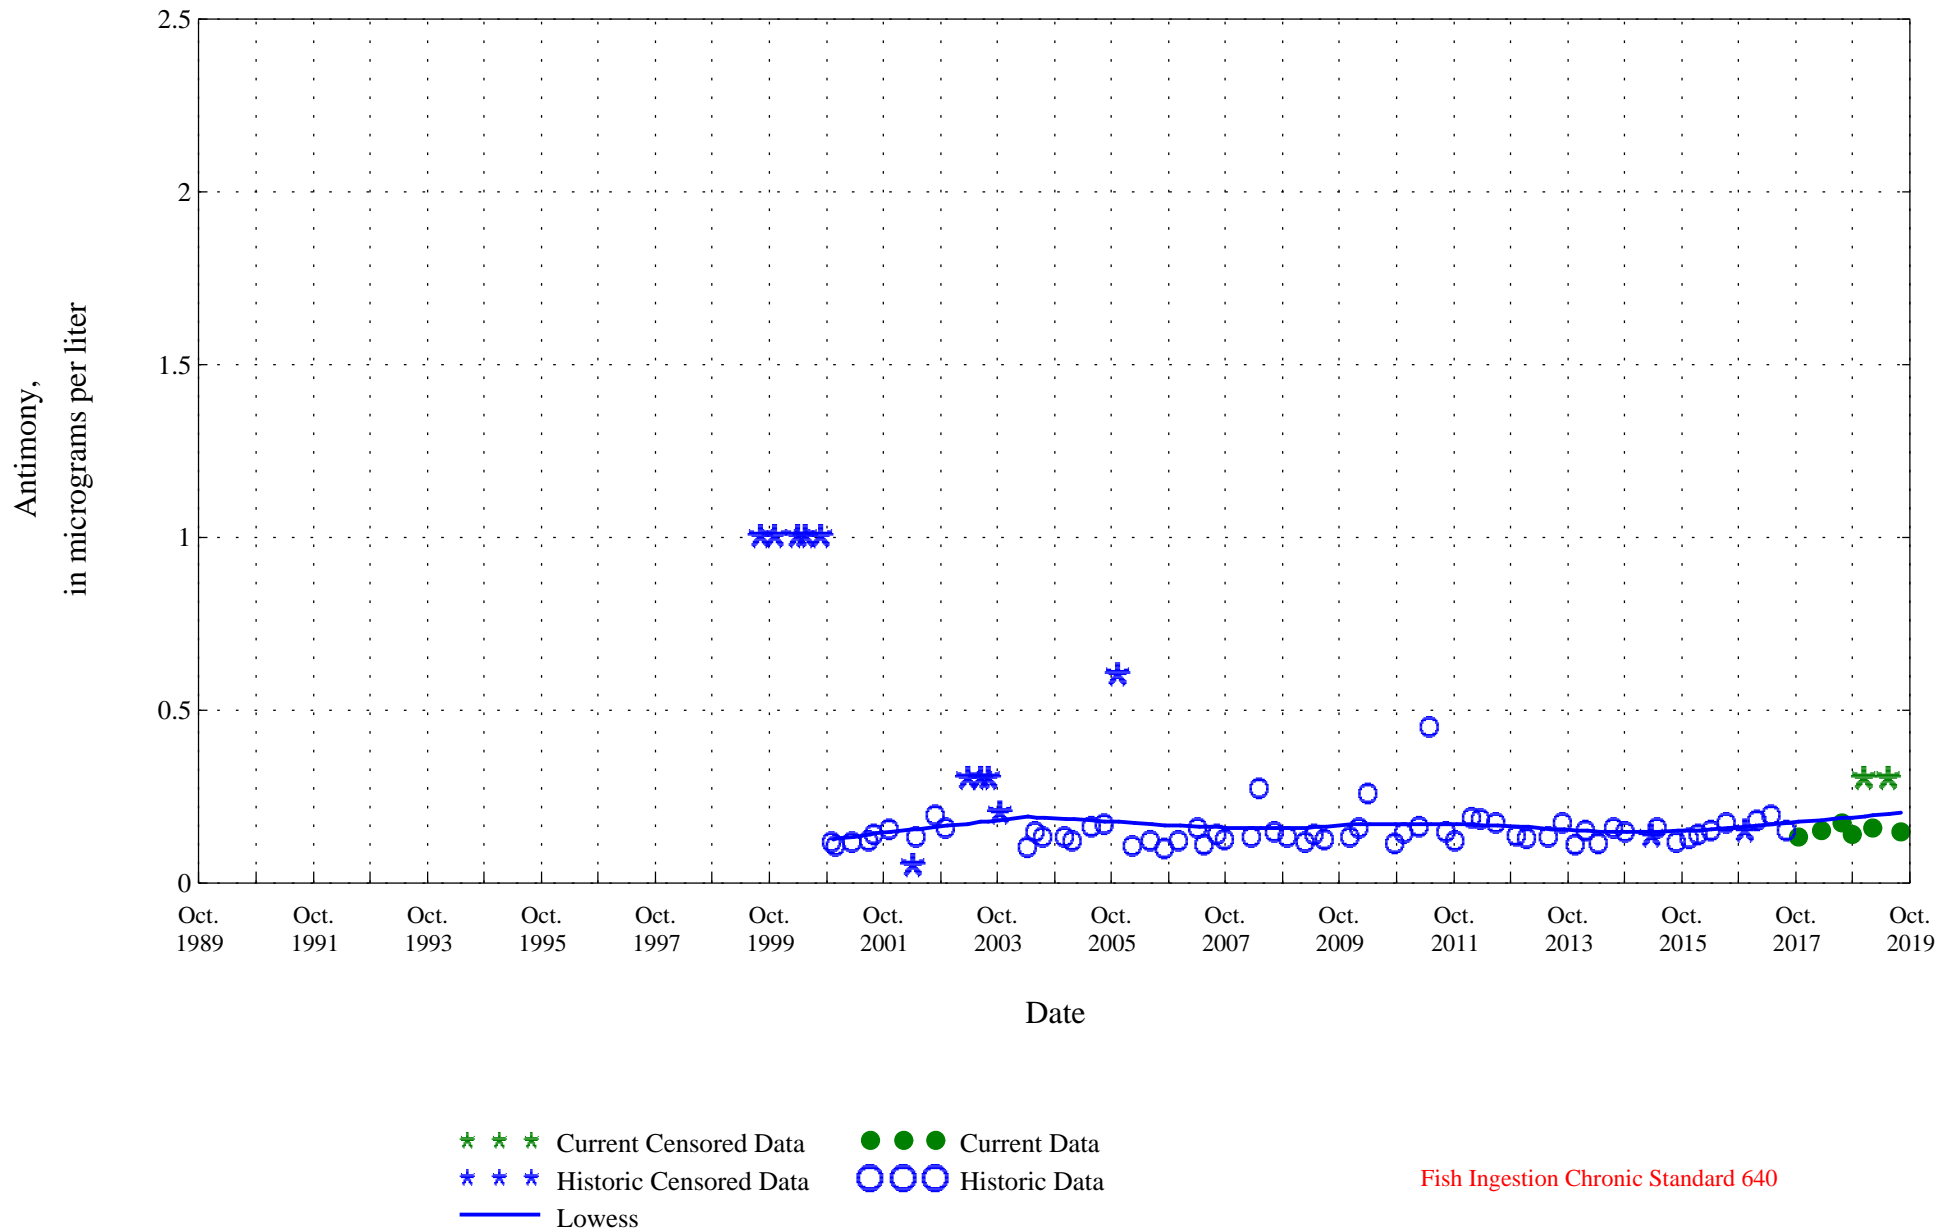
Figure 3. Distribution of selected water-quality constituents relative to time for

Piceance Creek below Ryan Gulch, near Rio Blanco, Co., station 09306200.

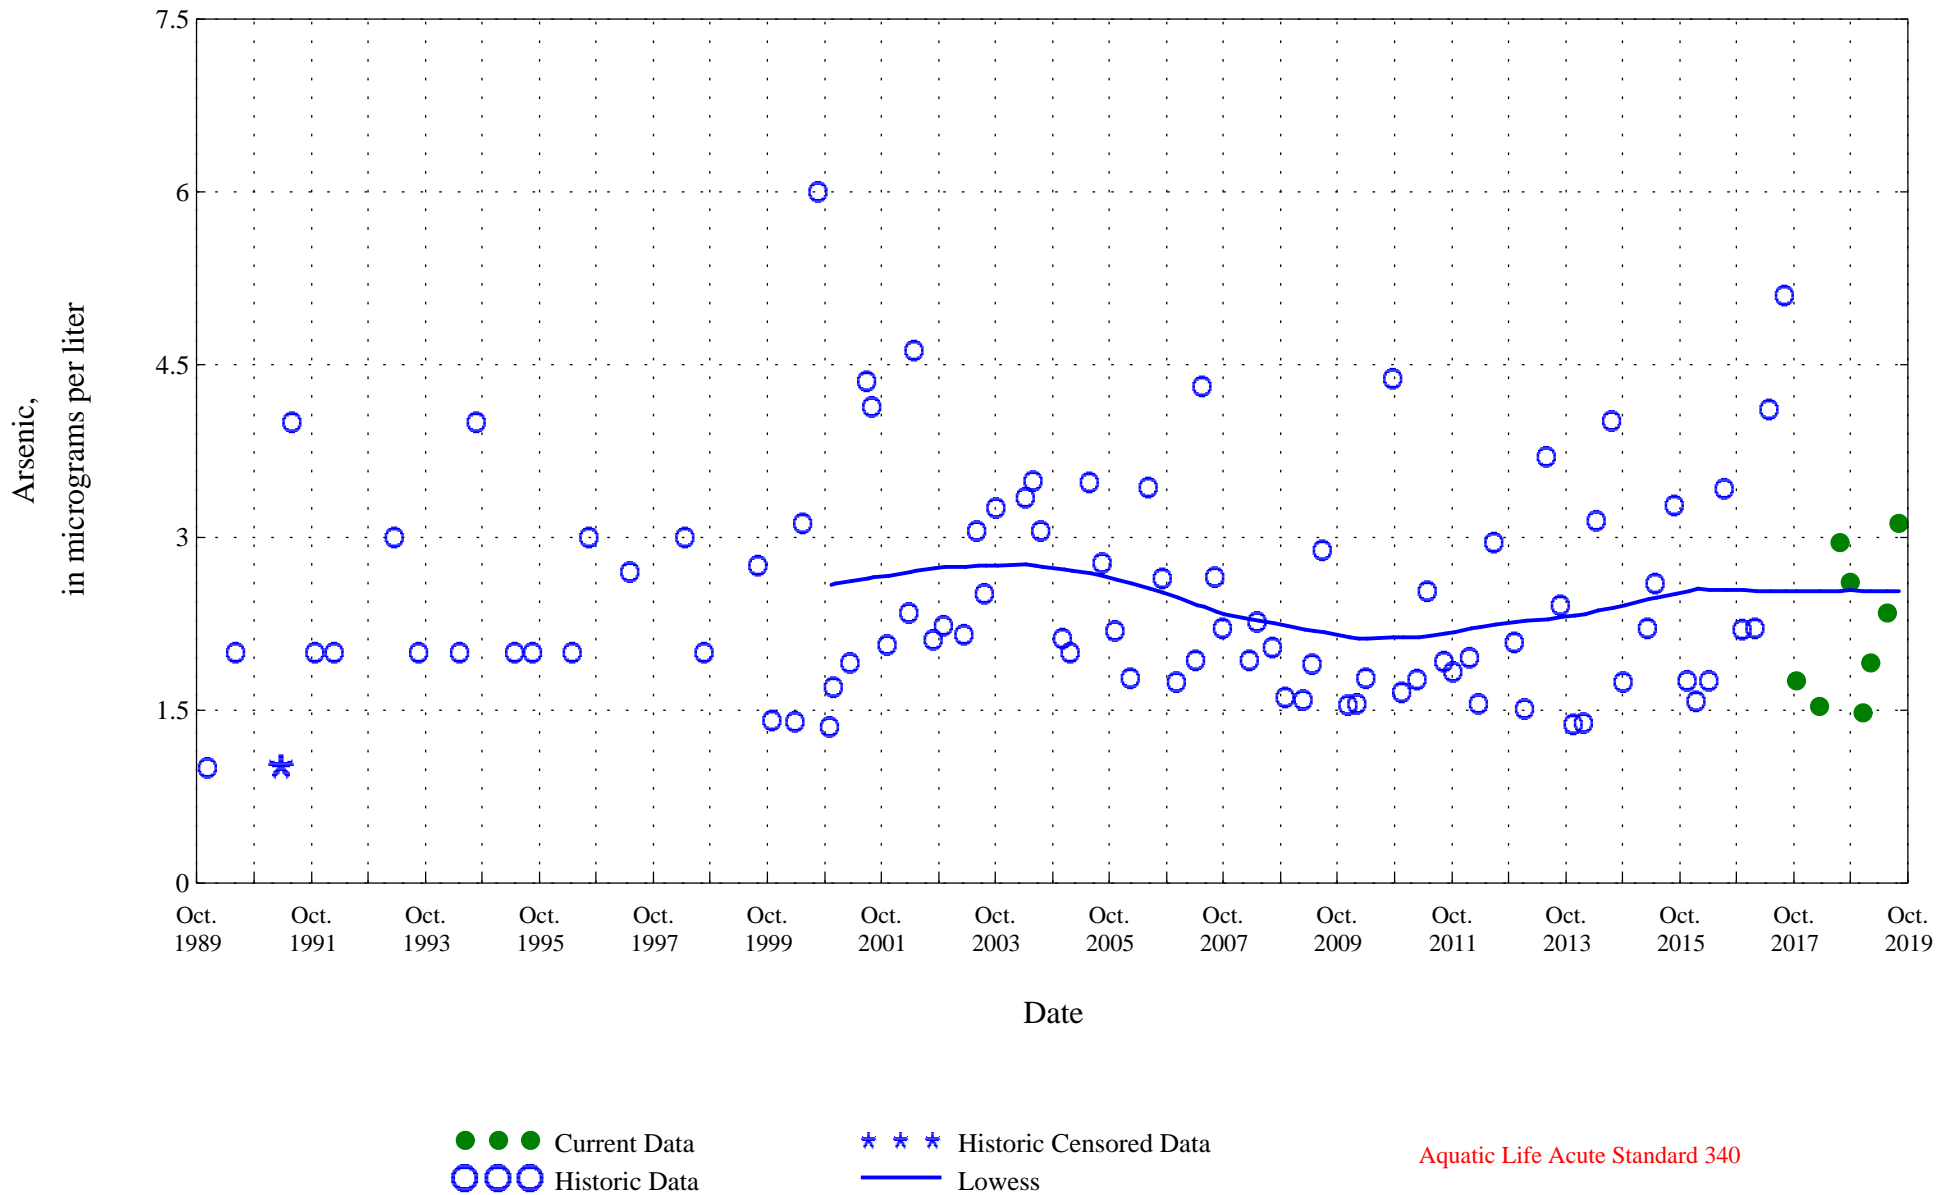
Figure 3. Distribution of selected water-quality constituents relative to time for

Piceance Creek below Ryan Gulch, near Rio Blanco, Co., station 09306200.

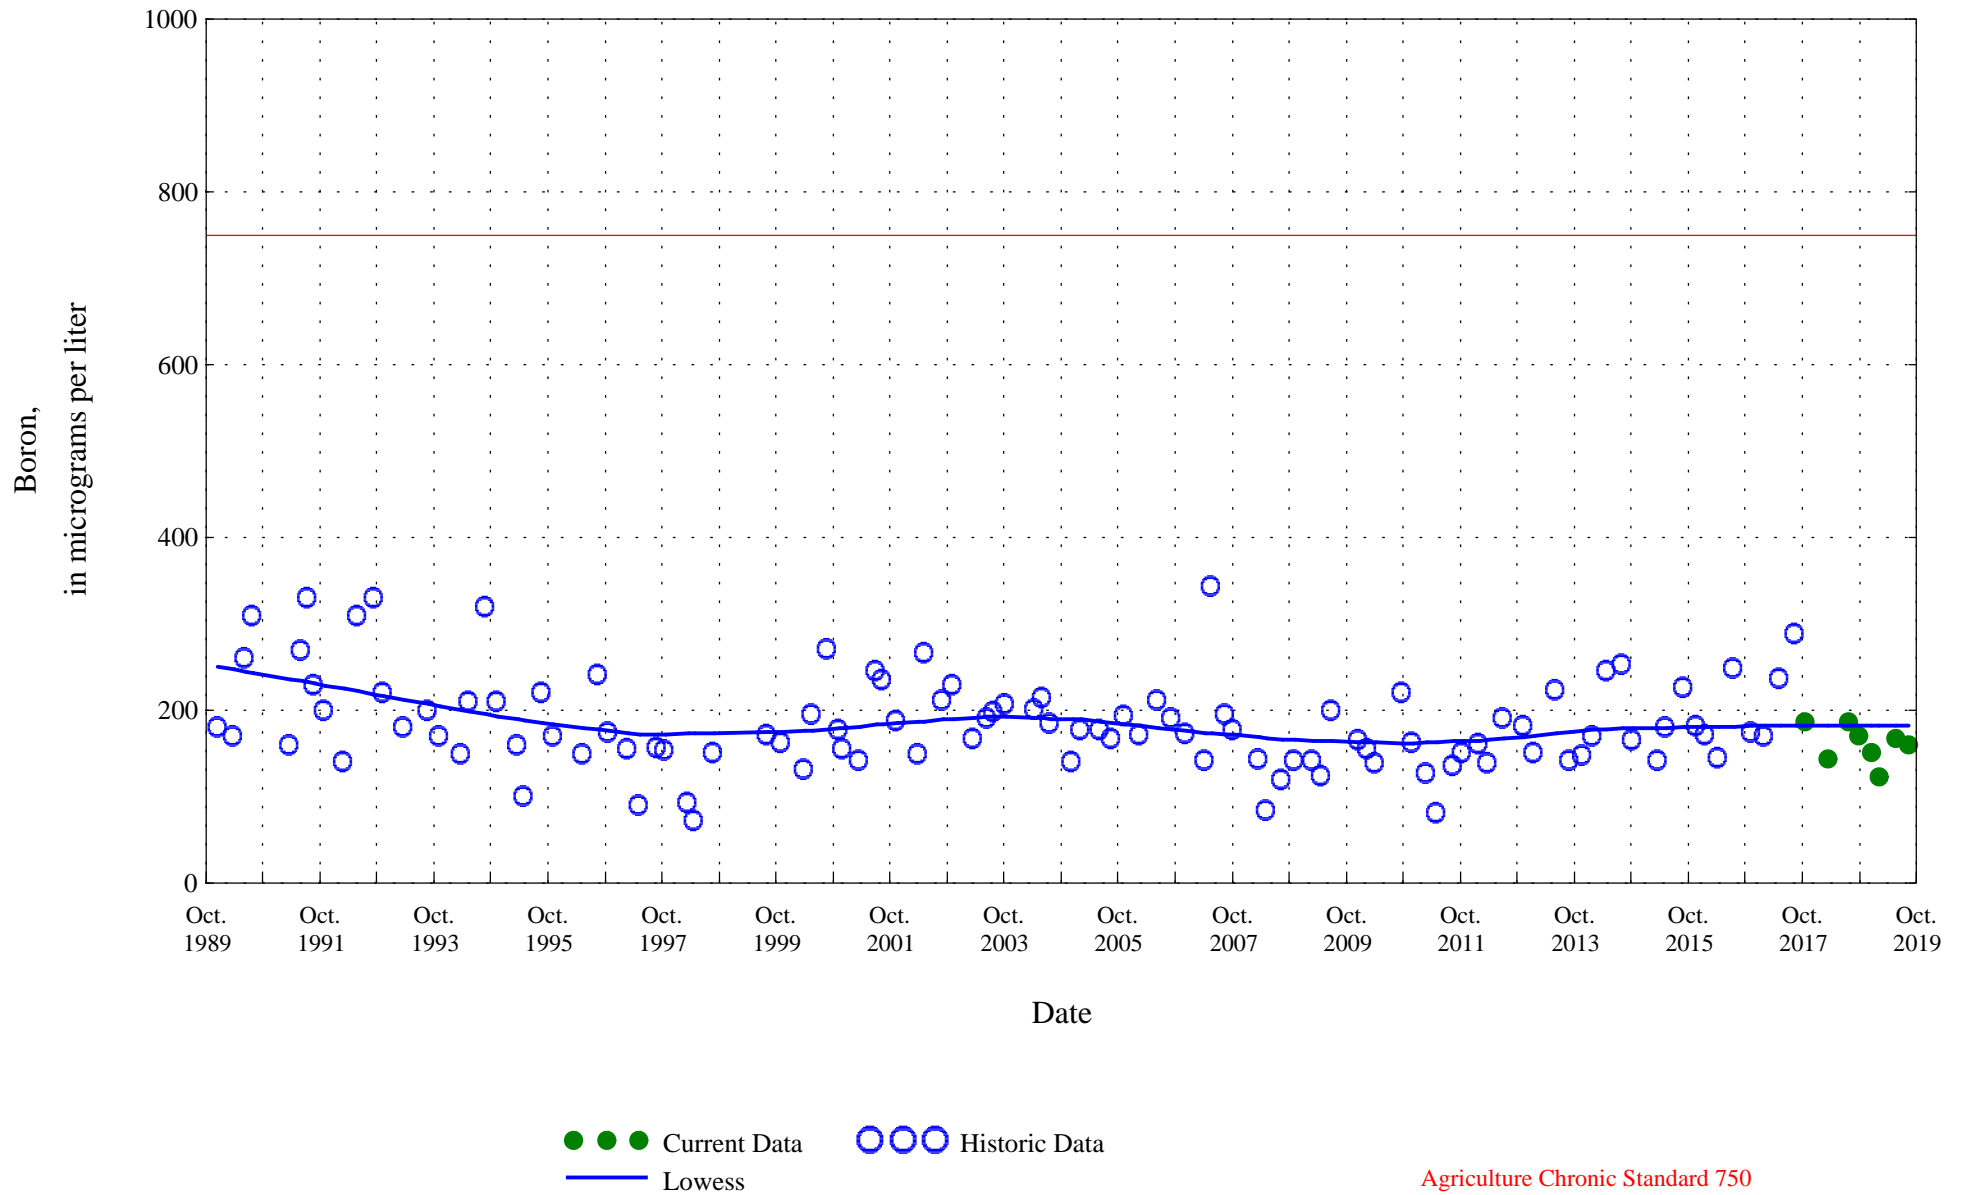
Figure 3. Distribution of selected water-quality constituents relative to time for

Piceance Creek below Ryan Gulch, near Rio Blanco, Co., station 09306200.

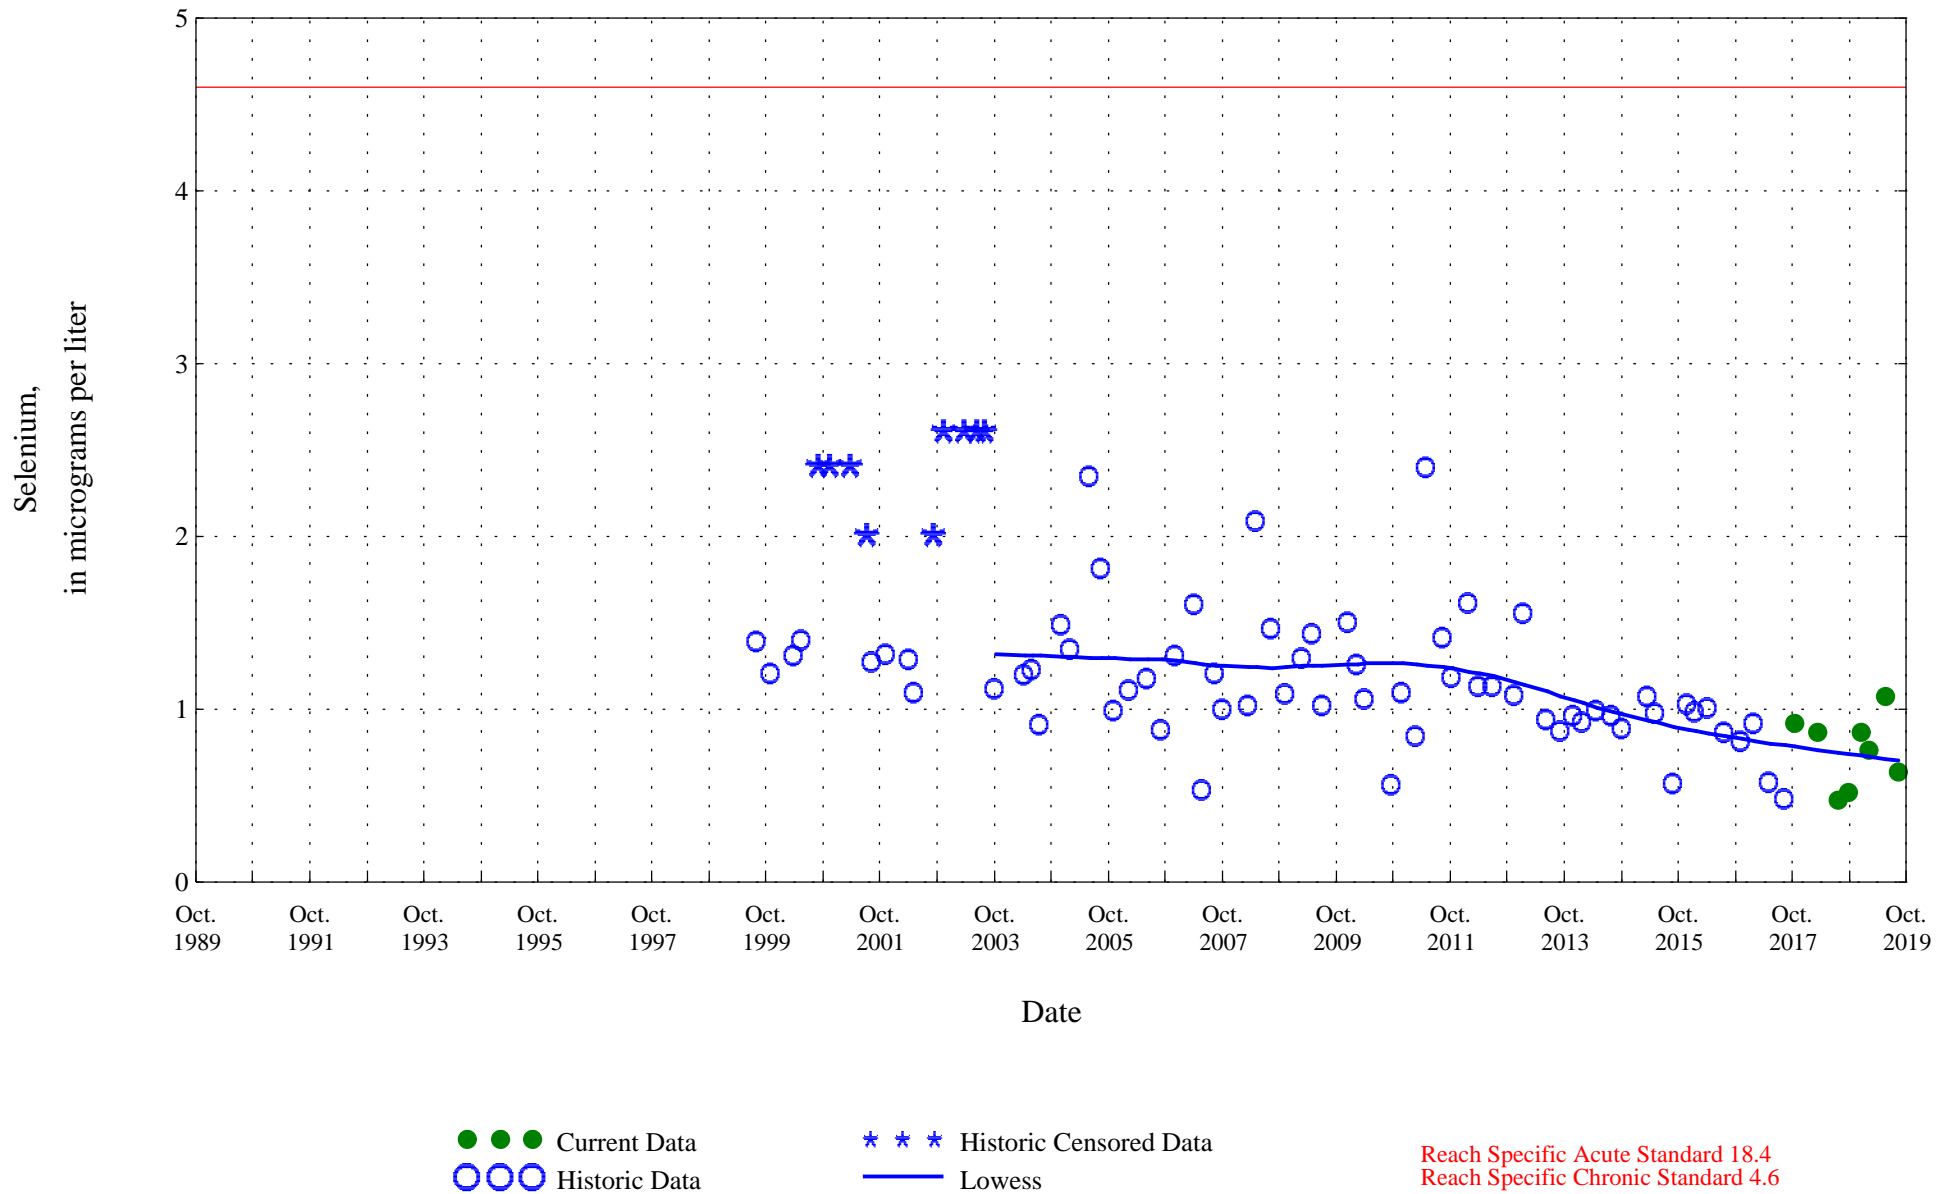
Figure 3. Distribution of selected water-quality constituents relative to time for

Piceance Creek below Ryan Gulch, near Rio Blanco, Co., station 09306200.

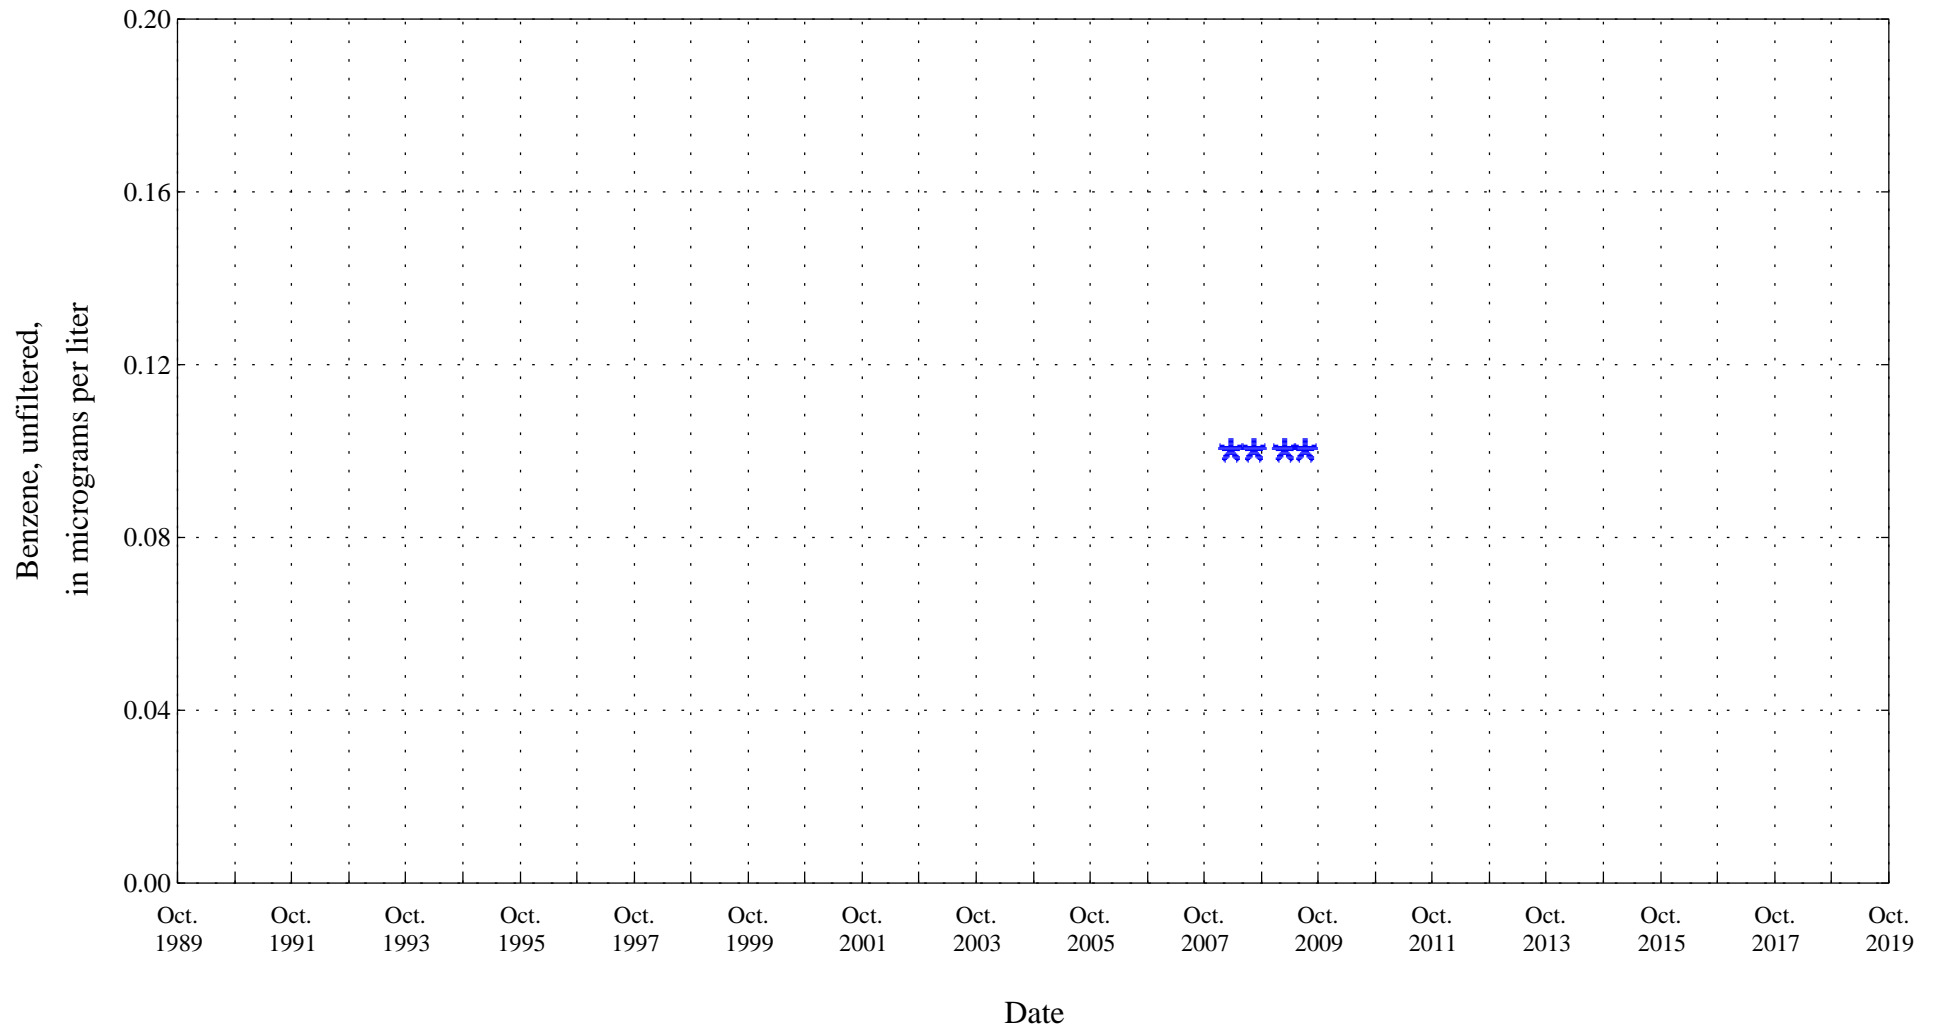
Figure 3. Distribution of selected water-quality constituents relative to time for

Piceance Creek below Ryan Gulch, near Rio Blanco, Co., station 09306200.

* * * Historic Censored Data

Fish Ingestion Chronic Standard 51.0

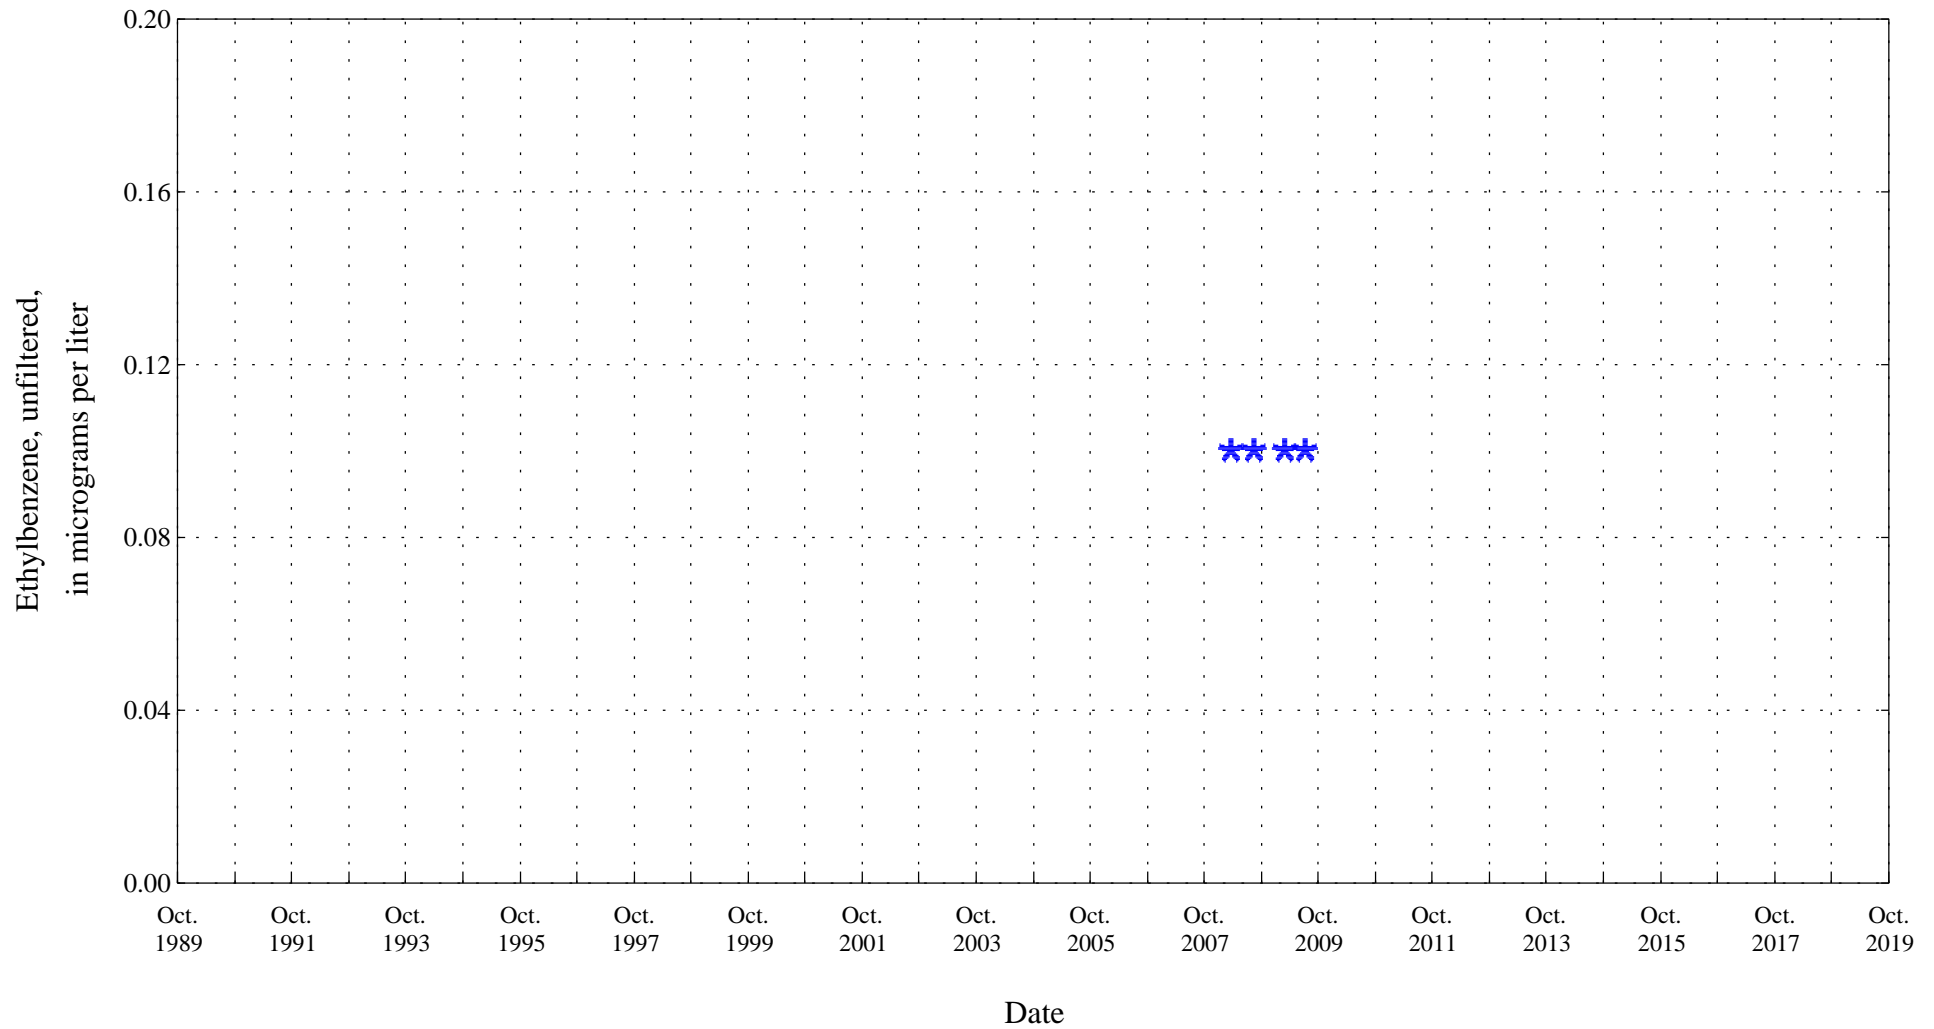
Figure 3. Distribution of selected water-quality constituents relative to time for

Piceance Creek below Ryan Gulch, near Rio Blanco, Co., station 09306200.

* * * Historic Censored Data

Fish Ingestion Chronic Standard 2,100

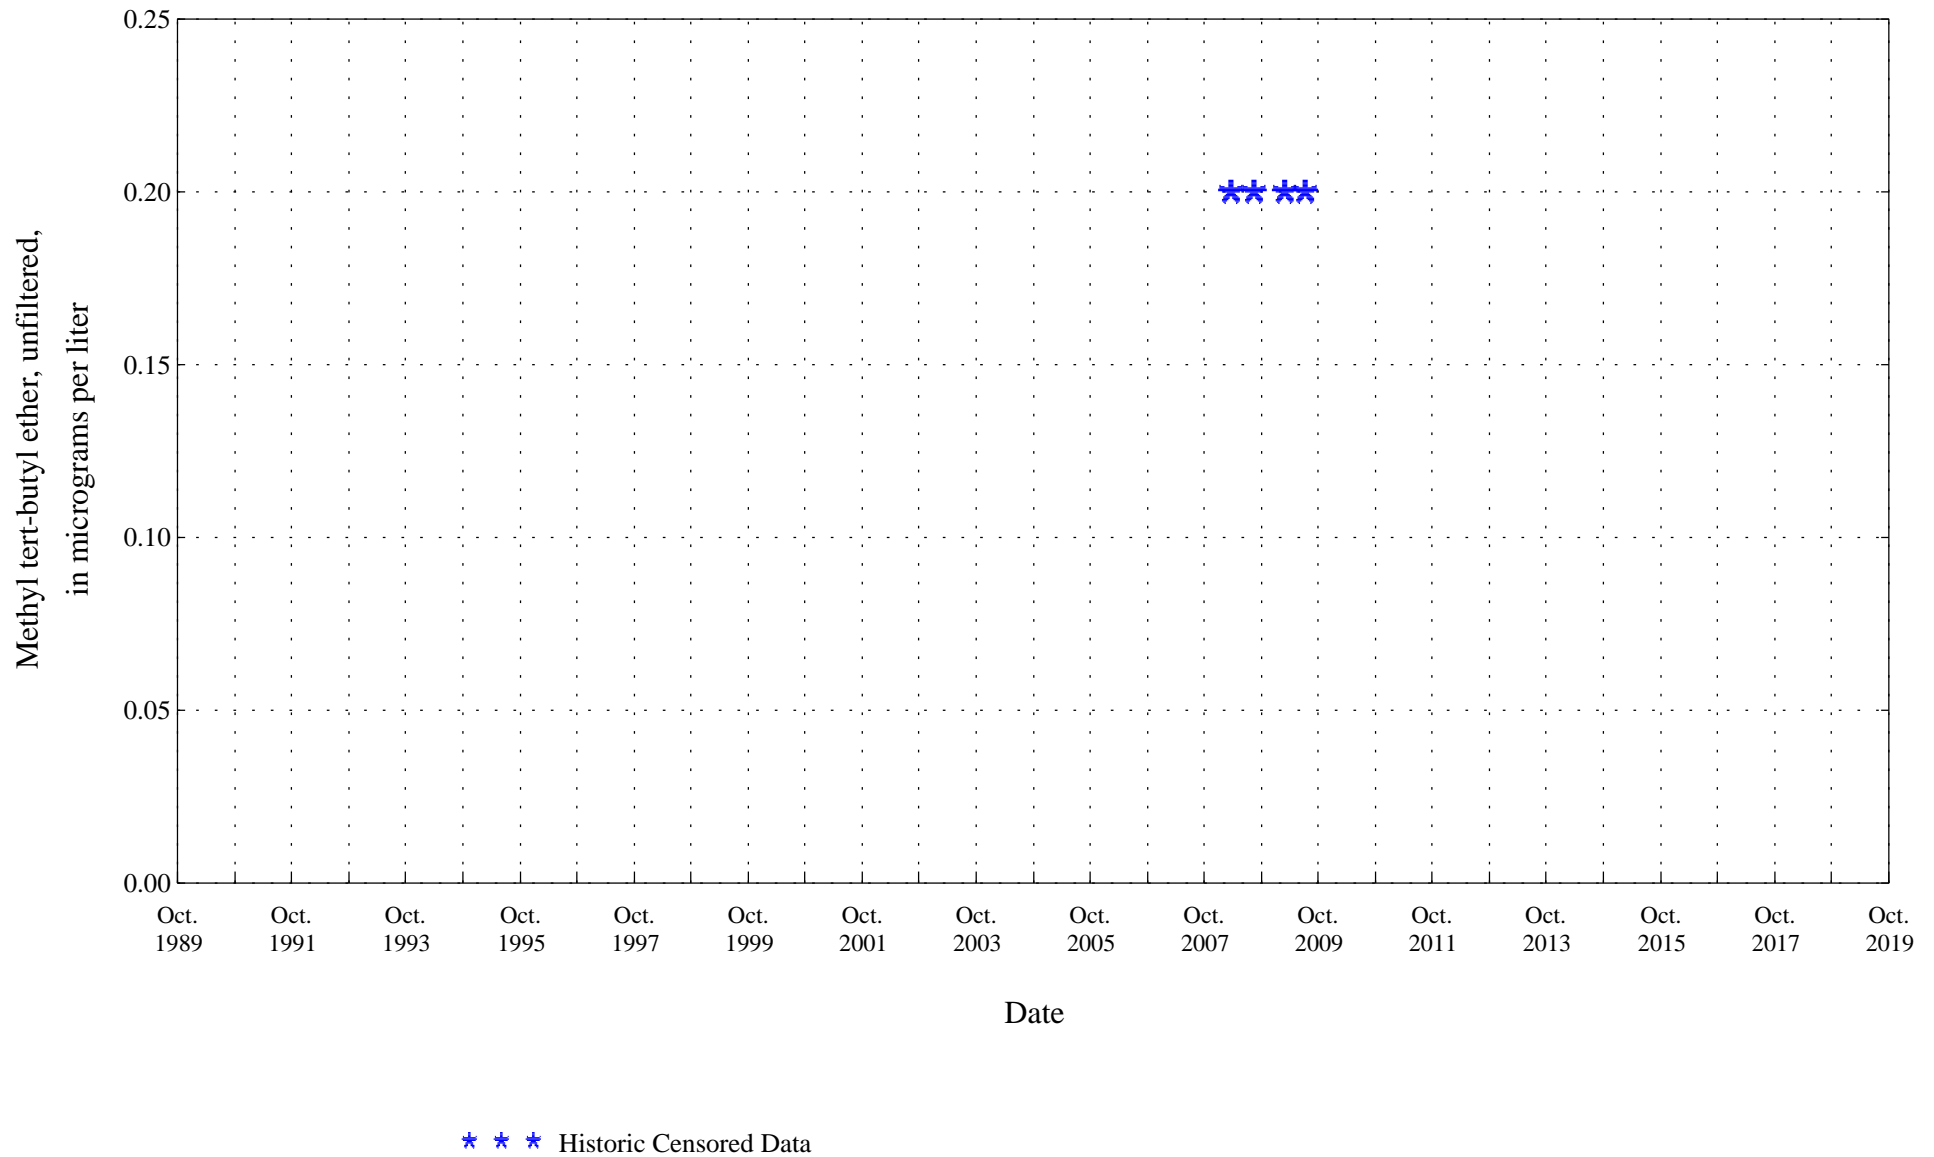
Figure 3. Distribution of selected water-quality constituents relative to time for

Piceance Creek below Ryan Gulch, near Rio Blanco, Co., station 09306200.

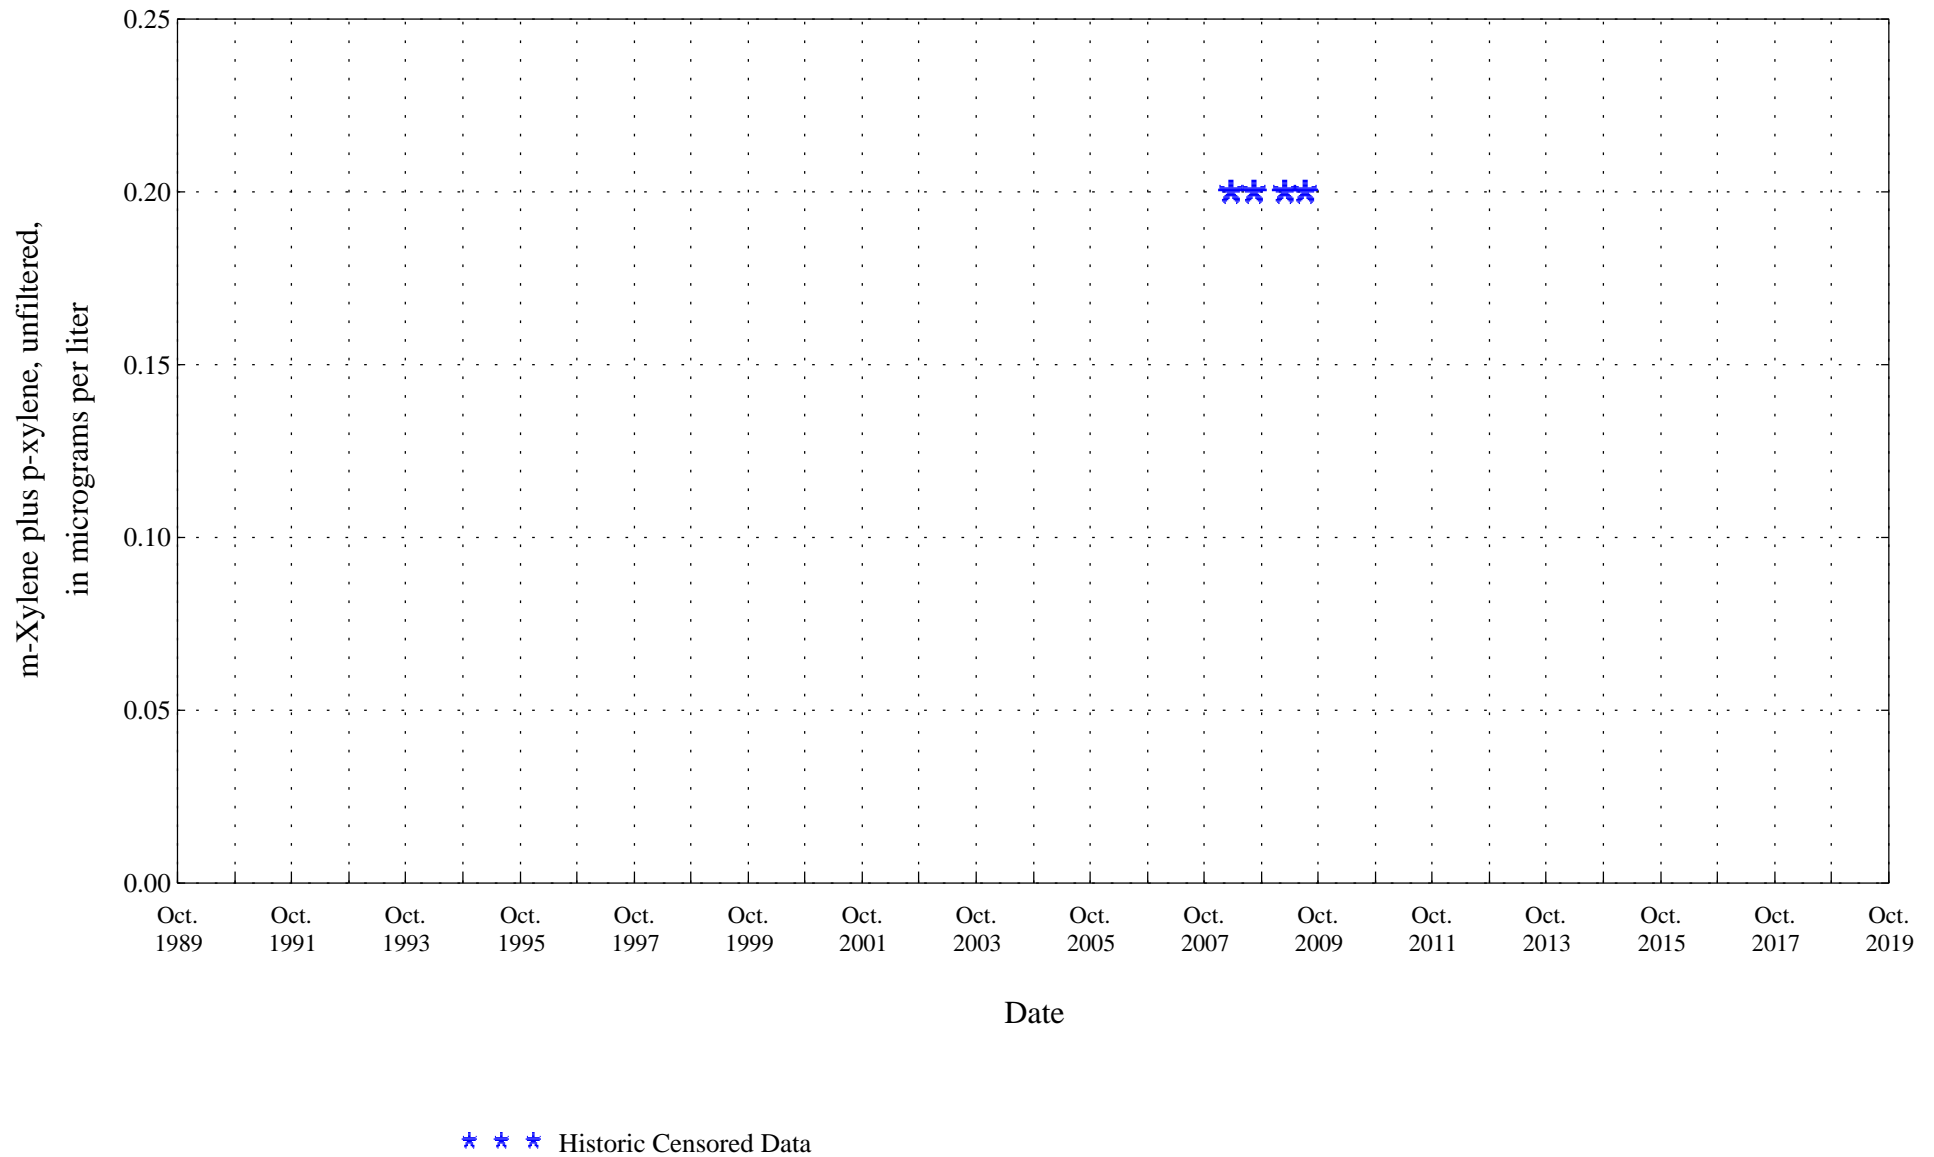
Figure 3. Distribution of selected water-quality constituents relative to time for

Piceance Creek below Ryan Gulch, near Rio Blanco, Co., station 09306200.

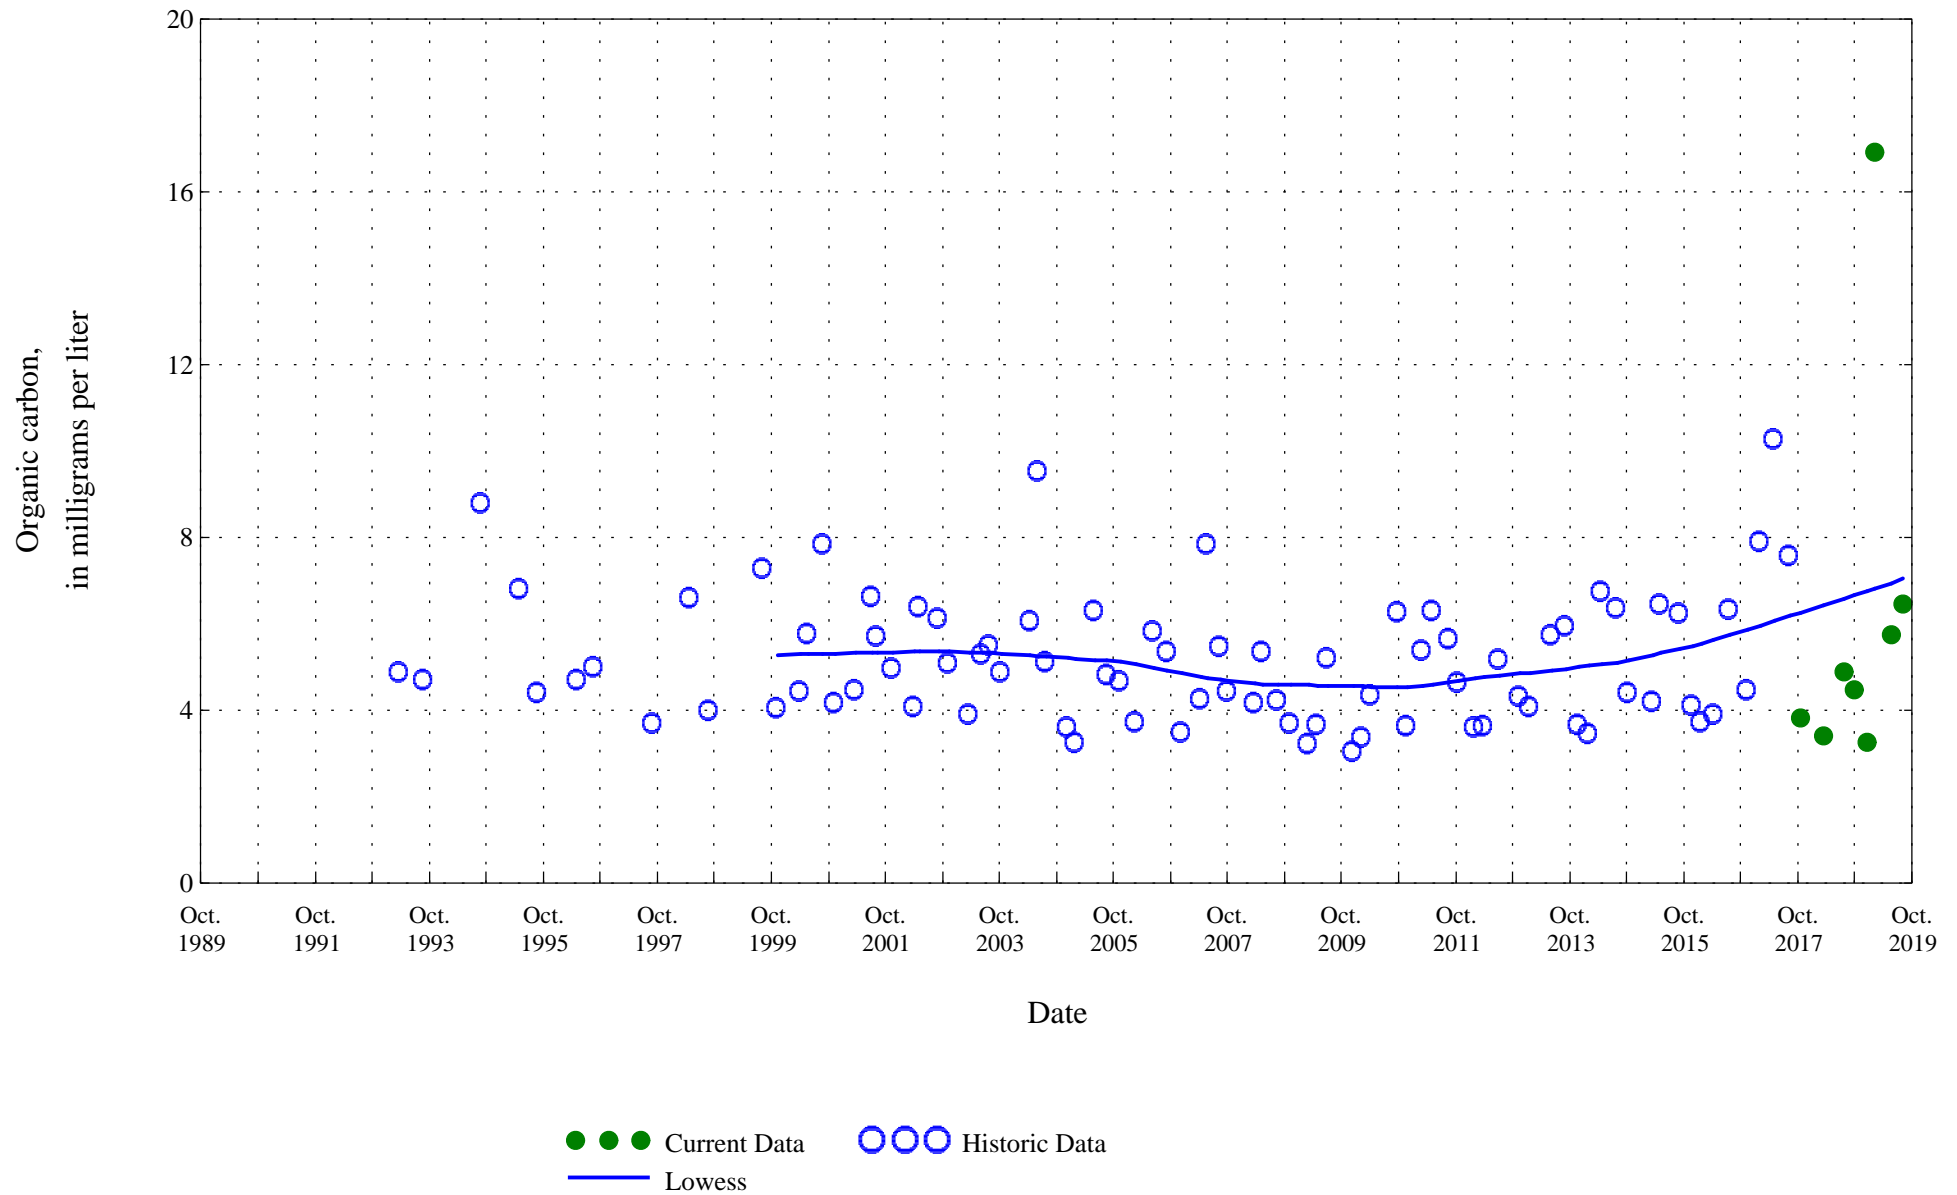
Figure 3. Distribution of selected water-quality constituents relative to time for

Piceance Creek below Ryan Gulch, near Rio Blanco, Co., station 09306200.

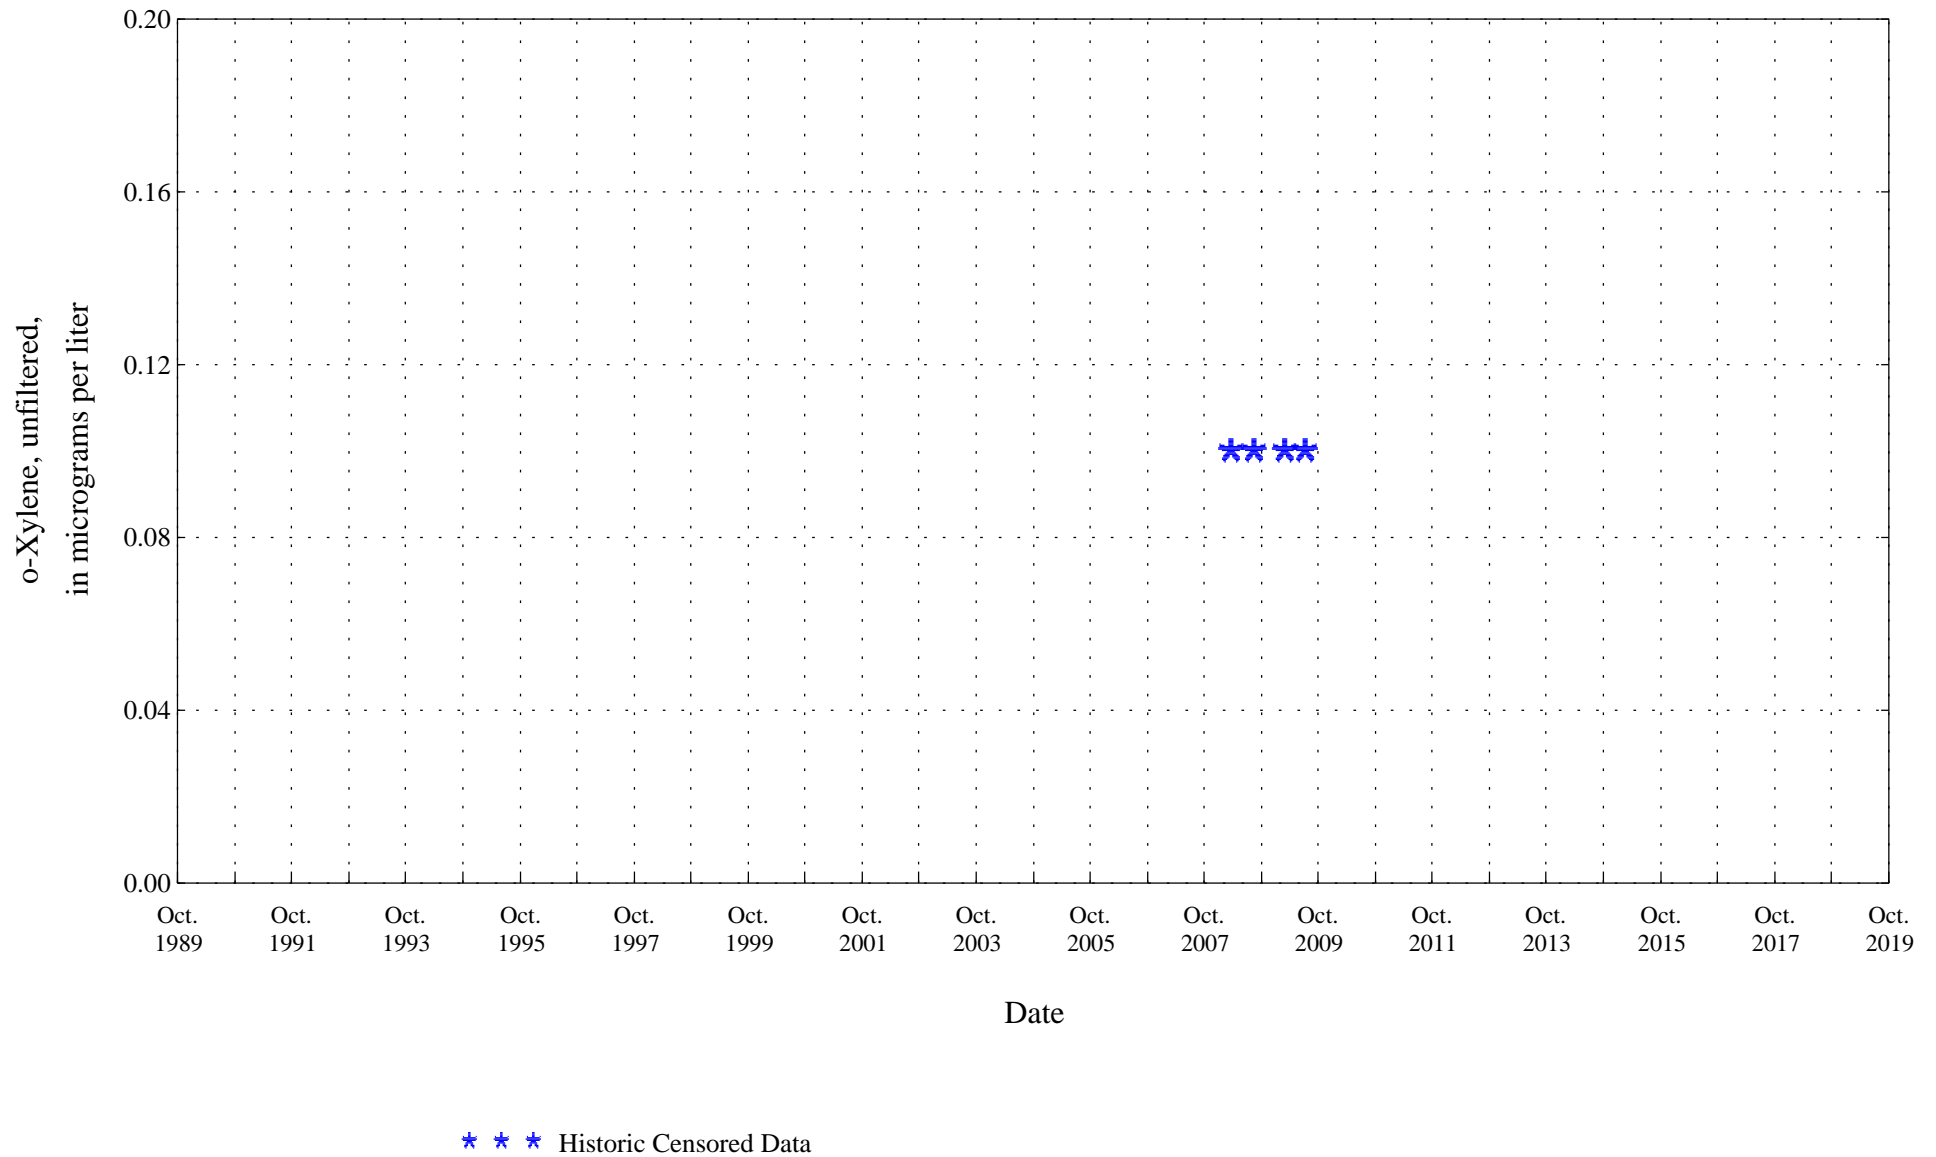
Figure 3. Distribution of selected water-quality constituents relative to time for

Piceance Creek below Ryan Gulch, near Rio Blanco, Co., station 09306200.
