Figure 3. Distribution of selected water-quality constituents relative to time for

Piceance Creek below Ryan Gulch, near Rio Blanco, Co., station 09306200.

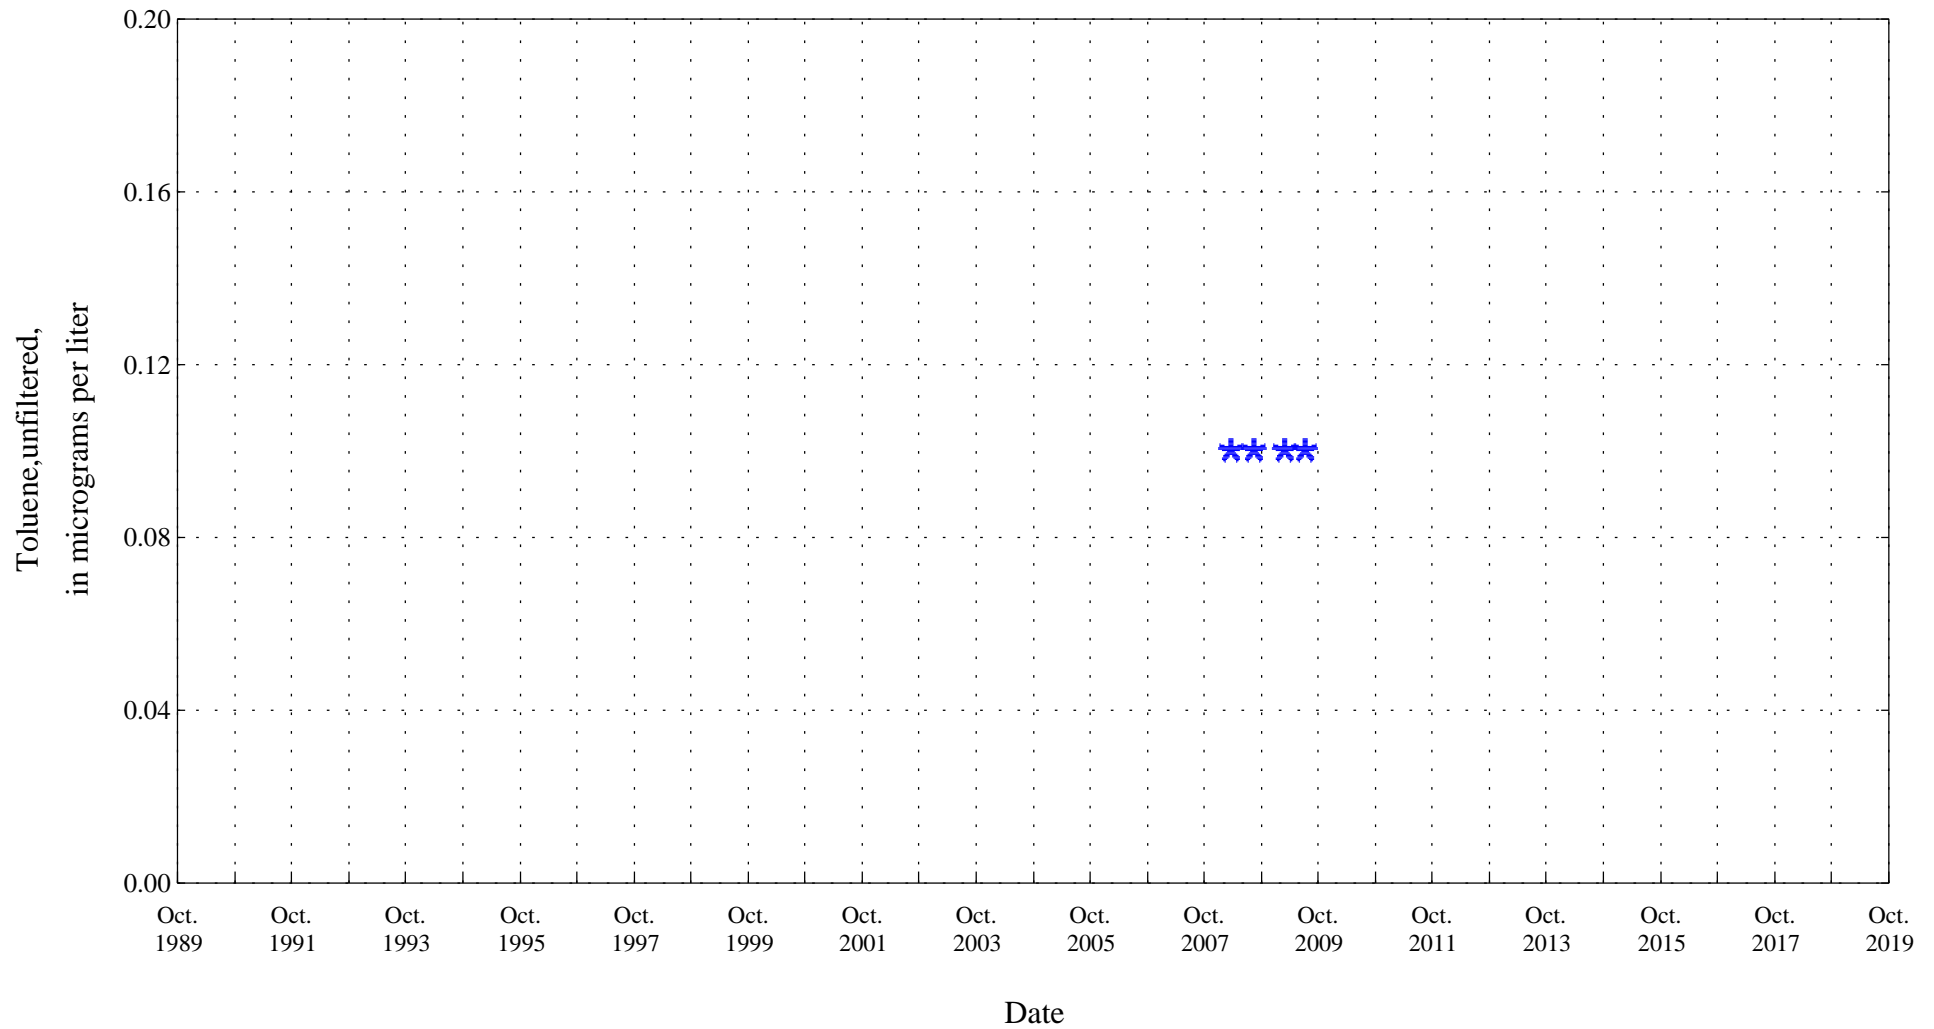
Figure 3. Distribution of selected water-quality constituents relative to time for

Piceance Creek below Ryan Gulch, near Rio Blanco, Co., station 09306200.

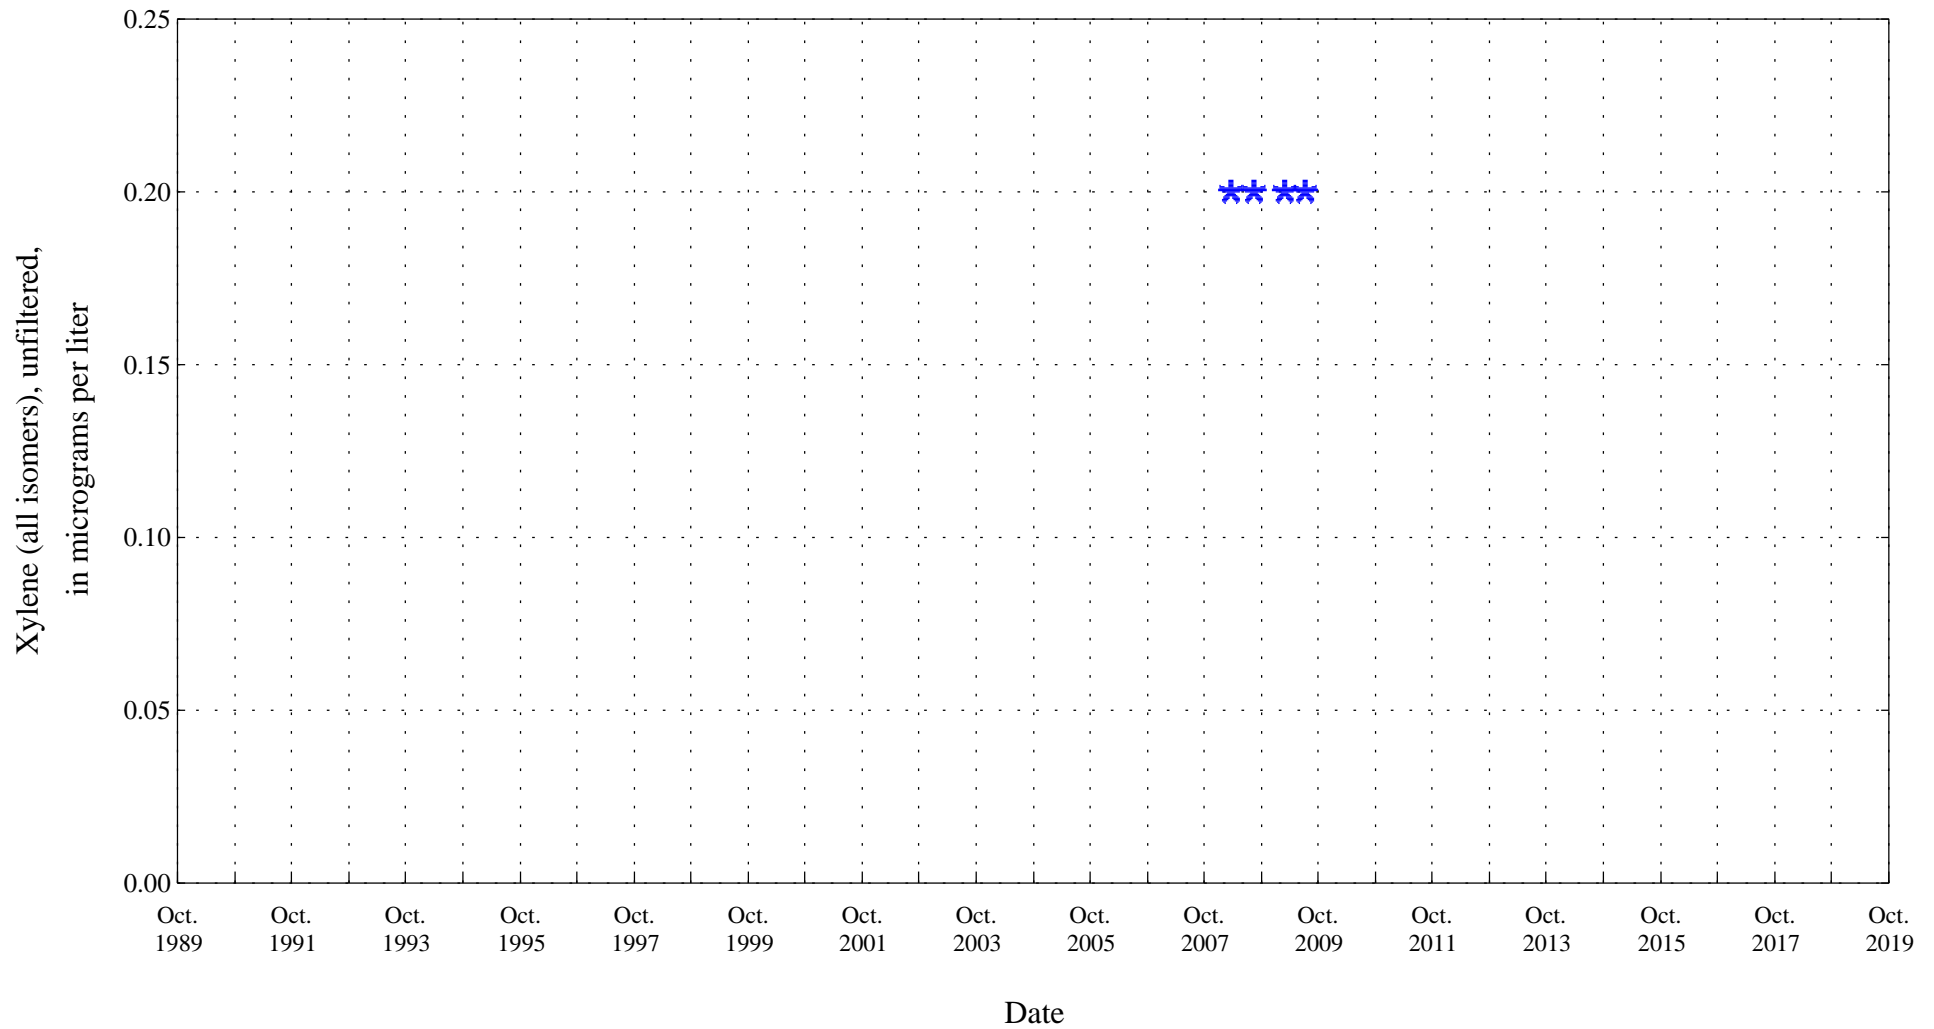
Figure 3. Distribution of selected water-quality constituents relative to time for

Piceance Creek below Ryan Gulch, near Rio Blanco, Co., station 09306200.

* * * Historic Censored Data

Human Health Based Water Supply Chronic Standard 1,400

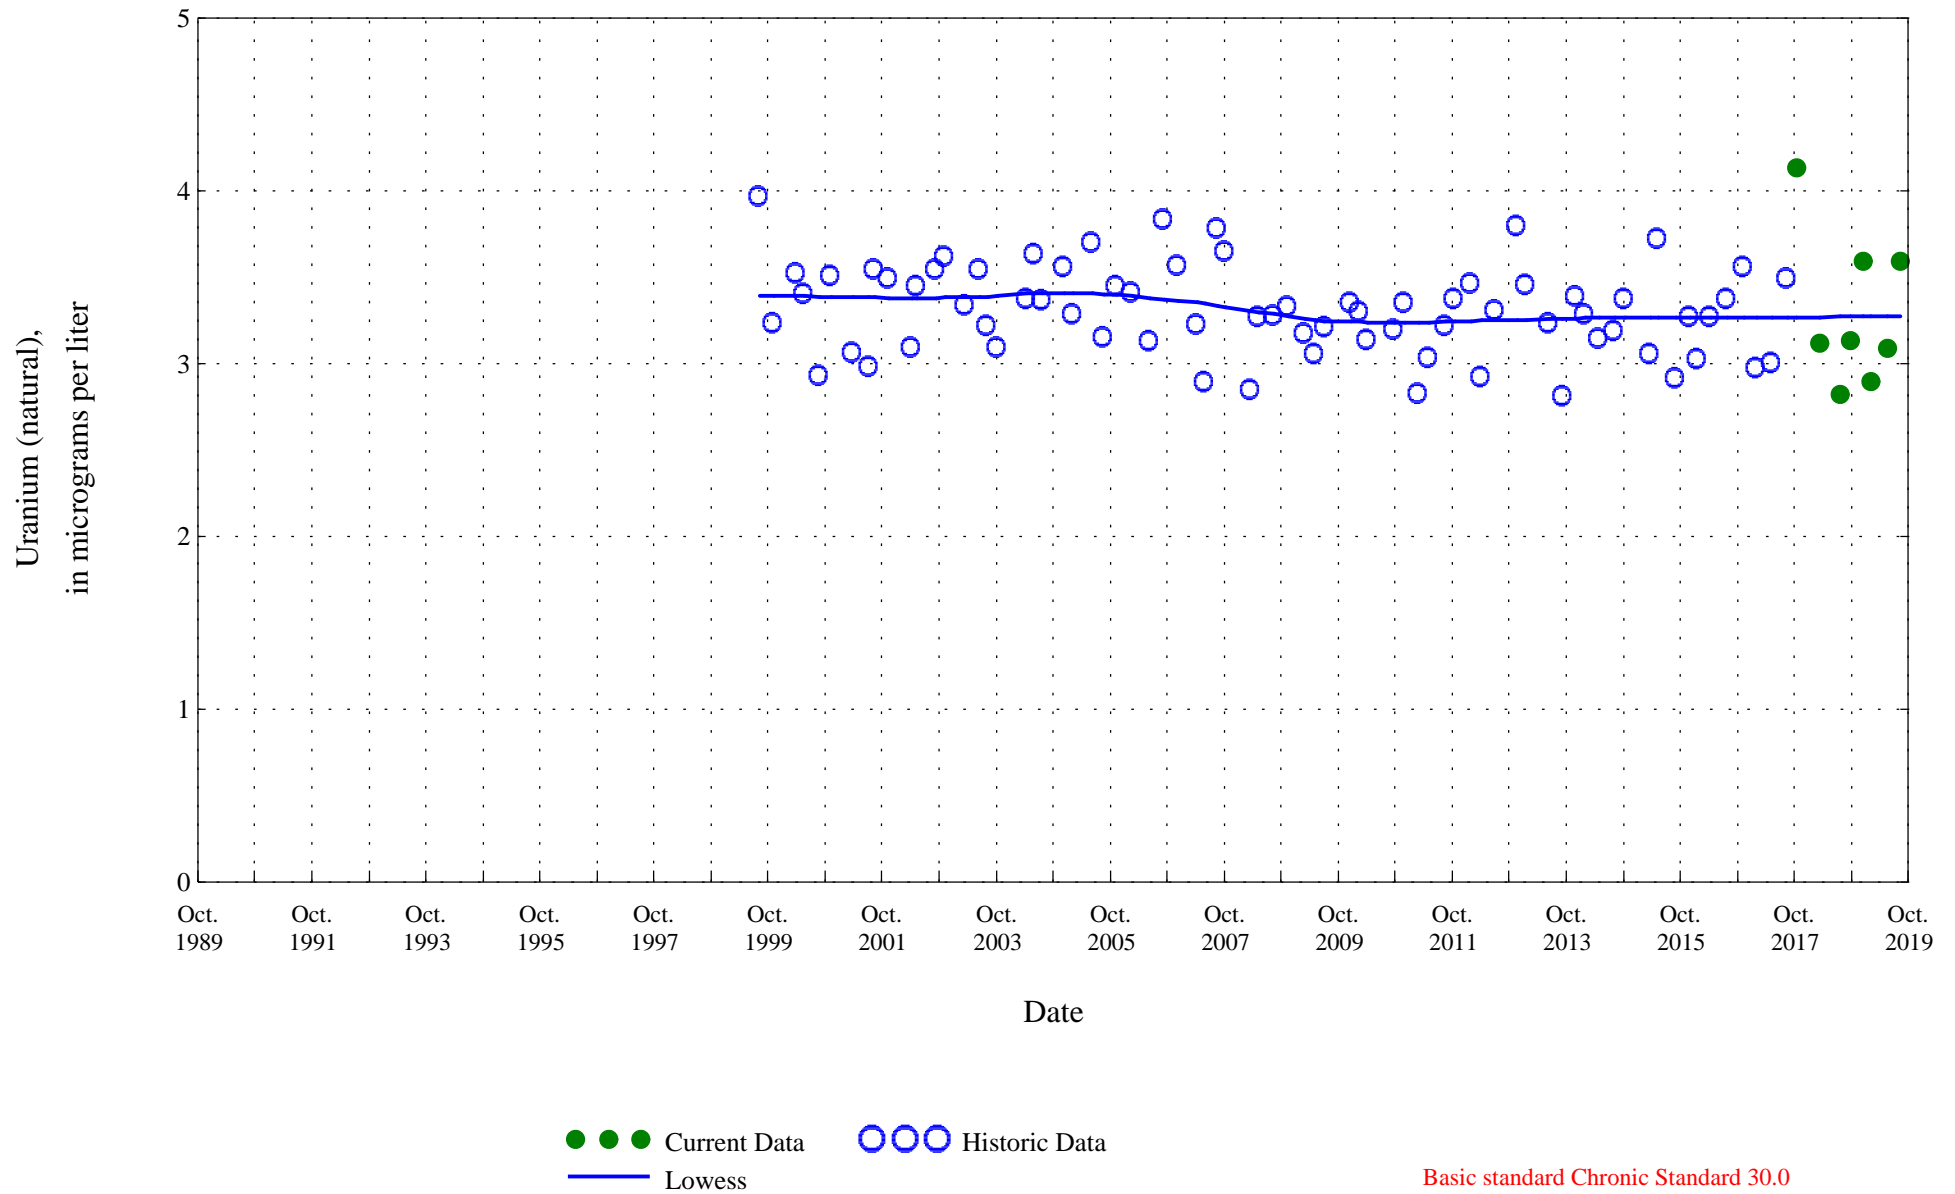
Figure 3. Distribution of selected water-quality constituents relative to time for

Piceance Creek below Ryan Gulch, near Rio Blanco, Co., station 09306200.

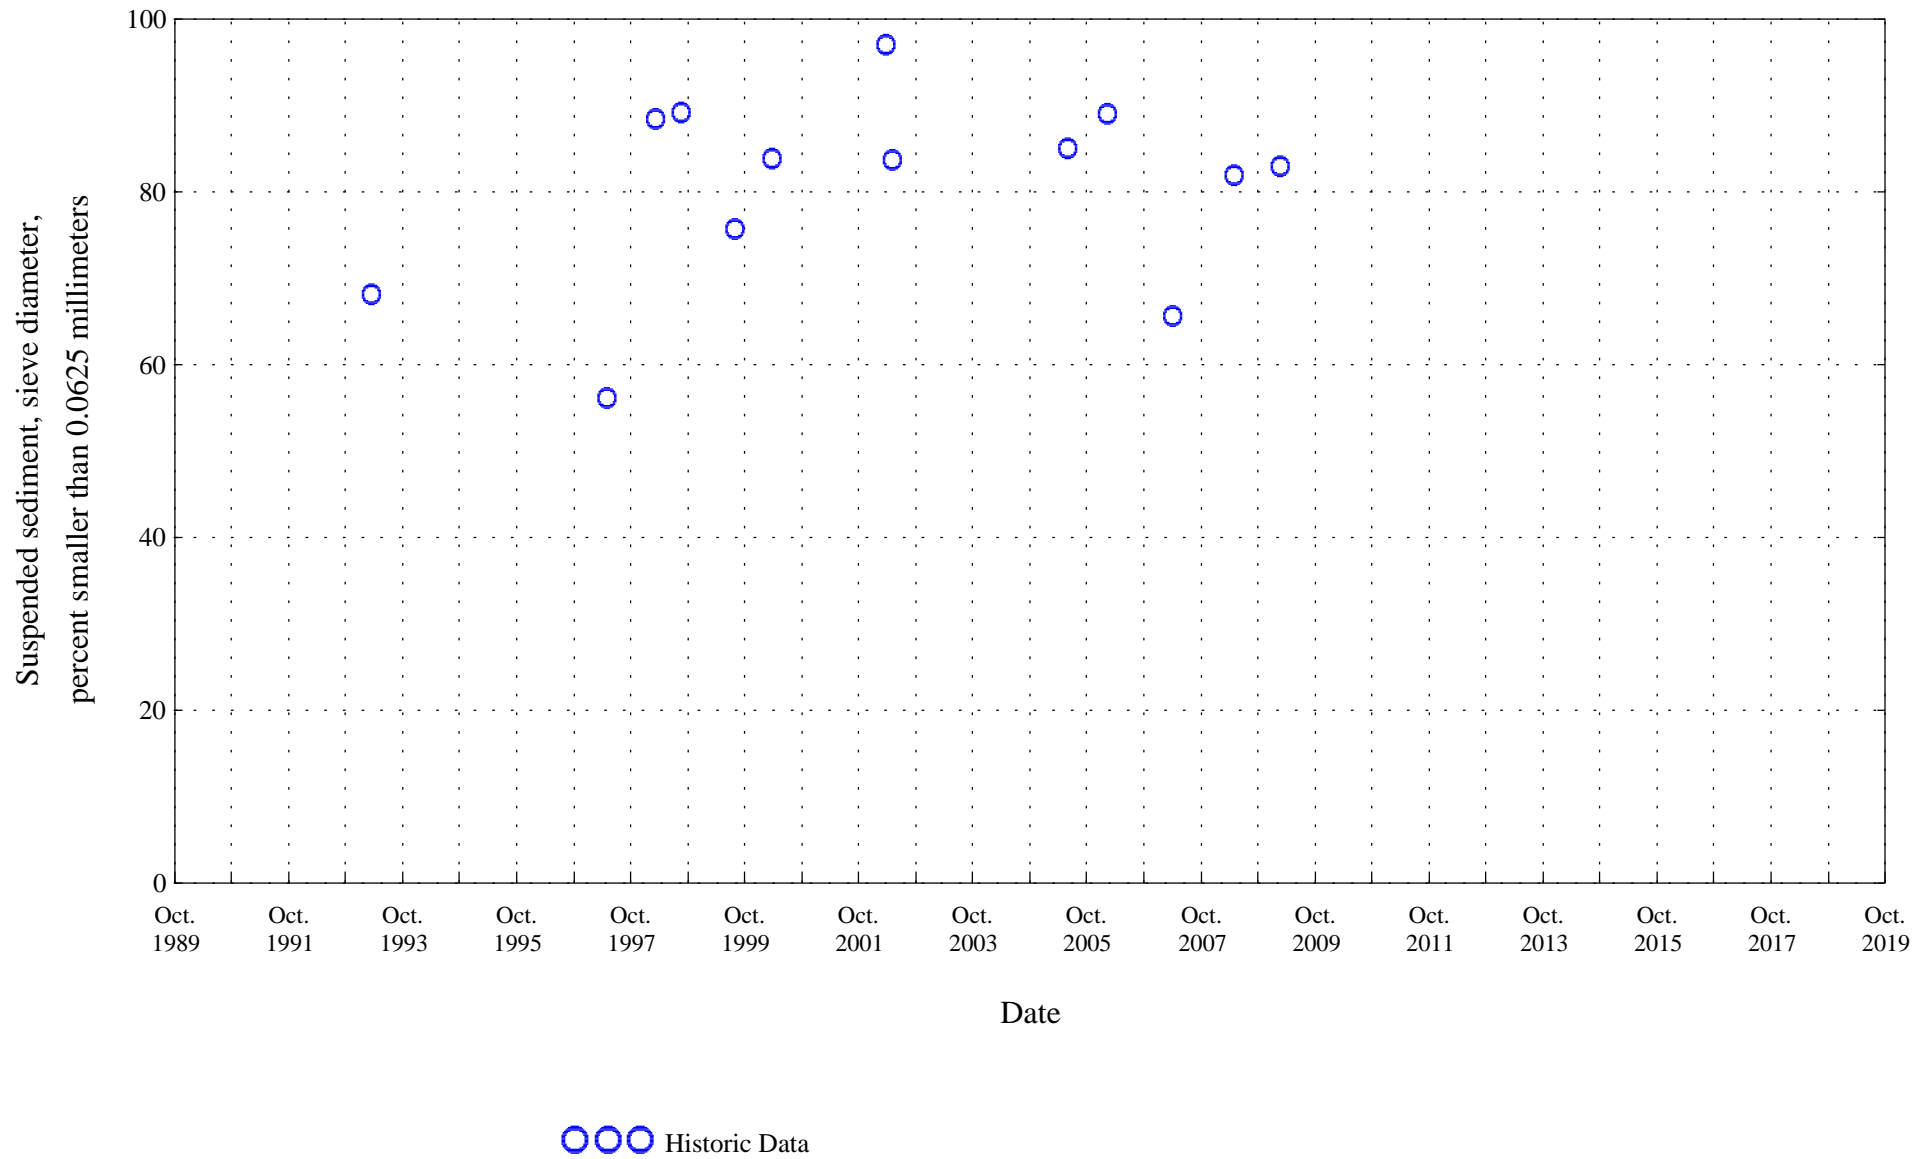
Figure 3. Distribution of selected water-quality constituents relative to time for

Piceance Creek below Ryan Gulch, near Rio Blanco, Co., station 09306200.

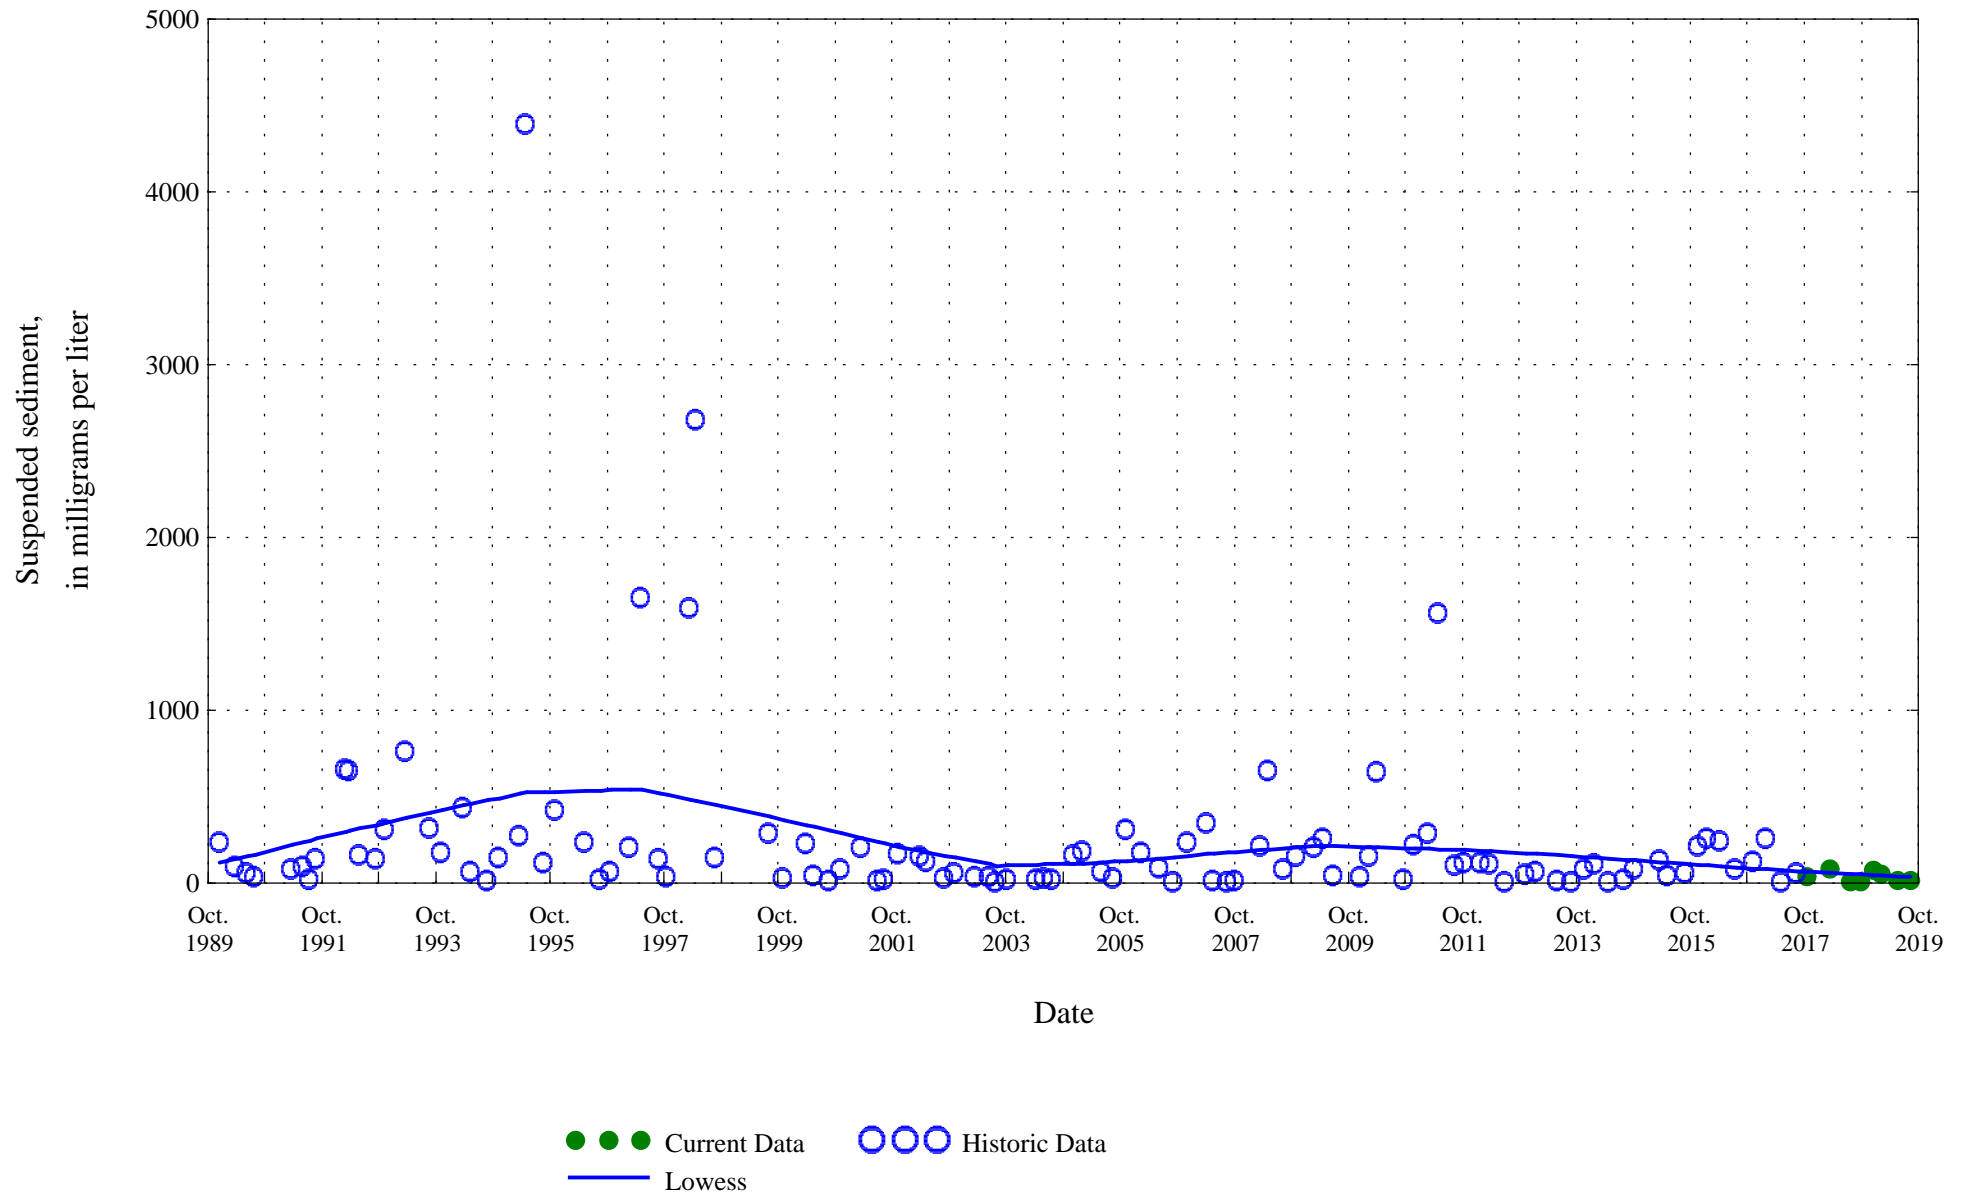
Figure 3. Distribution of selected water-quality constituents relative to time for

Piceance Creek below Ryan Gulch, near Rio Blanco, Co., station 09306200.
