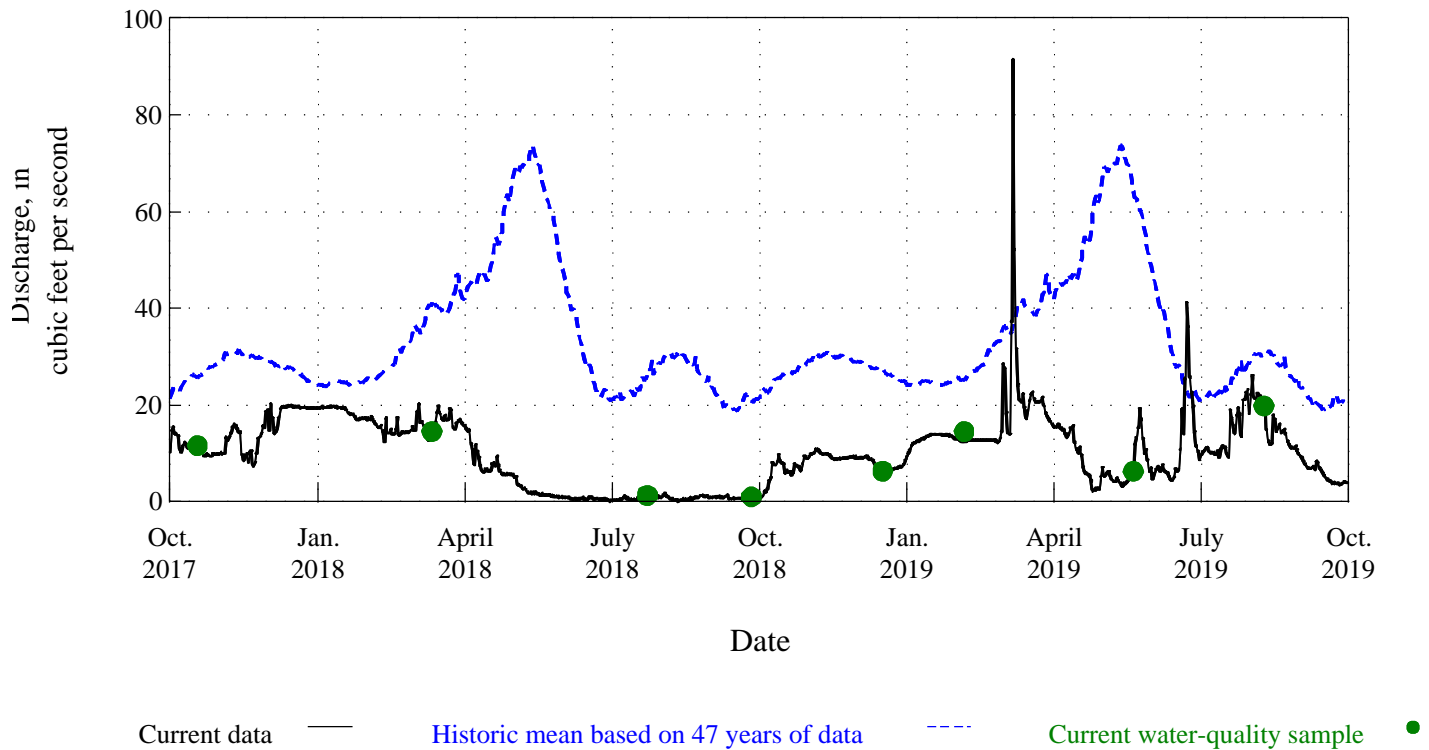
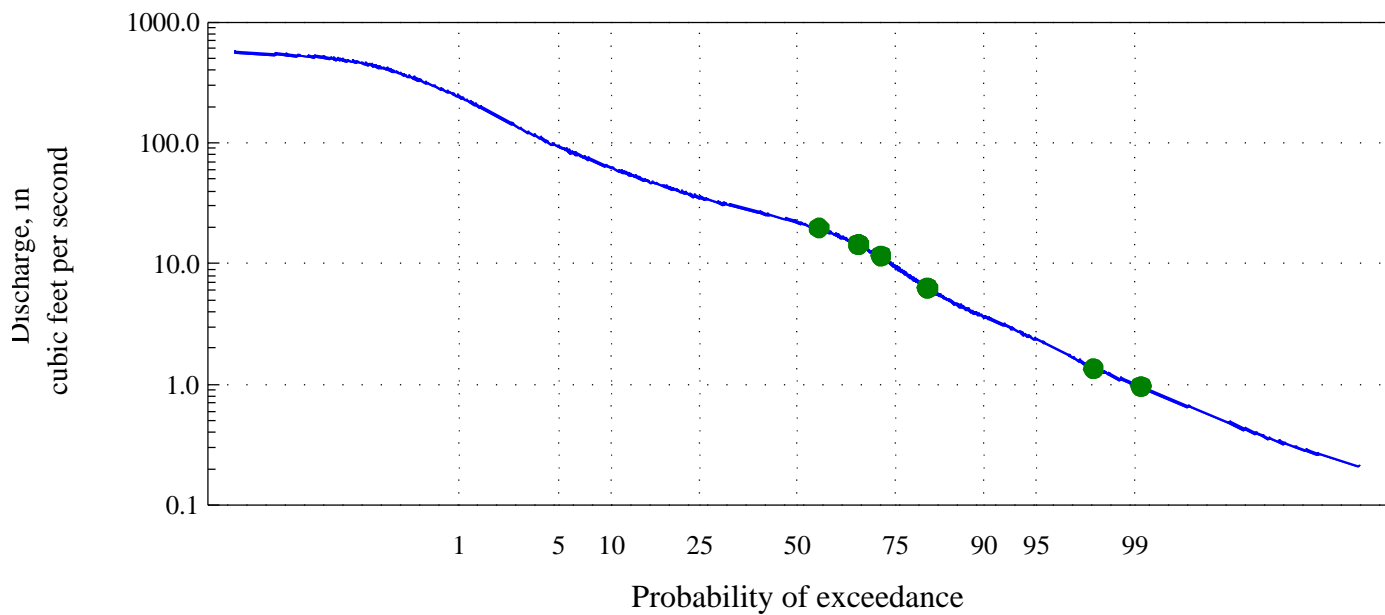
Figure 4. Time distribution and associated discharge of water-quality samples for
Piceance Creek at White River, Co., station 09306222.
