Figure 10. Distribution of selected water-quality constituents relative to time for

Olympus Tunnel at Lake Estes Co., station 06734900.

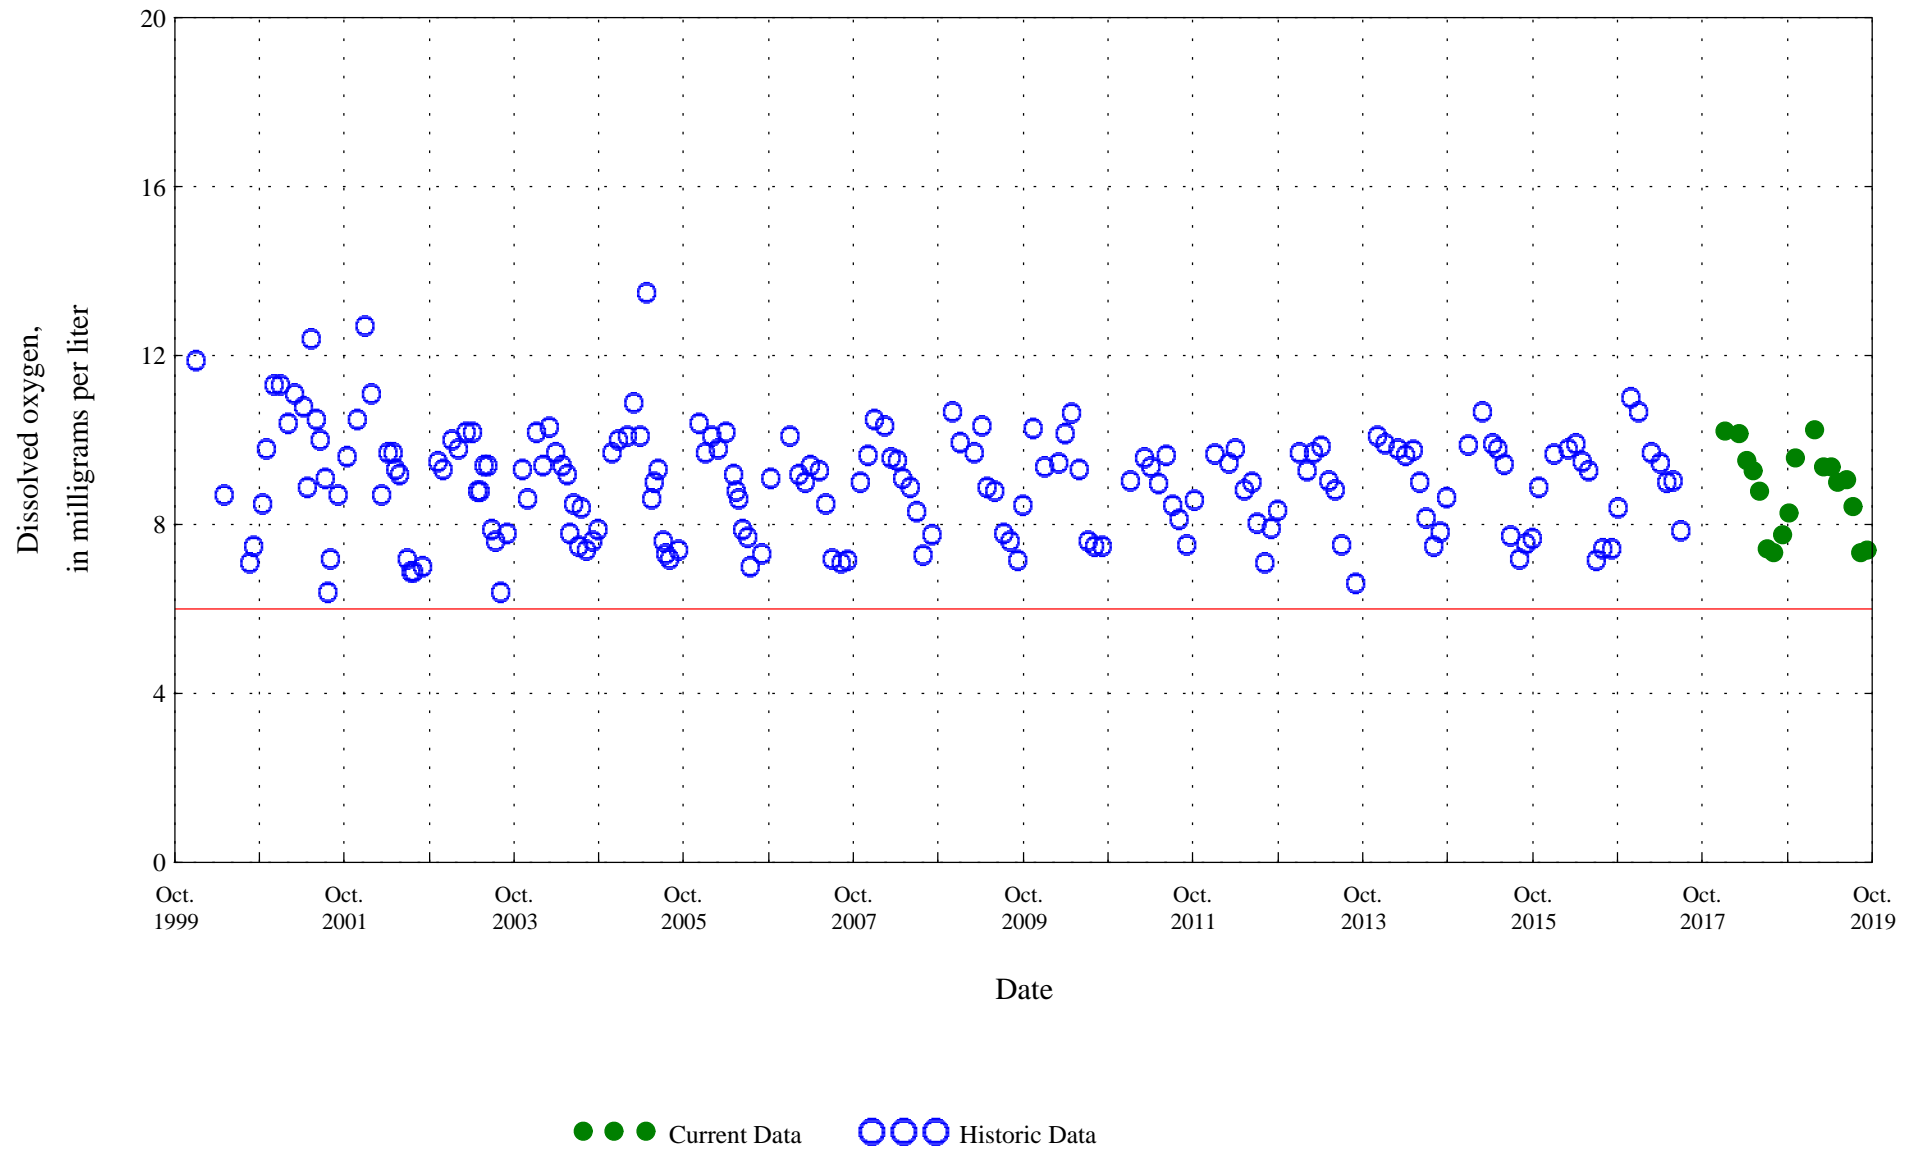
Figure 10. Distribution of selected water-quality constituents relative to time for

Olympus Tunnel at Lake Estes Co., station 06734900.

Aquatic Life Standard 6.0

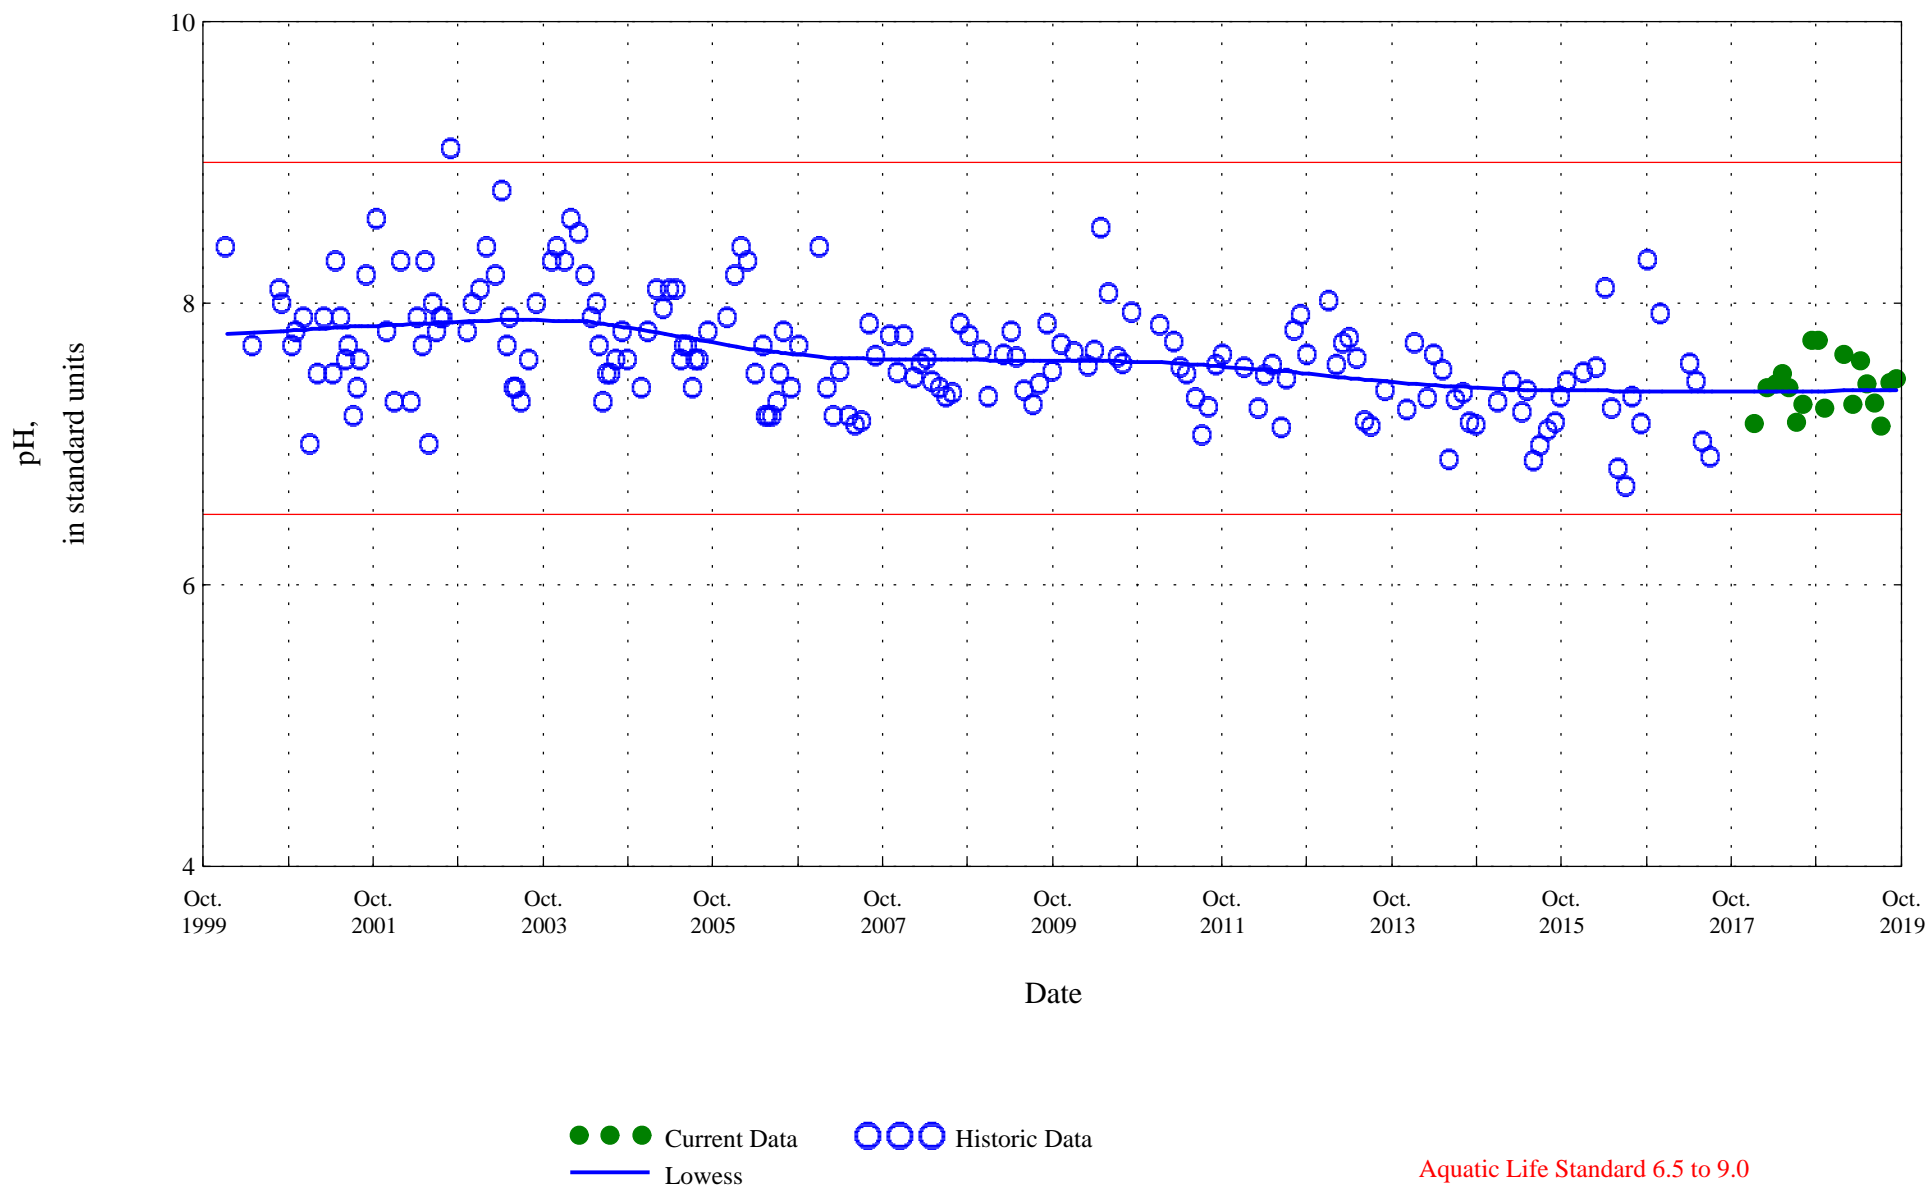
Figure 10. Distribution of selected water-quality constituents relative to time for

Olympus Tunnel at Lake Estes Co., station 06734900.

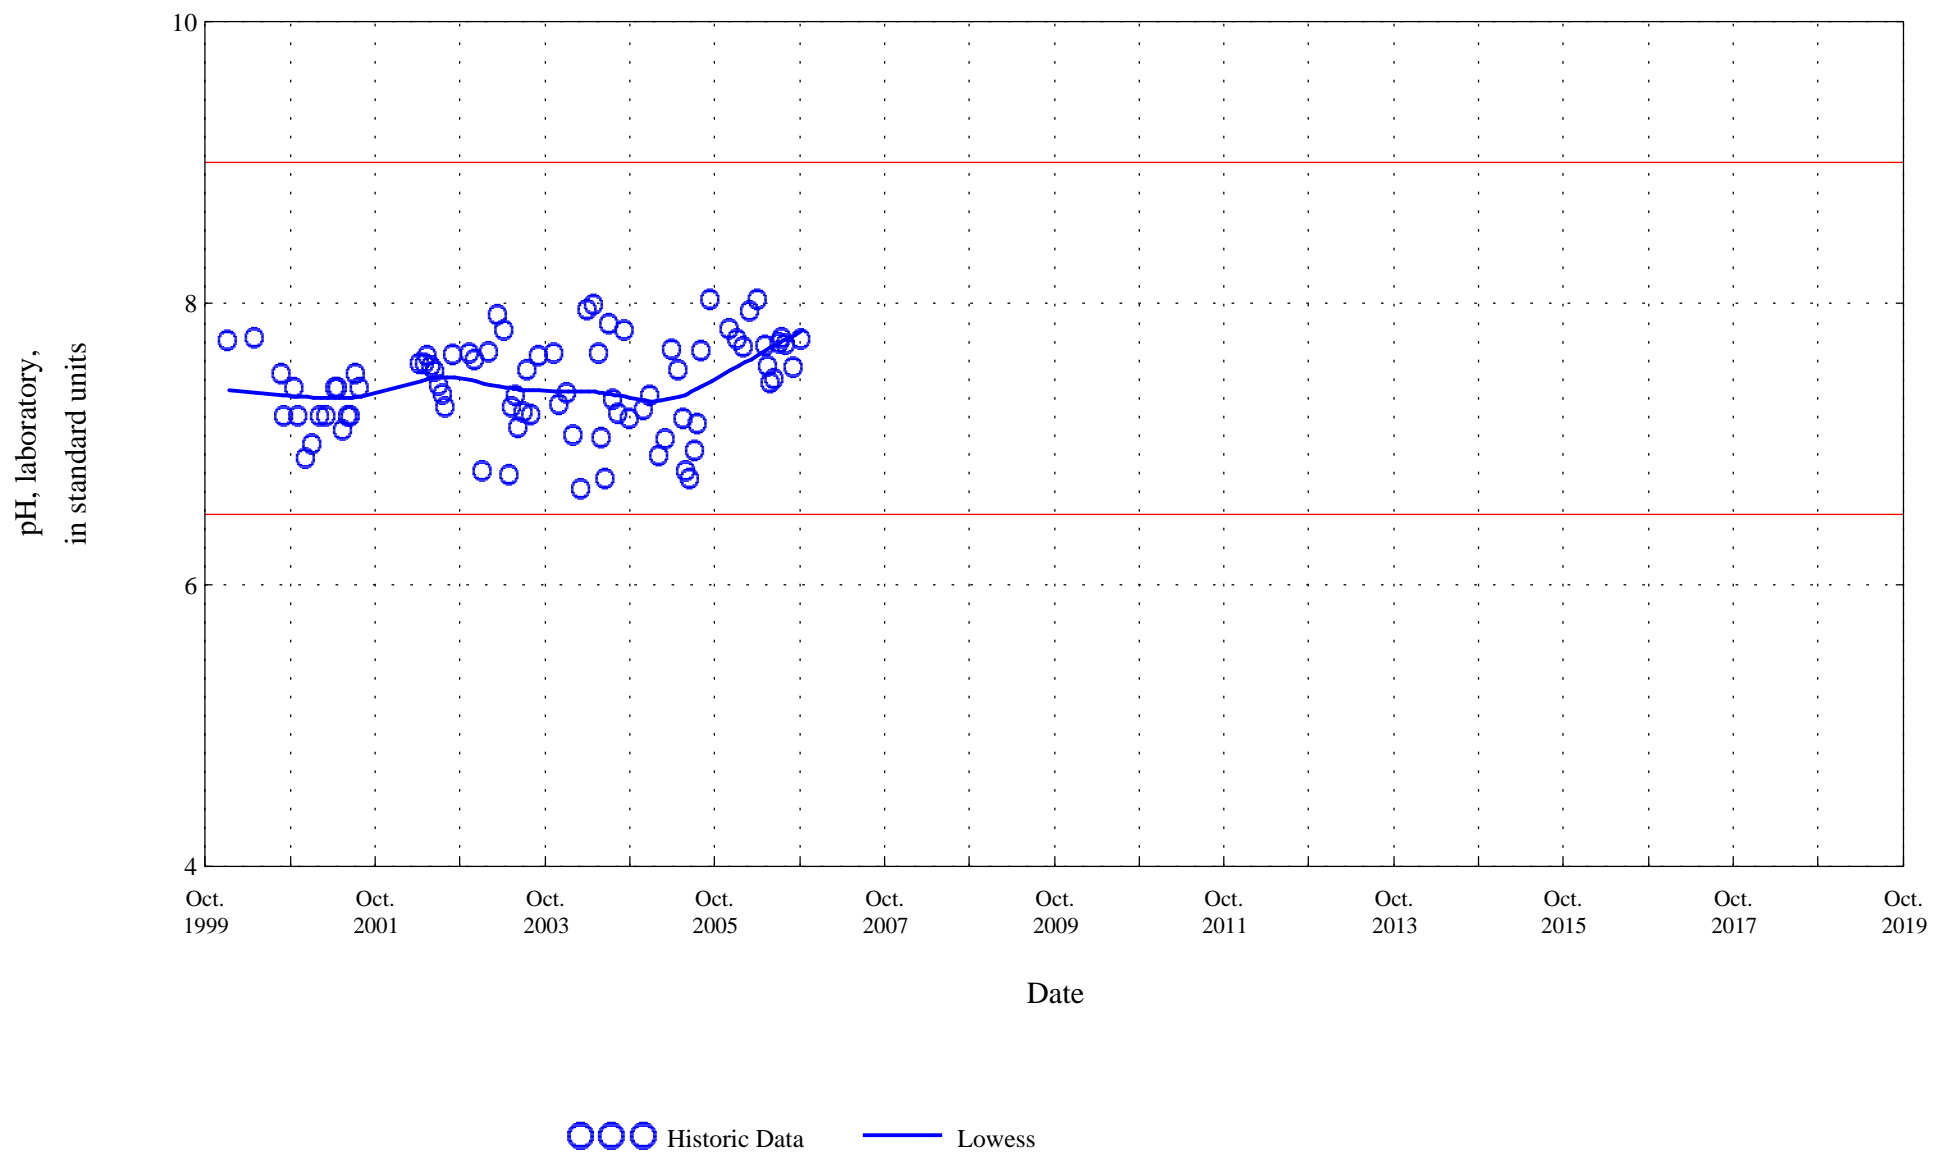
Figure 10. Distribution of selected water-quality constituents relative to time for

Olympus Tunnel at Lake Estes Co., station 06734900.

Aquatic Life Standard 6.5 to 9.0

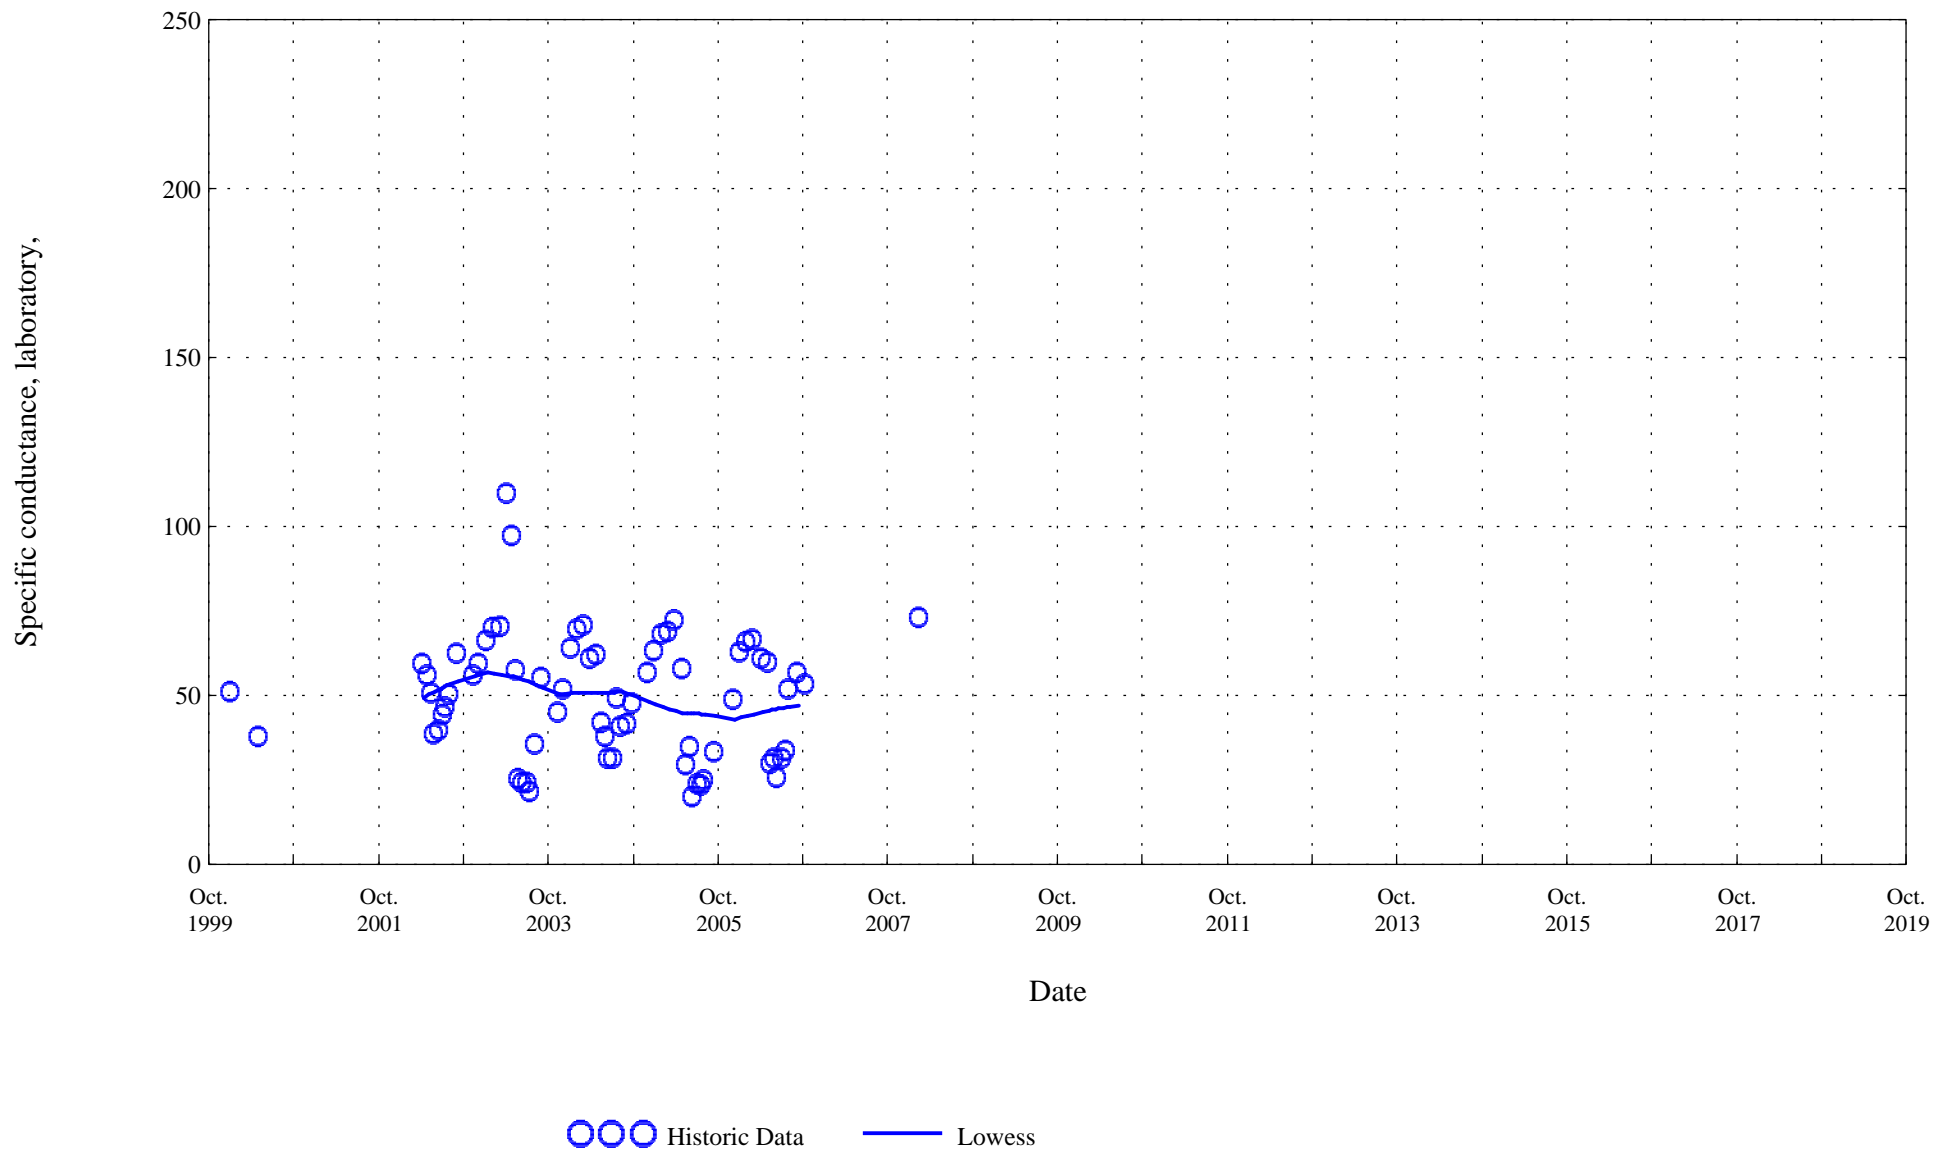
Figure 10. Distribution of selected water-quality constituents relative to time for

Olympus Tunnel at Lake Estes Co., station 06734900.

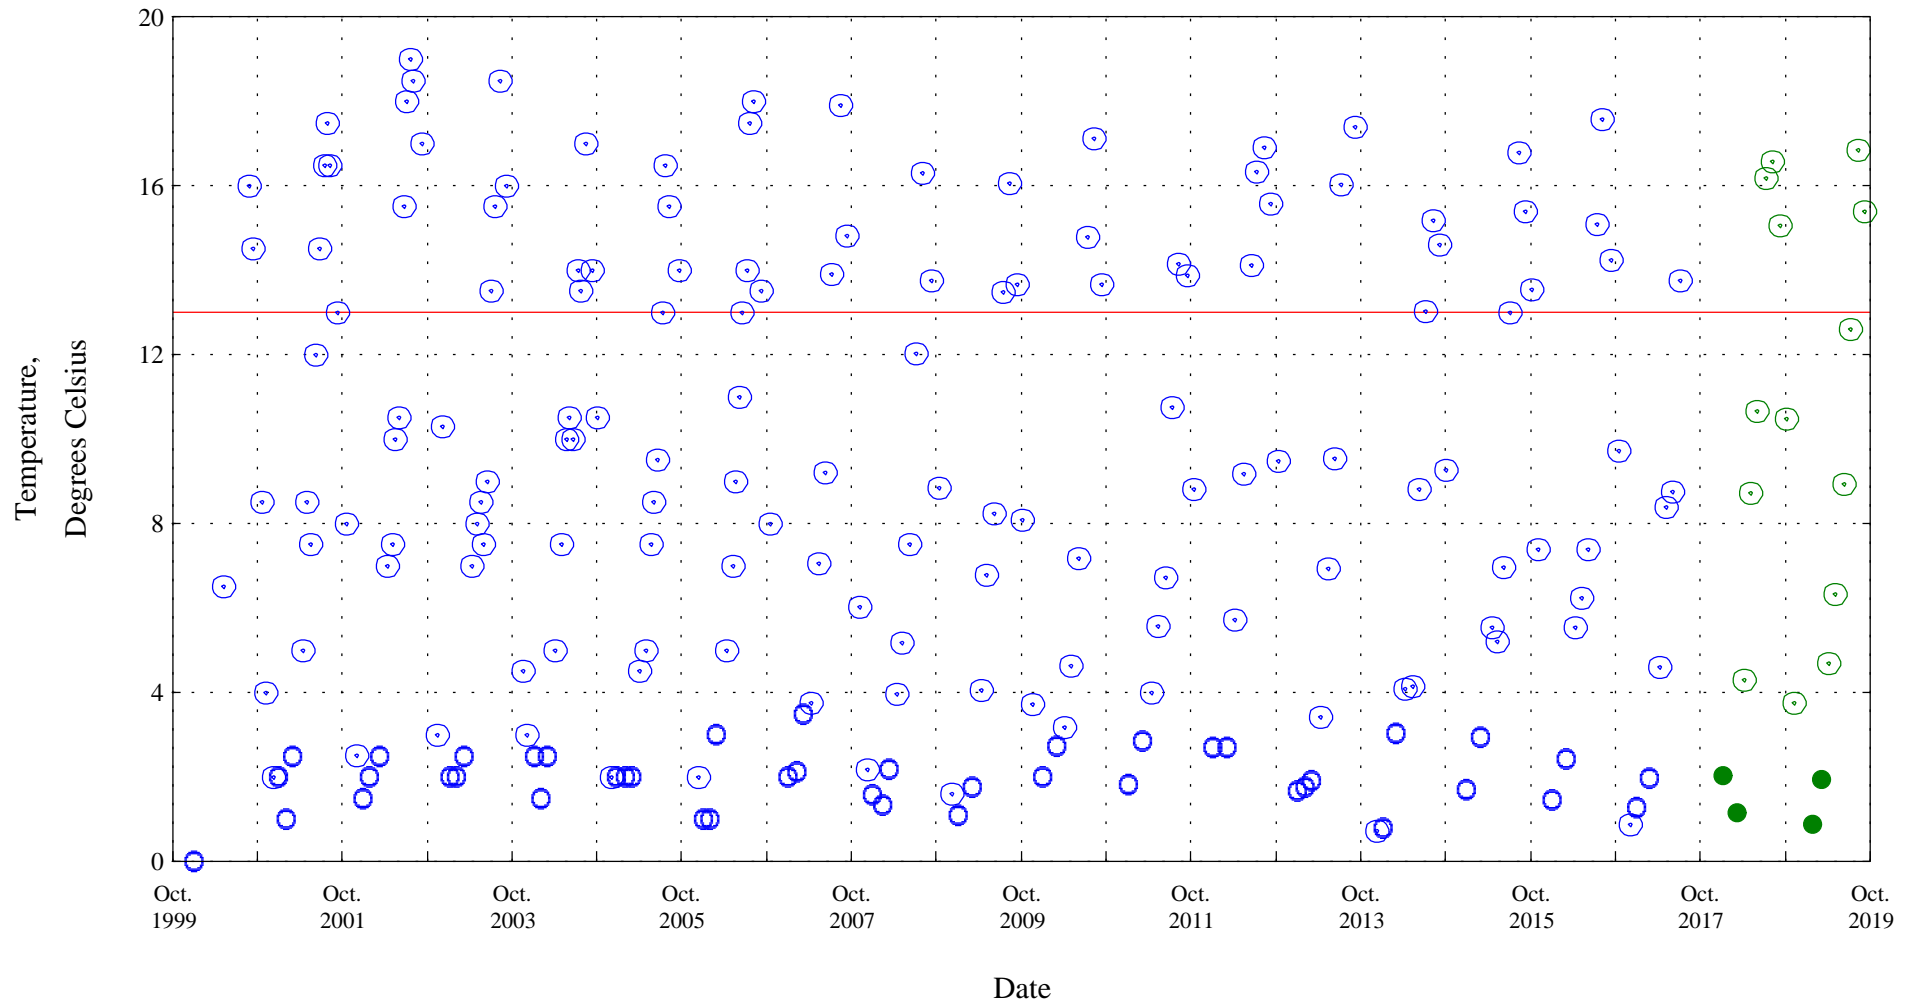
Figure 10. Distribution of selected water-quality constituents relative to time for

Olympus Tunnel at Lake Estes Co., station 06734900.

●●● Current Data, Cool Season Std
○●○ Historic Data, Cool Season Std

●●● Current Data, Warm Season Std
○●○ Historic Data, Warm Season Std

Aquatic Life Jan - Mar, Cool Season Std 13.0
Aquatic Life Apr - Dec, Warm Season Std 23.8

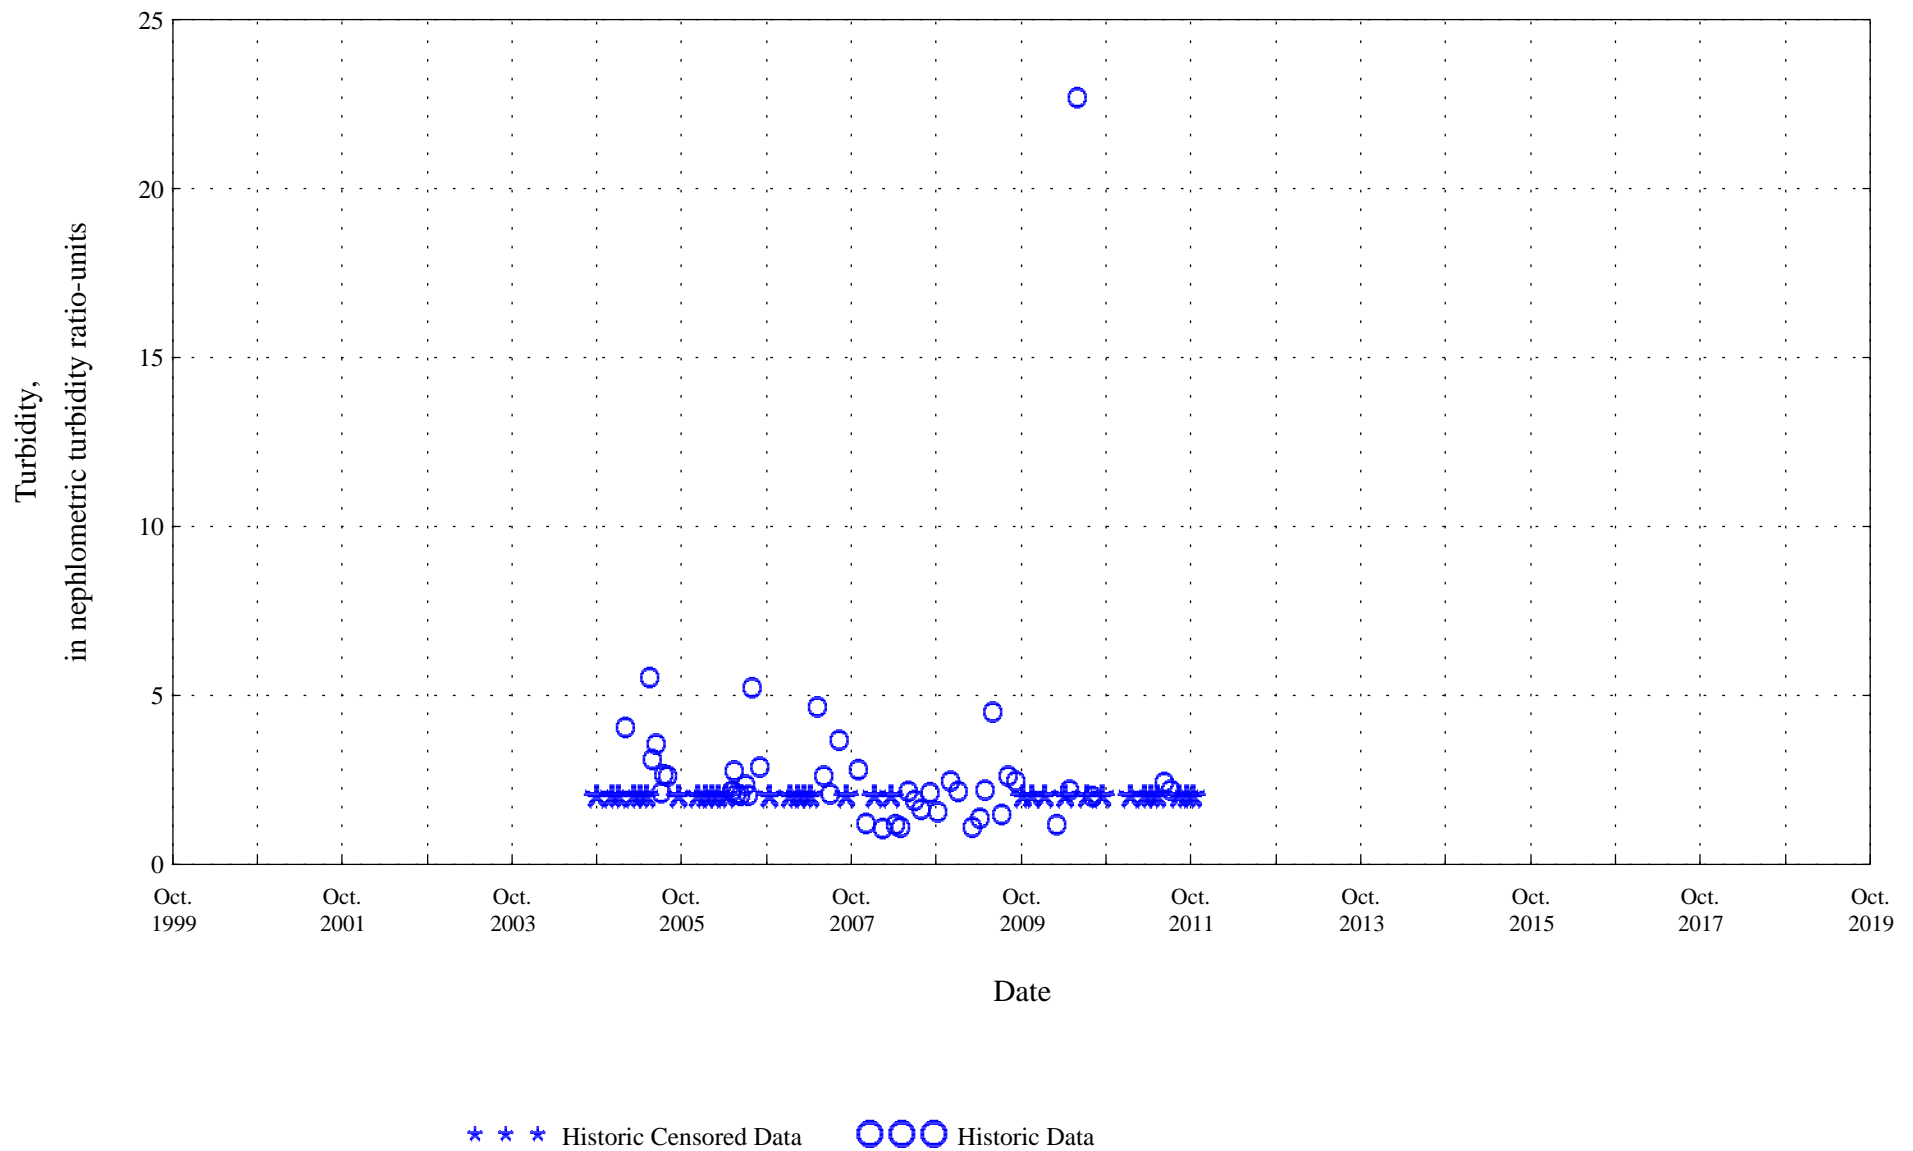
Figure 10. Distribution of selected water-quality constituents relative to time for

Olympus Tunnel at Lake Estes Co., station 06734900.

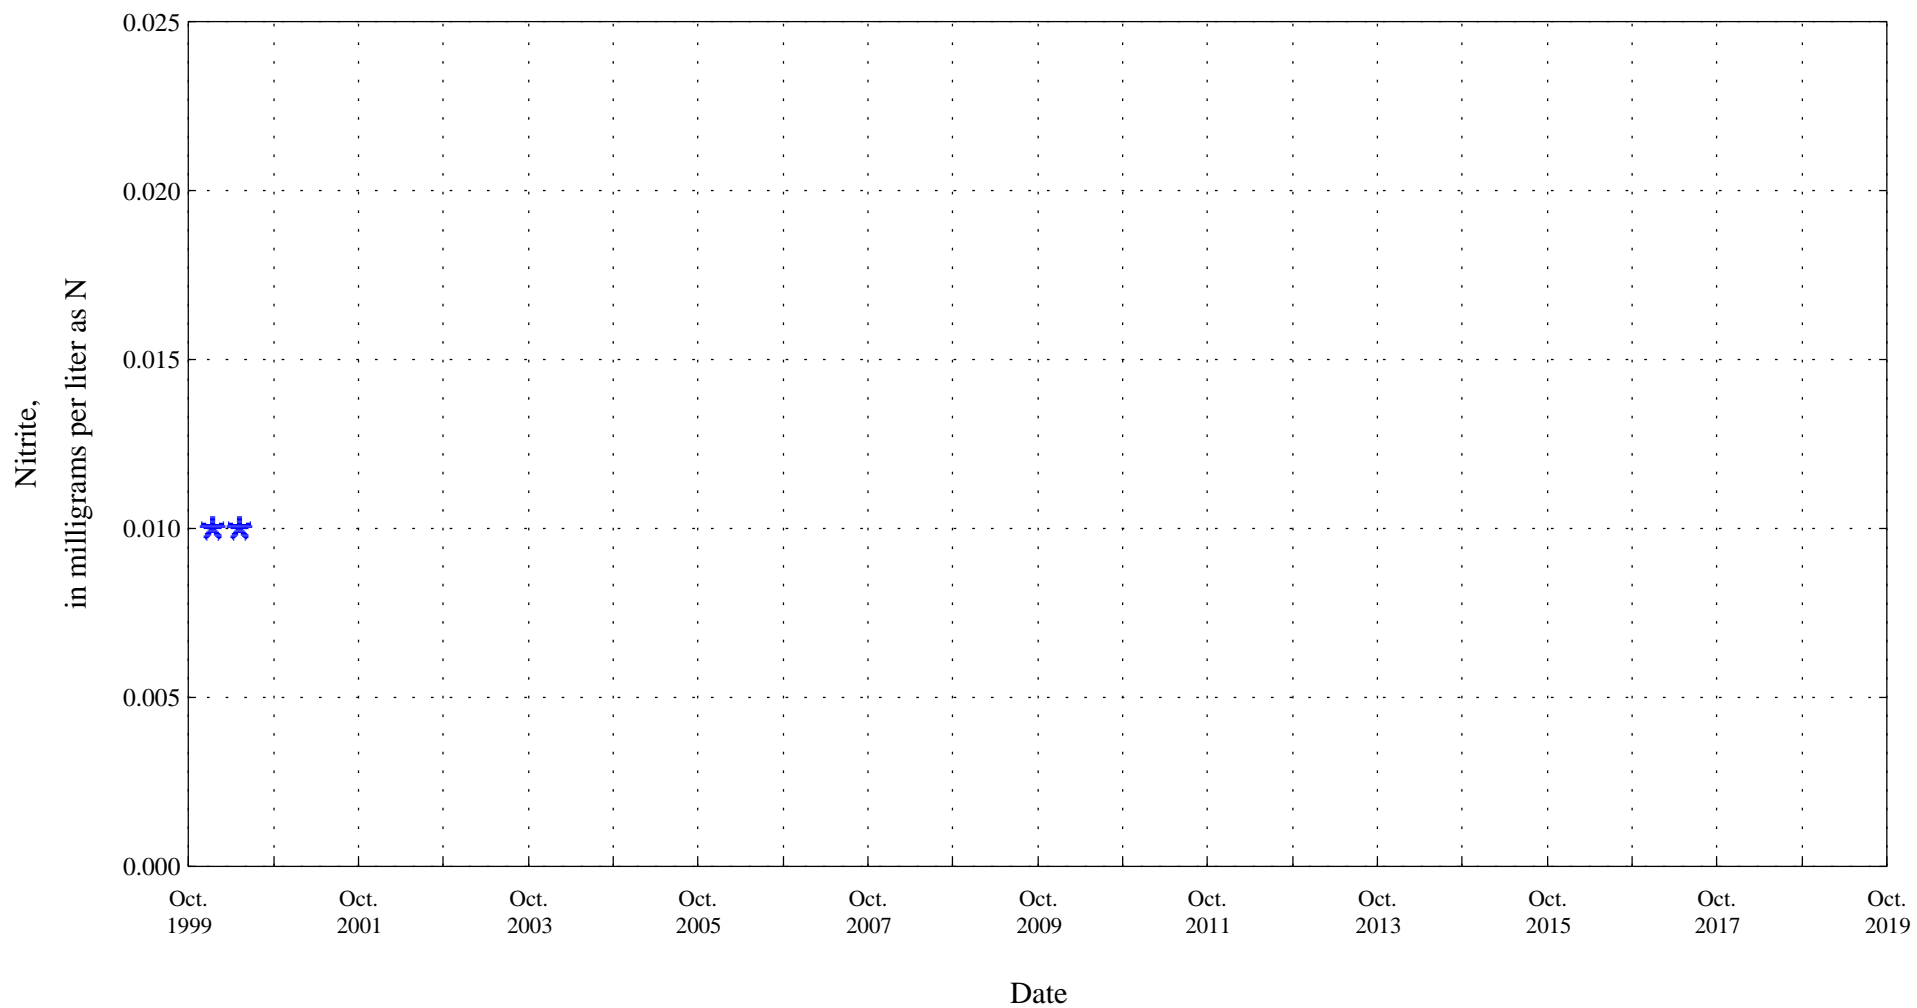
Figure 10. Distribution of selected water-quality constituents relative to time for

Olympus Tunnel at Lake Estes Co., station 06734900.

* * * Historic Censored Data

Aquatic Life Standard 0.05

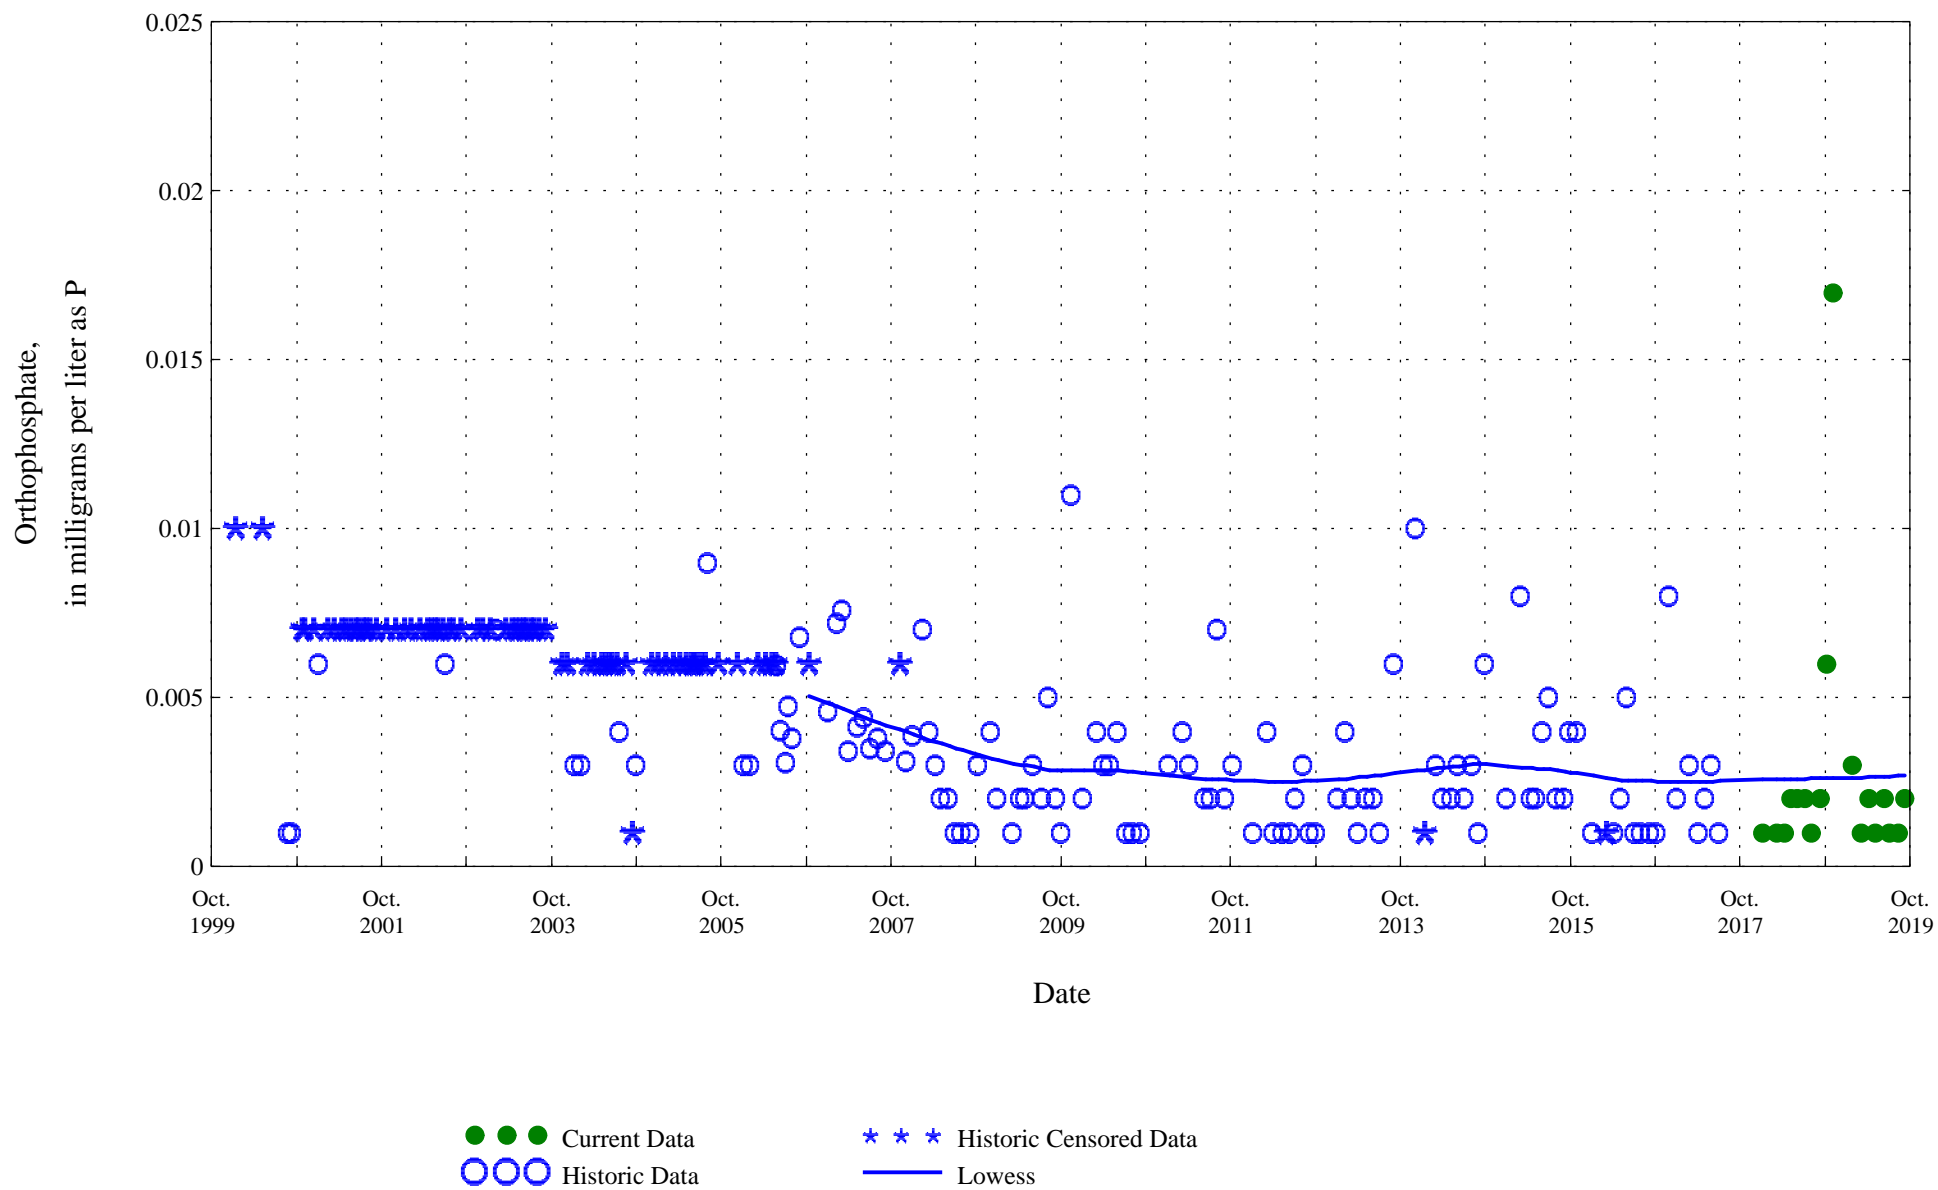
Figure 10. Distribution of selected water-quality constituents relative to time for

Olympus Tunnel at Lake Estes Co., station 06734900.

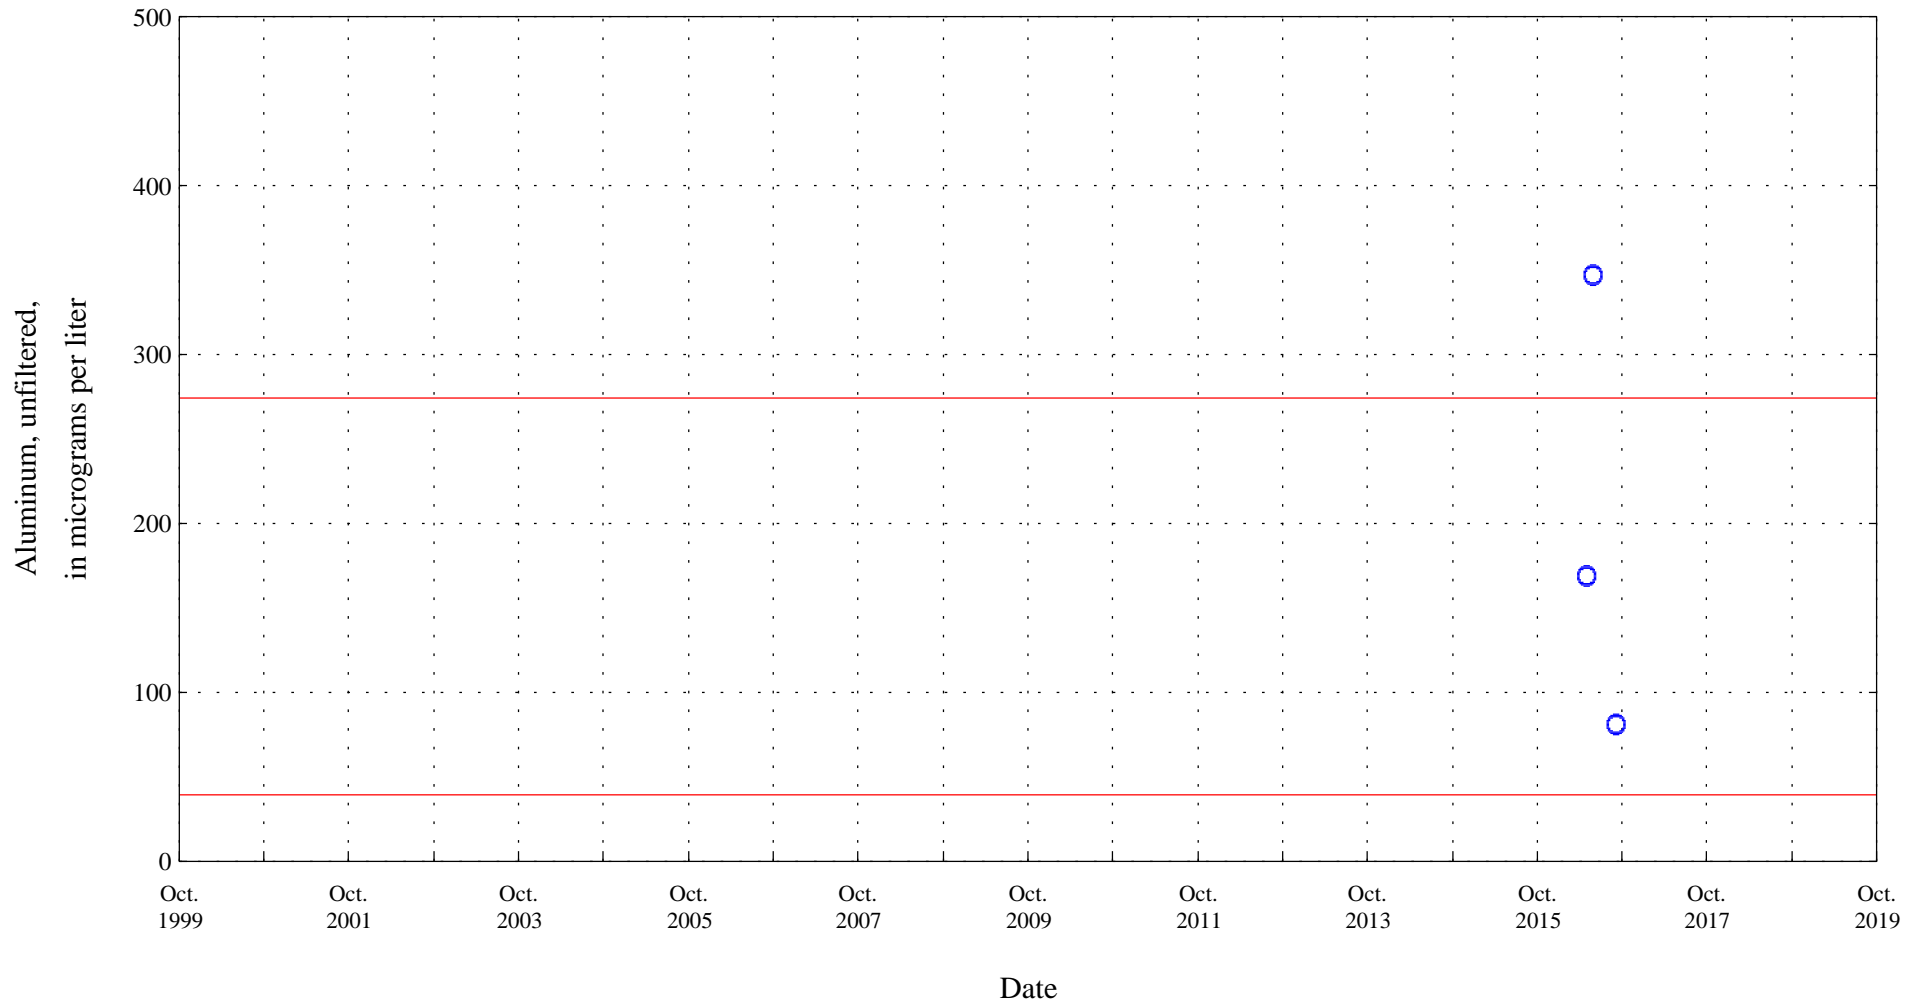
Figure 10. Distribution of selected water-quality constituents relative to time for

Olympus Tunnel at Lake Estes Co., station 06734900.

○ ○ ○ Historic Data

Aquatic Life Acute Standard 275
Aquatic Life Chronic Standard 39.2

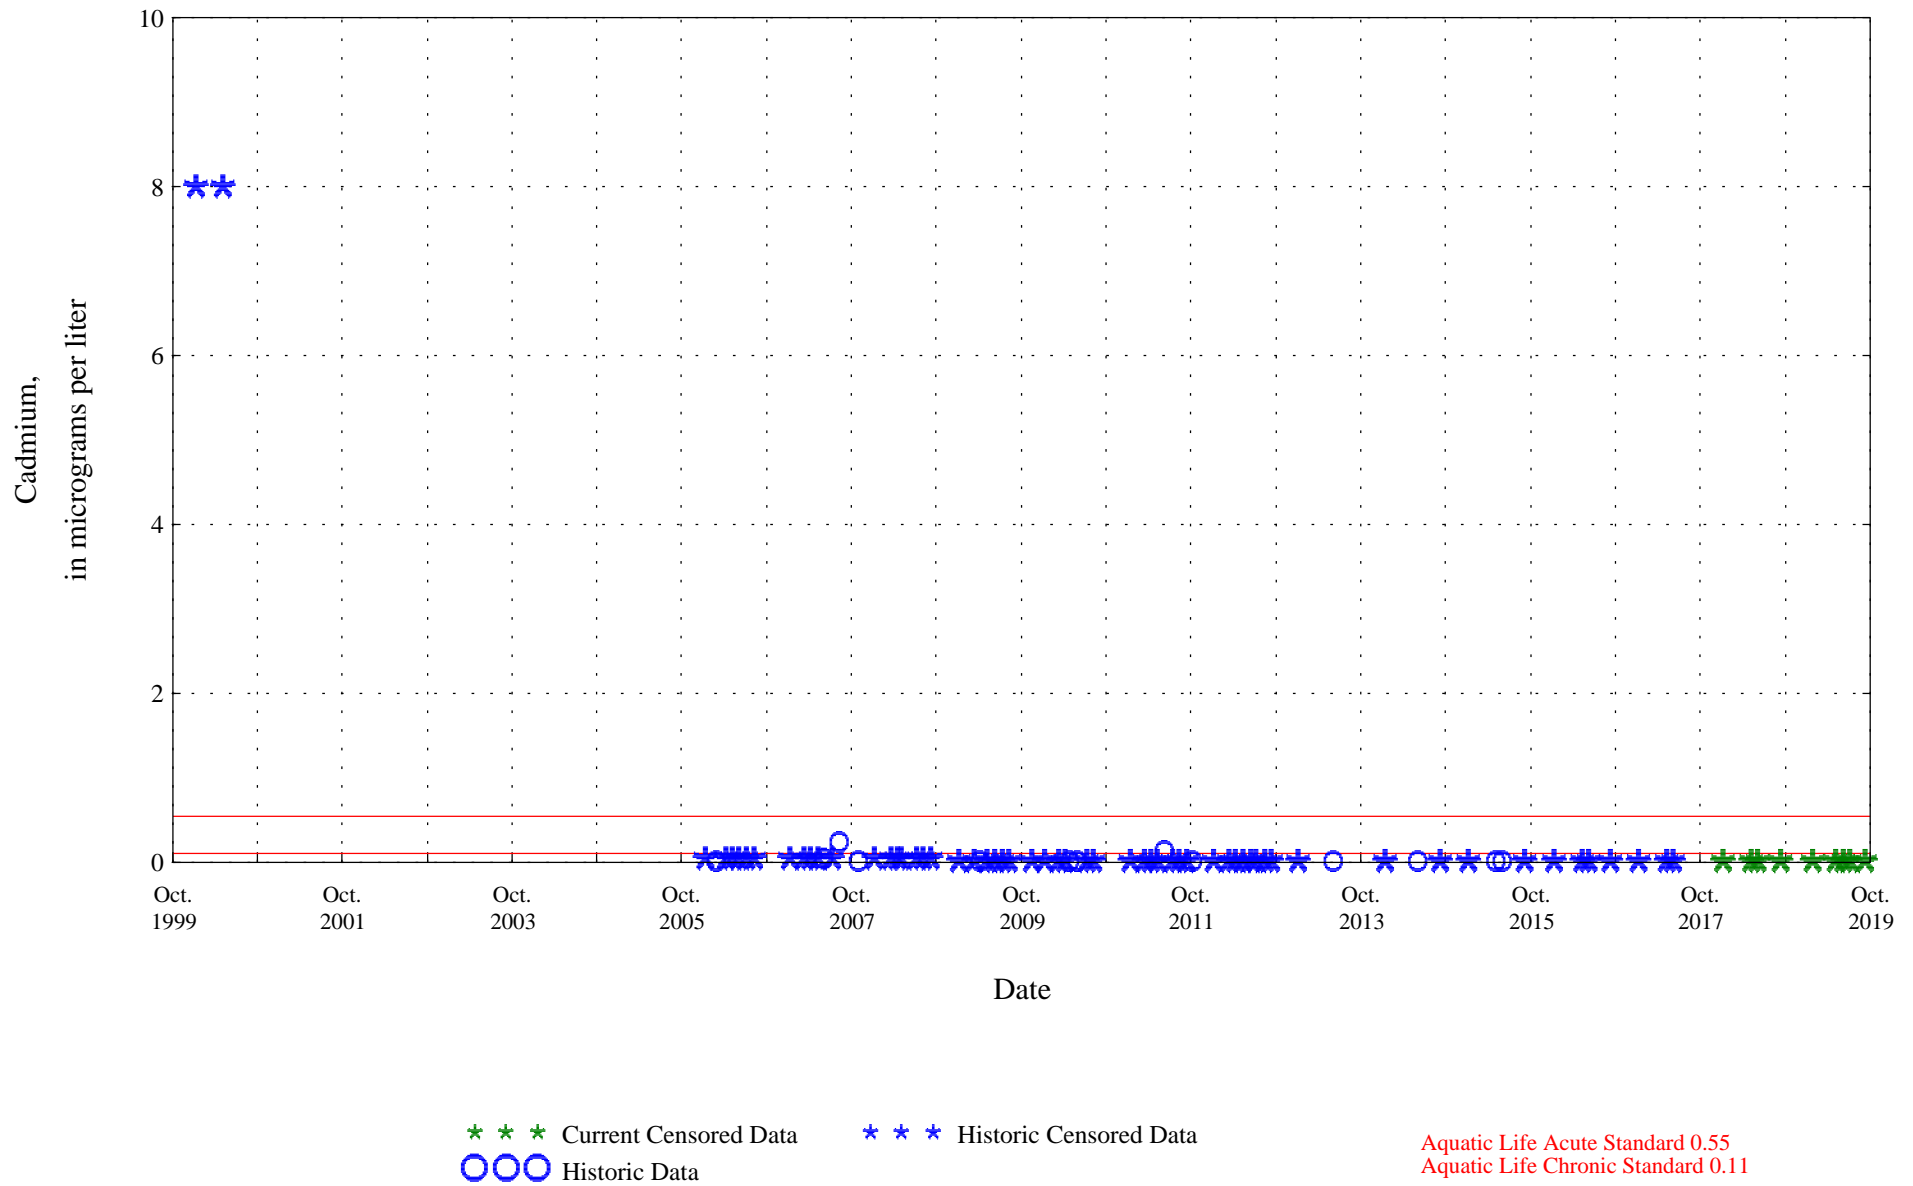
Olympus Tunnel at Lake Estes Co., station 06734900.
