Figure 10. Distribution of selected water-quality constituents relative to time for

Olympus Tunnel at Lake Estes Co., station 06734900.

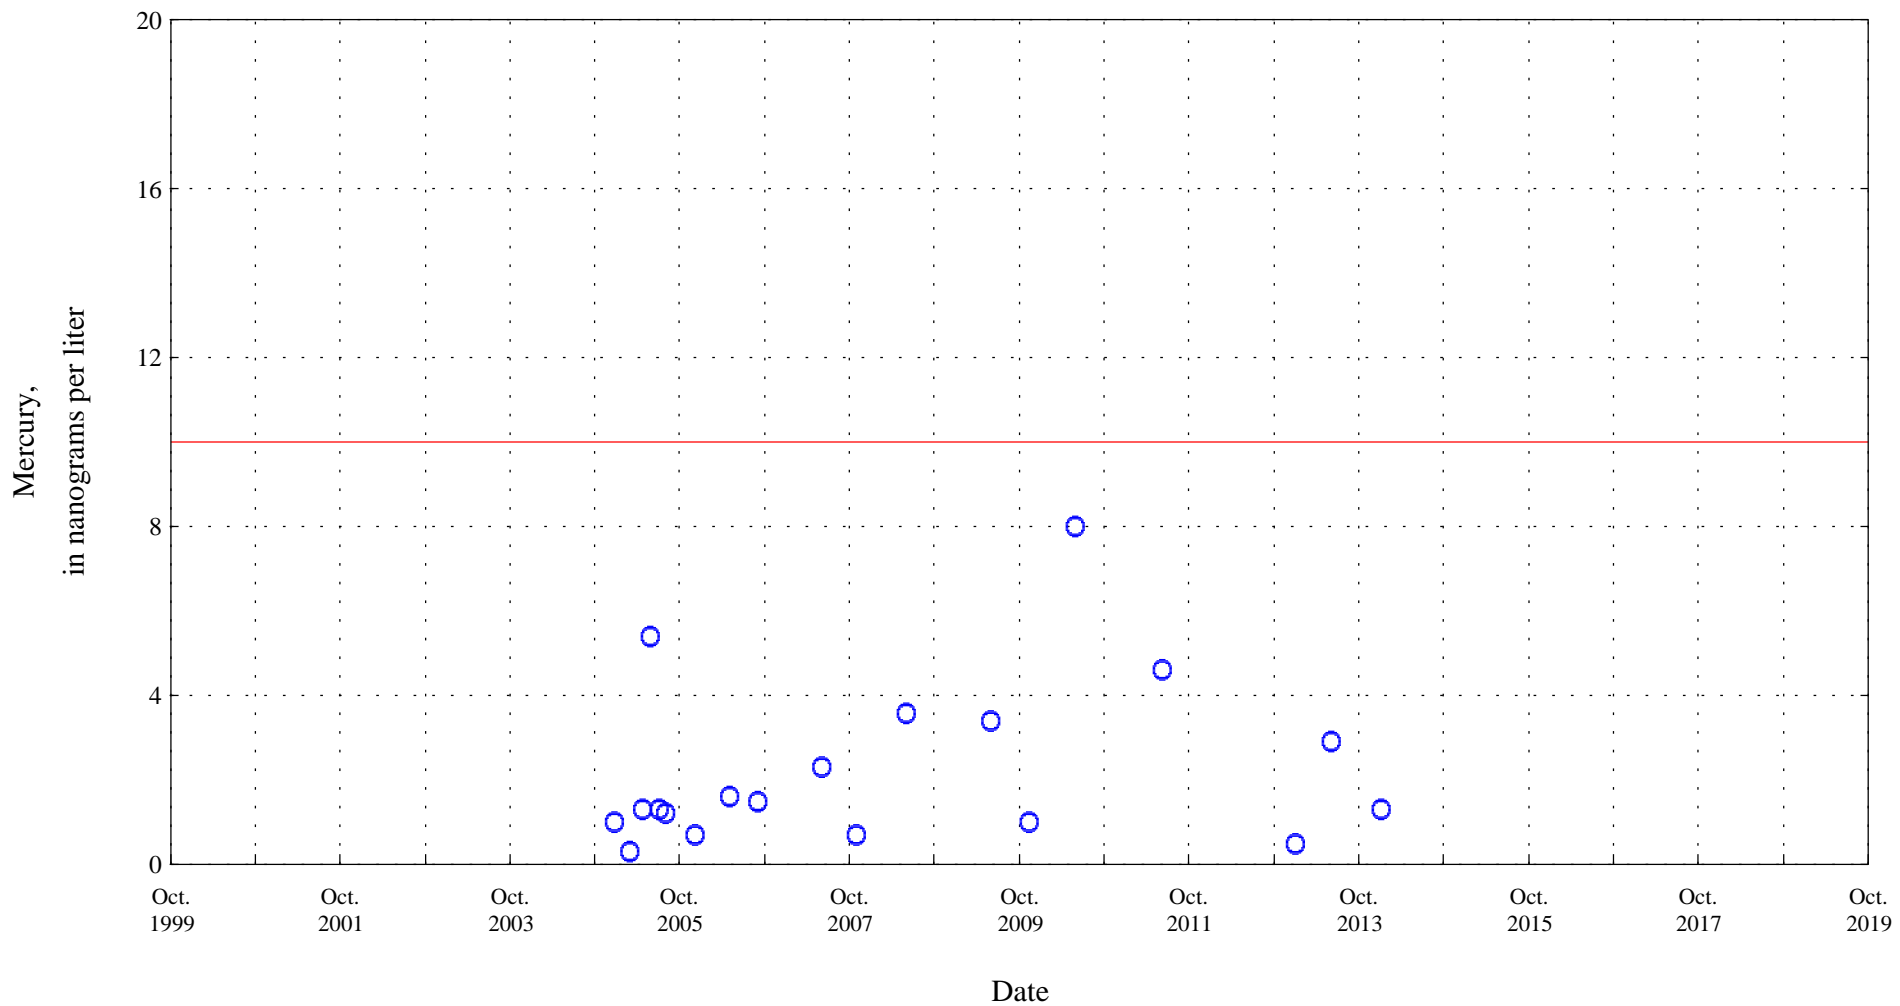
Figure 10. Distribution of selected water-quality constituents relative to time for

Olympus Tunnel at Lake Estes Co., station 06734900.

○ ○ ○ Historic Data

Aquatic Life Chronic Standard 10.0

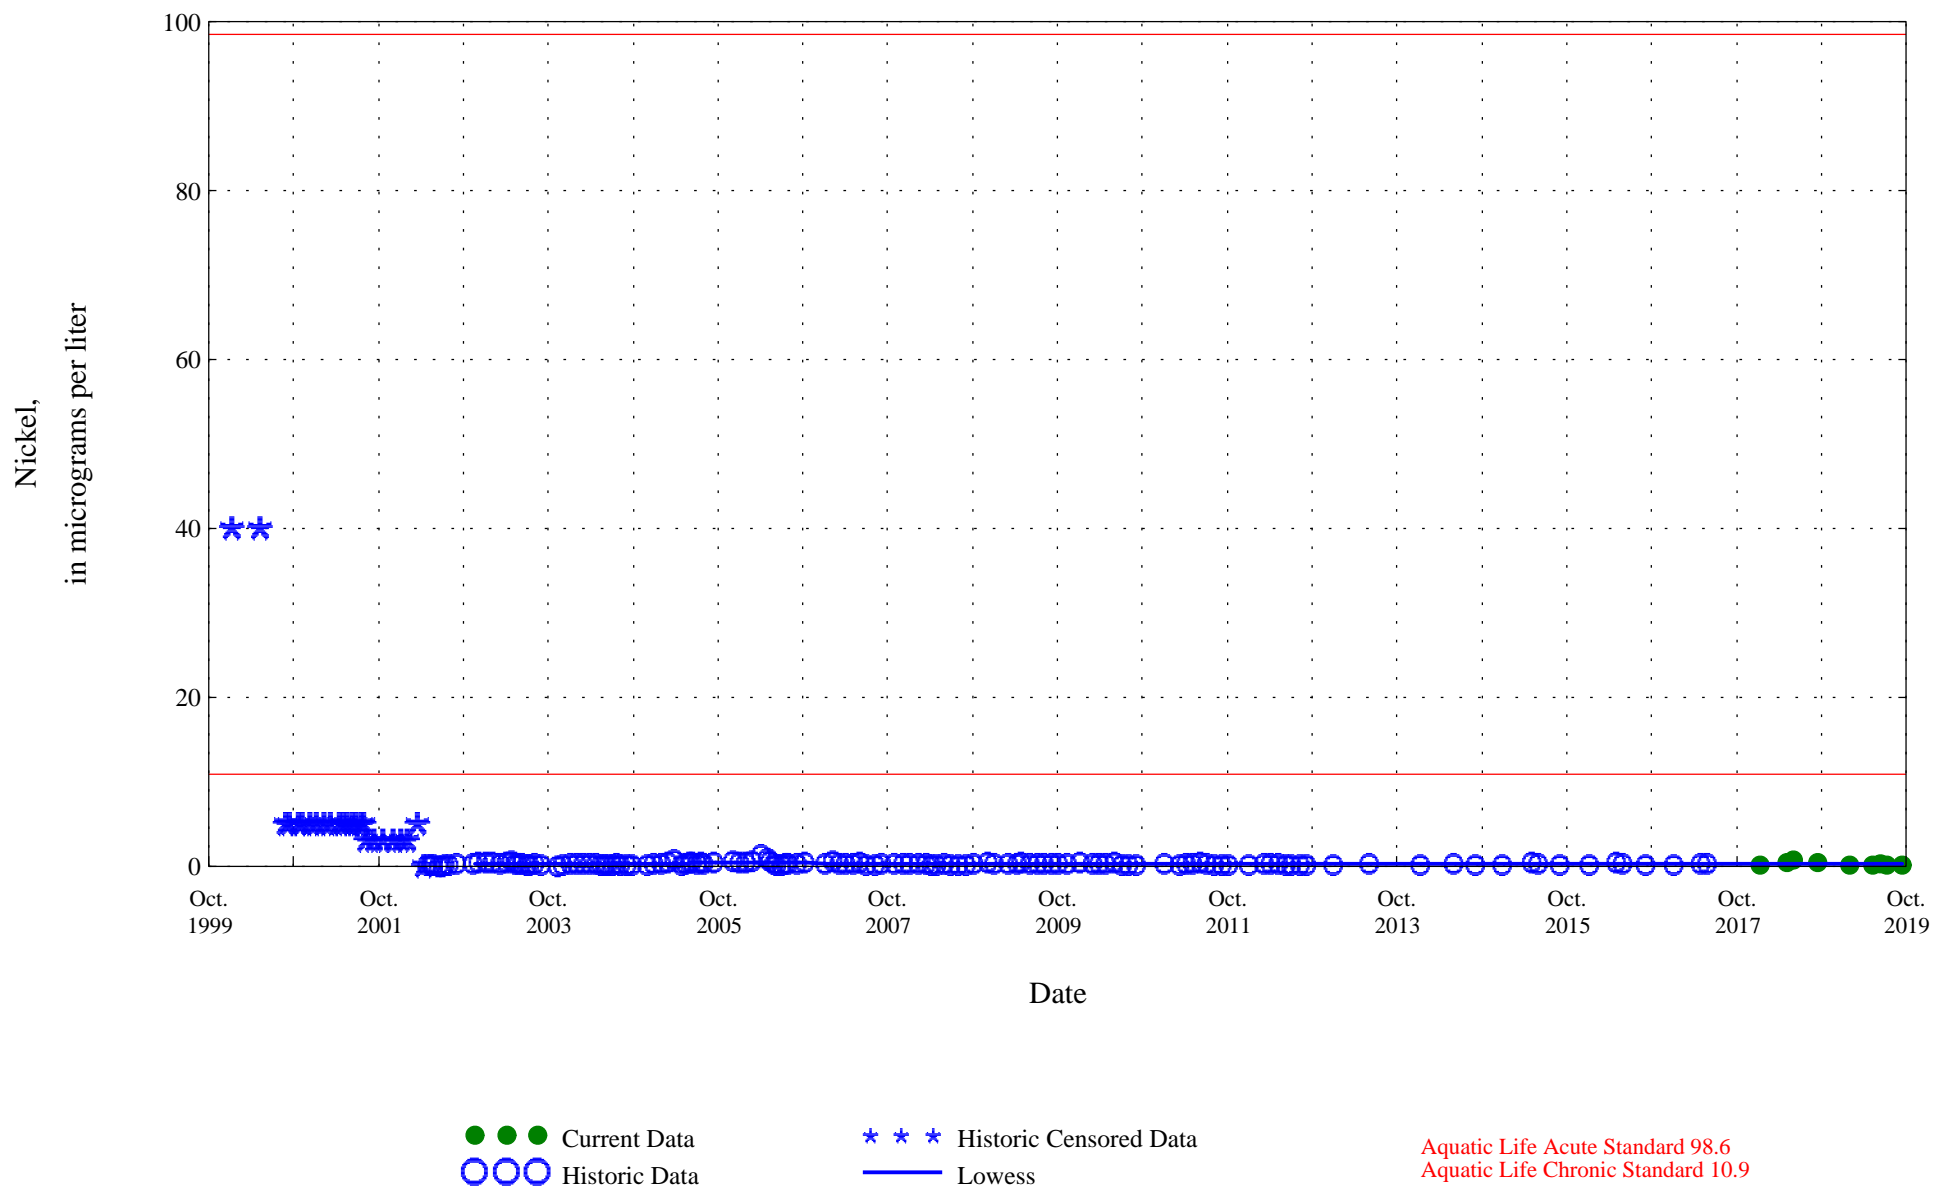
Figure 10. Distribution of selected water-quality constituents relative to time for

Olympus Tunnel at Lake Estes Co., station 06734900.

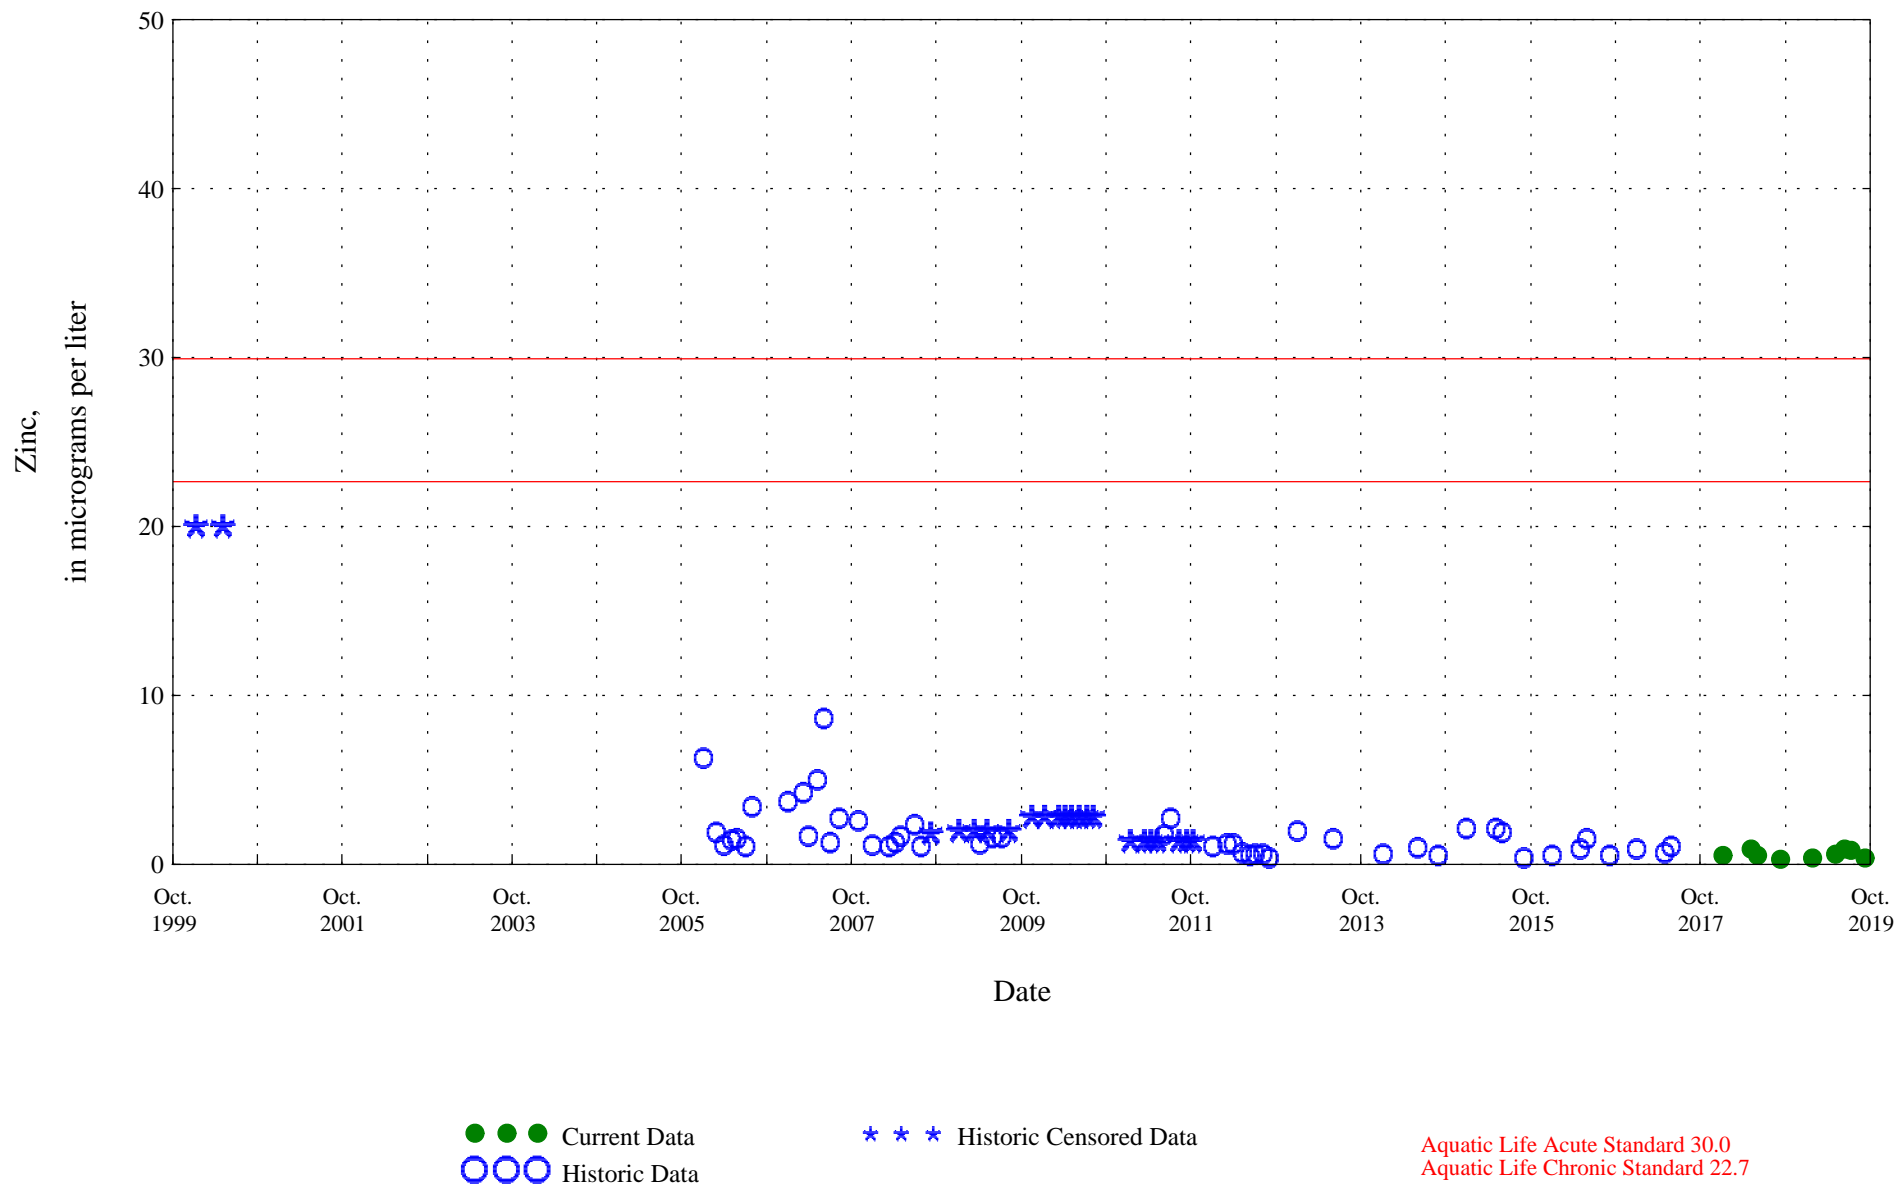
Figure 10. Distribution of selected water-quality constituents relative to time for

Olympus Tunnel at Lake Estes Co., station 06734900.

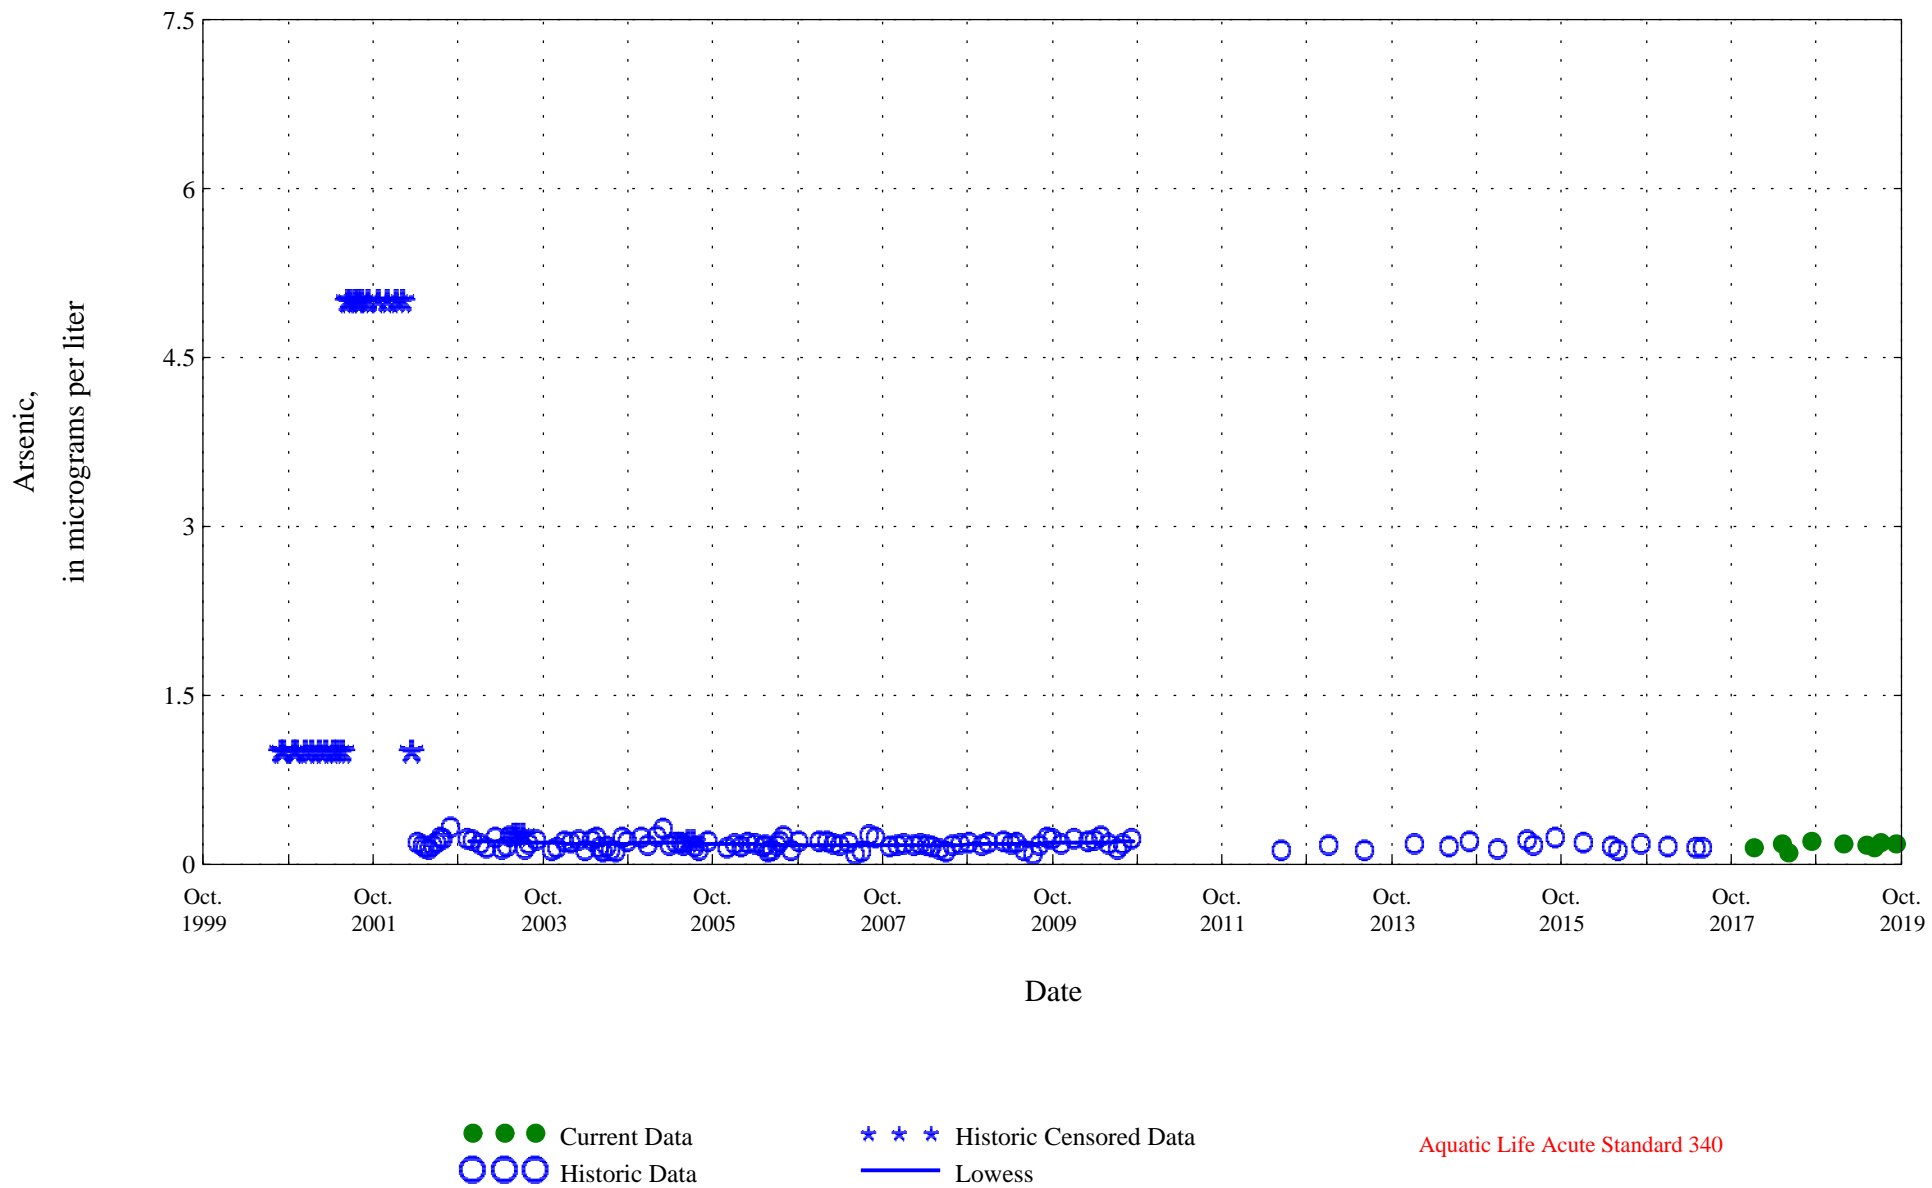
Figure 10. Distribution of selected water-quality constituents relative to time for

Olympus Tunnel at Lake Estes Co., station 06734900.

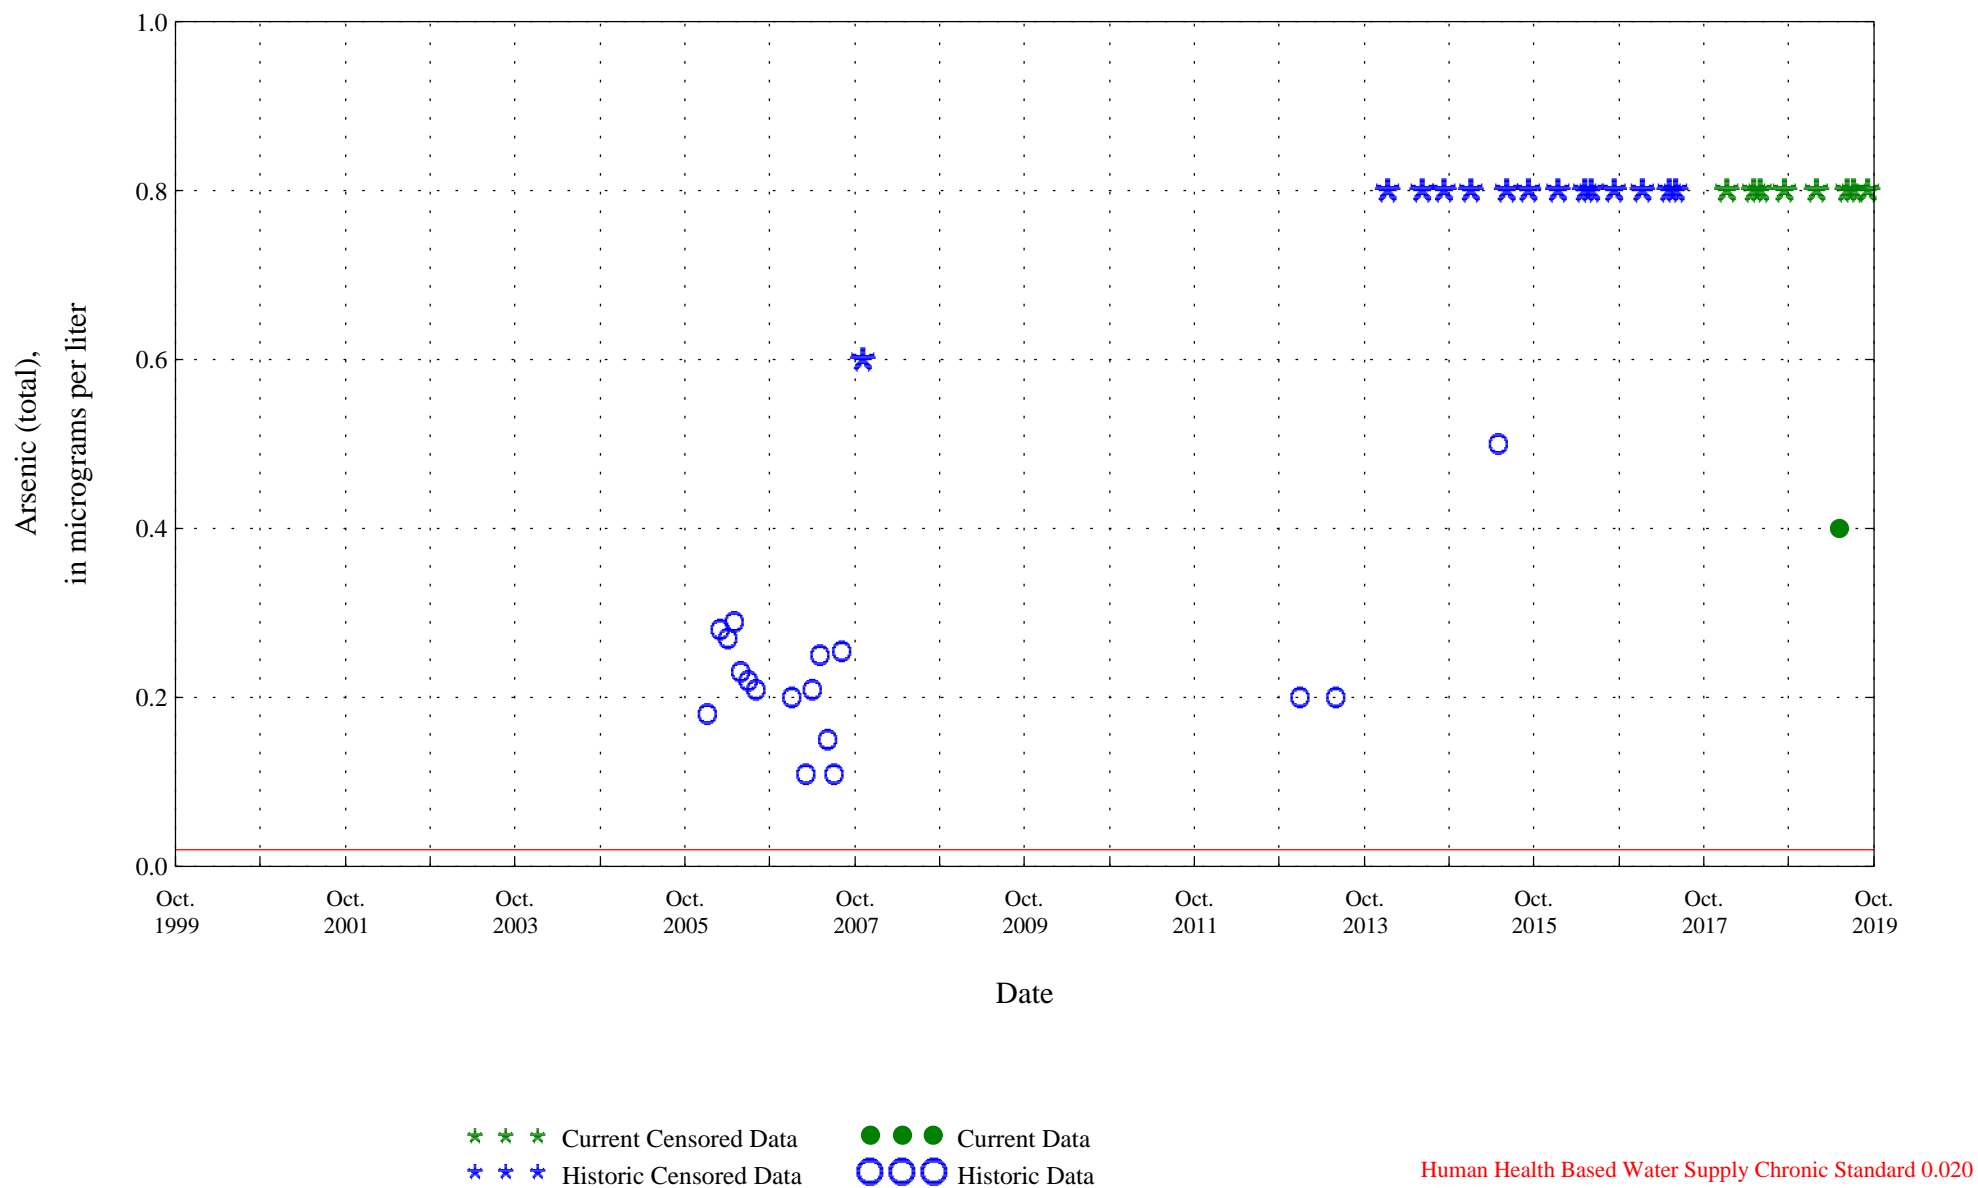
Figure 10. Distribution of selected water-quality constituents relative to time for

Olympus Tunnel at Lake Estes Co., station 06734900.

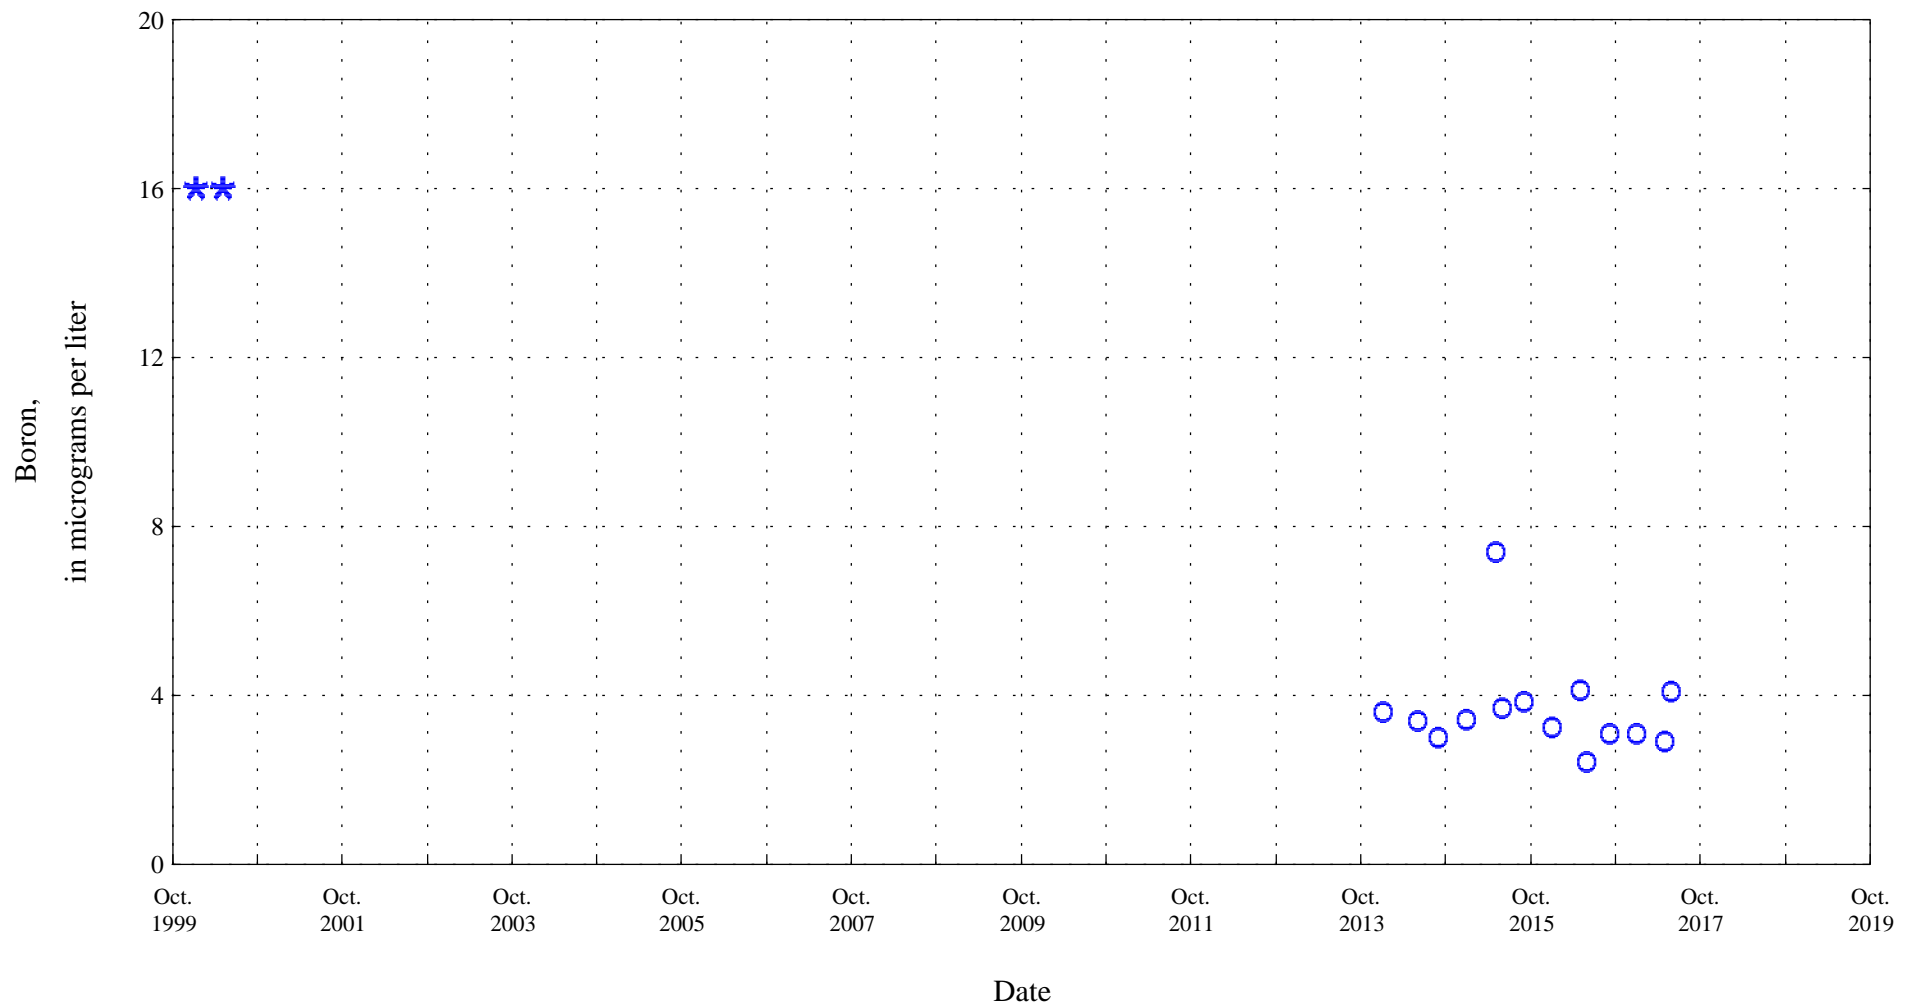
Figure 10. Distribution of selected water-quality constituents relative to time for

Olympus Tunnel at Lake Estes Co., station 06734900.

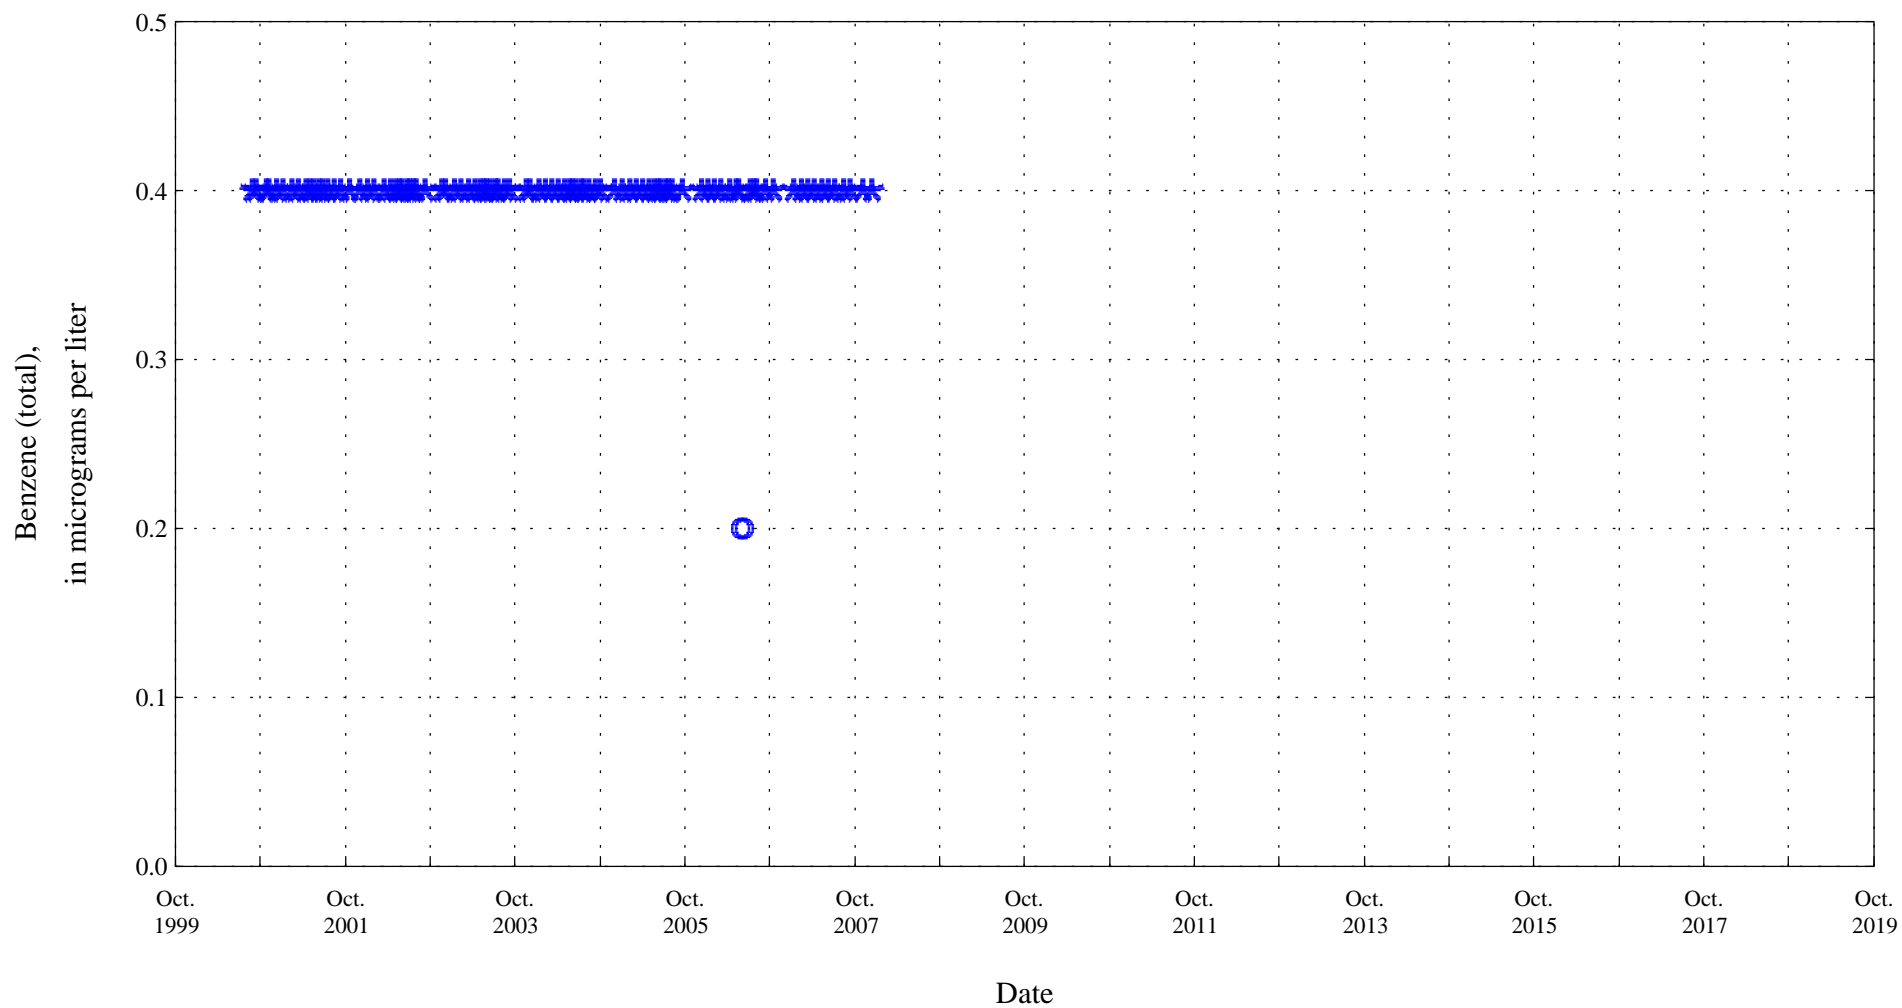
Figure 10. Distribution of selected water-quality constituents relative to time for

Olympus Tunnel at Lake Estes Co., station 06734900.

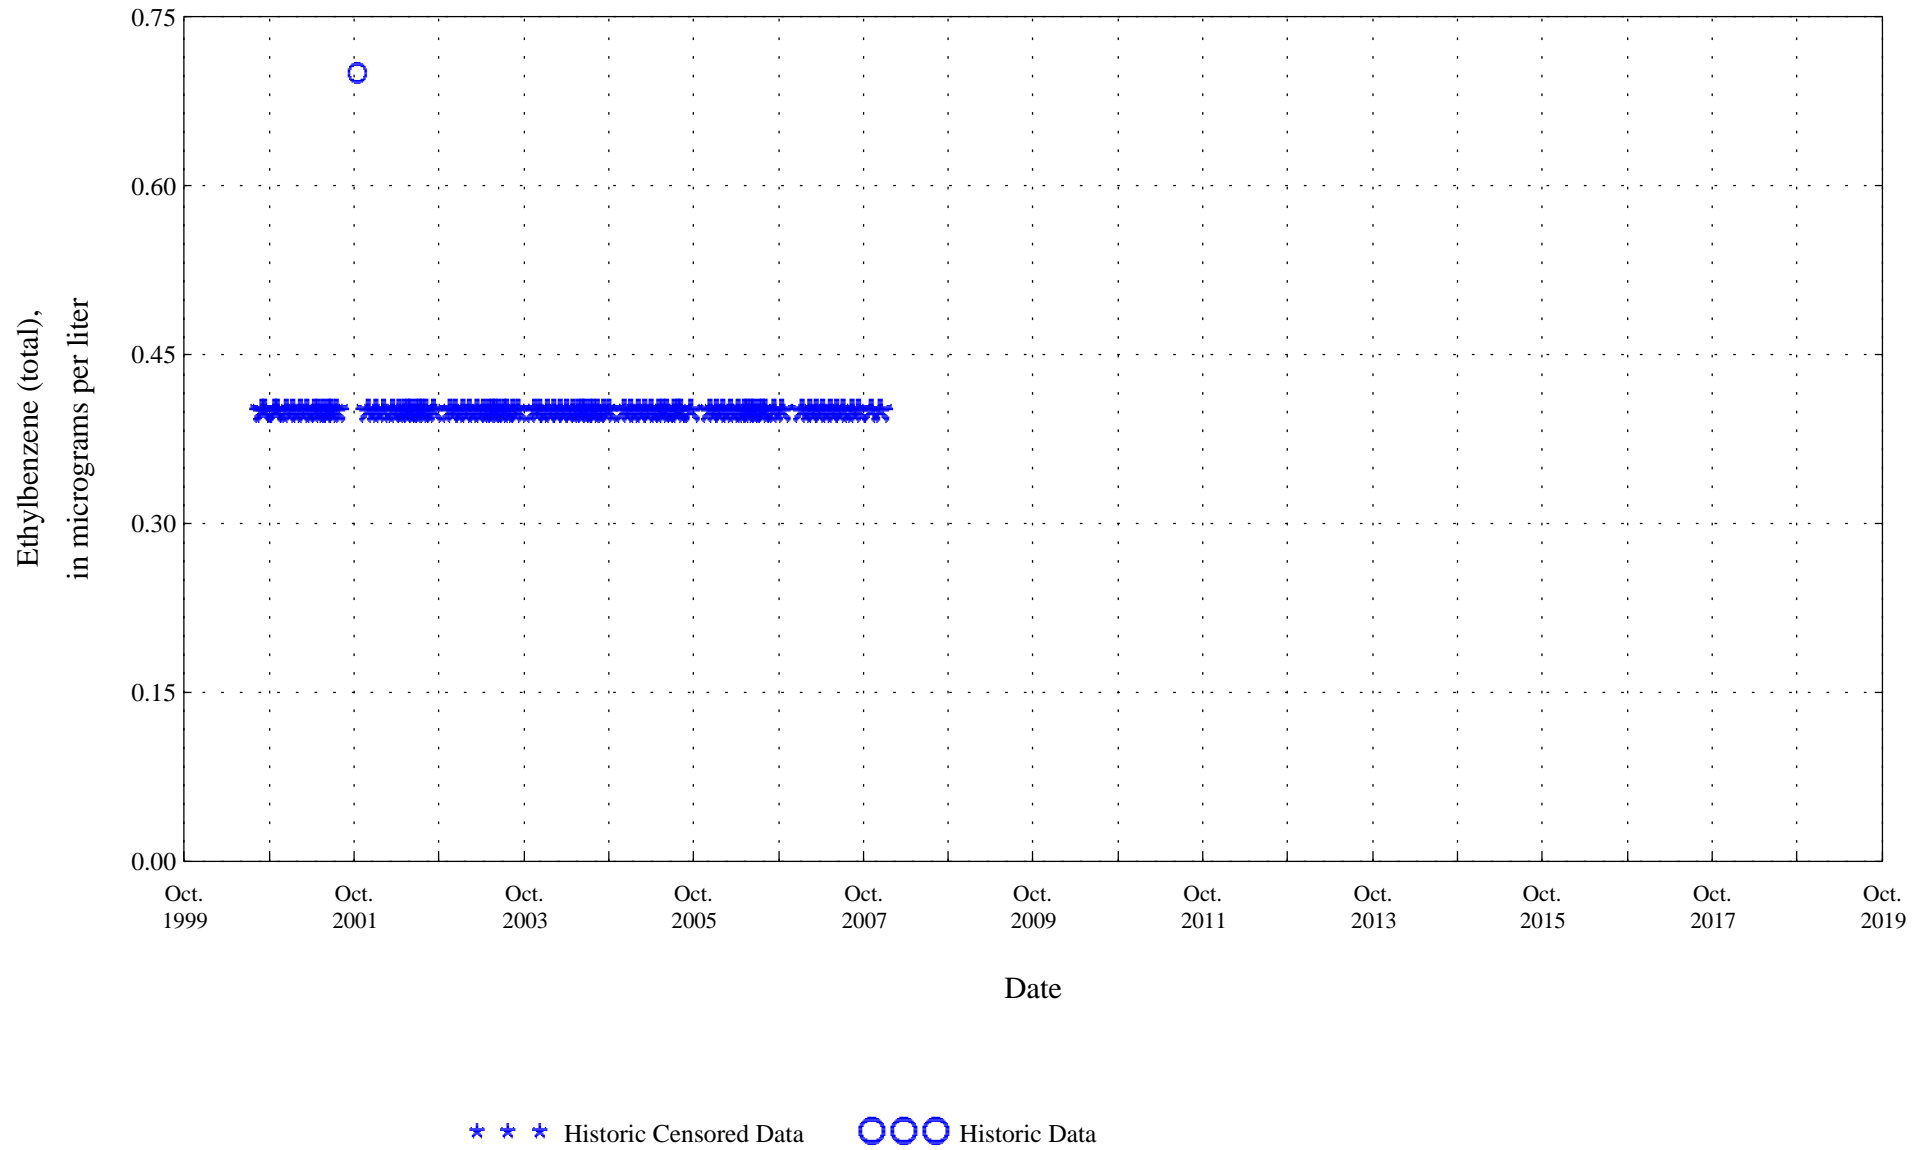
Water and Fish Chronic Standard 2.2

Figure 10. Distribution of selected water-quality constituents relative to time for

Olympus Tunnel at Lake Estes Co., station 06734900.

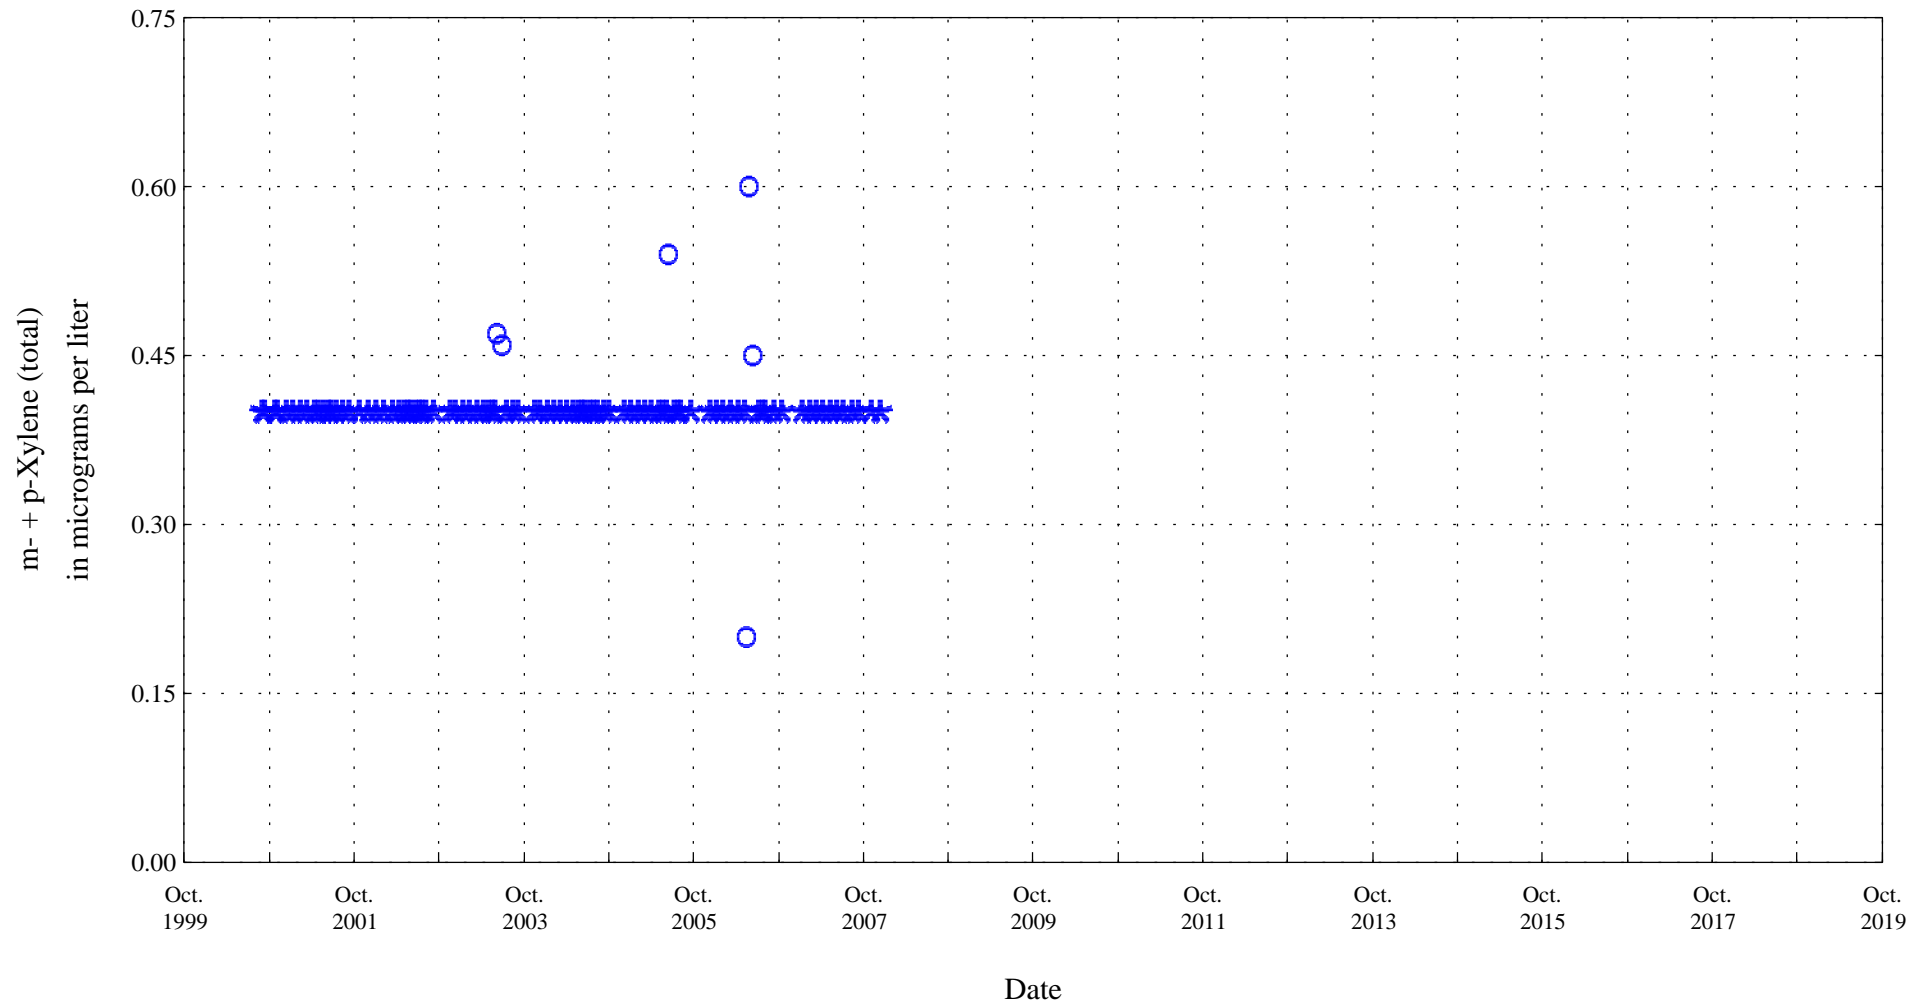
Water and Fish Chronic Standard 530

Figure 10. Distribution of selected water-quality constituents relative to time for

Olympus Tunnel at Lake Estes Co., station 06734900.

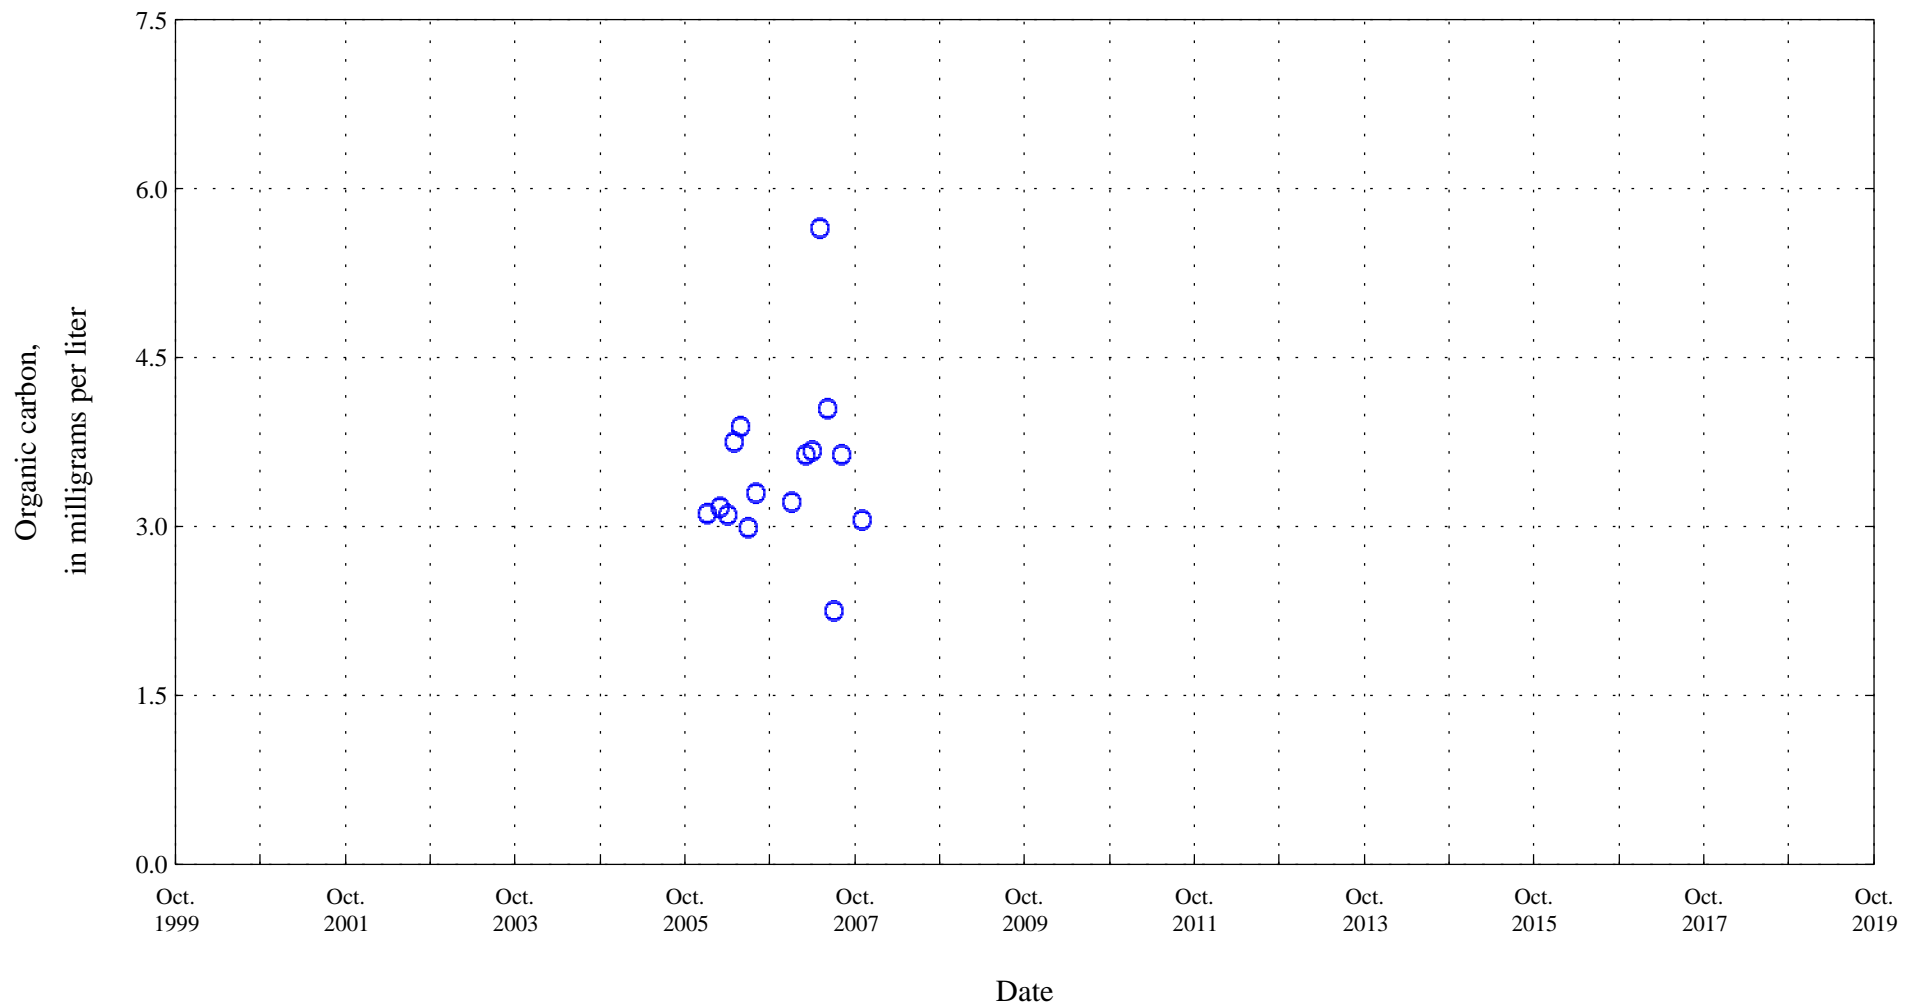
Human Health Based Water Supply Chronic Standard 1,400

Figure 10. Distribution of selected water-quality constituents relative to time for

Olympus Tunnel at Lake Estes Co., station 06734900.
