Figure 10. Distribution of selected water-quality constituents relative to time for

Olympus Tunnel at Lake Estes Co., station 06734900.

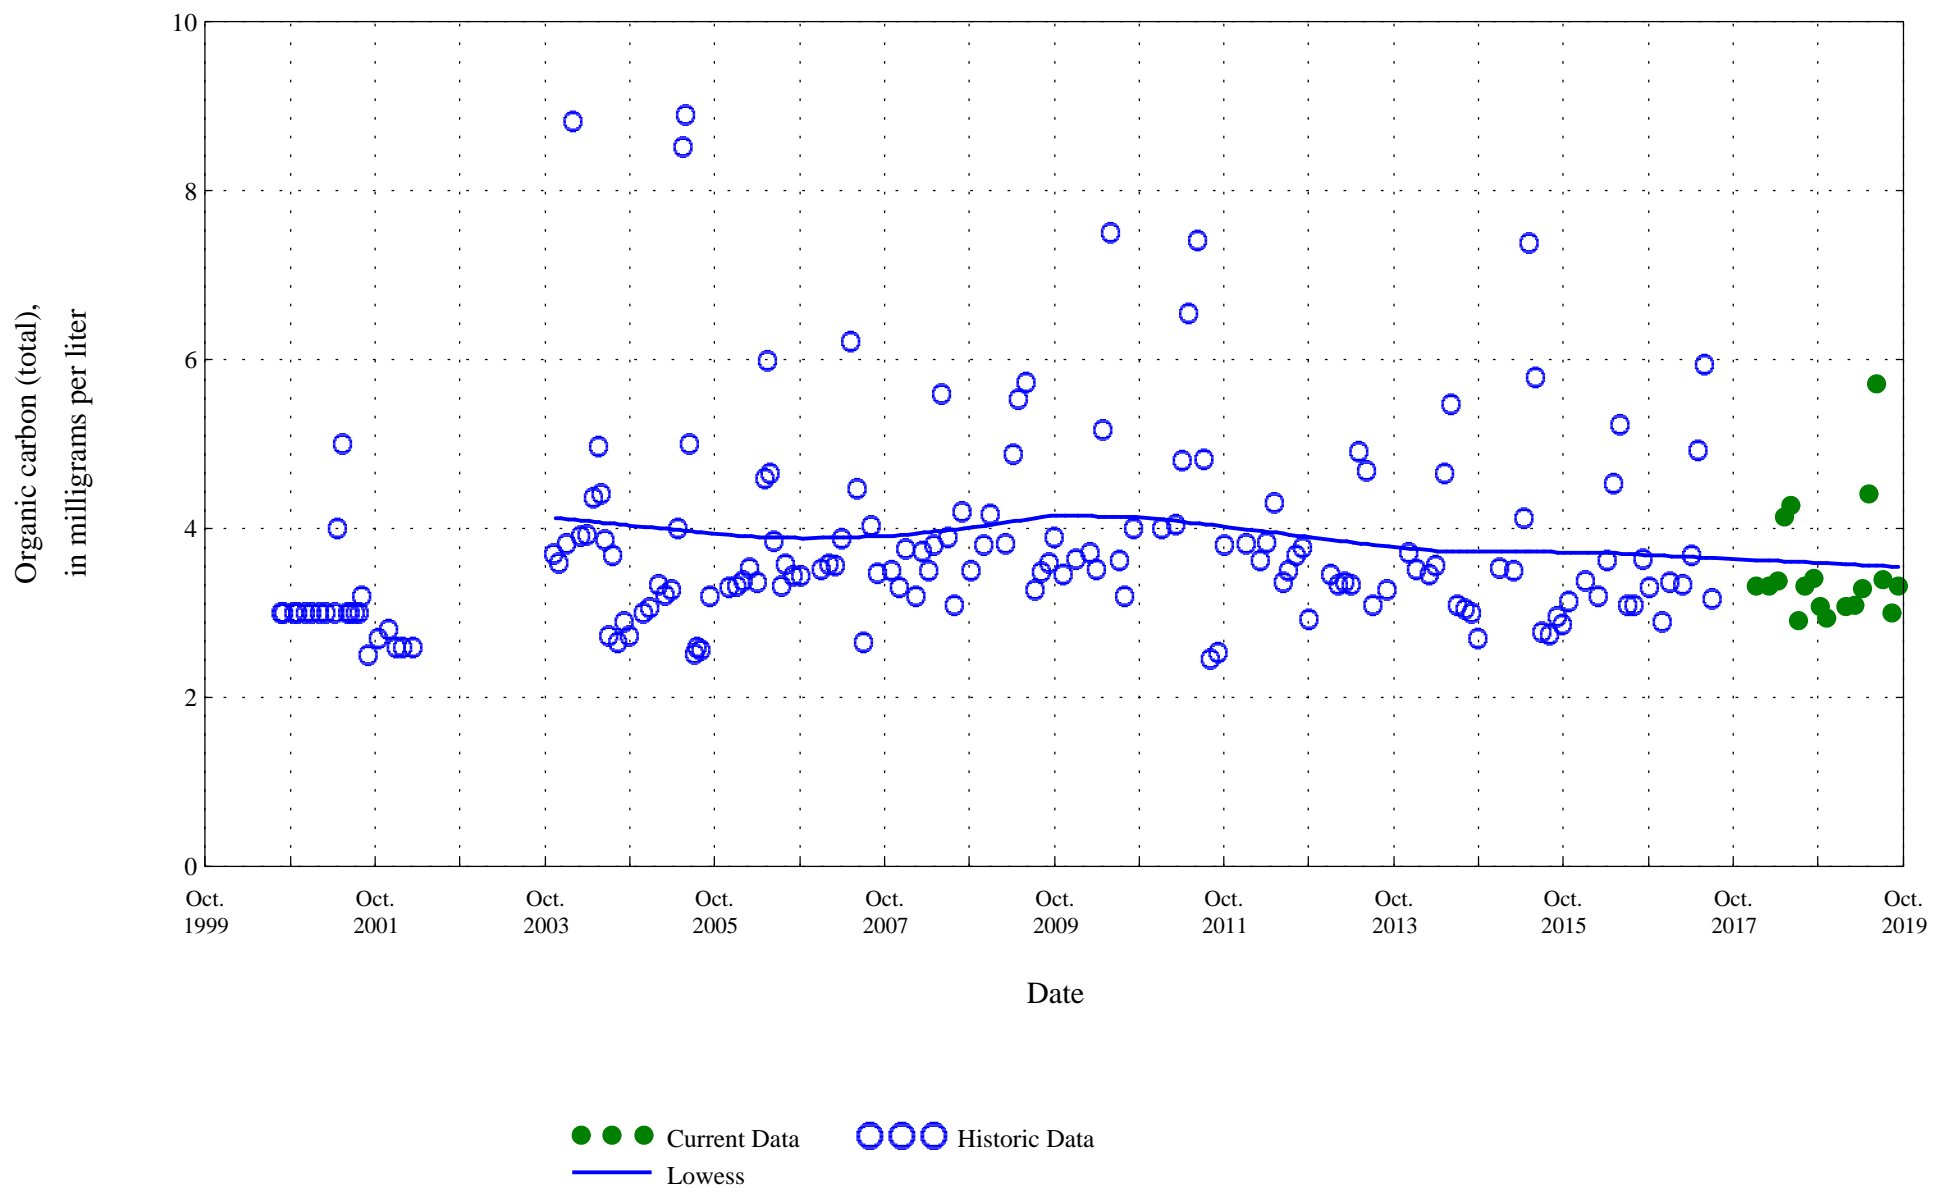
Figure 10. Distribution of selected water-quality constituents relative to time for

Olympus Tunnel at Lake Estes Co., station 06734900.

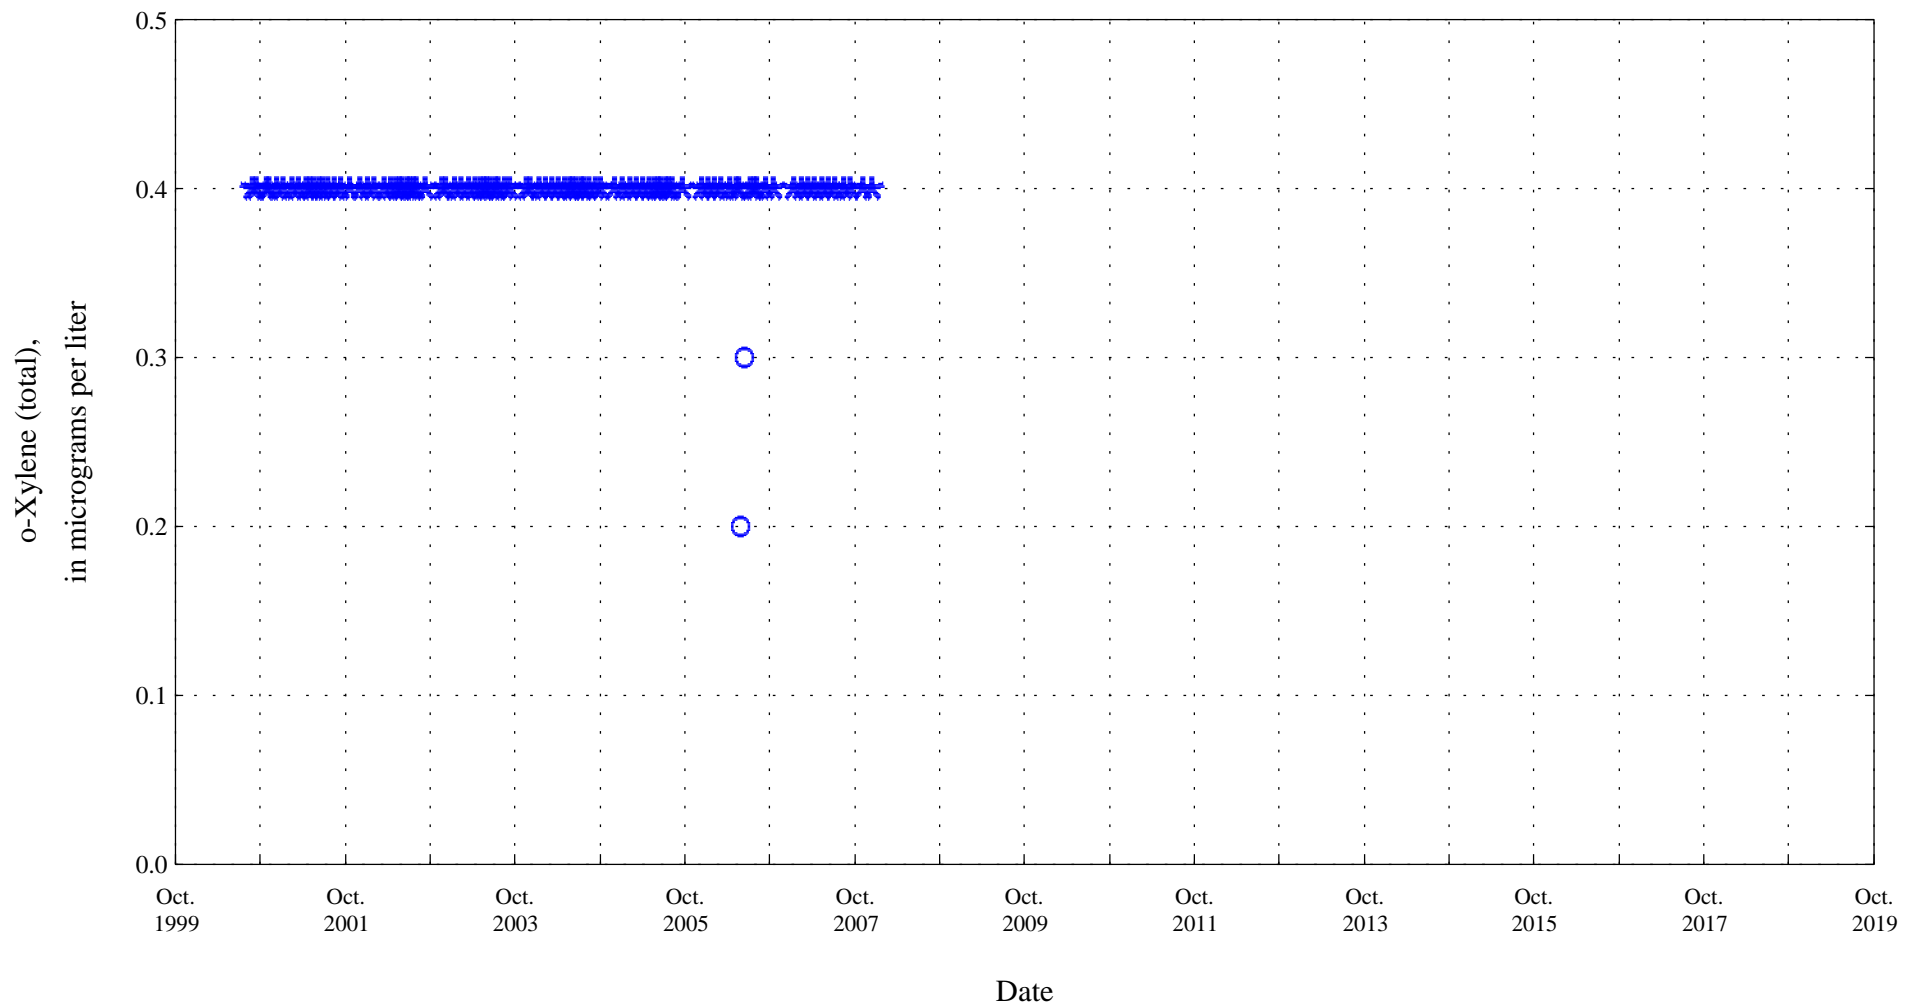
Figure 10. Distribution of selected water-quality constituents relative to time for

Olympus Tunnel at Lake Estes Co., station 06734900.

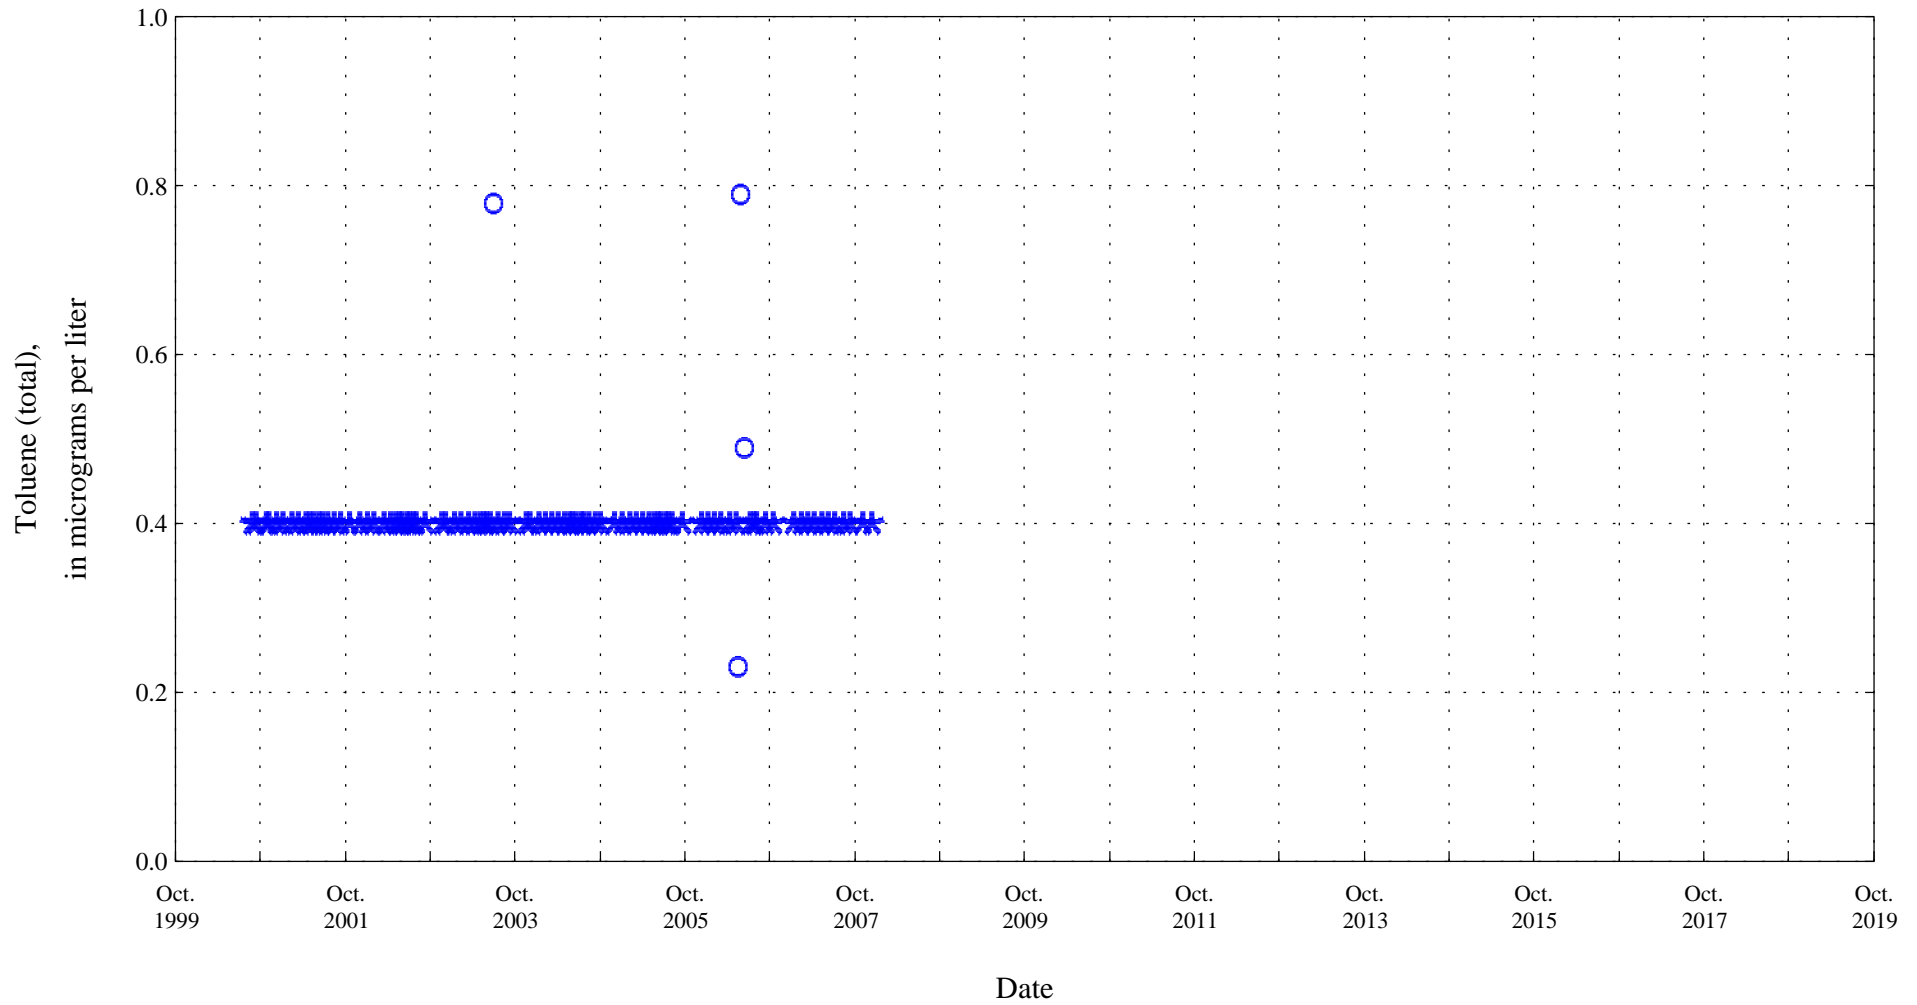
Human Health Based Water Supply Chronic Standard 1,400

Figure 10. Distribution of selected water-quality constituents relative to time for

Olympus Tunnel at Lake Estes Co., station 06734900.

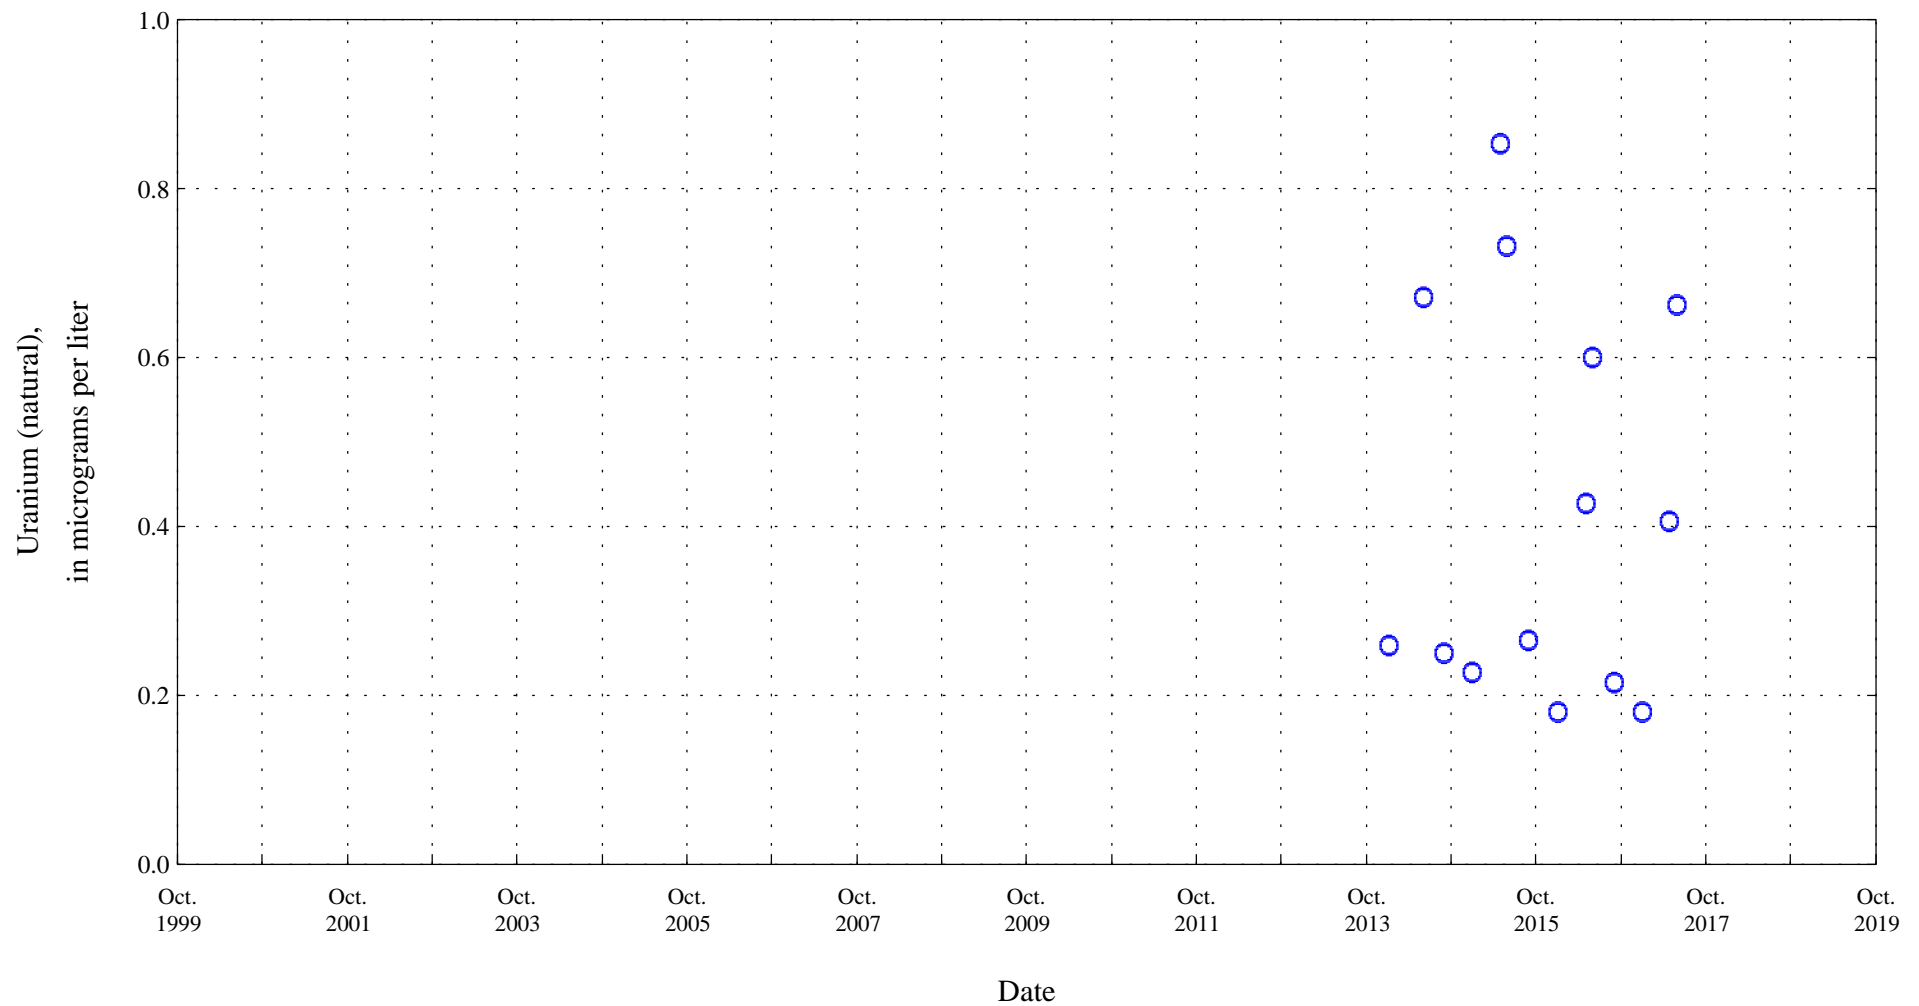
Water and Fish Chronic Standard 510

Figure 10. Distribution of selected water-quality constituents relative to time for

Olympus Tunnel at Lake Estes Co., station 06734900.
