Figure 26. Distribution of selected water-quality constituents relative to time for Little Thompson River at Co. Highway 257 at Milliken, Co., station 06743470.

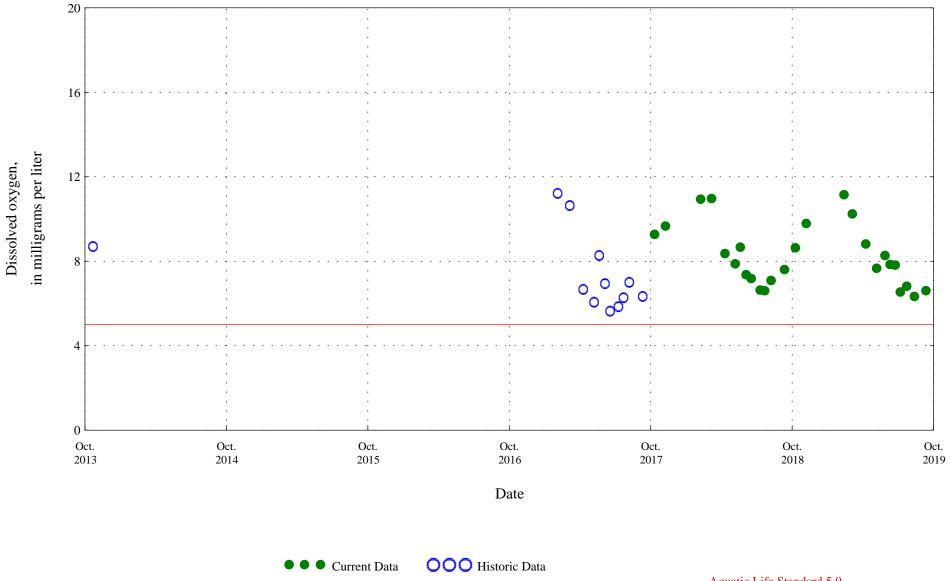
Figure 26. Distribution of selected water-quality constituents relative to time for Little Thompson River at Co. Highway 257 at Milliken, Co., station 06743470.

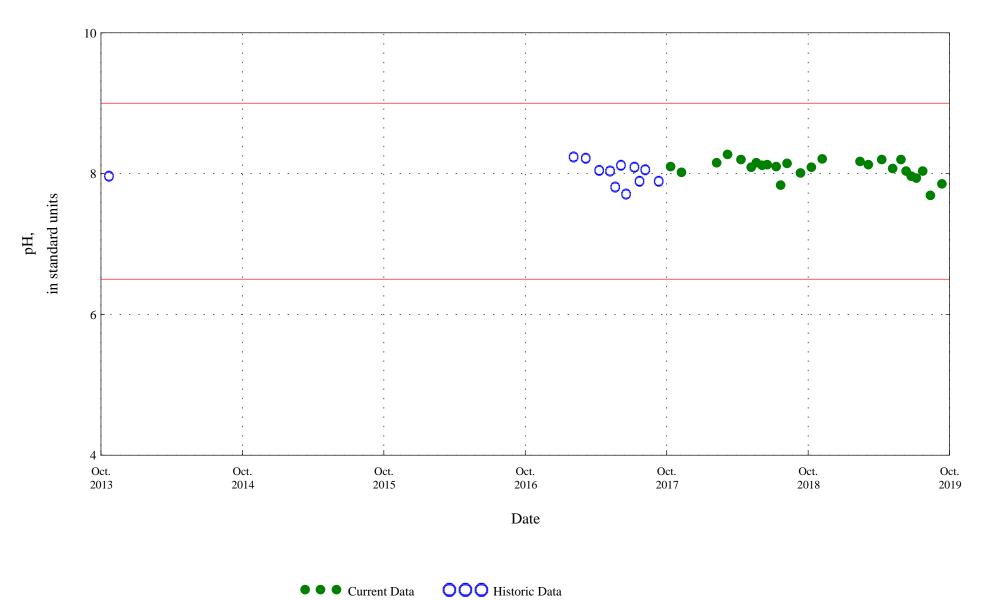
Figure 26. Distribution of selected water-quality constituents relative to time for Little Thompson River at Co. Highway 257 at Milliken, Co., station 06743470.

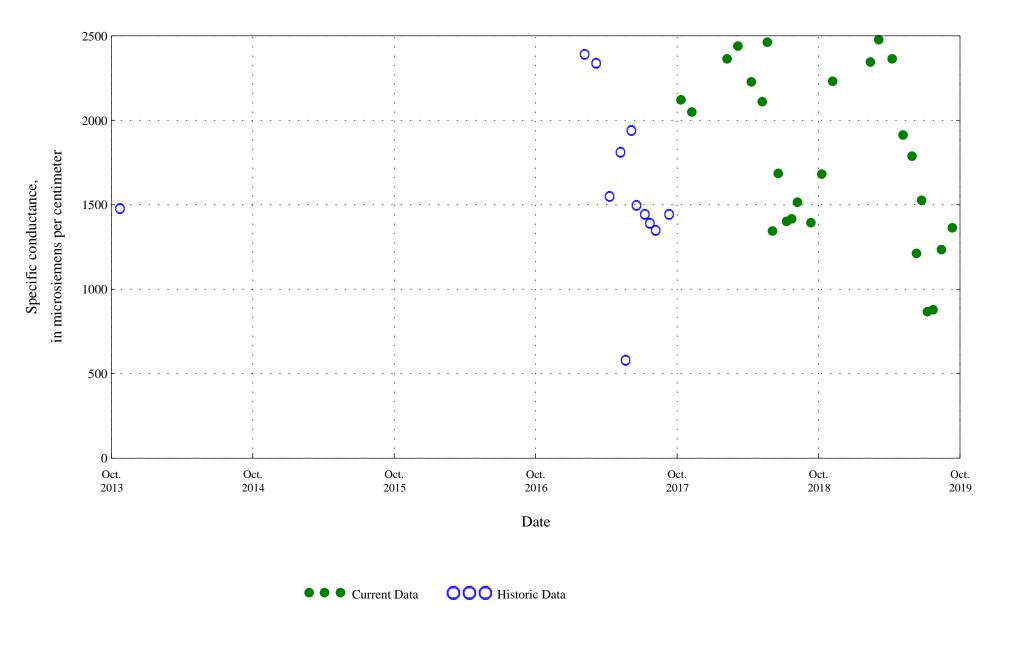
Figure 26. Distribution of selected water-quality constituents relative to time for Little Thompson River at Co. Highway 257 at Milliken, Co., station 06743470.

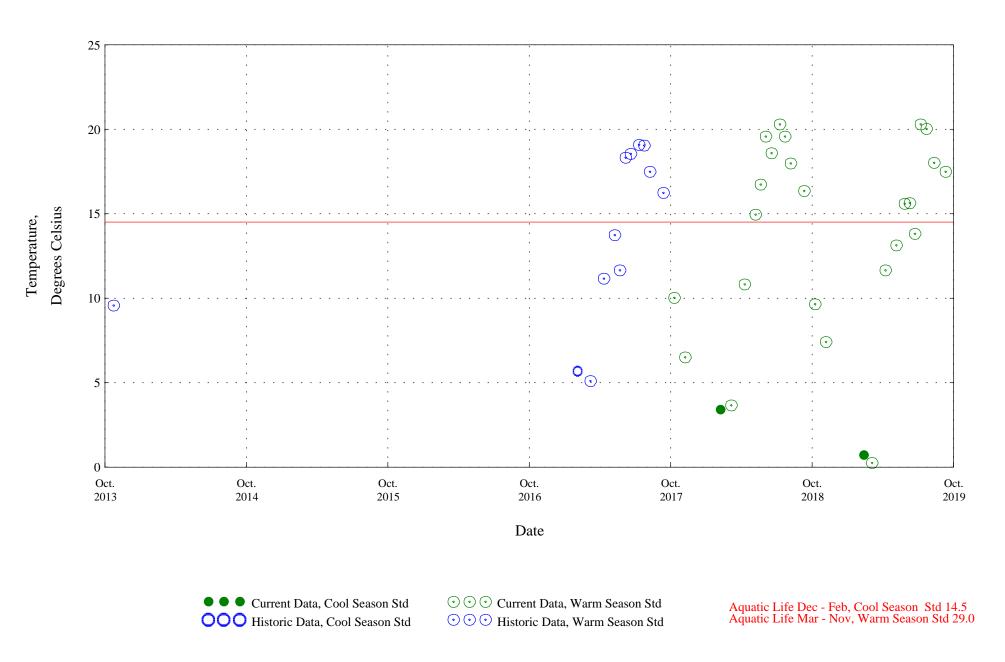
Figure 26. Distribution of selected water-quality constituents relative to time for

Little Thompson River at Co. Highway 257 at Milliken, Co., station 06743470.

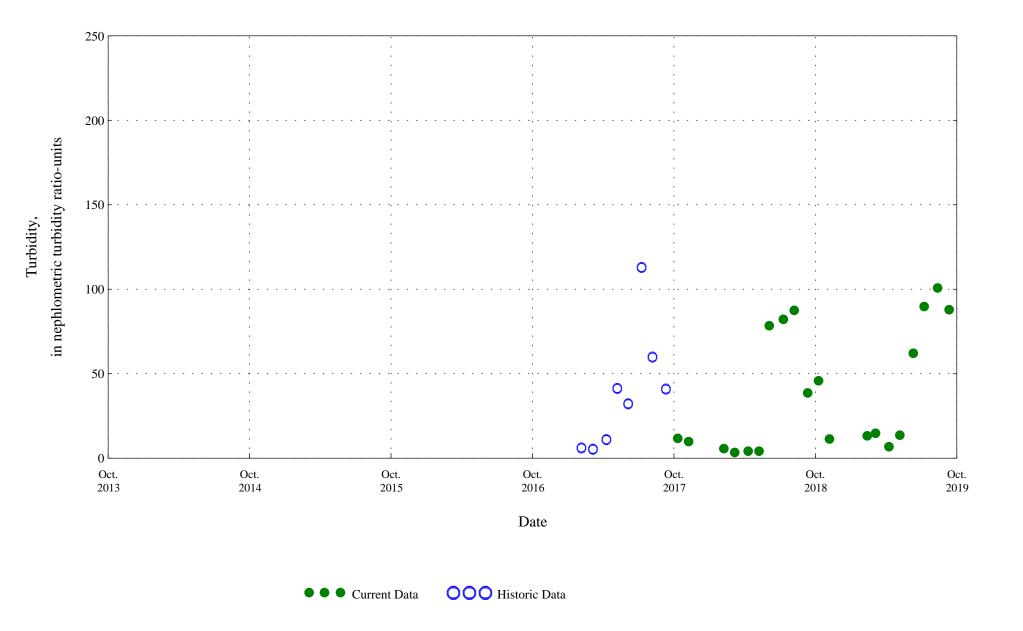
Figure 26. Distribution of selected water-quality constituents relative to time for Little Thompson River at Co. Highway 257 at Milliken, Co., station 06743470.

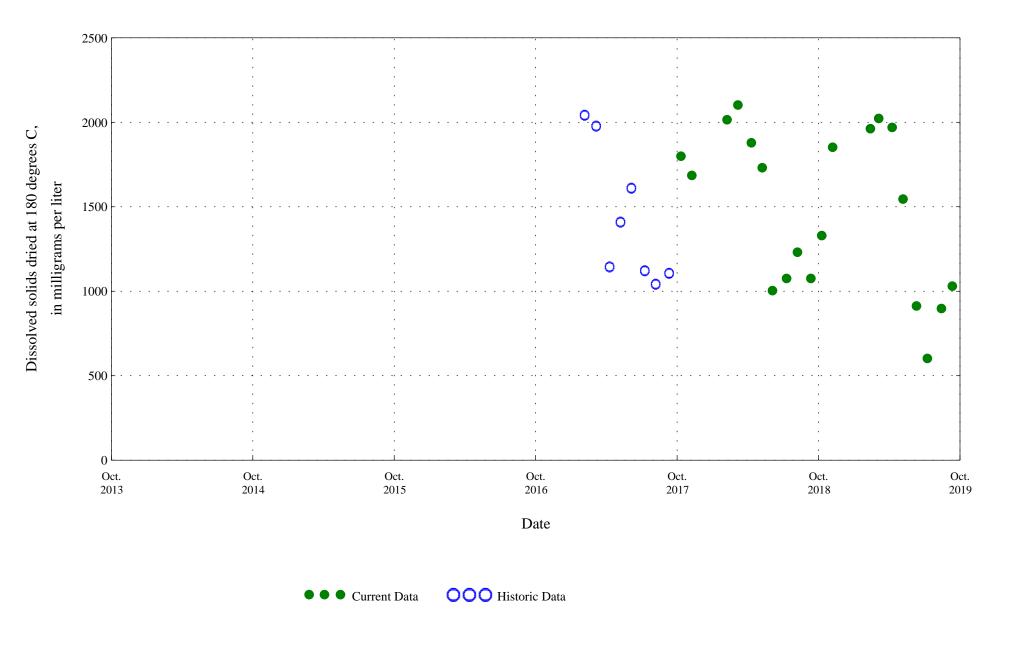
Figure 26. Distribution of selected water-quality constituents relative to time for Little Thompson River at Co. Highway 257 at Milliken, Co., station 06743470.

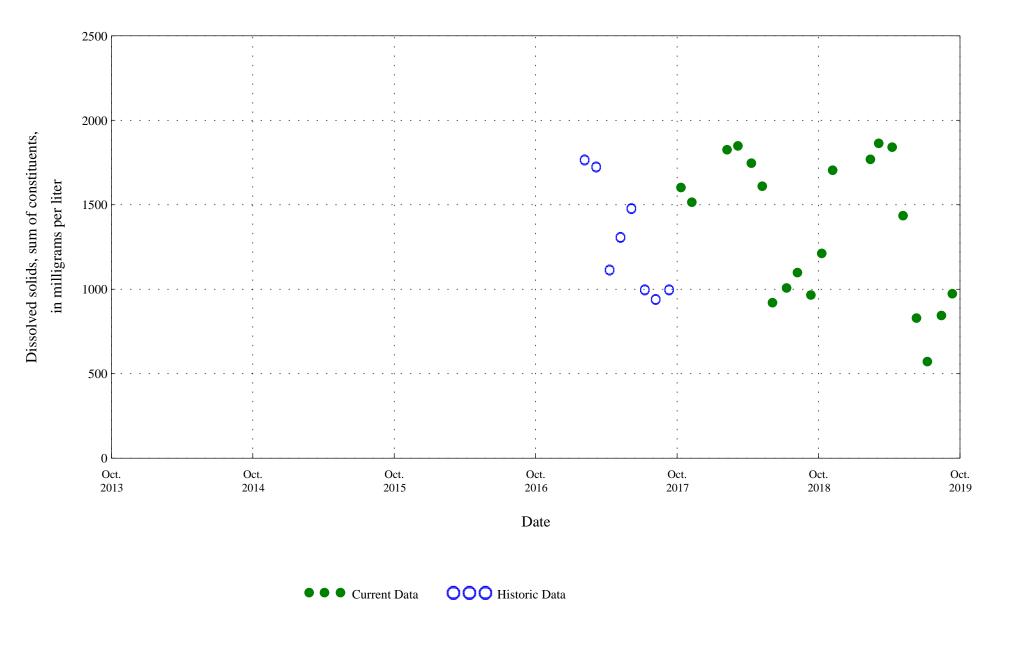
Figure 26. Distribution of selected water-quality constituents relative to time for Little Thompson River at Co. Highway 257 at Milliken, Co., station 06743470.

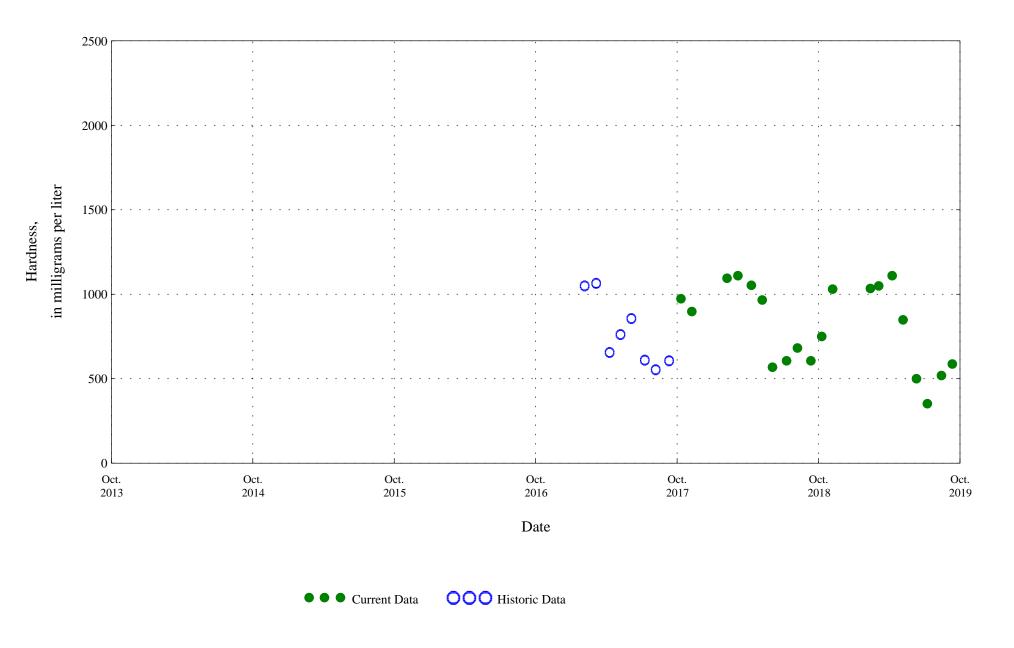
Figure 26. Distribution of selected water-quality constituents relative to time for Little Thompson River at Co. Highway 257 at Milliken, Co., station 06743470.

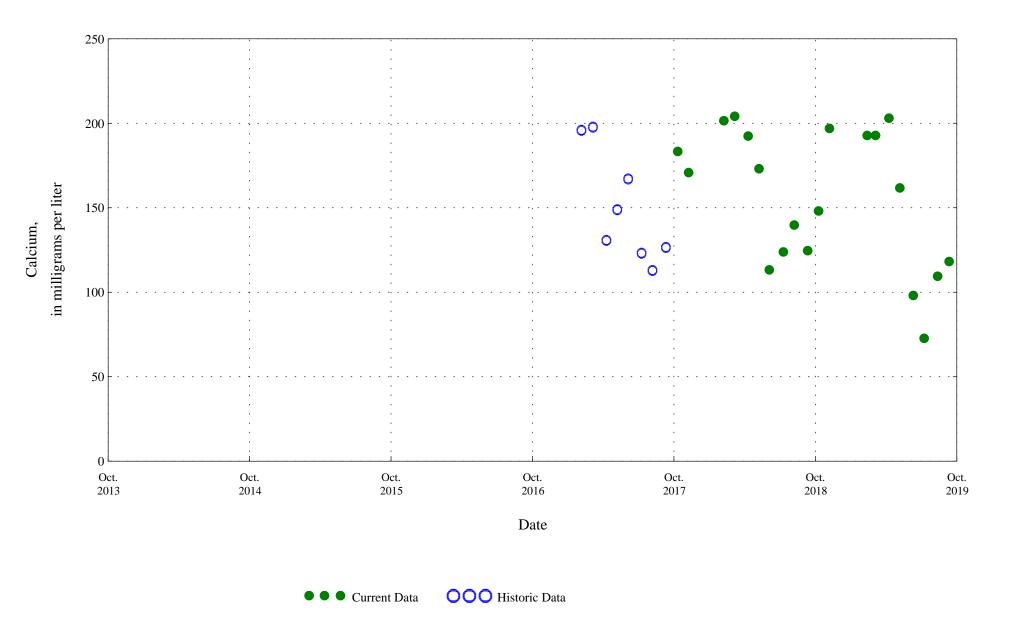
Figure 26. Distribution of selected water-quality constituents relative to time for Little Thompson River at Co. Highway 257 at Milliken, Co., station 06743470.

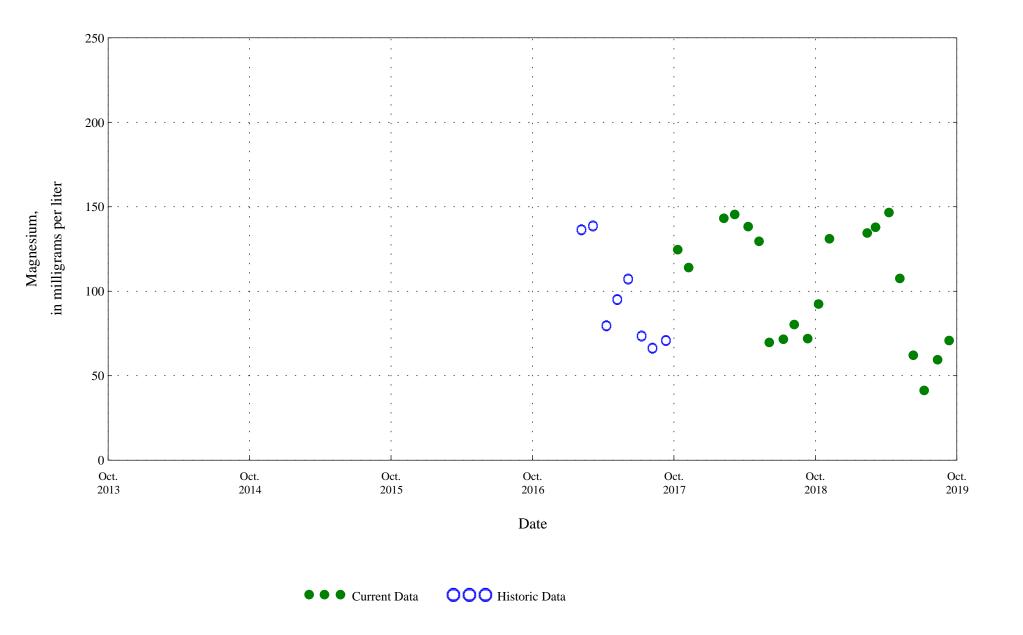
Figure 26. Distribution of selected water-quality constituents relative to time for Little Thompson River at Co. Highway 257 at Milliken, Co., station 06743470.

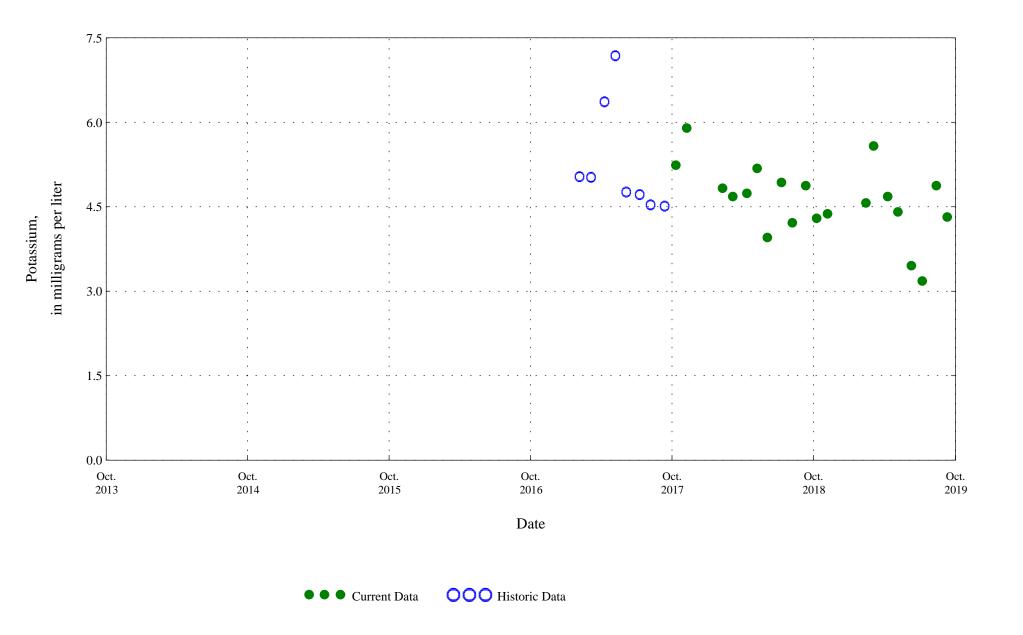
Figure 26. Distribution of selected water-quality constituents relative to time for Little Thompson River at Co. Highway 257 at Milliken, Co., station 06743470.

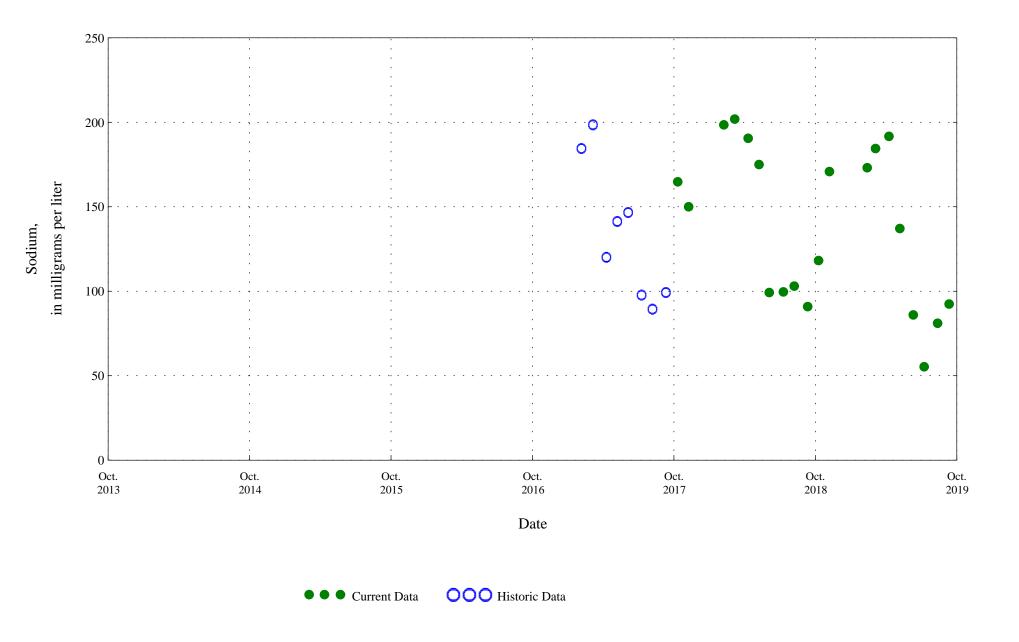
Figure 26. Distribution of selected water-quality constituents relative to time for Little Thompson River at Co. Highway 257 at Milliken, Co., station 06743470.

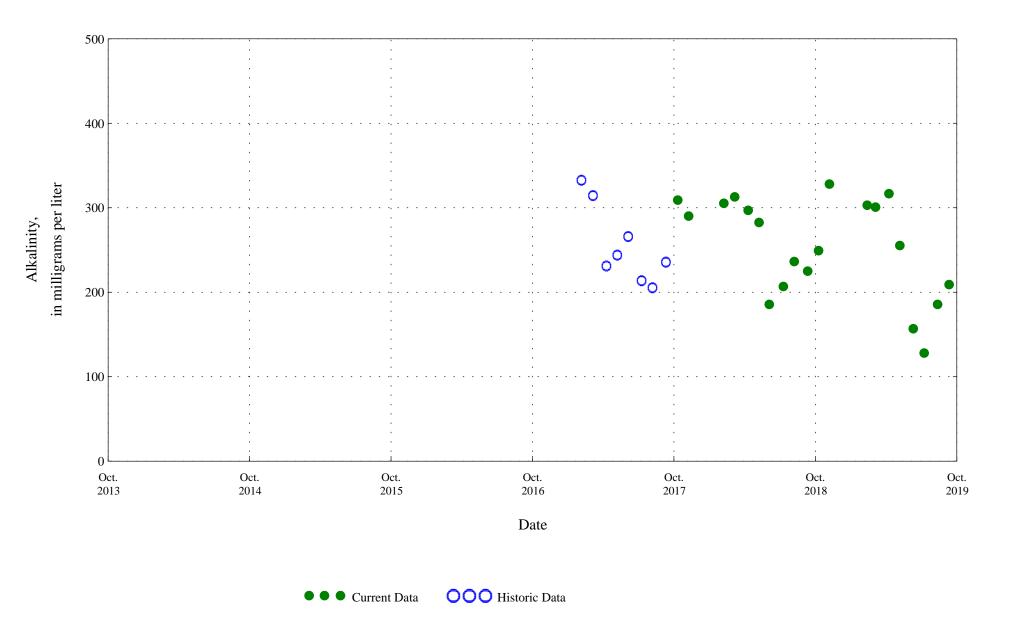
Figure 26. Distribution of selected water-quality constituents relative to time for Little Thompson River at Co. Highway 257 at Milliken, Co., station 06743470.

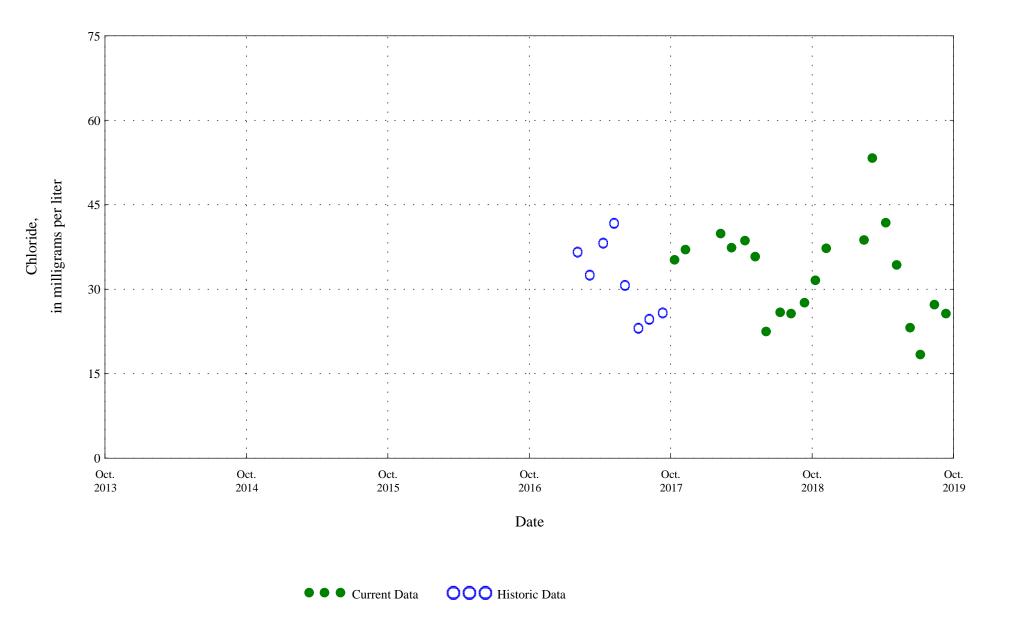
Figure 26. Distribution of selected water-quality constituents relative to time for Little Thompson River at Co. Highway 257 at Milliken, Co., station 06743470.

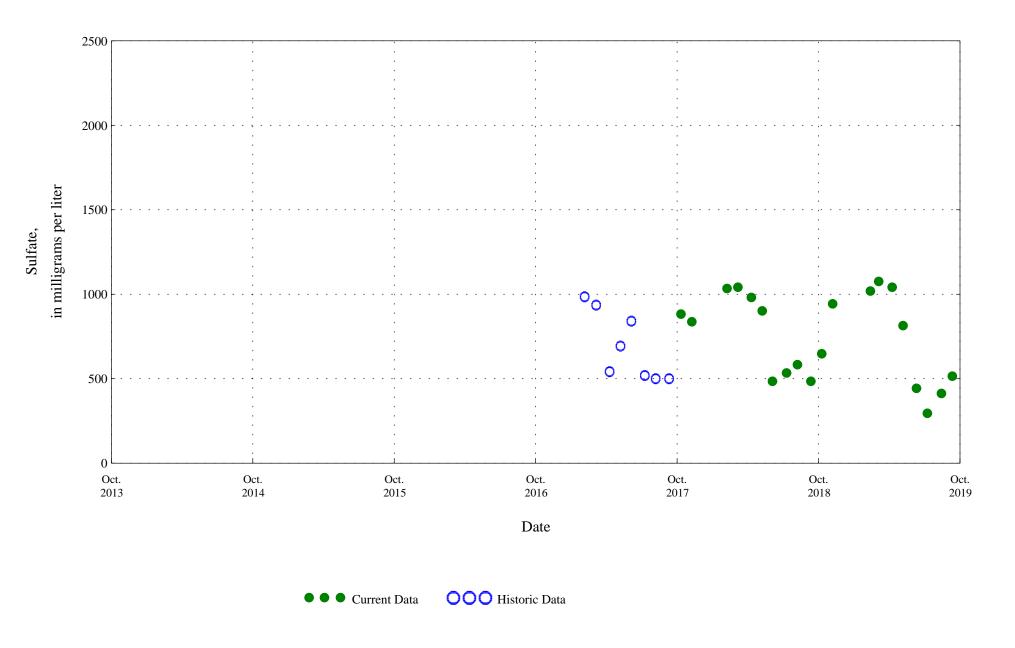
Figure 26. Distribution of selected water-quality constituents relative to time for Little Thompson River at Co. Highway 257 at Milliken, Co., station 06743470.

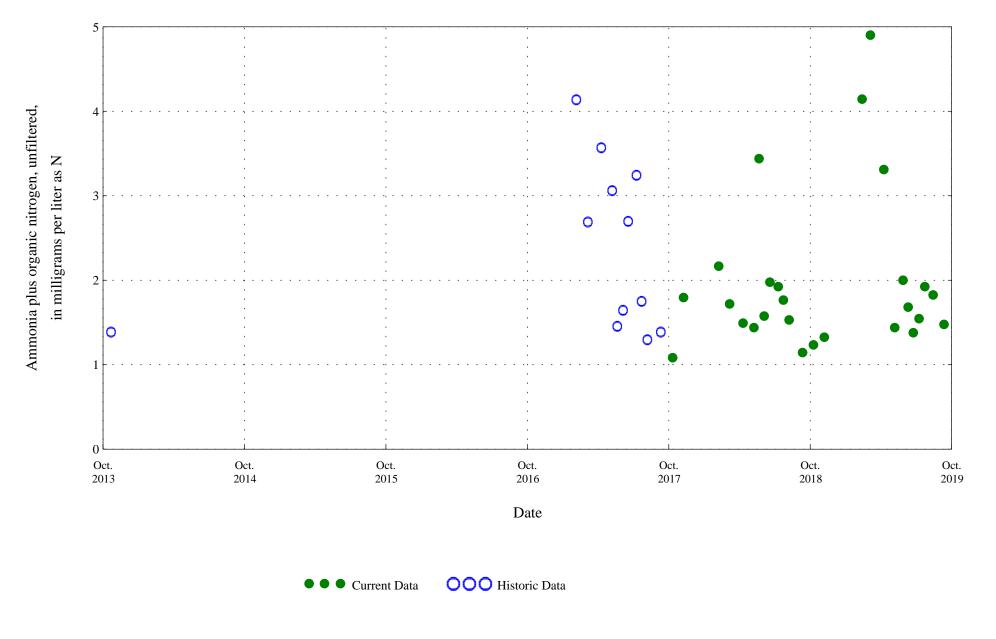
Figure 26. Distribution of selected water-quality constituents relative to time for Little Thompson River at Co. Highway 257 at Milliken, Co., station 06743470.

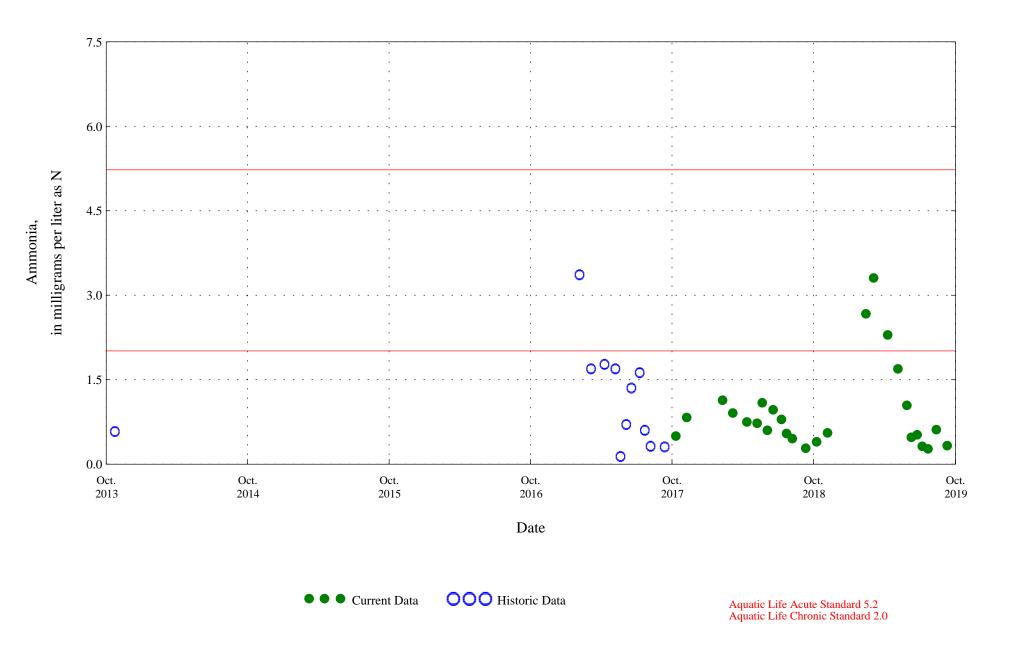
Figure 26. Distribution of selected water-quality constituents relative to time for Little Thompson River at Co. Highway 257 at Milliken, Co., station 06743470.

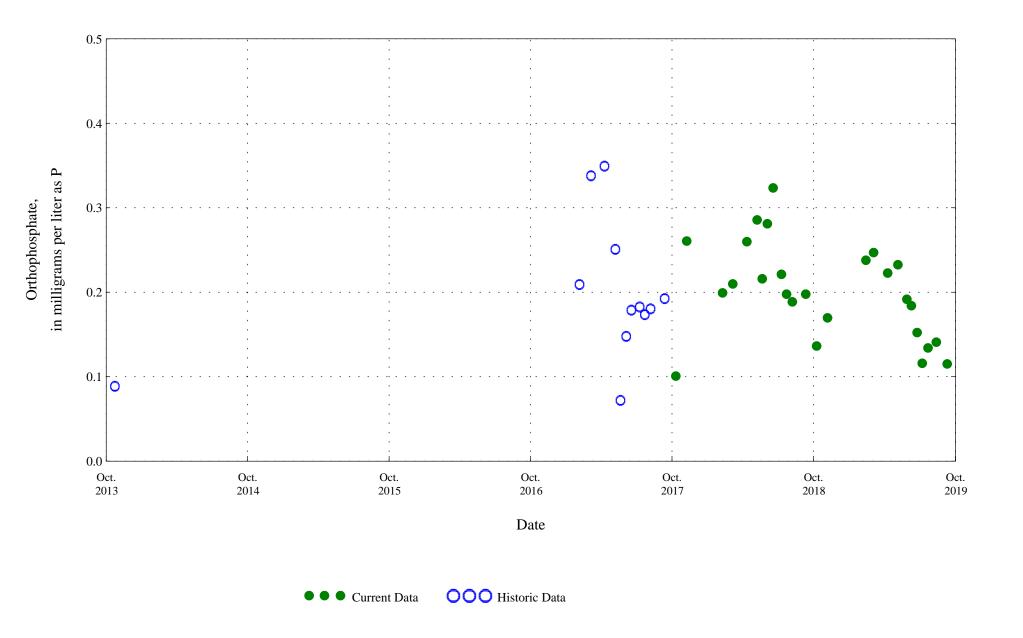
Figure 26. Distribution of selected water-quality constituents relative to time for Little Thompson River at Co. Highway 257 at Milliken, Co., station 06743470.

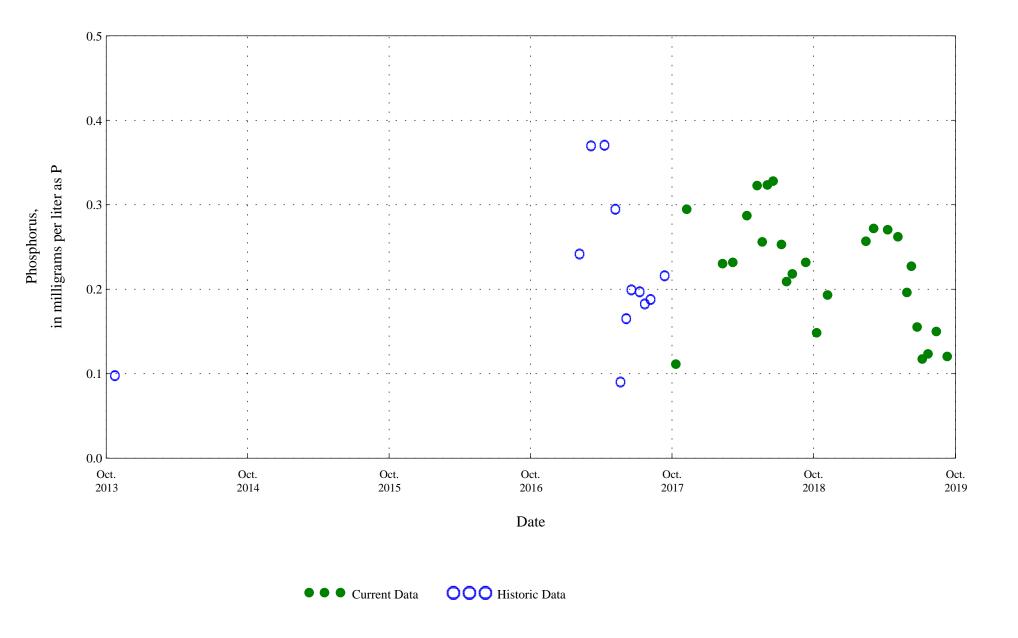
Figure 26. Distribution of selected water-quality constituents relative to time for Little Thompson River at Co. Highway 257 at Milliken, Co., station 06743470.

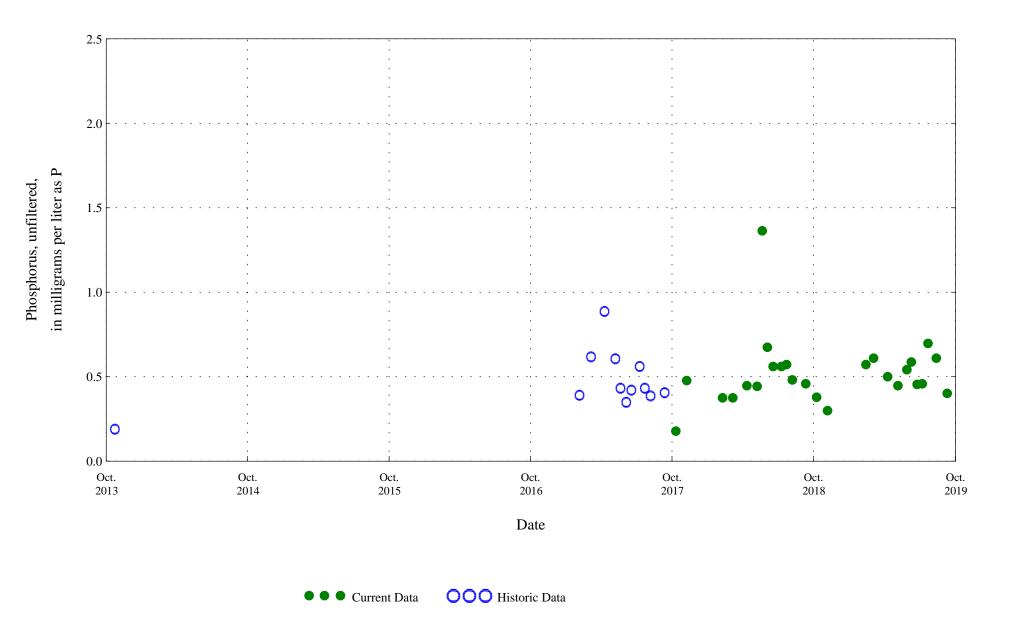
Figure 26. Distribution of selected water-quality constituents relative to time for Little Thompson River at Co. Highway 257 at Milliken, Co., station 06743470.

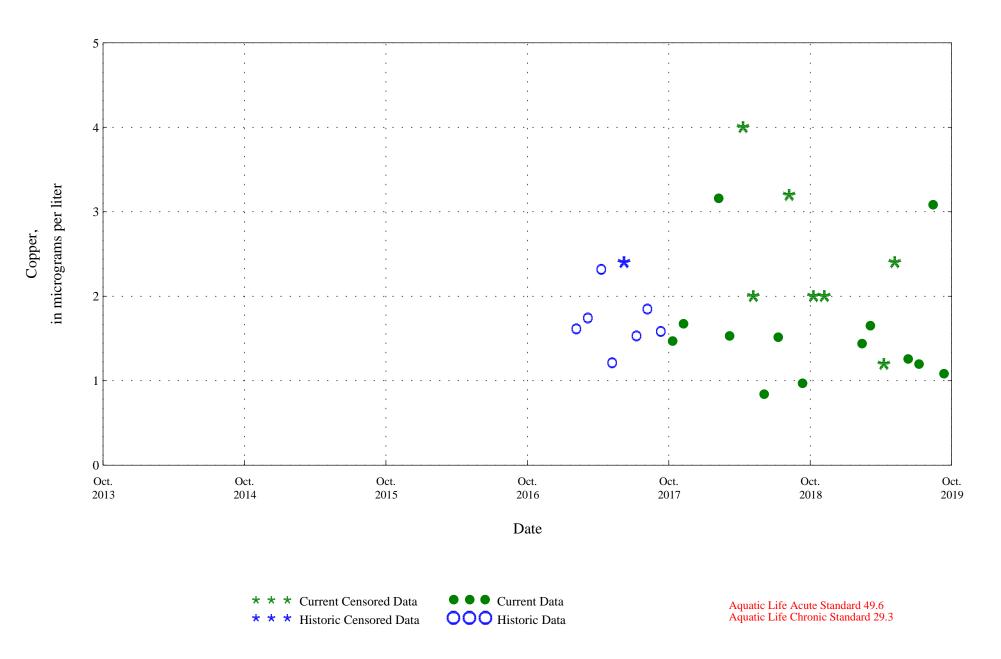
Figure 26. Distribution of selected water-quality constituents relative to time for Little Thompson River at Co. Highway 257 at Milliken, Co., station 06743470.

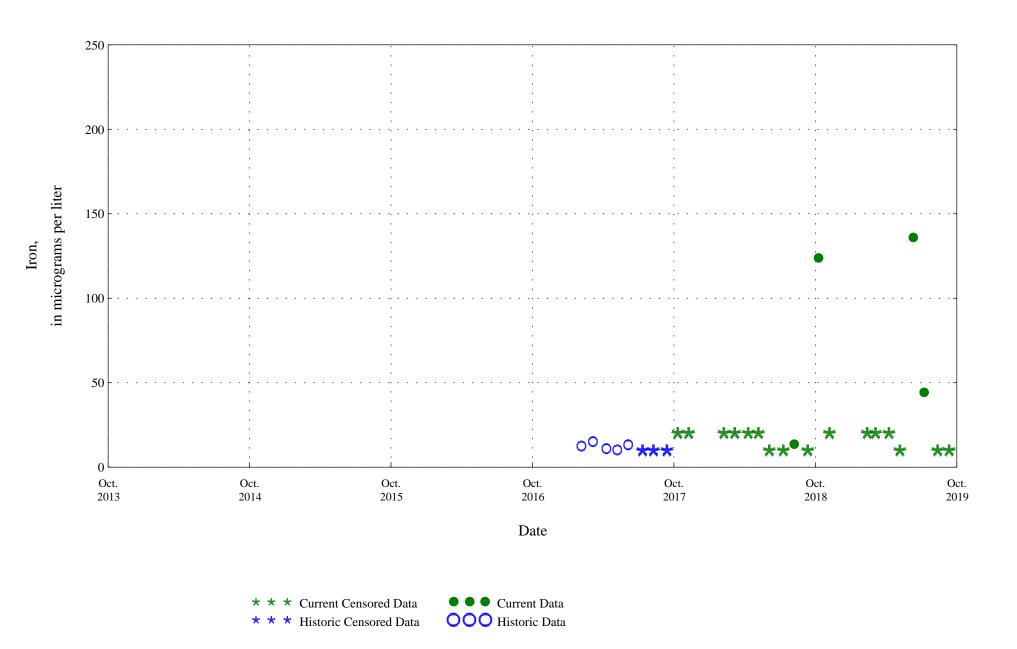
Figure 26. Distribution of selected water-quality constituents relative to time for Little Thompson River at Co. Highway 257 at Milliken, Co., station 06743470.

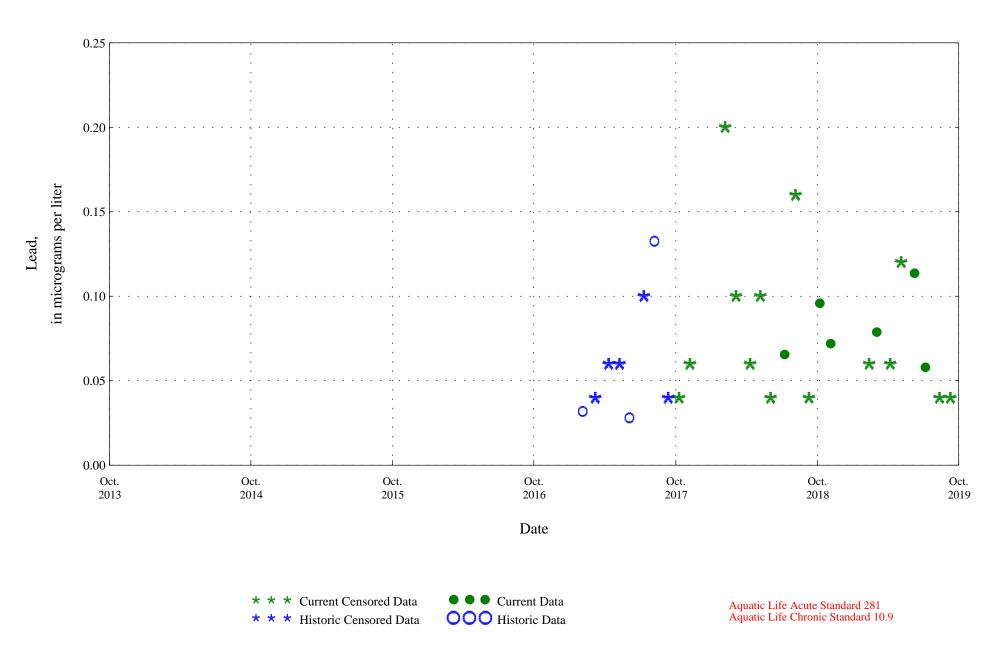
Figure 26. Distribution of selected water-quality constituents relative to time for Little Thompson River at Co. Highway 257 at Milliken, Co., station 06743470.

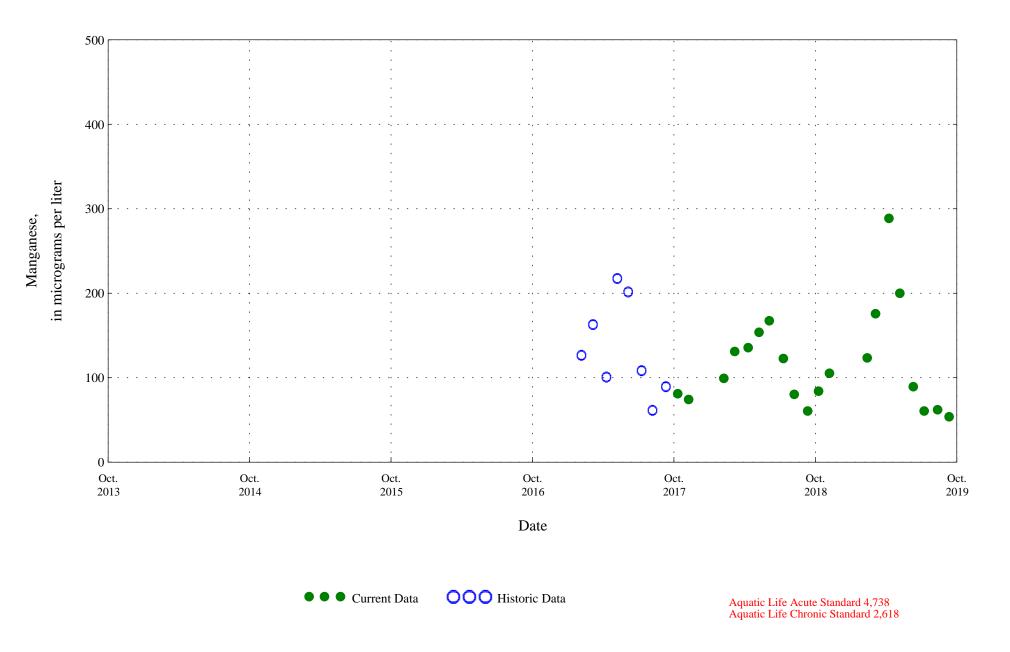
Figure 26. Distribution of selected water-quality constituents relative to time for Little Thompson River at Co. Highway 257 at Milliken, Co., station 06743470.

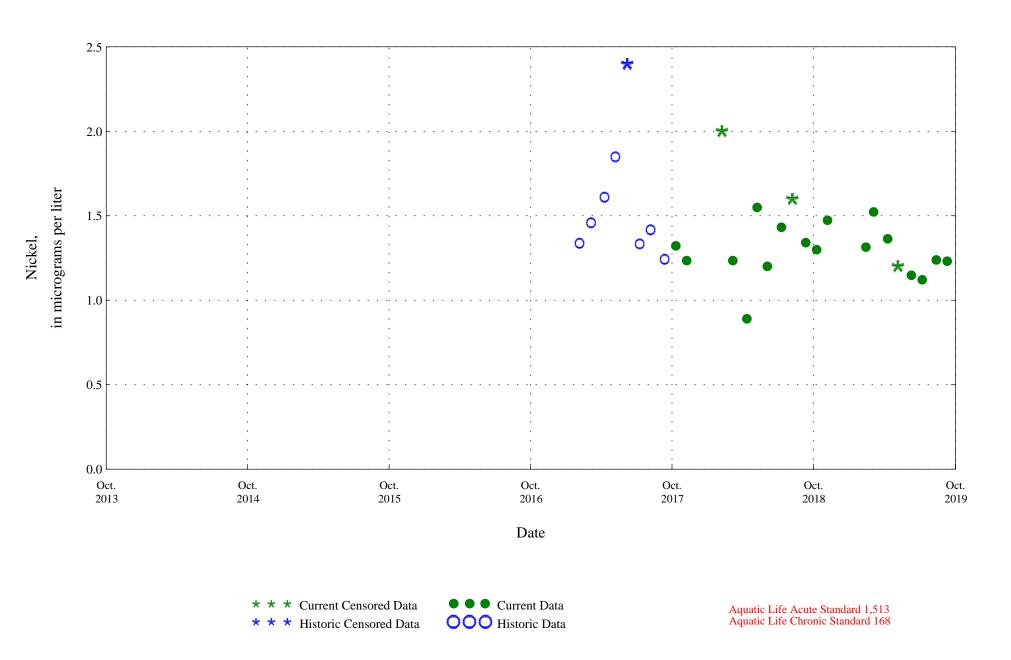
Figure 26. Distribution of selected water-quality constituents relative to time for Little Thompson River at Co. Highway 257 at Milliken, Co., station 06743470.

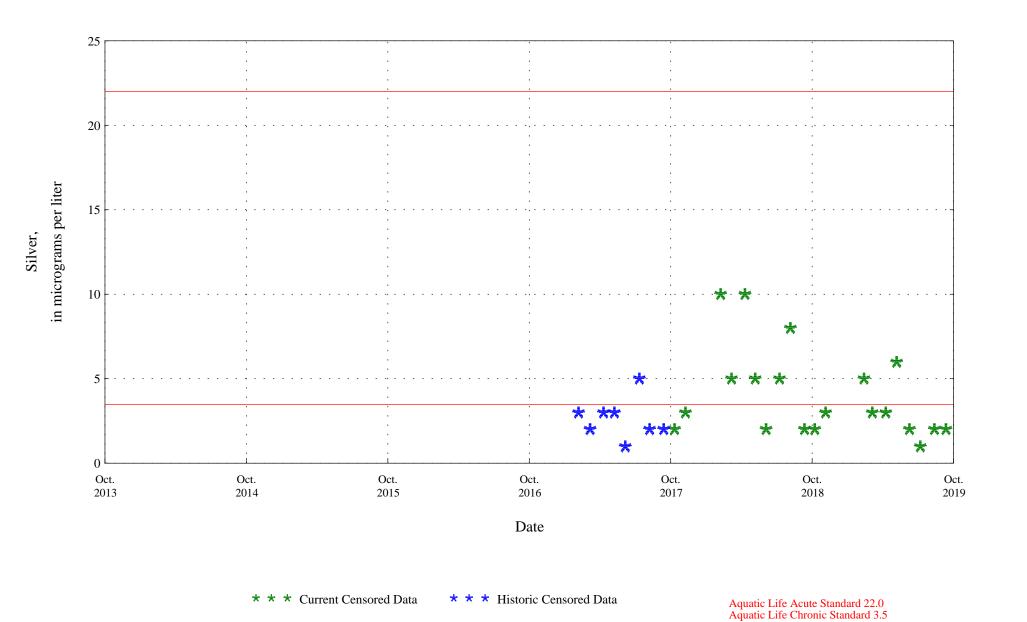
Figure 26. Distribution of selected water-quality constituents relative to time for Little Thompson River at Co. Highway 257 at Milliken, Co., station 06743470.

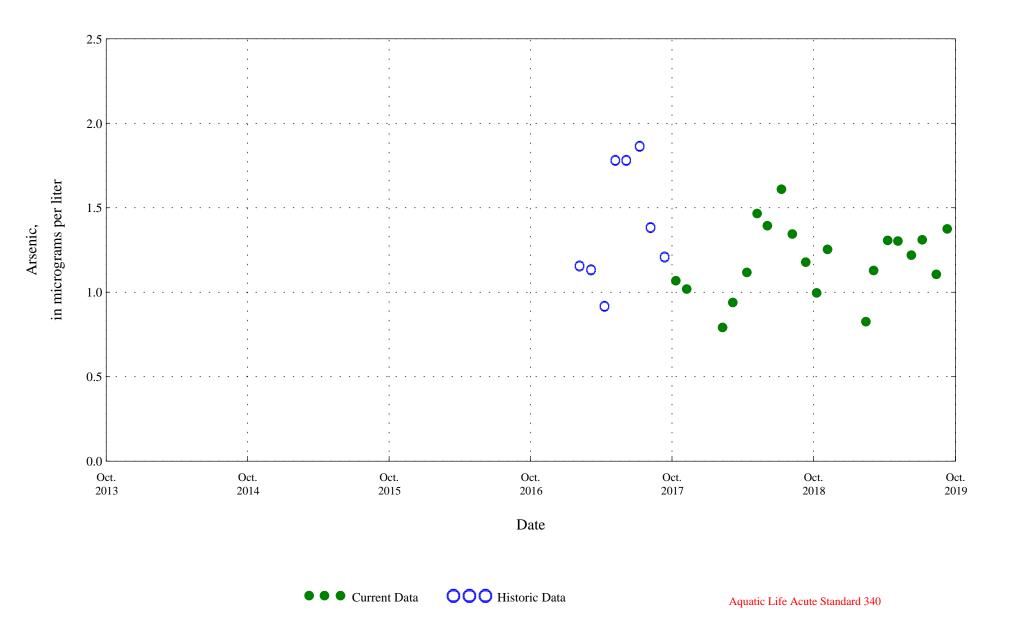
Figure 26. Distribution of selected water-quality constituents relative to time for Little Thompson River at Co. Highway 257 at Milliken, Co., station 06743470.

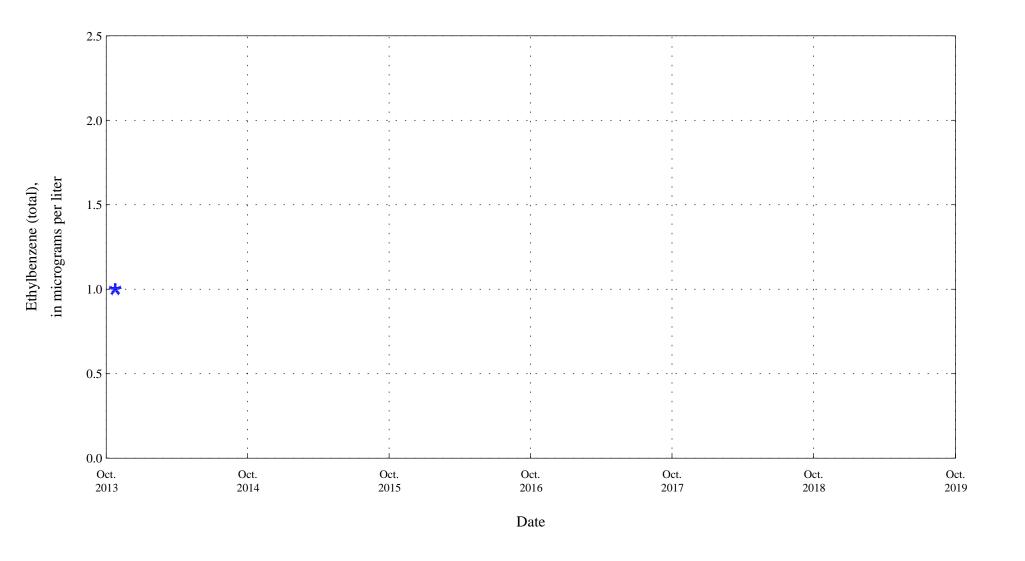
Figure 26. Distribution of selected water-quality constituents relative to time for Little Thompson River at Co. Highway 257 at Milliken, Co., station 06743470.

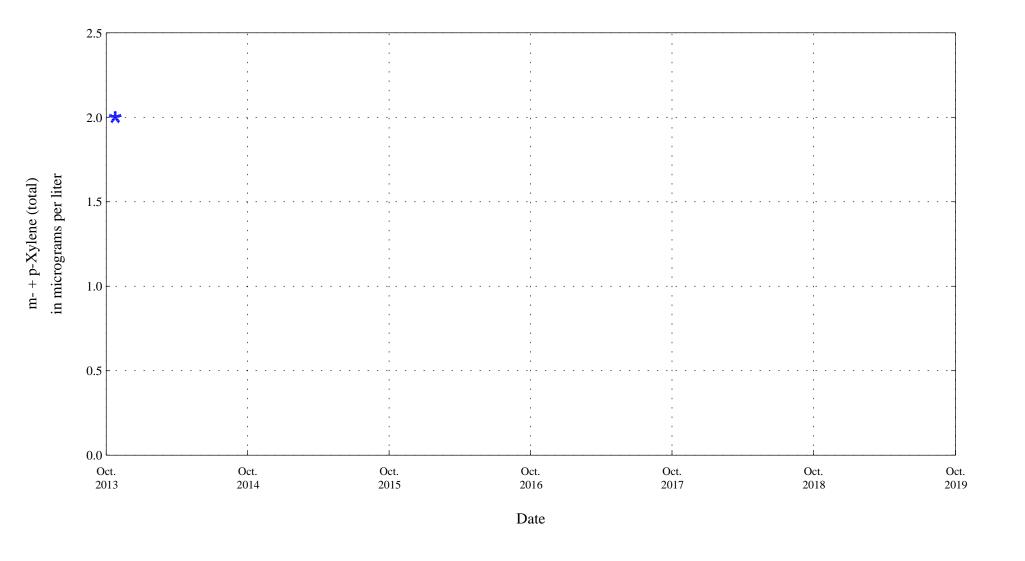
Figure 26. Distribution of selected water-quality constituents relative to time for Little Thompson River at Co. Highway 257 at Milliken, Co., station 06743470.

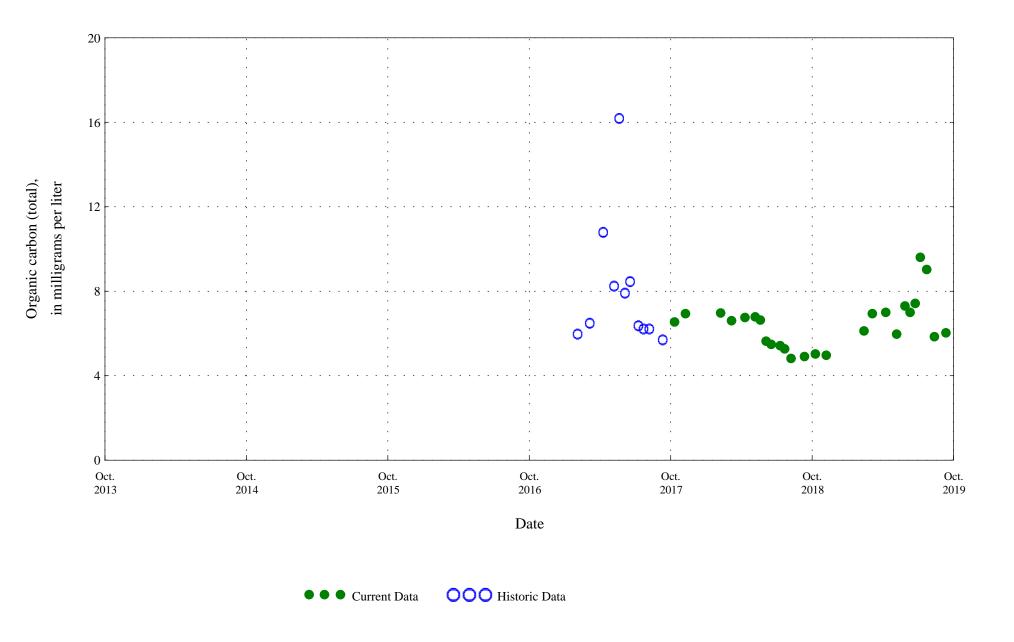
Figure 26. Distribution of selected water-quality constituents relative to time for Little Thompson River at Co. Highway 257 at Milliken, Co., station 06743470.

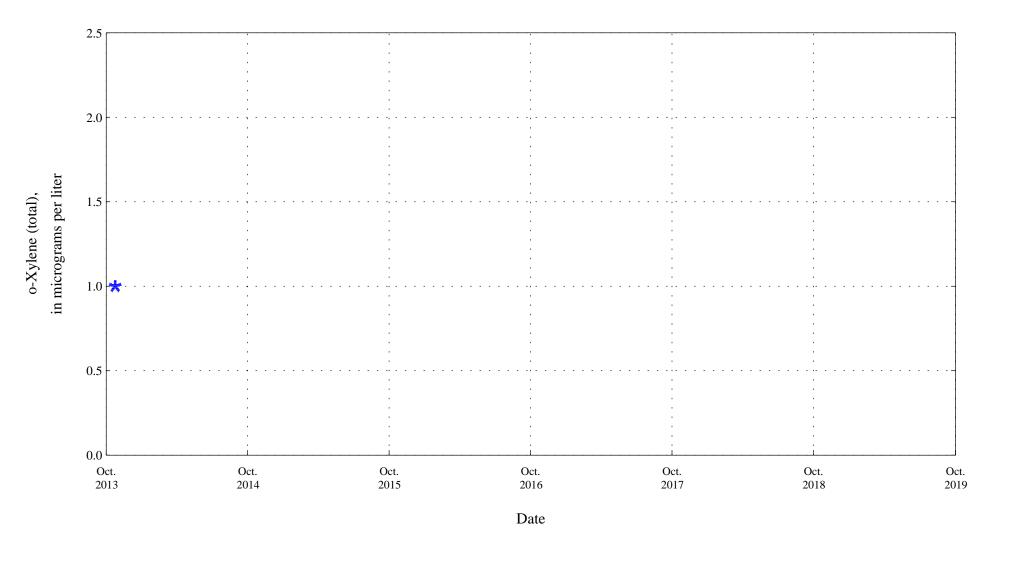
Figure 26. Distribution of selected water-quality constituents relative to time for Little Thompson River at Co. Highway 257 at Milliken, Co., station 06743470.

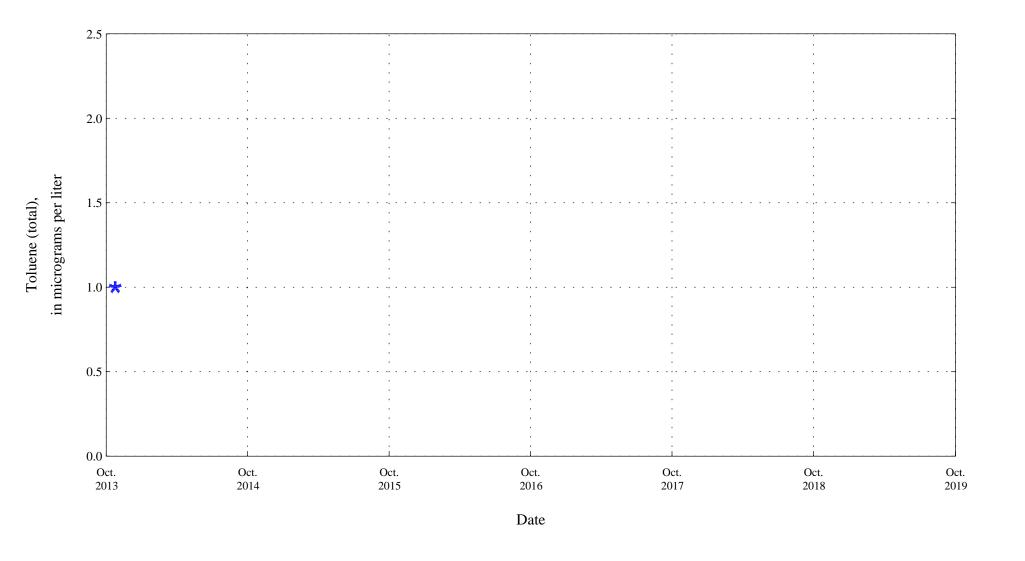
Figure 26. Distribution of selected water-quality constituents relative to time for Little Thompson River at Co. Highway 257 at Milliken, Co., station 06743470.
