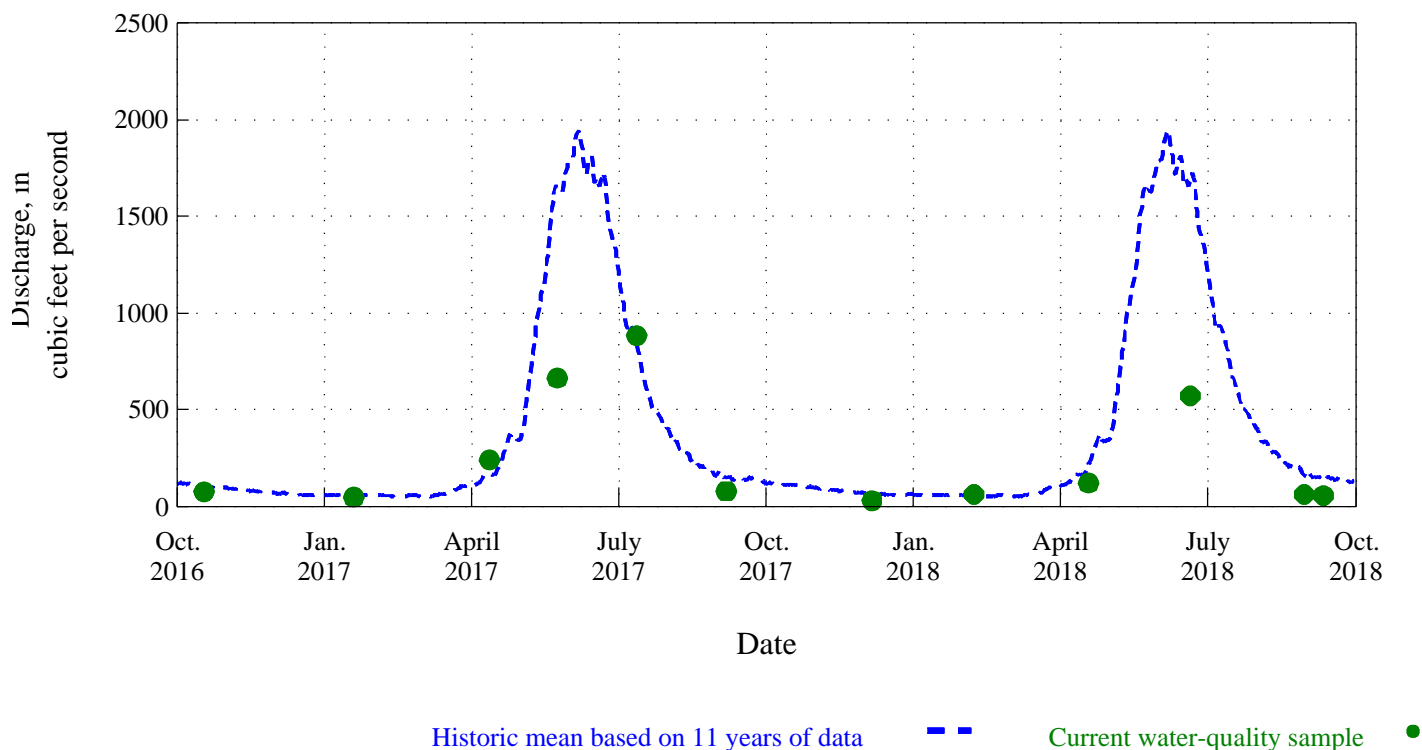
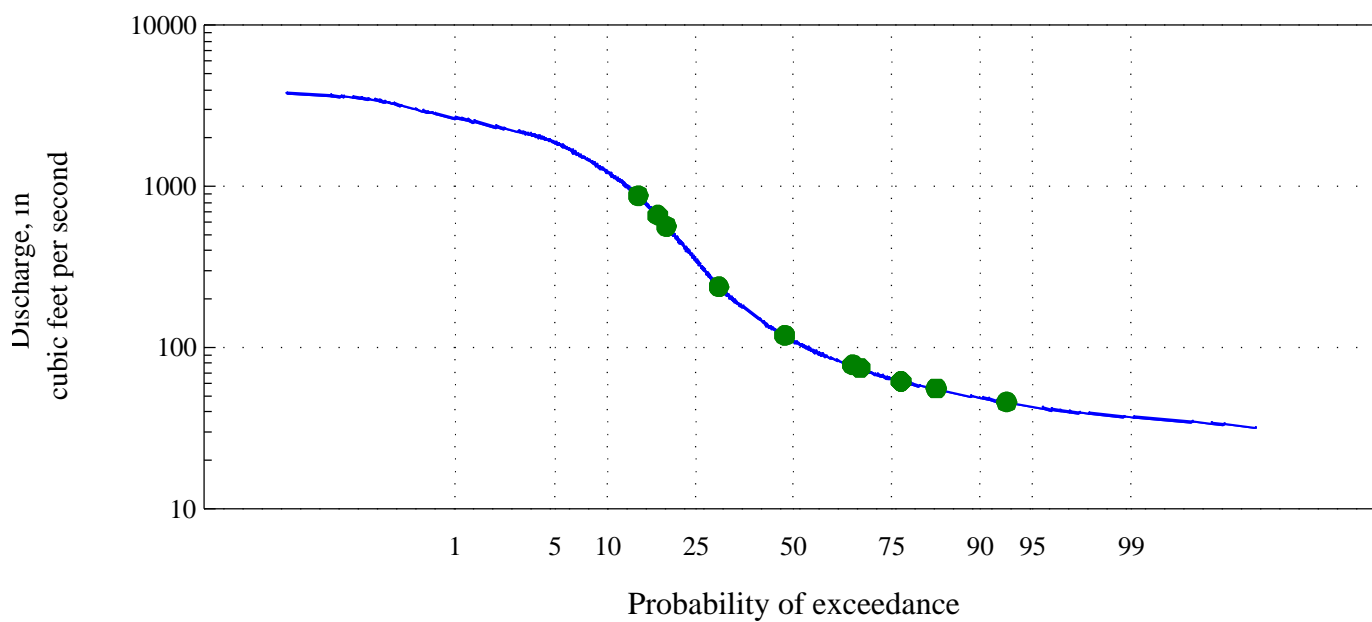
Figure 11. Time distribution and associated discharge of water-quality samples for Eagle River at Avon, Co., station 09067005.
