Figure 7. Time distribution and associated discharge of water-quality samples for Fraser River at Tabernash, CO., station 09027100.

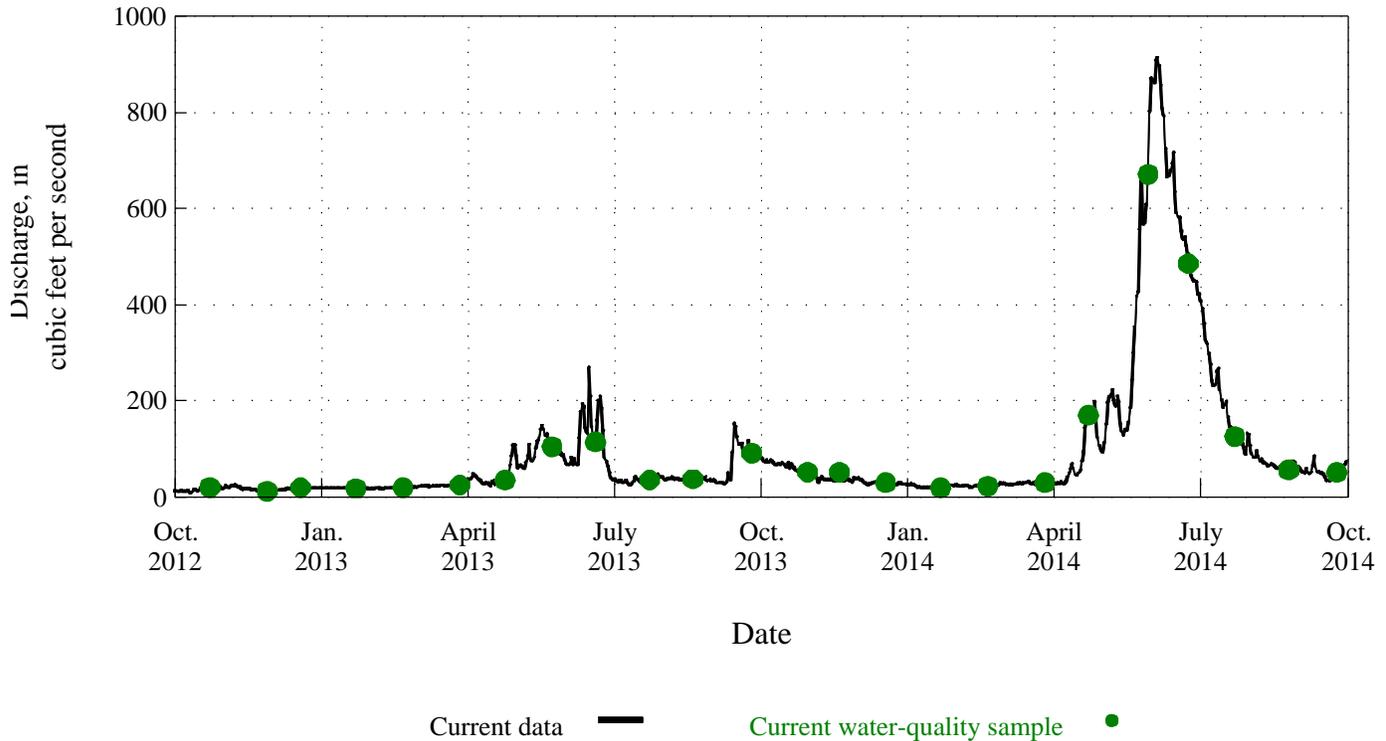
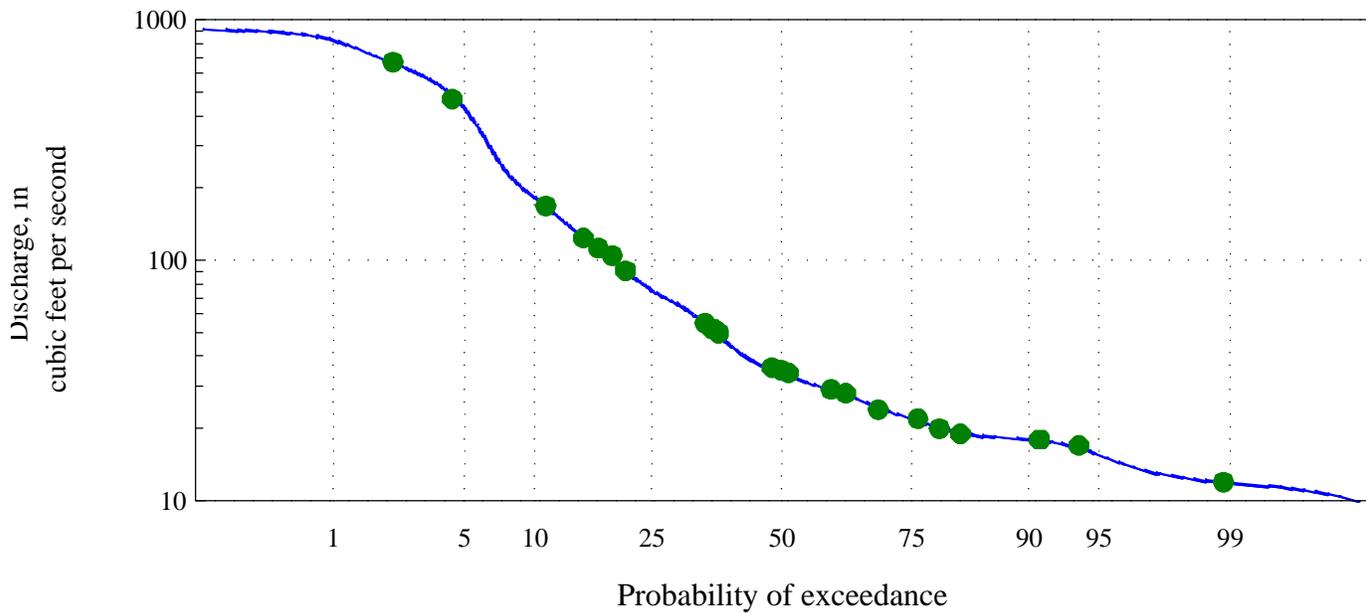
Duration curve based on 2 years of data      Current water-quality sample
