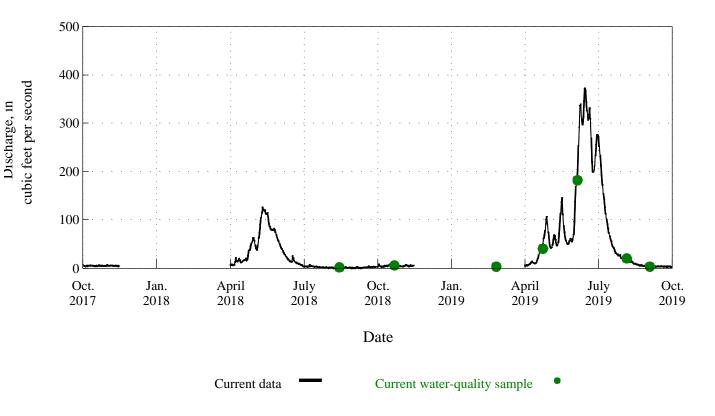
Figure 4. Time distribution and associated discharge of water-quality samples for Coal Creek above McCormick Ditch at Crested Butte, station 09111250.

Insufficient data for generation of flow duration curve.
