Figure 6. Distribution of selected water-quality constituents relative to time for

Yampa River below Stagecoach Reservoir, Co., station 09237500.

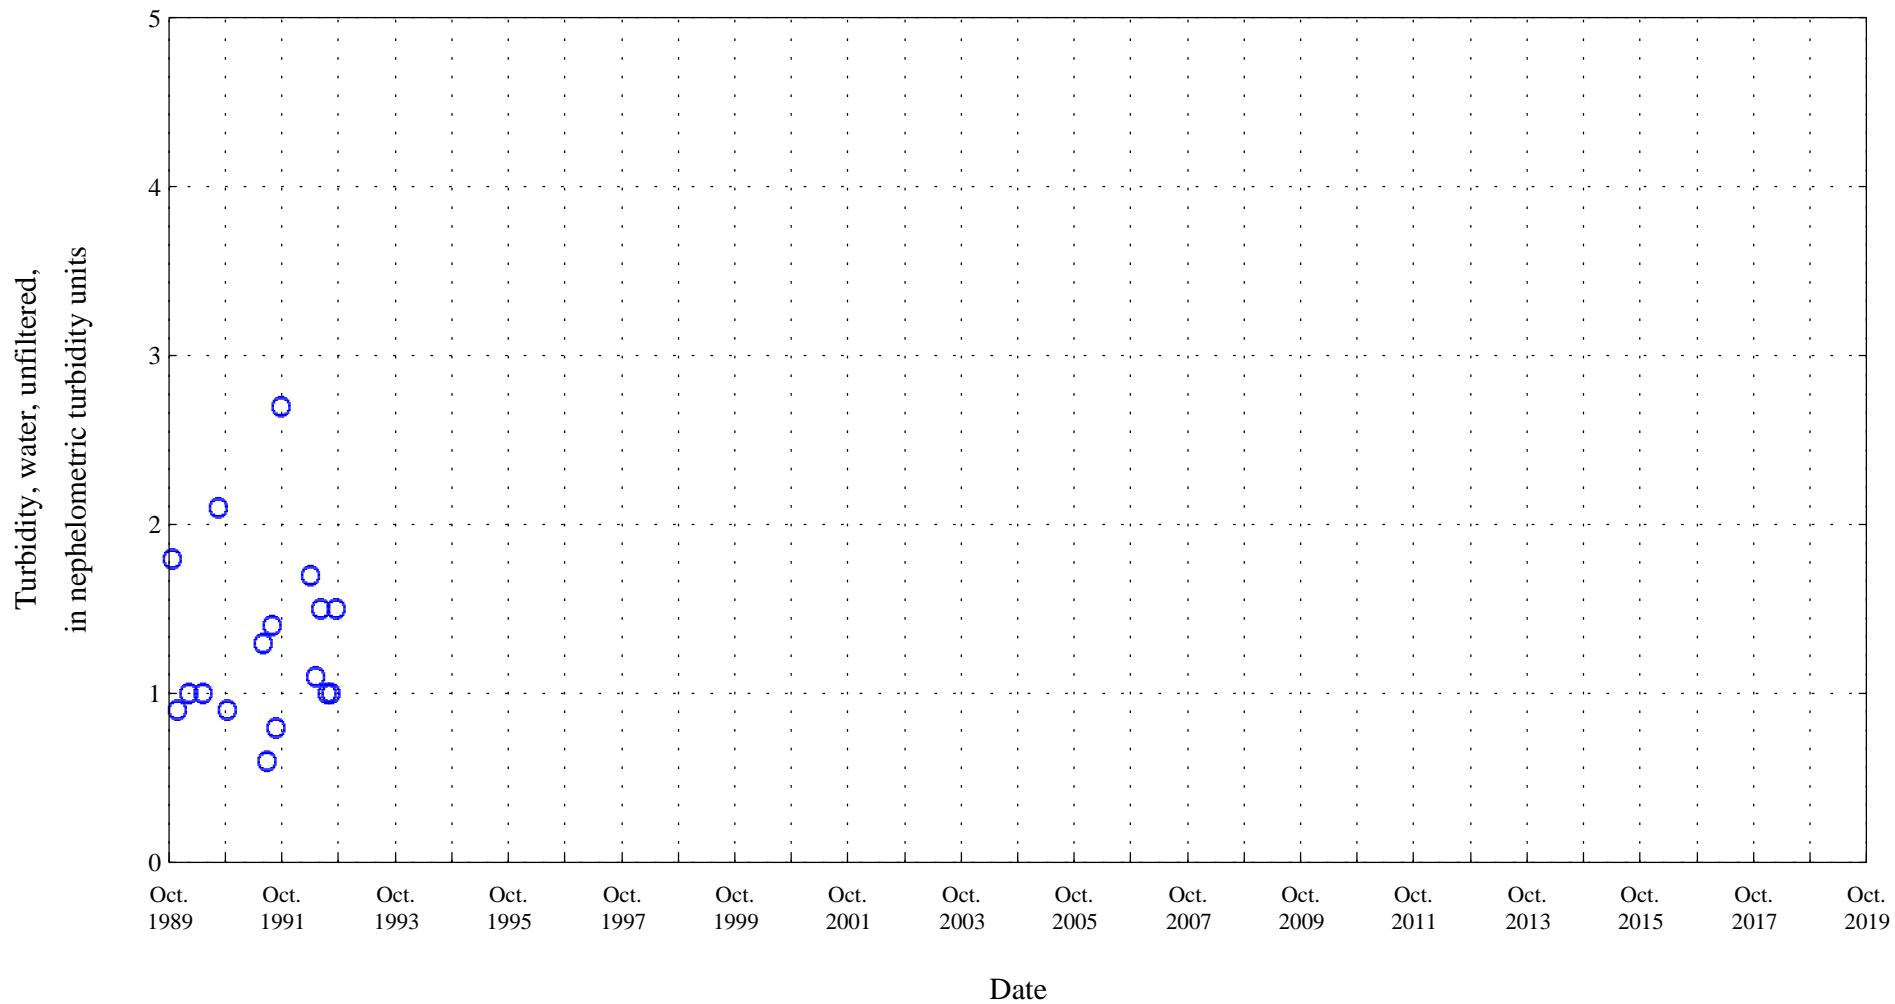
Figure 6. Distribution of selected water-quality constituents relative to time for

Yampa River below Stagecoach Reservoir, Co., station 09237500.

○ ○ ○ Historic Data

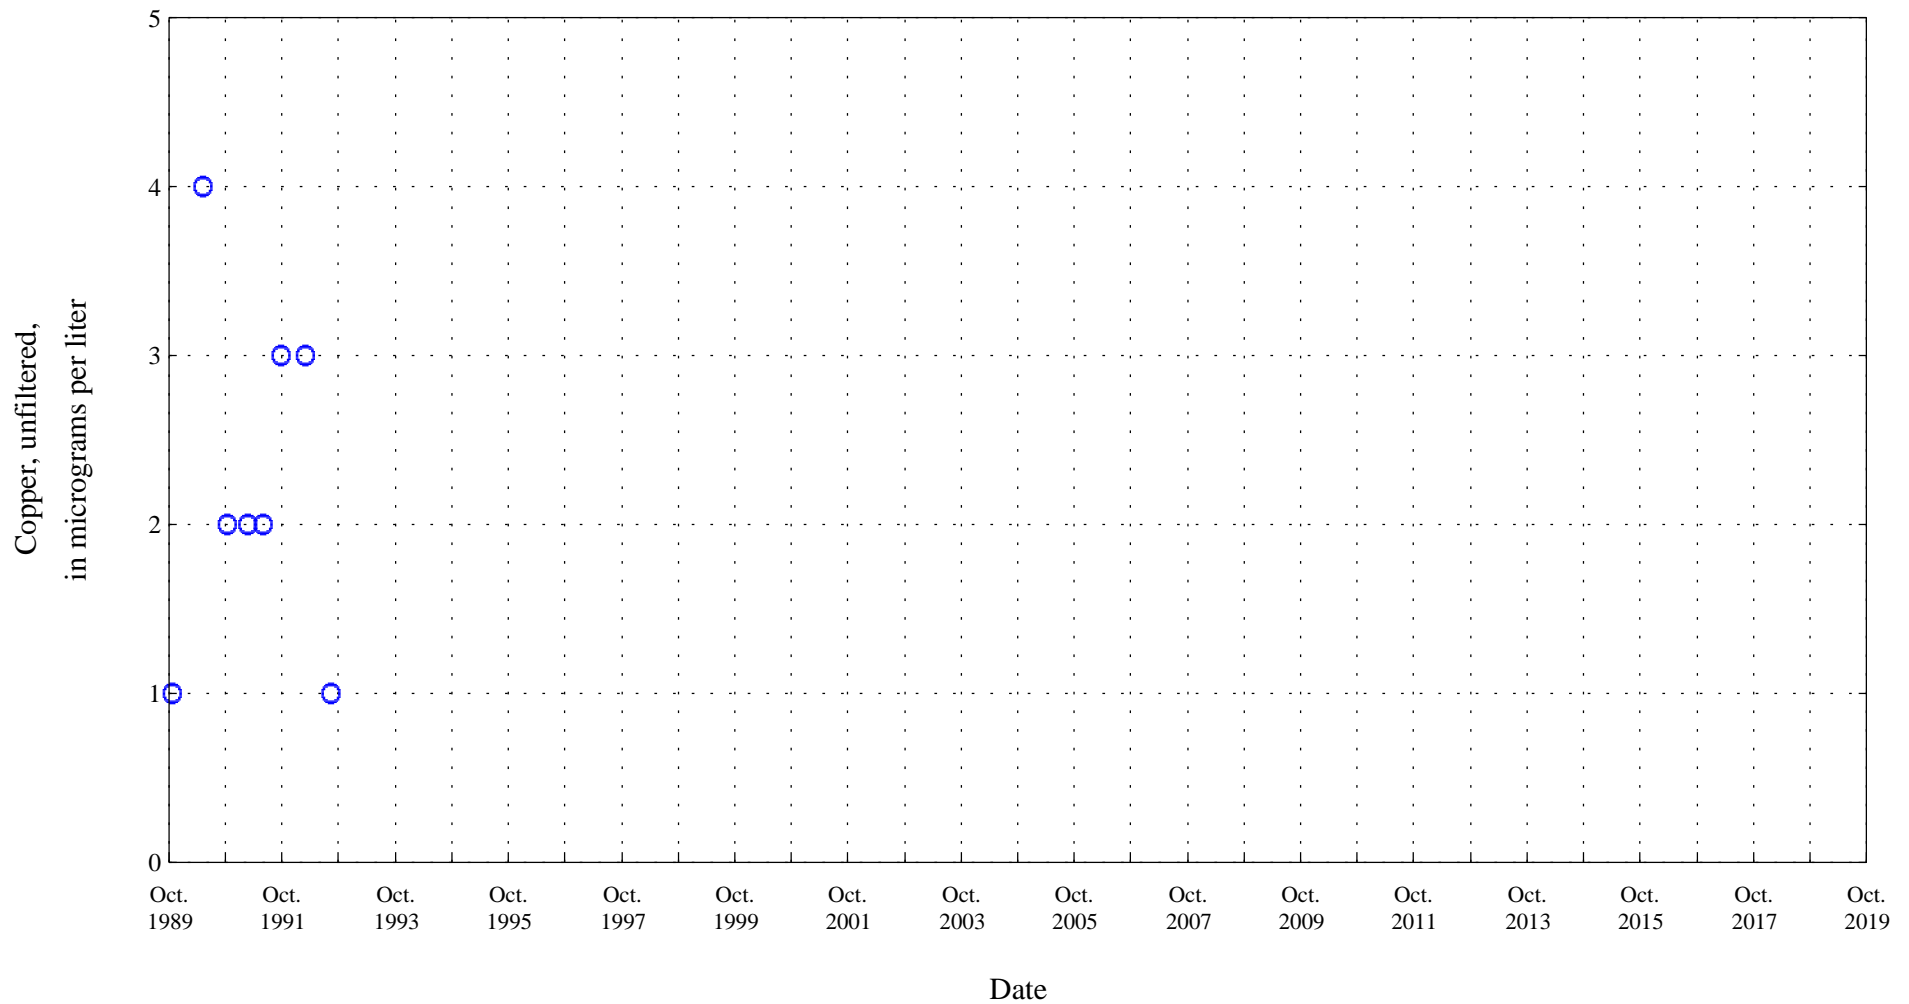
Figure 6. Distribution of selected water-quality constituents relative to time for

Yampa River below Stagecoach Reservoir, Co., station 09237500.

○ ○ ○ Historic Data

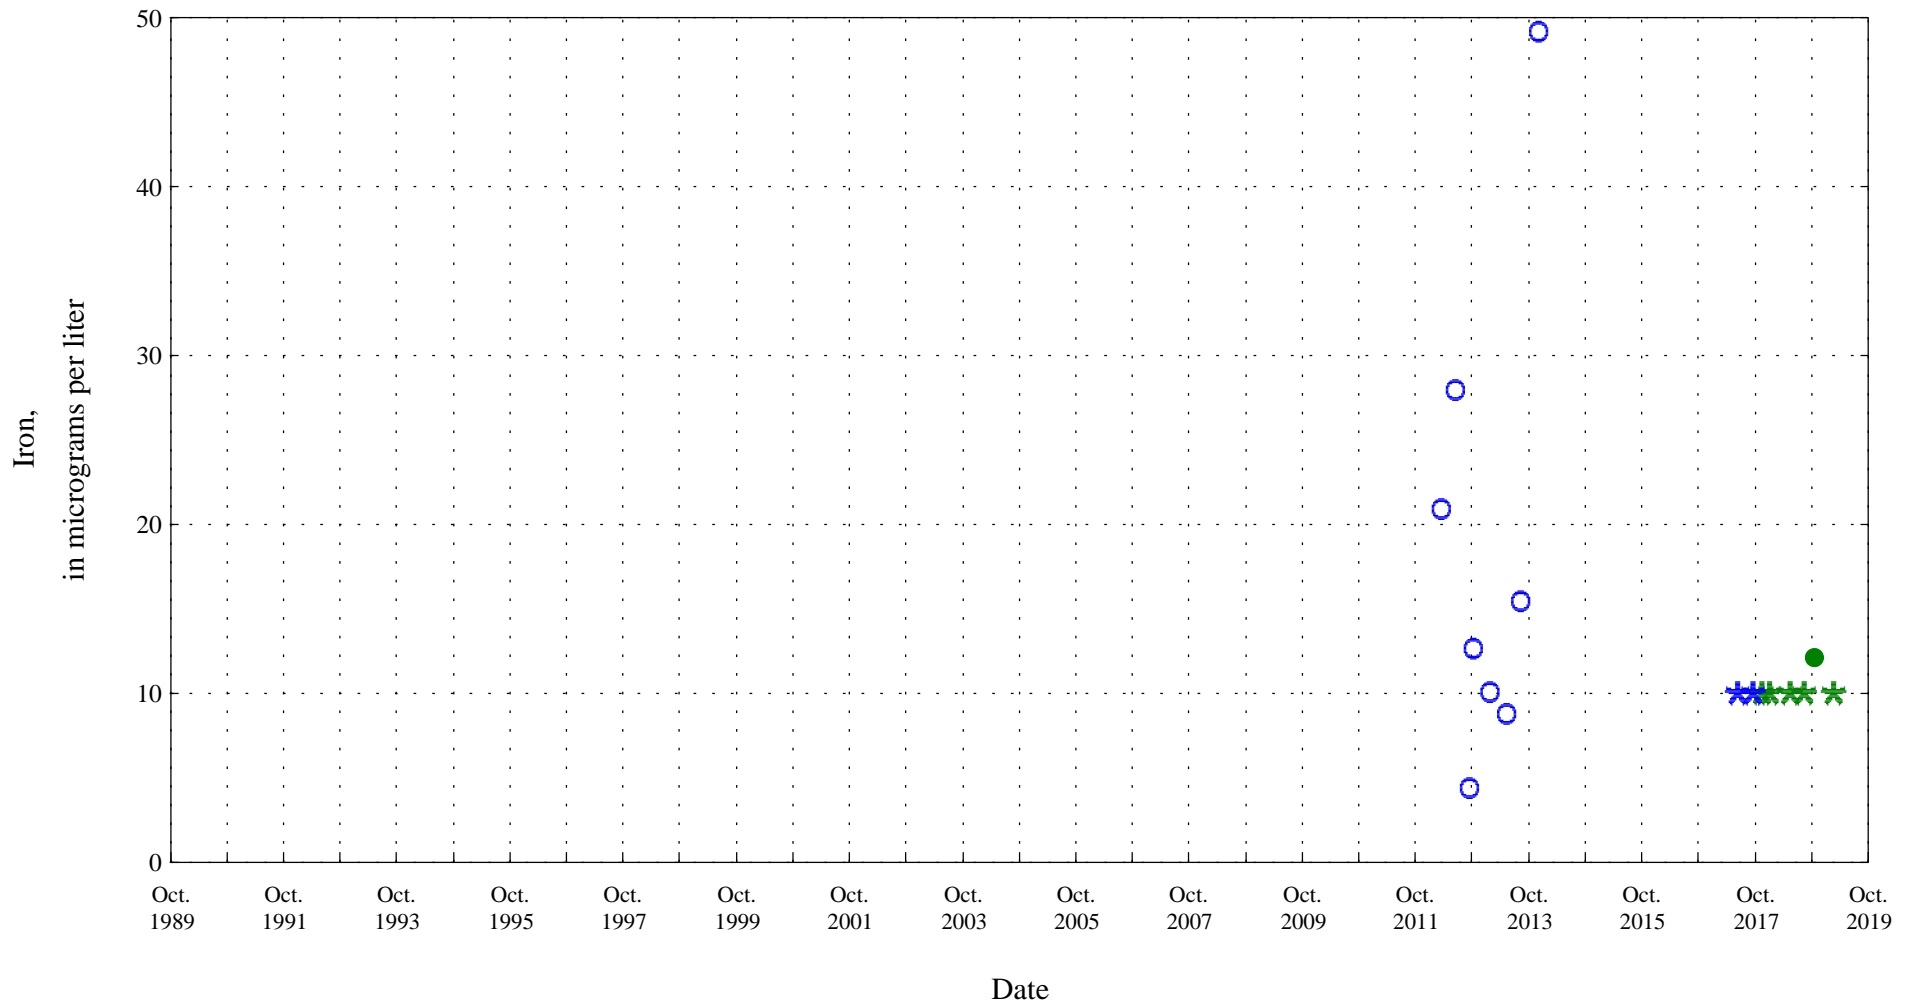
Yampa River below Stagecoach Reservoir, Co., station 09237500.

Current Censored Data

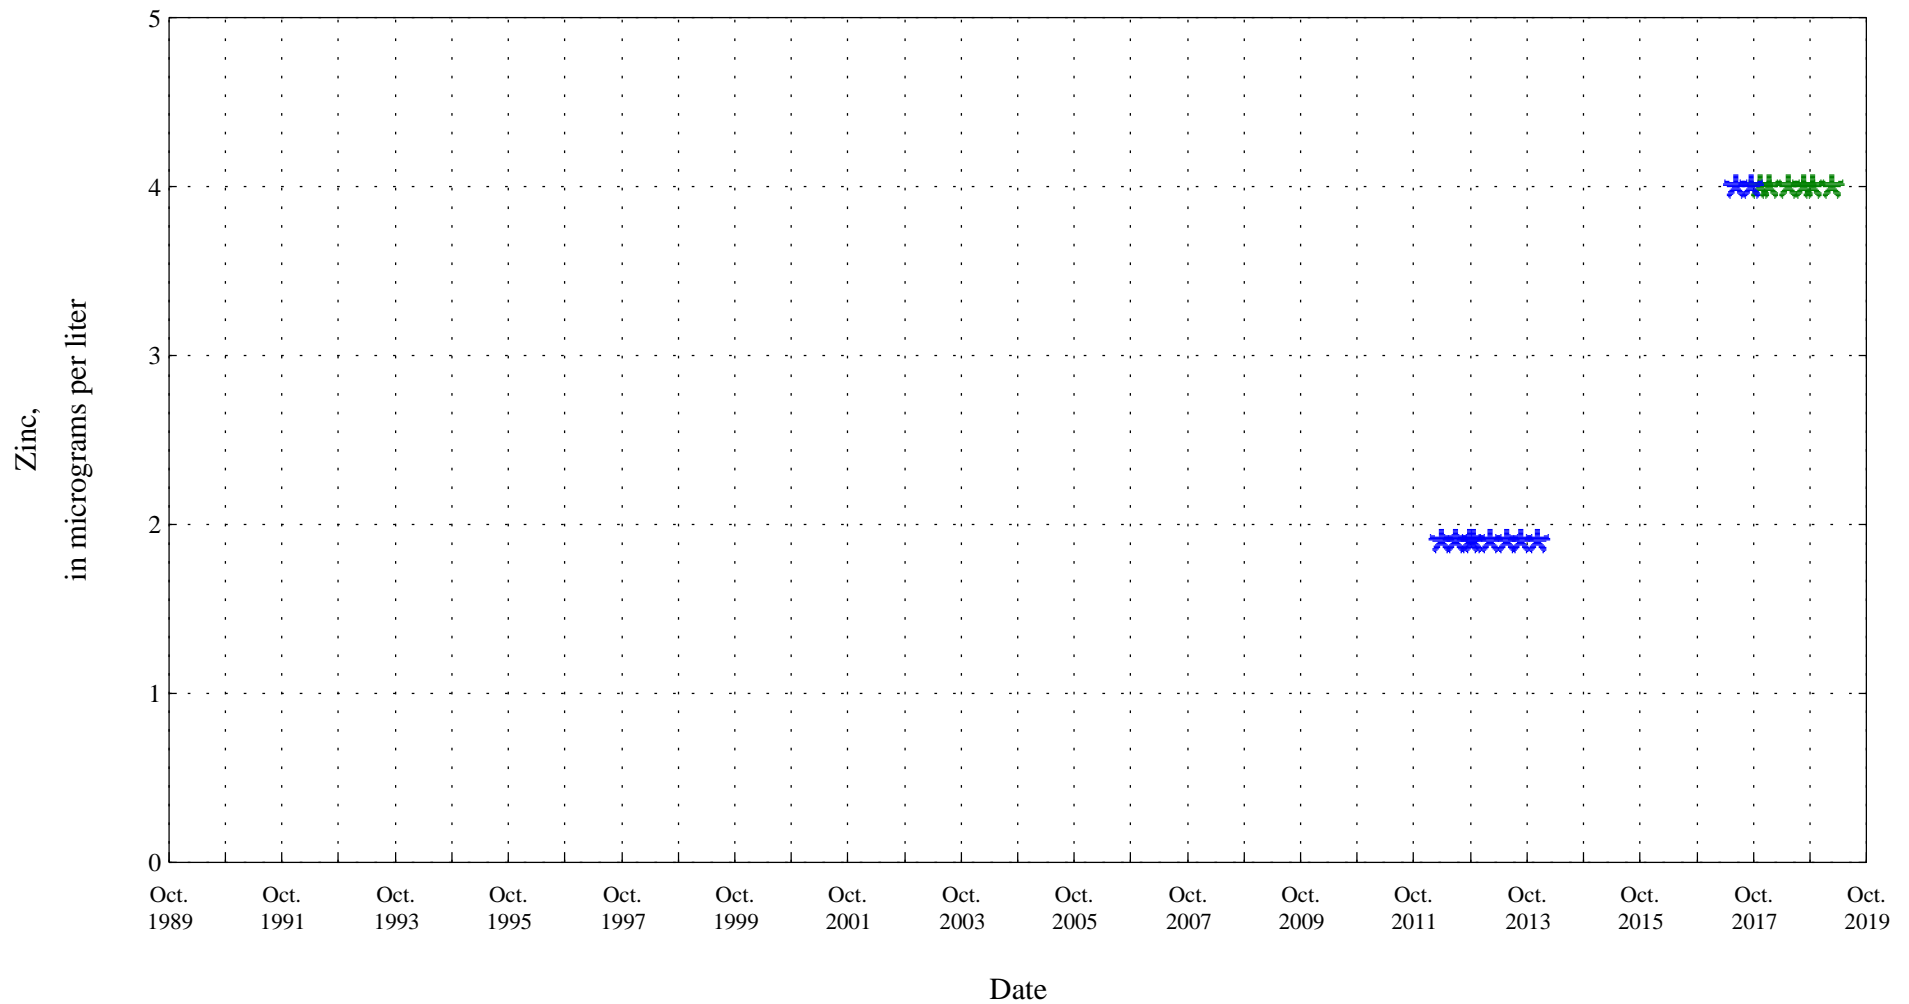
Figure 6. Distribution of selected water-quality constituents relative to time for

Yampa River below Stagecoach Reservoir, Co., station 09237500.

*** Current Censored Data *** Historic Censored Data

Aquatic Life Acute Standard 317
Aquatic Life Chronic Standard 240
